ATTACHMENT E
Instream gravel mining 2005 and 2006 seasons, Gualala River

Friends of the Gualala River
October 26, 2006

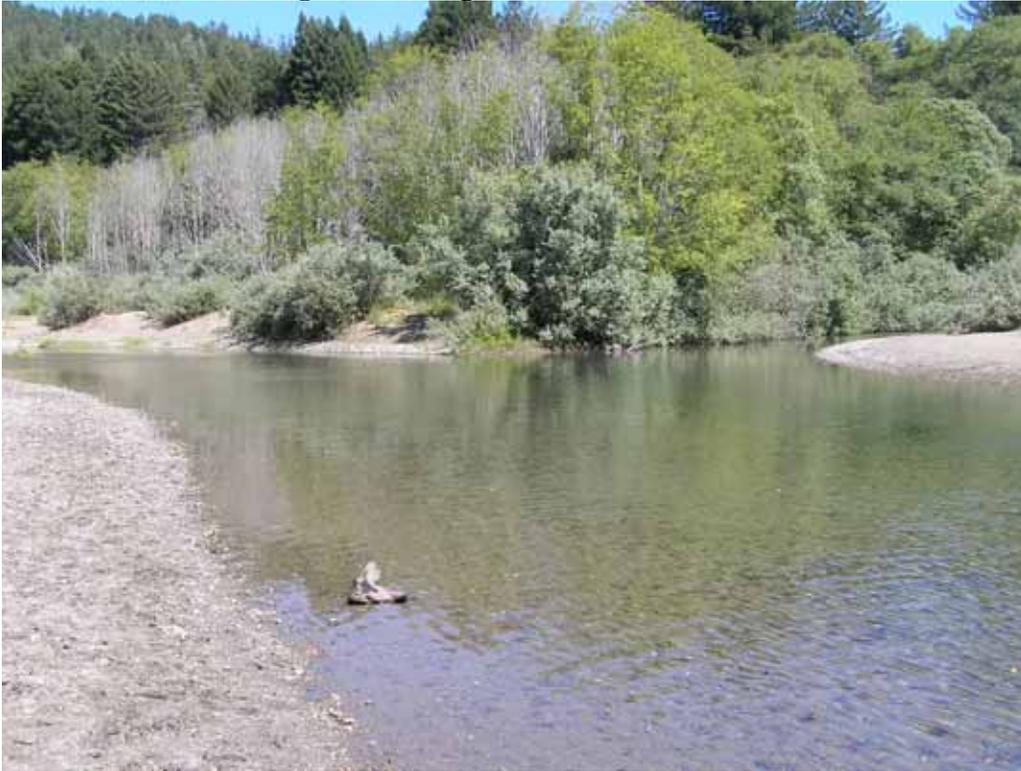
Fig 1a

Figure 1. Gravel mining site at terminal bar, confluence of South Fork, Wheatfield Fork, Gualala River, Valley Crossing, Annapolis Road bridge, 2005-2006. Abrupt change in post-mining channel configuration. 1a. July 2005, confluence of South Fork, view upstream (south), showing perennial channel (steelhead present) at eastern end of bar, meander into alder riparian forest cover; typical channel configuration of prior years. 1b. October 24, 2005. Mining pit in center of degraded terminal bar. Bar elevation had not regenerated after previous mining episode; low flats provide little potential confinement of high flows. 1c. April 1, 2006. Terminal bar breaches across mined center of depleted terminal bar, guided by pit remnant that had eroded to low flats following New Years flood. Note remnants of channel switching and multiple terminal lobes, indicating instability during high flows. Channel thalweg shifts to new central channel; old channel aggrades. 1d. August 8, 2006. New thalweg fails to maintain low-flow channel and becomes below-bed flow on hot, exposed gravel; seeps into confluence. Old channel in riparian forest is completely infilled. Atypical configuration.

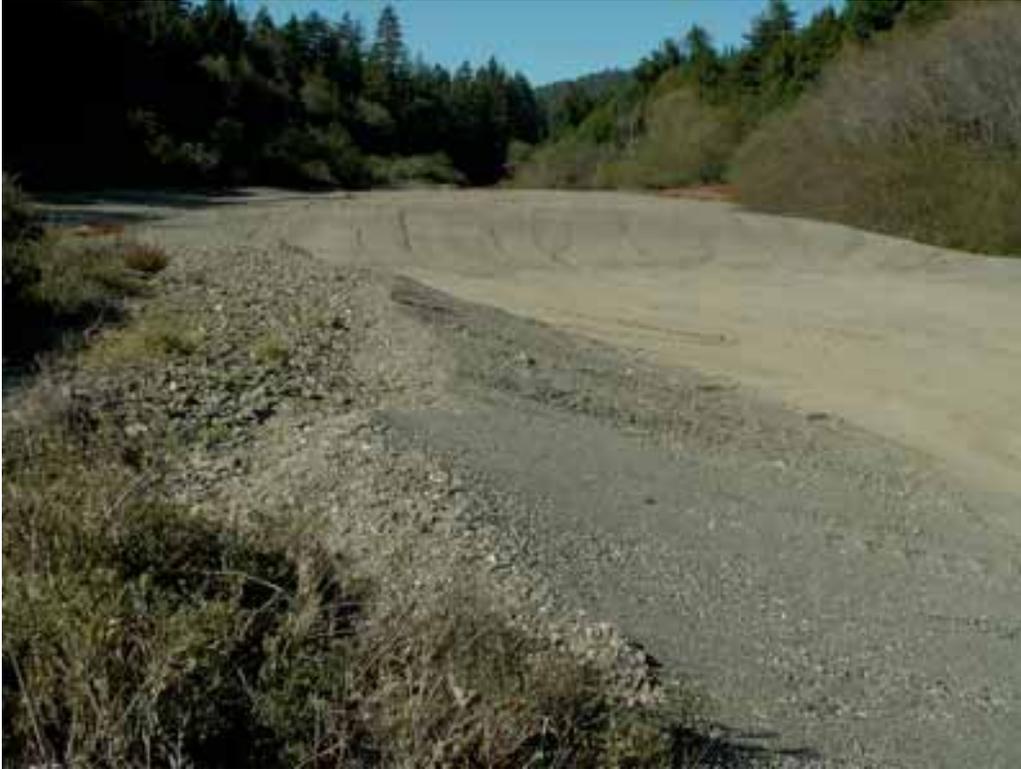
2a.

Figure 2. In-stream gravel mining on South Fork near Buckeye Creek. A. pit and berm, view downstream; pit terminates. B. pit, berm view downstream, right bank. C. pit, view upstream.

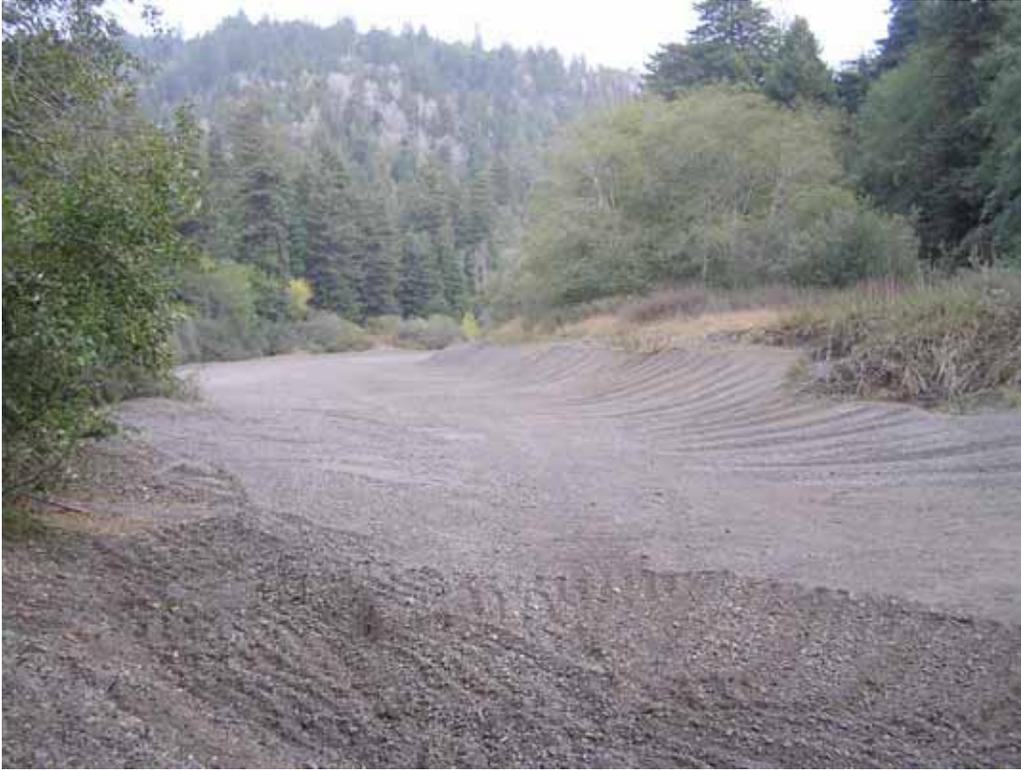
3a.

Figure 3. Bar 62 mining site, Wheatfield Fork. A. View upstream from toe of road access point into wide, shallow pit. B. View upstream at head of bar located at outer bend of meander. This low berm is all that separates high flows from being captured by pit during high flows (channel switching to position of outer bend configuration, which lacks the dense shade and stable hillslope toe of the north-facing south bank shown). C. View downstream, showing low residual gravel levee relief formed by mining pit. Note proximity of gravel surface to low flow water surface (less than 1 meter). Flood debris in alder branches is approximately 3 meters above the gravel surface.
