MEMORANDUM

SUBJECT: Engineering Geologic Review of Timber Harvest Plan 1-23-00099 SON

Inspection Date:
 December 8 and 15, 2023

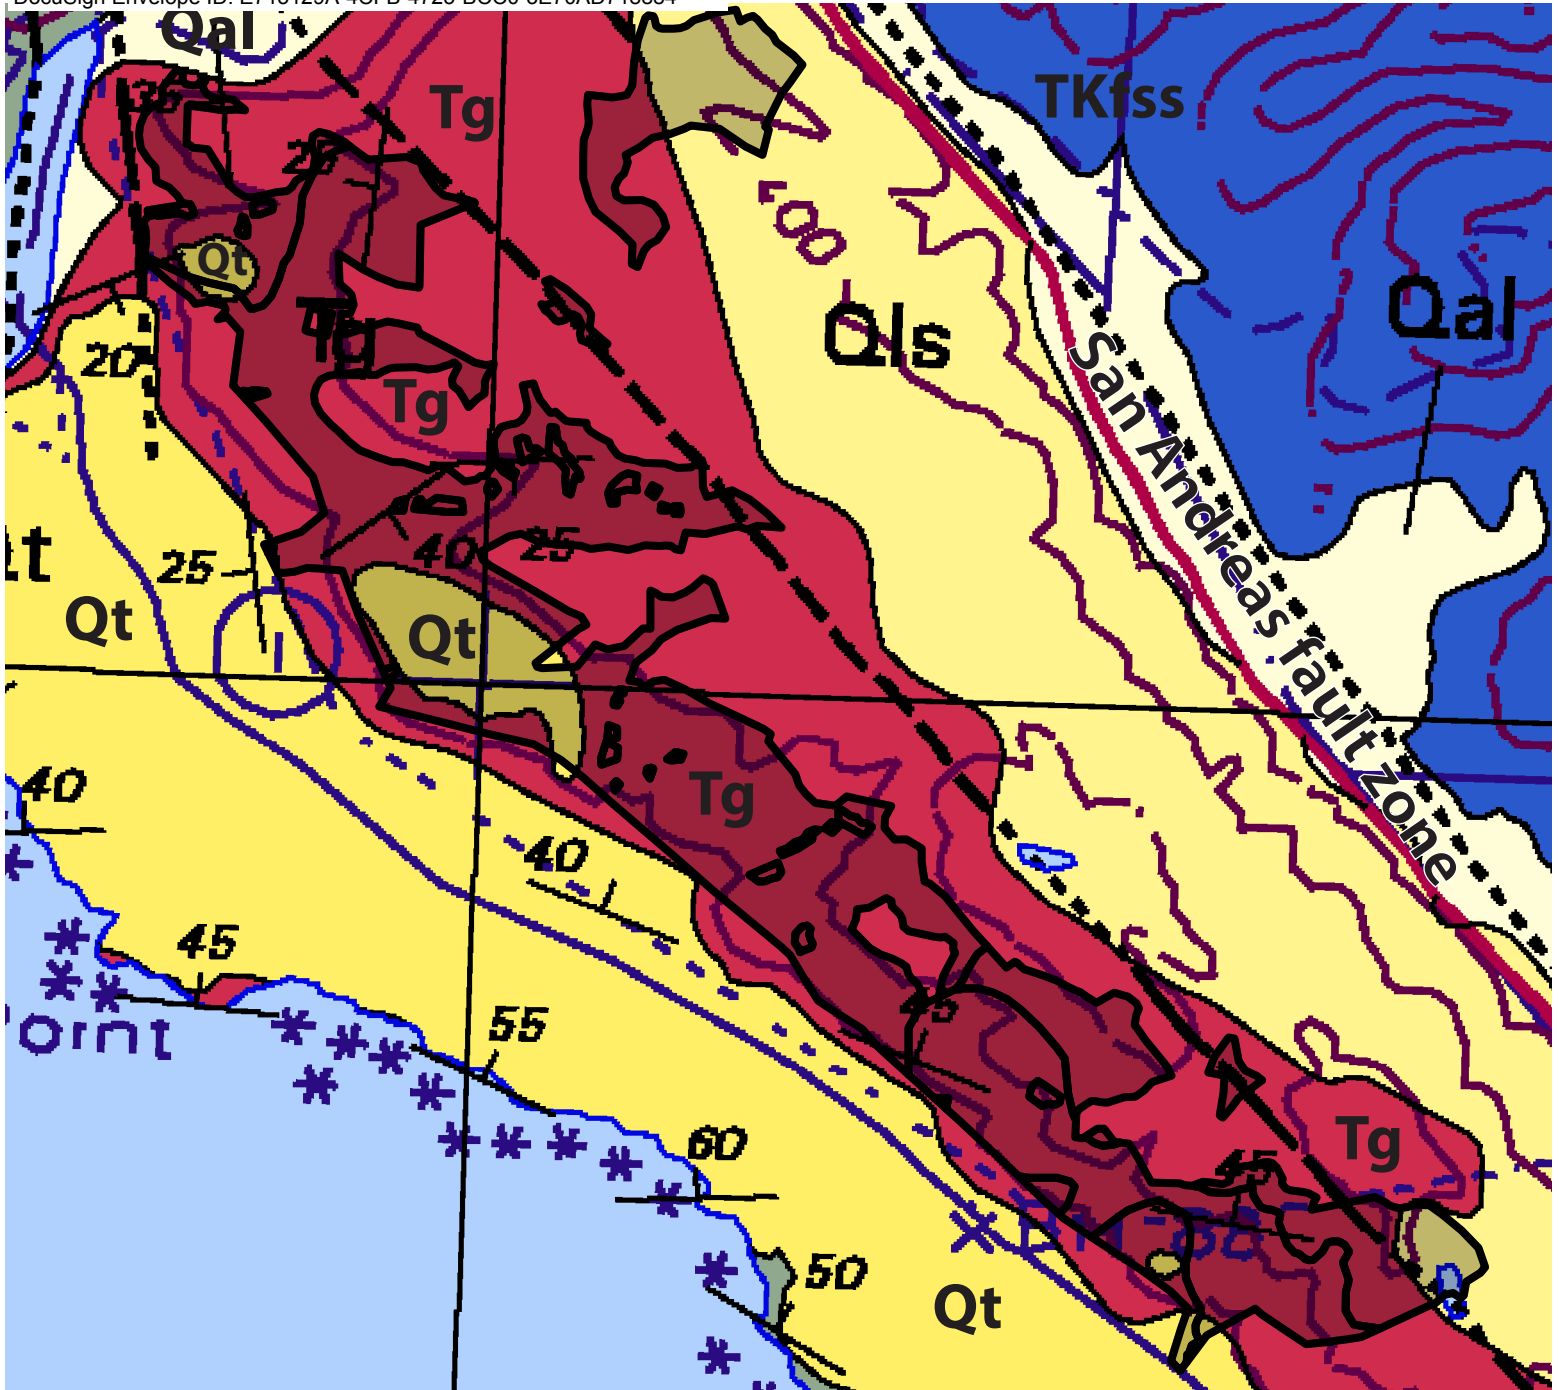
Figure:
1

While no evidence of large-scale, deep-seated ground movement was observed at these locations at this time, movement of the landslide features may be triggered by periodic strong ground shaking associated with tectonic movement along the San Andreas Fault Zone (SAFZ), which passes ¼- to 1½-miles to the east of the THP area (Figures 1 and 2).

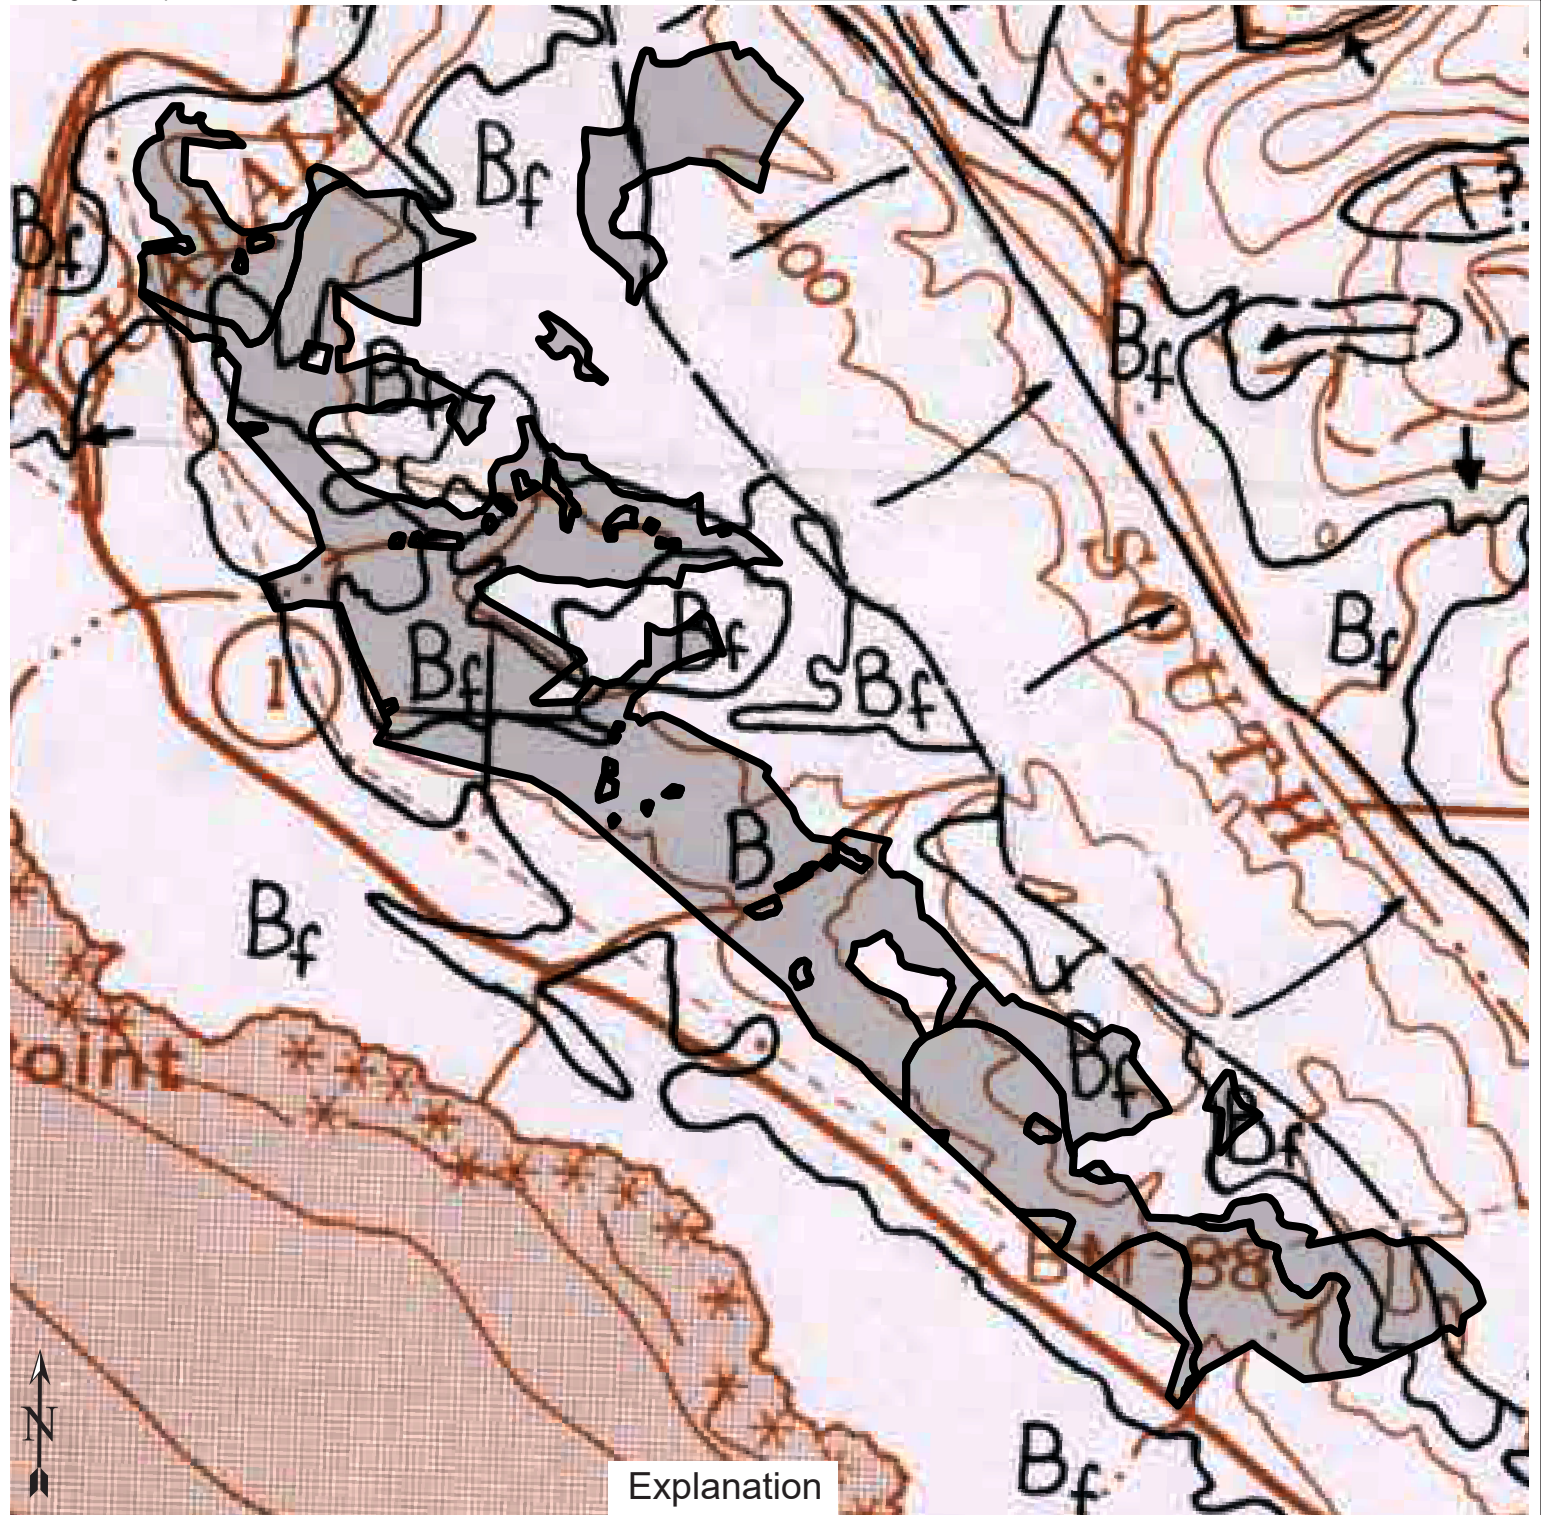
Date: 1/2024	Regional Landslide Map To Accompany Engineering Geologic Review of THP 1-23-00099 SON	Figure: 4
Scale: 1" = 2000'

3). Deep Seated Landslides. Published mapping shows apparent deep-seated landslides in the vicinity of the THP area located along northeast-facing slopes that drain to the South Fork Gualala River. Blake and others (2002; Figure 1) and Huffman and Armstrong (1980; Figure 4) identify a similar very large landslide complex in this area, while Fuller and others (2002; Figure 2) interpret smaller dormant deep-seated landslides along these slopes. Review of LiDAR imagery reveals subtle, bowl shaped headscarp slopes and benched and hummocky topography across these slopes where Blake and others (2002; Figure 1) and Huffman and Armstrong (1980; Figure 4) identify the very large landslide complex. LiDAR imagery generally shows more defined landslide features with somewhat more youthful morphology nested within this large landslide complex at the locations where Fuller and others (2002; Figure 2) identify dormant deep-seated landslides. During our review, we observed that these slopes are generally forested with straight standing advanced-growth conifers and old-growth stumps. Evidence of recent large-scale, deep-seated earth movement (for example ground cracks, bare scarps, offset road prisms) was not observed during the PHI. Based on our observations, the large deep-seated landslide complex and nested blocks appear to correspond to the "dormant-mature" to "dormant-old" morphological age classification of Keaton and DeGraff (1996).

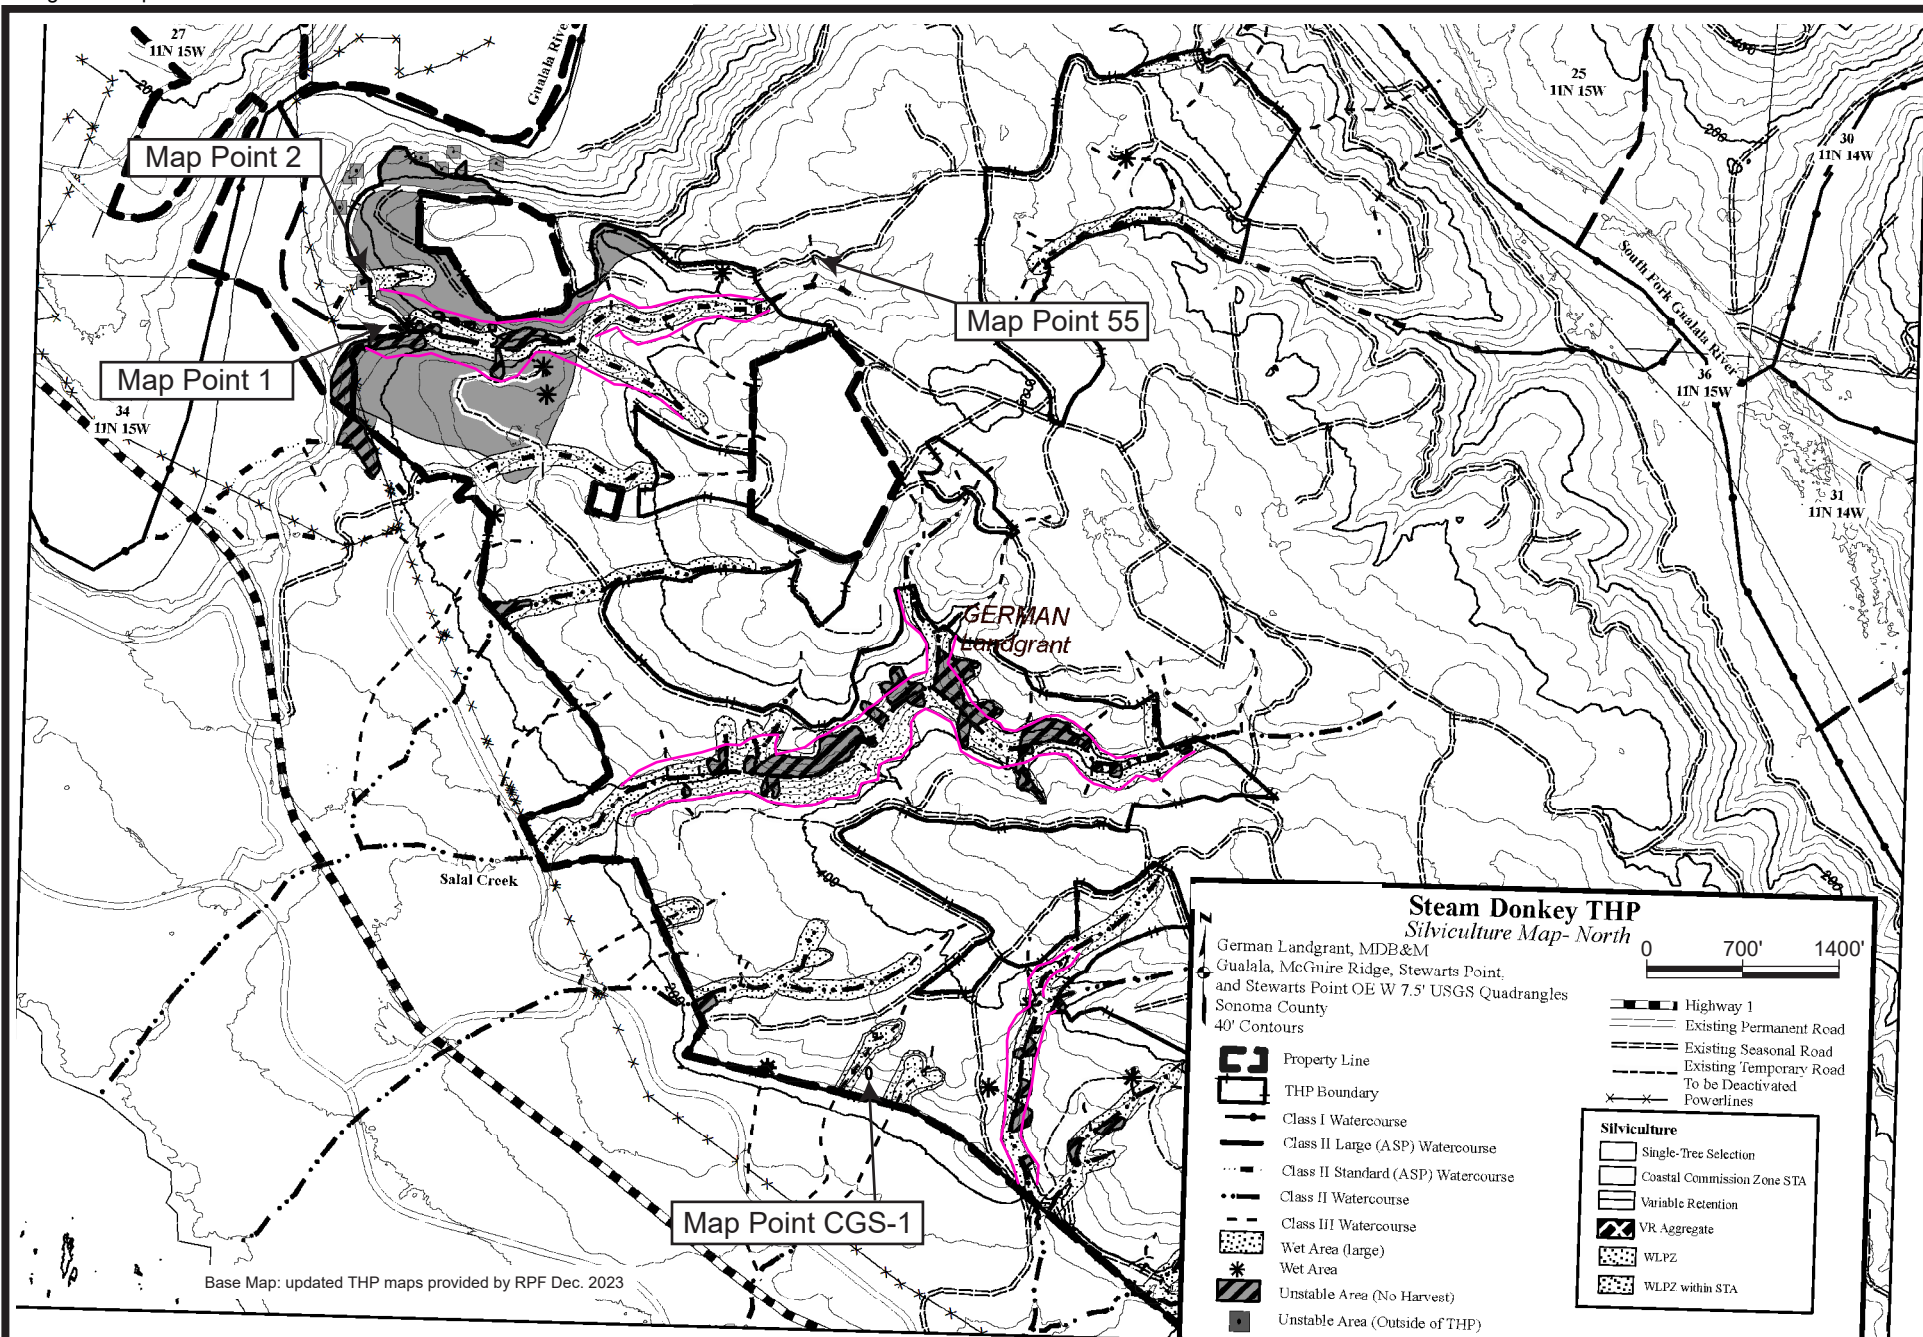
along these steep slopes, we also frequently noted the presence of vegetated bowl-shaped head scarps at or near the break in slope and spoon-/teardrop-shaped depressions/hollows extending downslope that appear to be indicative of former debris slide activity. These observations are consistent with the conditions for inner gorge formation described by Kelsey (1988) and the definition of inner gorge geomorphology from CGS Note 50 (CGS, 2013) and the Forest Practice Rules. Additionally, our review of the unpublished data discussed above (General Observation #1) revealed several instances where the GRI landslide database (GRI, 2004) records landslides in these areas with the noted "slope type" as inner gorge. Based on these observations, we conclude that the noted drainages have morphology consistent with inner gorge geomorphology. The interpreted break in slope in the areas of inner gorge geomorphology is shown on Figures 5 and 6.

THP. RPF response dated September 6, 2023 (Return No. 2 Responses) indicated that these past THP's were reviewed with respect to previously mapped unstable areas; however, during the first day of the PHI we field checked several of these locations and confirmed the presence of unstable areas that were not shown on the THP Operations Maps. After the first day of the PHI, the RPF performed additional review and field work, and submitted updated THP maps to the review team on December 14, 2023. The updated THP maps include additional unstable areas at locations where unstable areas are mapped in previous THP's and include revised mapping of some of the unstable areas shown on the original THP maps (Figures 5 and 6).

Over the course of the two-day PHI, we observed a representative sampling of the unstable areas shown on the revised THP maps (Figures 5 and 6), which generally consisted of suspended to dormant-historic debris slides, slumps, and skid trail failures that are nearly all located along steep slopes adjacent to watercourses within the THP area (some of which have inner gorge geomorphology; see General Observation #2). Item 38 (page 101) of the THP describes that all mapped unstable areas within the THP area are no-harvest equipment exclusion zones that are incorporated into the WLPZ areas. However, when submitting the updated THP maps to the review team the RPF clarified that Item 38 will need to be revised as some unstable areas extend outside of the WLPZ and are flagged with Do Not Cut flagging. Based on our observations, the updated THP maps (Figures 5 and 6) accurately depict the location of unstable areas, and the proposed avoidance and retention of canopy and root function on these mapped unstable areas appears adequate to minimize the potential for adverse impacts to slope stability of the unstable areas. One additional unstable area was observed during the PHI and is discussed under Specific Observations (Map Point CGS-1).

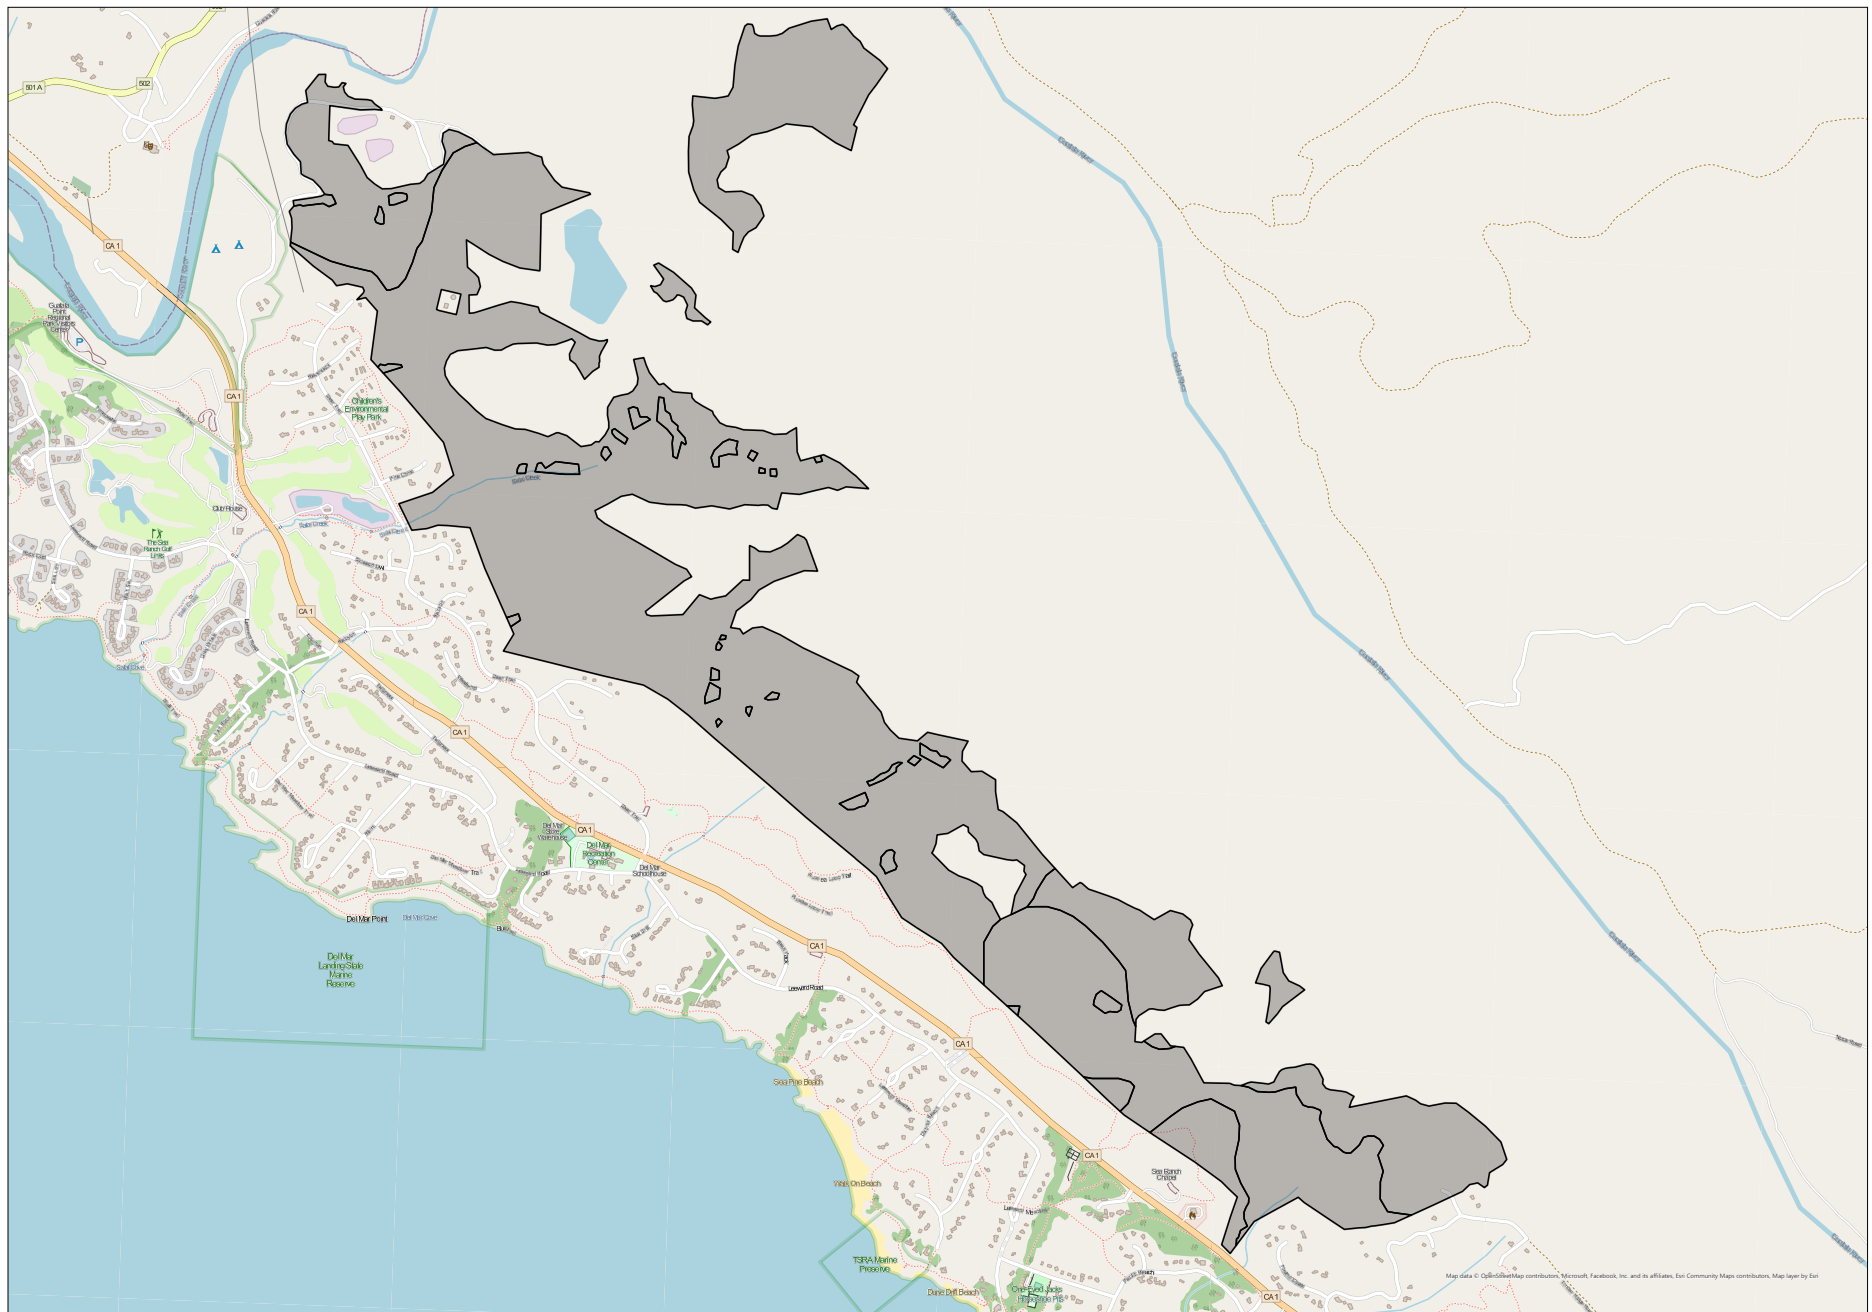
7

5). Public Safety. During our review of the THP, we noted that there are numerous residential structures/developments (for example Sea Ranch) and public roads and highways (for example Deer Trail road, State Route 1) downslope of the proposed THP area. We noted that the residential structures/developments are not shown on the THP maps (Figure 7). During the PHI, we discussed that these structures should be disclosed in the THP to provide complete information to the review team so that the review team can assess the proposed timber harvesting operations with respect to potential impacts to the downslope structures.

Open Street Map Layer by ESRI showing public roads and highways (white and orange) and residential structures and developments (gray polygons) in proximity to THP area.

5). Prior to second review, the THP maps shall be updated to disclose the location of residential structures and developments that are located downslope of the THP.
