# Copper Top THP

## Section V

## Mendocino County, California

Prepared for:  
Redwood Empire Sawmills

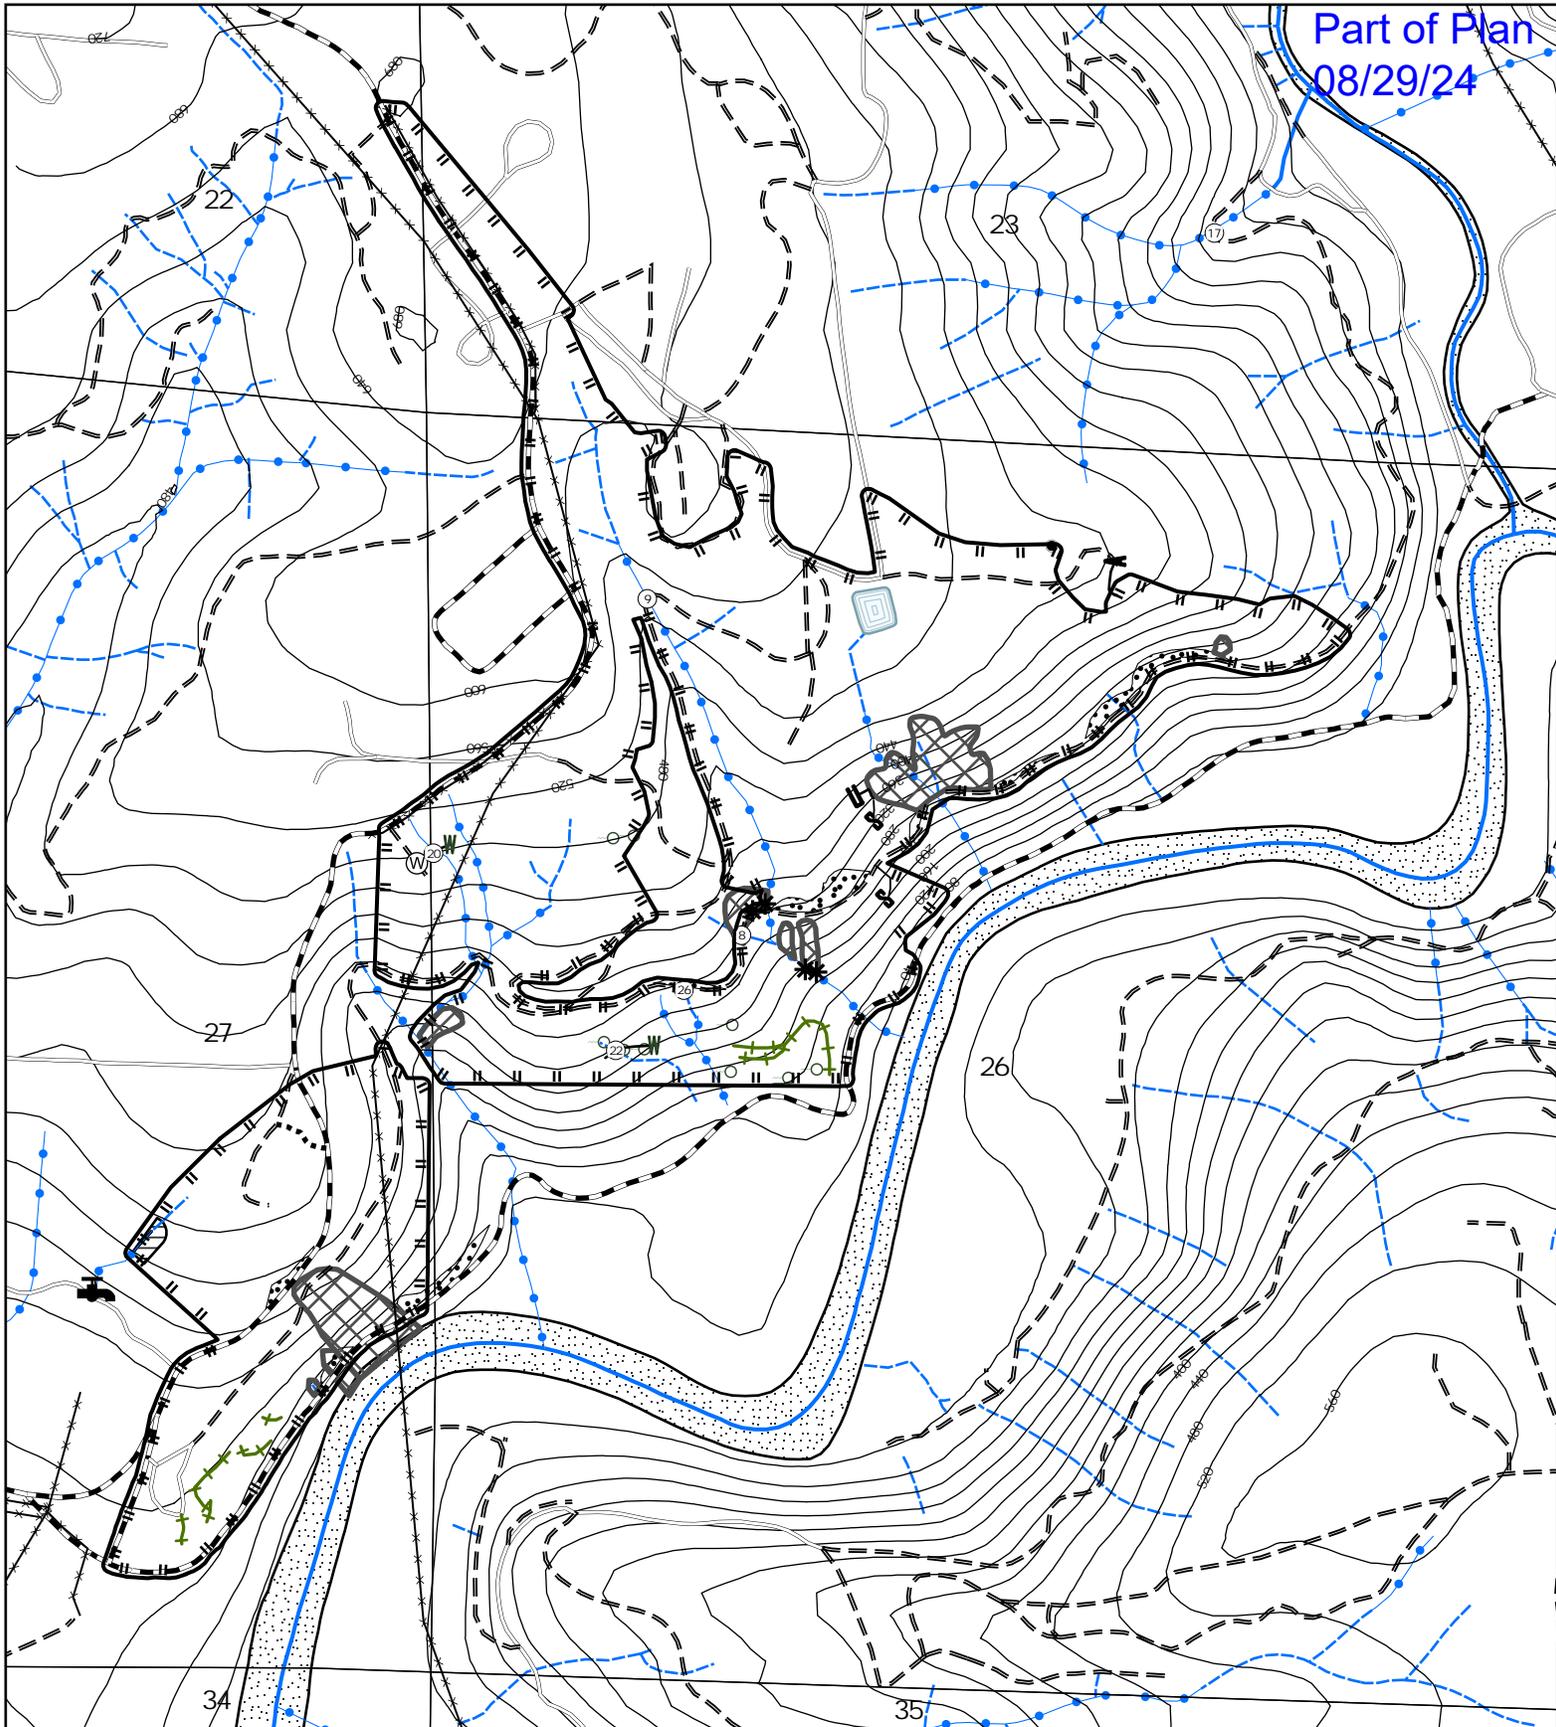
**Copper Top THP**  
**ECP Points**

Map Point	Type	Description	Treatment	Delivery Risk	Delivery Potential	Total Site Volume	Treatment Priority
4	Complex	18" Metal DR. Inlet is partially buried, and outlet is entirely buried.  Class III watercourse crossing with no watercourse crossing place. No active erosion observed	DRC: Excavate inlet and outlet and inspect for rust. Replace with 18" minimum culvert if necessary. If culvert is sound no further treatment.  WC: if wet at times of operations drain via a 4" flex pipe. After operations and prior to the winter period, install dip to drain feature after operations.	Medium	2yd	10yd	Medium
8	Complex	WC: Class III crossing with 18" metal culvert that is rusting through.  Functioning.  Seep: 50 feet east of WC is a bank seep that runs across the road with no drainage feature in place.  Minimal erosion occurring at site and no sediment delivery to watercourse was observed.	WATERCOURSE CROSSING: Replace with 24" minimum culvert. Refer to Sec II, Item 38 Typical.  Bank Seep: if wet at time of operations drain via a 4" flex pipe, after operations remove flex pipe and install dip to drain feature after operations.	Medium	2 yd	5 yd	Medium

9	WATERCOURSE CROSSING	36" metal culvert with inlet rusting out. Functioning.	Replace culvert with 36" minimum culvert.  Refer to Sec II, Item 38, Typical.	Low	1 yd	10 yd	Medium
11	TRACTOR CROSSING	Existing Class III tractor crossing.	If utilized: Use only if crossing is dry. After operations, slash pack approaches within ELZ	Low	3yd	3yd	High

23	Watercourse Crossing	Existing Class II watercourse crossing utilizing a 40" metal culvert. Culvert is undercut. The WC is located at the base of a steep cut into a rock face. The WC has evidence of being	Remove WC and replace culvert with a 48" minimum culvert. Move culvert inlet away from rock wall 1-3' well maintaining sufficient road prism width to allow for logging vehicle traffic. To the extent feasible	High	3yd	10yd	High

overtopped during high flow events resulting in minor road erosion. Overtopping occurred as the result of tree falling across inlet during the winter of 2024, which the landowner removed.	remove rocks that jut out of rock face and direct flows away from crossing site. Refer to Sec II, Item 38 Typical.				
26	Watercourse Crossing	An 18" metal culvert that forms the head of Class III. Inlet is partially buried and outlet is rusting through.	Replace with 24" minimum culvert. Refer to Sec II, Item 38 Typical.	Medium	2yd	5yd	Medium
