M e m o r a n d u m

Subject: Hydrologic and Biologic Review of THP 1-18-095 MEN

This memorandum reports the results of a focused Pre-Harvest Inspection (PHI) for the Little THP (1-18-095 MEN). Field inspection participants for the PHI held on August 29, 2019 included the following individuals:

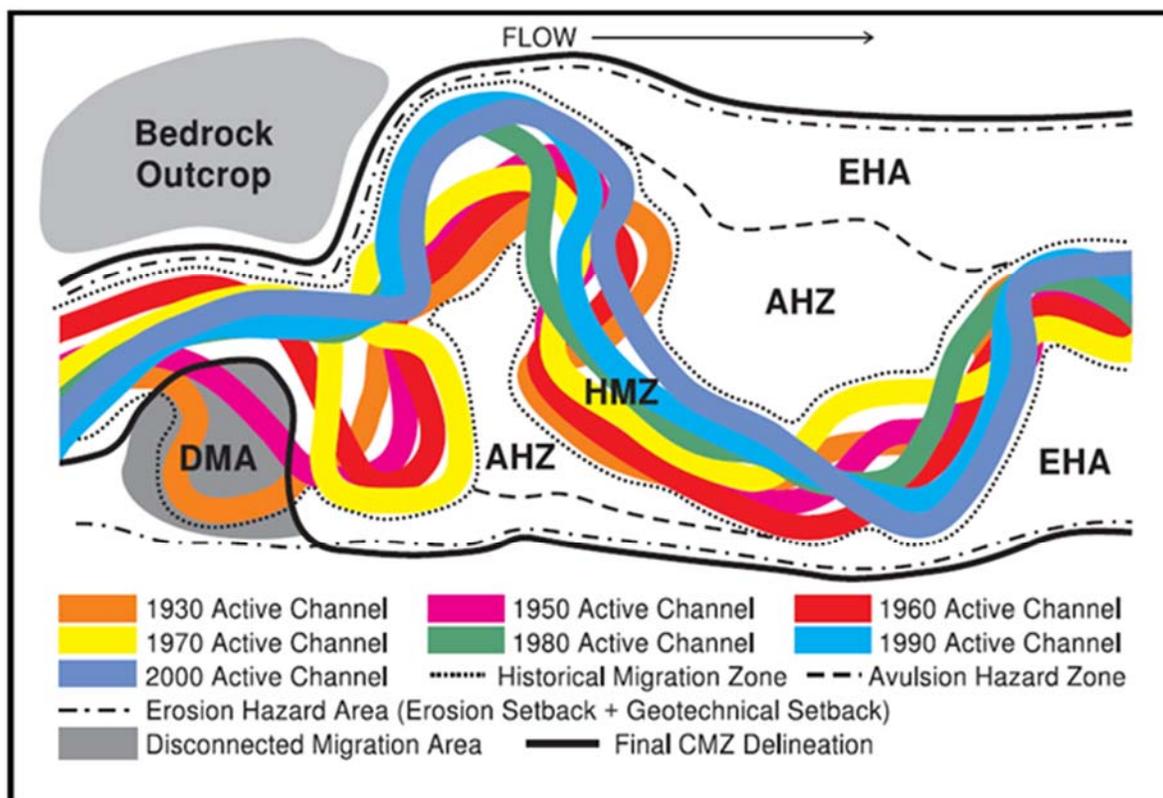
Figure 1. An example of the channel migration zone as a combination of the Historical Migration Zone, Avulsion Hazard Zone, Erosion Hazard Area, and Disconnected Migration Area based on historical and field analysis/interpretation (from Rapp and Abbe, 2003).

$$(1) \text{ Channel Migration Zone} = \text{HMZ} + \text{AHZ} + \text{EHA} - \text{DMA}$$

Channel migration zone evaluations rely heavily on historical analysis and field assessments to solve Equation 1 and determine the spatial extent of the CMZ.

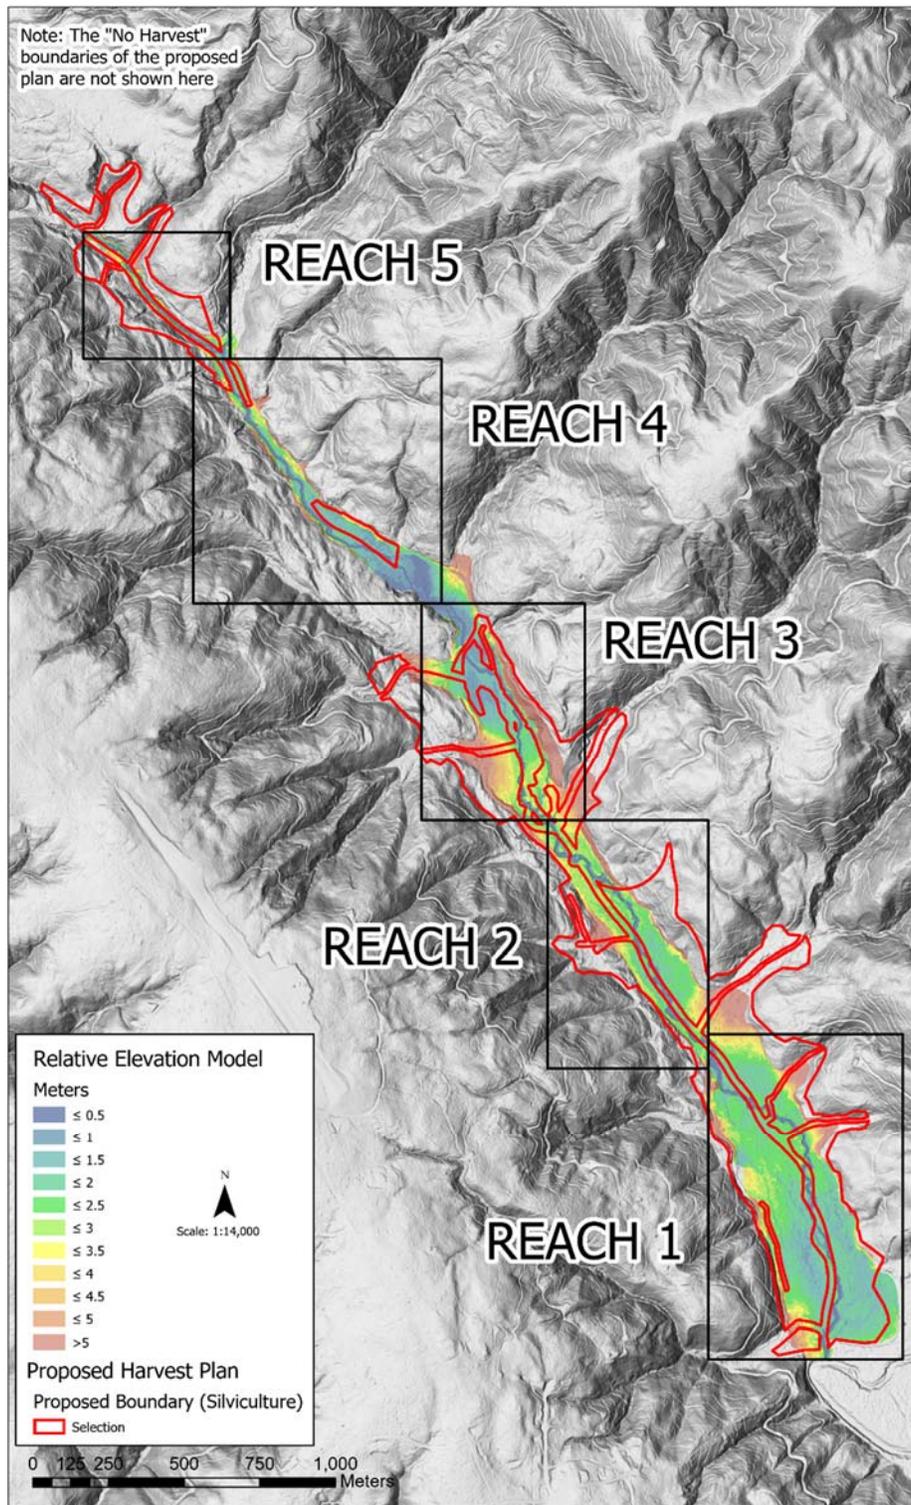
Figure 2. A relative elevation model produced by CAL FIRE WPP staff to help verify the channel migration zone evaluation provided by the plan proponent. The five relative elevation model reaches are displayed, as well as the THP unit boundaries.

CAL FIRE WPP staff generated multiple relative elevation model maps on a reach scale (five reaches in total) using methods contained within the Washington State Department of Ecology document titled “A Methodology for Delineating Planning-Level Channel Migration Zones” (Olson et al., 2014) to determine whether the field sites assessed during the channel migration zone evaluation were reasonable to allow for CMZ delineation (see Appendix A). These relative elevation models represent floodplain elevations relative to the stream centerline, thereby detrending changes in elevation in the downstream direction. Reaches were delineated based on changes in flow due to significant tributary influx. The modeled areas of the floodplain are shown in Figure 2.

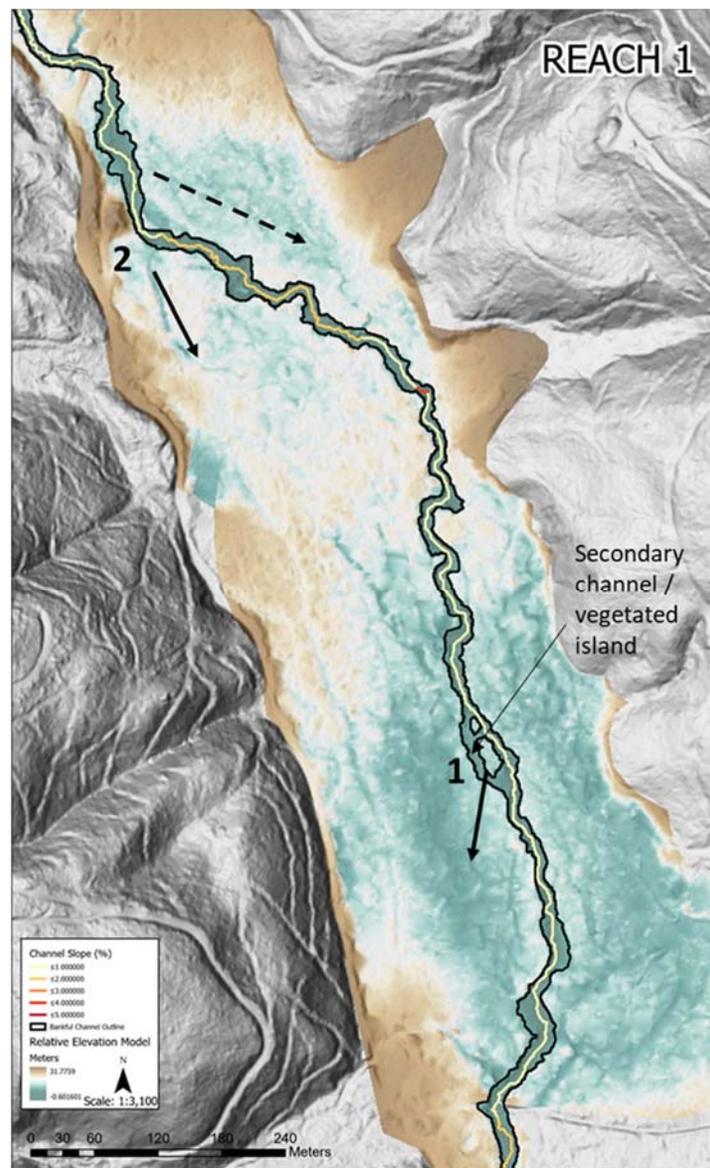
Site 1 is within Reach 1 at the lower end of the Little North Fork of the Gualala River and is shown in Figure 3. Dr. O'Connor identified and evaluated Site 1 based on concerns by CDFW that the area was subject to potential avulsion from the Little North Fork of the Gualala River. The relative elevation model confirms the presence of potential overbank flooding in the vicinity. However, the relative elevation model indicates that this flooding is generally dispersed rather than concentrated into channelized flowpaths.

Figure 3. Relative elevation map of Reach 1 of the Little North Fork of the Gualala River. Numbers refer to sites assessed in the O'Connor channel migration zone evaluation (OCE, 2019a). Arrows represent potential flowpaths evaluated in the field.

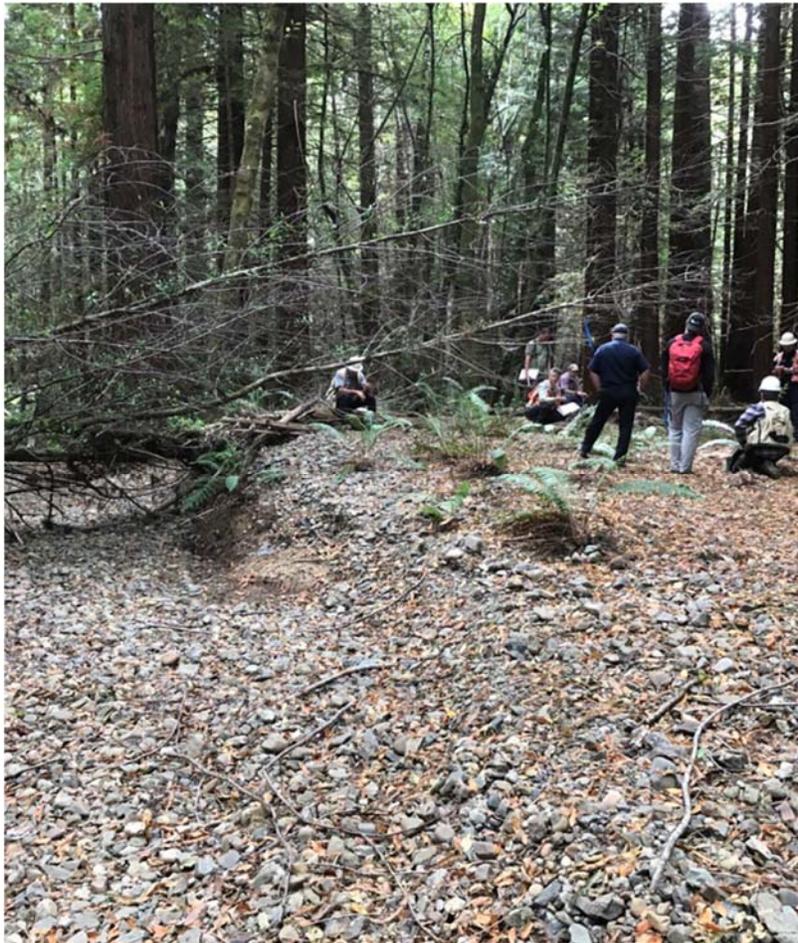
Dr. O'Connor noted the presence of secondary channels that create small vegetated islands upstream of Site 1, and noted it as a form of small scale channel migration that is characteristic throughout the Little North Fork Gualala River. He also suggested that the secondary channel be given Class I watercourse protection. Dr. O'Connor noted that a right-bank² linear to curvilinear swale was present down gradient of the secondary channel (Figure 4), but stated that the flowpath was distributary in nature and did not reconnect with the primary channel. He concluded that the swale did not have the erosive power to create a new primary/secondary channel. CAL FIRE WPP staff observations were consistent with those noted by Dr. O'Connor. Avulsion potential is greatly increased when the floodplain flowpath gradient is 3-5 times greater than that of the primary/secondary channel (WFPB, 2004). Staff measured the slope of the secondary channel and swale feature and found them to be approximately equal ($\approx 1\%$), indicating a relatively low potential for avulsion.

Figure 4. The secondary channel and broadly convergent right-bank floodplain surface at Site 1.

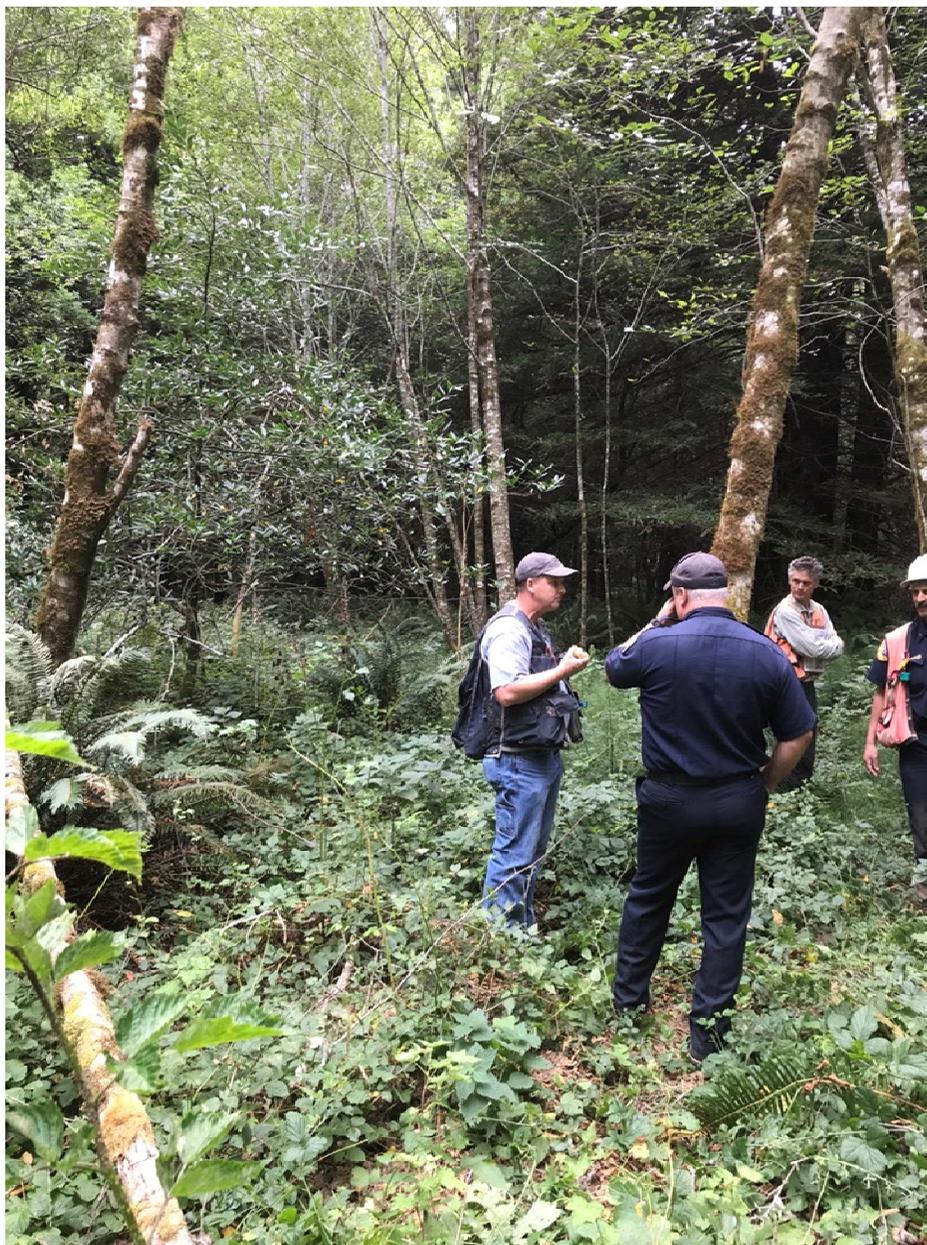
Dr. O'Connor characterized Site 2 as a right-bank floodplain feature that acted as a distributary flowpath and did not rejoin the primary channel of the Little North Fork of the Gualala River. Dr. O'Connor suggested that the feature may be an old skid trail or road. Overall, he determined the avulsion potential as being low because: water was dissipated across the floodplain in the downslope direction; the floodplain feature lacked bedload and was comprised of silt and sand deposits; and the fact that a large left-bank overflow floodplain feature (see dashed arrow on Figure 3) would moderate the amount of flow that could travel down the right-bank floodplain feature.

The observations and rationale provided by Dr. O'Connor were confirmed by CAL FIRE WPP staff. Staff determined the water surface elevation would have to rise by 5-6 feet (Figure 5) before it would access the right-bank floodplain feature. The 20-year recurrence interval storm is predicted to overtop this feature (OCE, 2019a), but did not show signs of recent overtopping. The slope of the floodplain feature was approximately three times greater than that of the primary channel (1.5% vs. 6%). However, the steeper surface only persisted for approximately 100 feet before flattening to a gentler slope. The feature does have characteristics that indicate it might have been a skid trail at one time, as the soil appeared compacted and had the same approximate width of a skid trail. The relative elevation model shows strong evidence that the feature acts more as a flooding and depositional flowpath rather than as a potential avulsion pathway. Staff also noted the presence of the left-bank overflow floodplain feature noted in Dr. O'Connor's report, and this is expected to convey most of the overbank flow, rather than the right-bank feature, during a storm event.

Figure 5. A view of the potential flowpath at Site 2. The water surface elevation would have to rise 5 to 6 feet to reach the elevation of this floodplain surface.

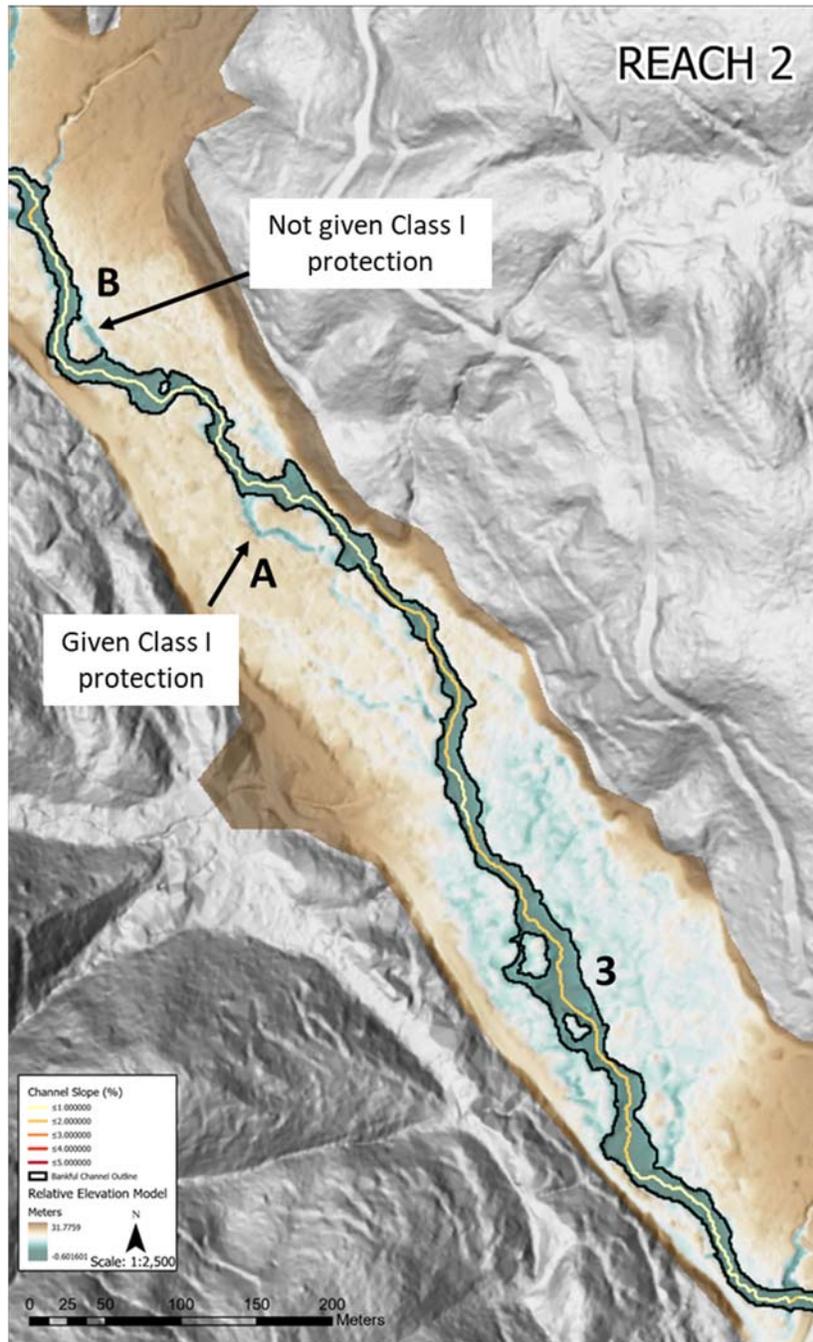
Site 3 is within Reach 2 and is shown in Figure 6. Dr. O'Connor identified and evaluated Site 3 based on the presence of secondary channels and a series of islands similar to those at Site 1. The relative elevation model confirms the presence of split flowpaths in the vicinity of Site 3, including some upstream of the area evaluated by Dr. O'Connor.

Dr. O'Connor characterized Site 3 as primary and secondary channels separated by vegetated islands. He further stated that the secondary channels should receive Class I protection (Figure 7). CAL FIRE WPP staff confirmed these observations and agree with the recommendation to treat the secondary channels as a Class I watercourse.

Figure 6. Relative elevation model of Reach 2 of the Little North Fork of the Gualala River. Numbers refer to sites assessed in the O'Connor channel migration zone evaluation. Alphabetical designations represent areas with secondary channel or potential secondary channels.

The relative elevation model indicates two locations upstream of Site 3 that showed similar signs of secondary channel development. Site A (Figure 6) indicates the presence of a possible secondary channel. Revised silviculture maps submitted by the plan proponent indicate this feature has proposed Class I watercourse protection. Site B (Figure 6) shows another location along the Little North Fork of the Gualala River where a secondary channel may also be present. The revised silviculture maps indicate that this potential secondary channel has not been given Class I watercourse protection. It was also not evaluated by Dr. O'Connor in his report. As a result, we suggest that this area be evaluated for the presence of a secondary channel, and the need for Class I watercourse protection (**Recommendation 1**).

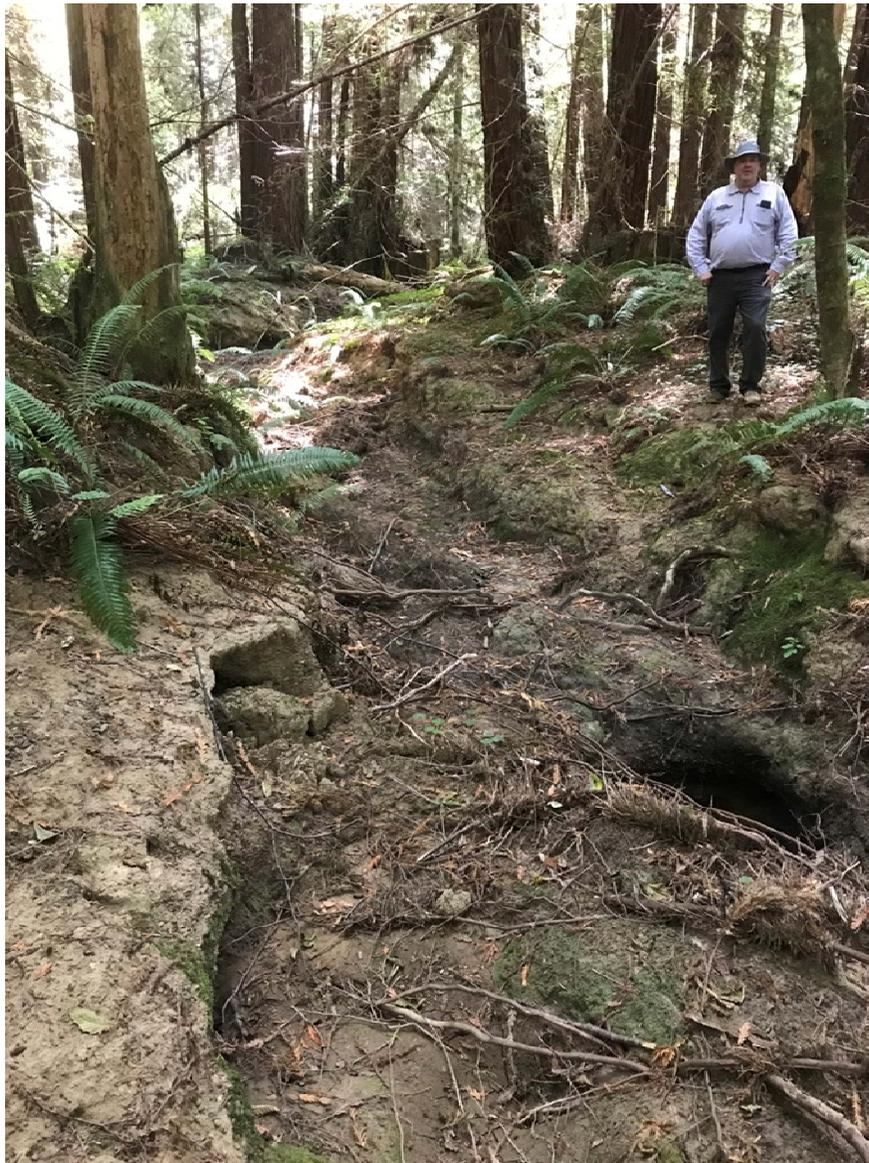
Figure 7. A secondary channel at Site 3. This channel received Class I watercourse protection.

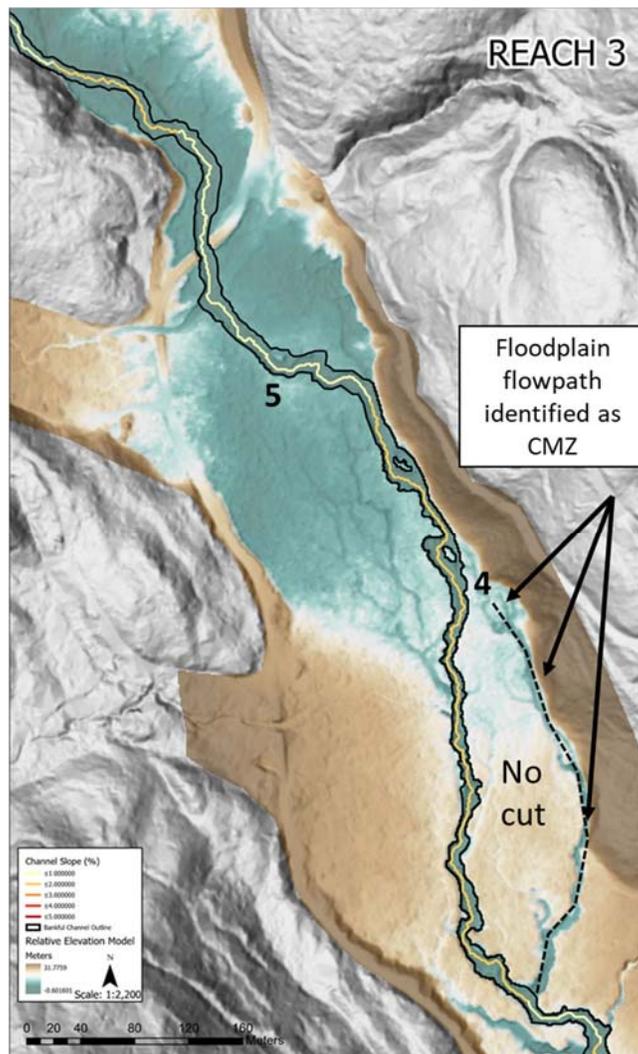
Site 4 is within Reach 3 and is shown in Figure 8. Dr. O'Connor identified and evaluated Site 4 because it is a left-bank flowpath that was predicted to have flow with the hydraulic modeling study (OCE, 2019b). The relative elevation model shows clear evidence of a defined flowpath on the left bank that has potential upstream and downstream connectivity with the primary channel. Dr. O'Connor identified this area as possibly being influenced by an old road with a high likelihood of avulsion, and identified the area as channel migration zone for approximately 1000 feet. Additionally, red alder stands were evident in this area using the 1988 aerial photos. The area between the left-bank flowpath and the primary channel fits the criteria of an Avulsion Hazard Zone.

Figure 8. The relative elevation model map for Reach 3. Numbers refer to sites assessed in the O'Connor channel migration zone evaluation (Sites 4 and 5). Site 4 refers to the entire flowpath defined by the dashed line. The area between the dashed line and the primary channel, labeled as "no cut", and can be considered an Avulsion Hazard Zone.

Site 5 is within Reach 3 and is shown in Figure 8. Dr. O'Connor identified and evaluated Site 5 due to its potential as a source of landslide and/or alluvial fan sediments that may affect the downstream avulsion potential at Site 4. The relative elevation model indicates that much of the floodplain is likely inundated during flood events, and there is clear evidence of an alluvial fan from a left-bank tributary upstream from Site 5. Dr. O'Connor stated that the area was subject to extensive overbank flooding but should not be considered a channel migration zone.

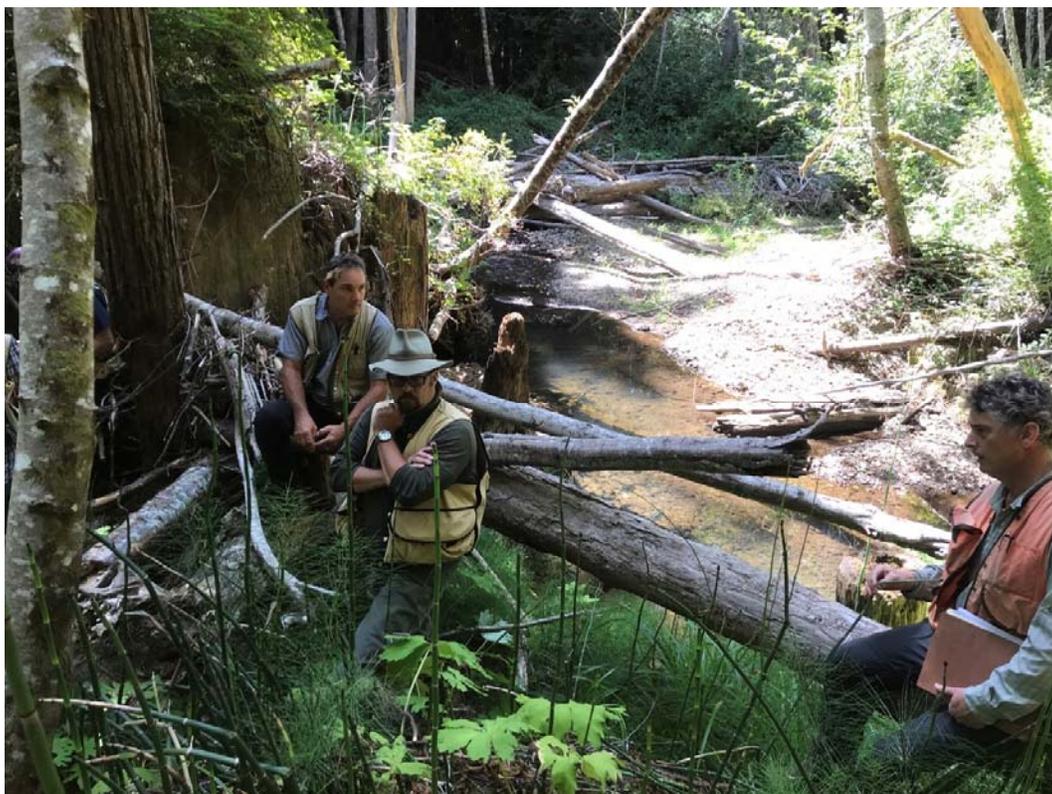
CAL FIRE WPP staff agree with this assessment. Staff noted that the upstream end of this flowpath is approximately three feet higher than the existing channel, and is located within a bend in the channel with a large woody debris jam directly downstream. Form roughness in combination with in-channel large woody debris roughness (Figure 9) has the potential to cause a rise in water surface elevation which could shift the main flow to this left-bank flowpath.

Figure 9. The upstream end of the Site 4 flowpath. Note the large woody debris jam in the background.

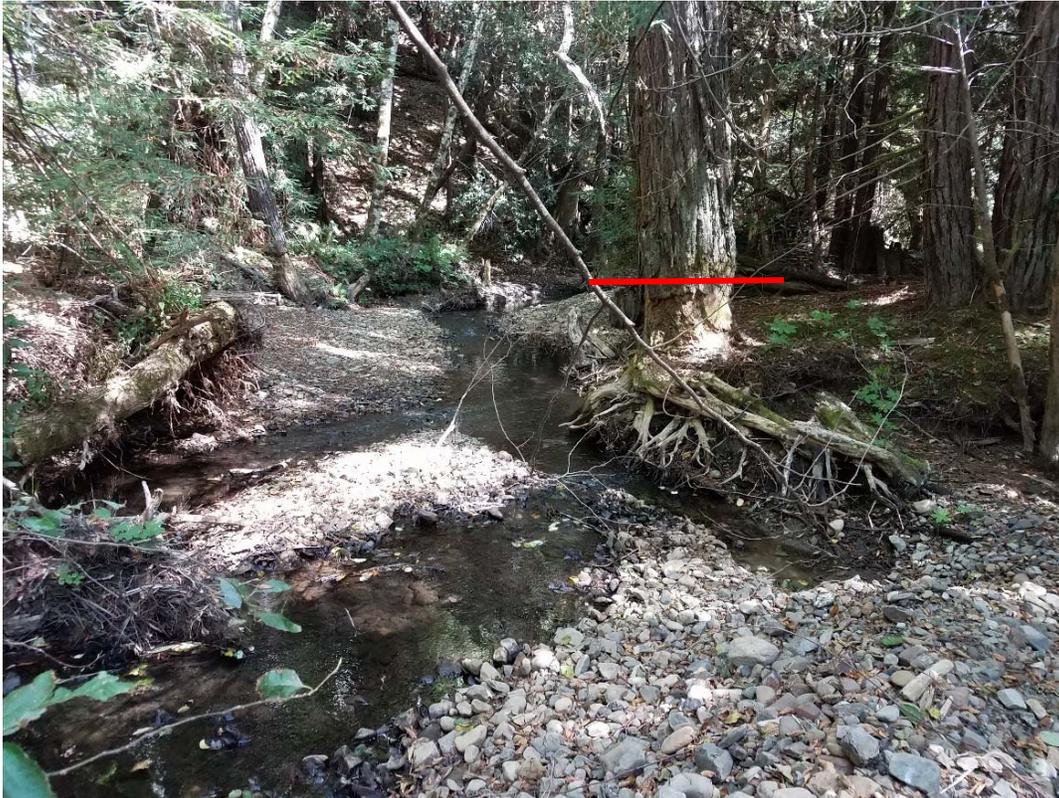
CAL FIRE WPP staff agree with the assessment provided by Dr. O'Connor. Evidence of abrasion on the base of snags showed that floodplain depths can reach two feet above the bankfull elevation (Figure 10). There was no evidence of abandoned channels that could act as potential avulsion flowpaths.

Figure 10. Evidence of abrasion on the base of a snag illustrating floodplain depths can reach two feet above the bankfull elevation (red line).

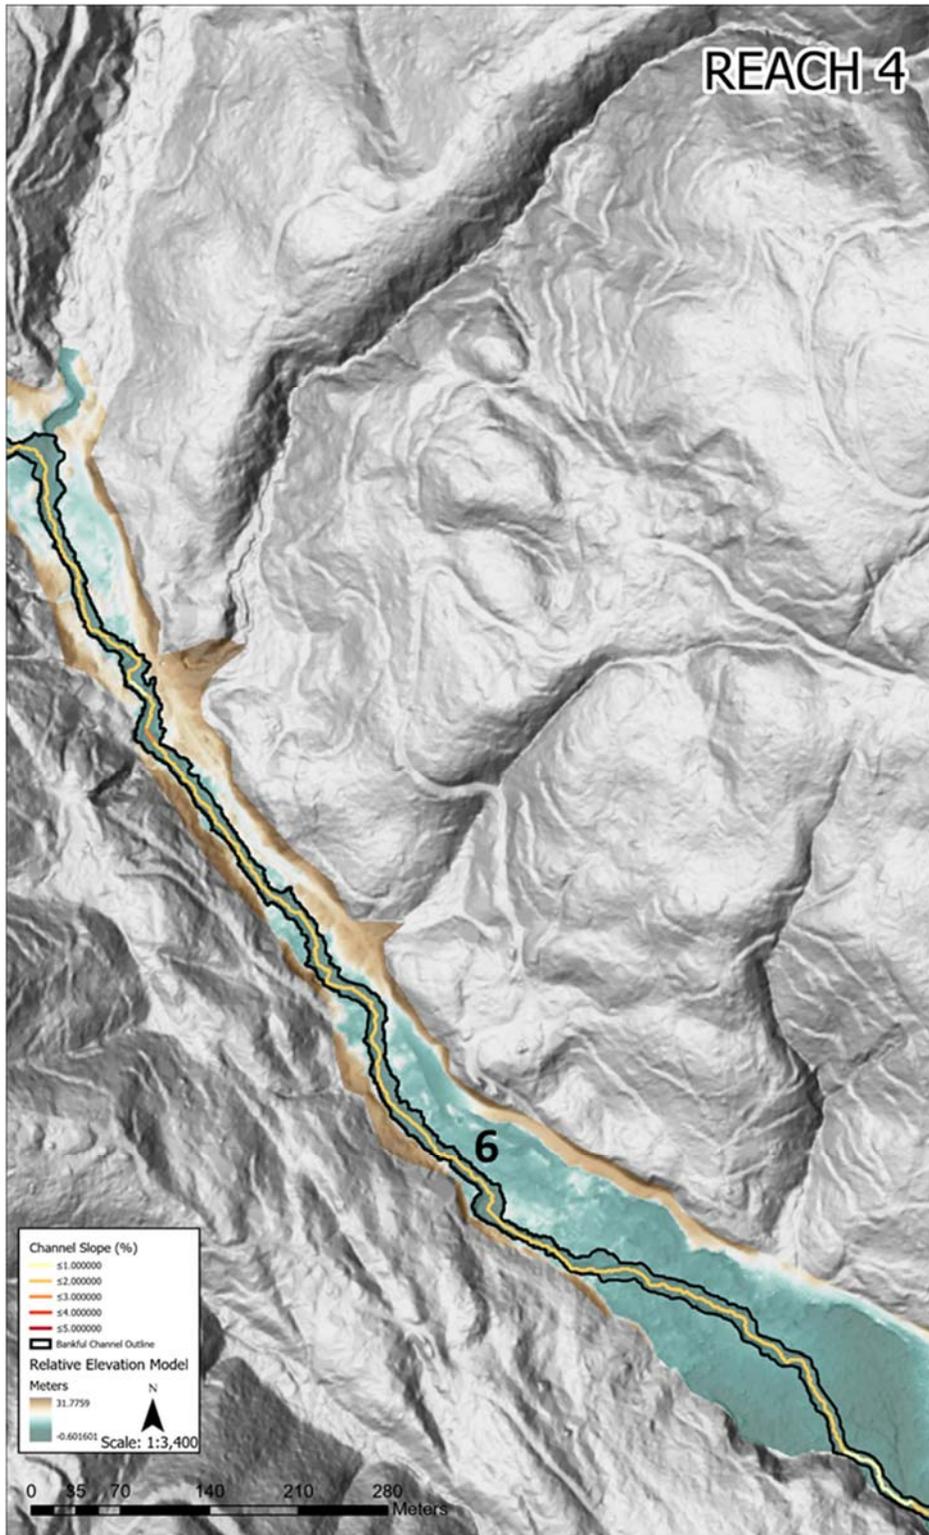
Site 6 was investigated by Dr. O'Connor due to the potential presence of secondary channels as indicated by the hydraulic model simulation (OCE, 2019b). The relative elevation model (Figure 11) indicates the potential for extensive overbank flooding near Site 6. In his report, Dr. O'Connor mentioned the presence of a landslide that impinged on the Little North Fork of the Gualala River, with the potential to cause the channel to shift its position (OCE, 2019a). However, he concluded that the landslide did not trigger an avulsion of the Little North Fork of the Gualala River. Dr. O'Connor concluded that the area is not a channel migration zone.

Figure 11. The relative elevation model for Reach 4. The number refers to the site assessed in the O'Connor channel migration zone evaluation (Site 6).

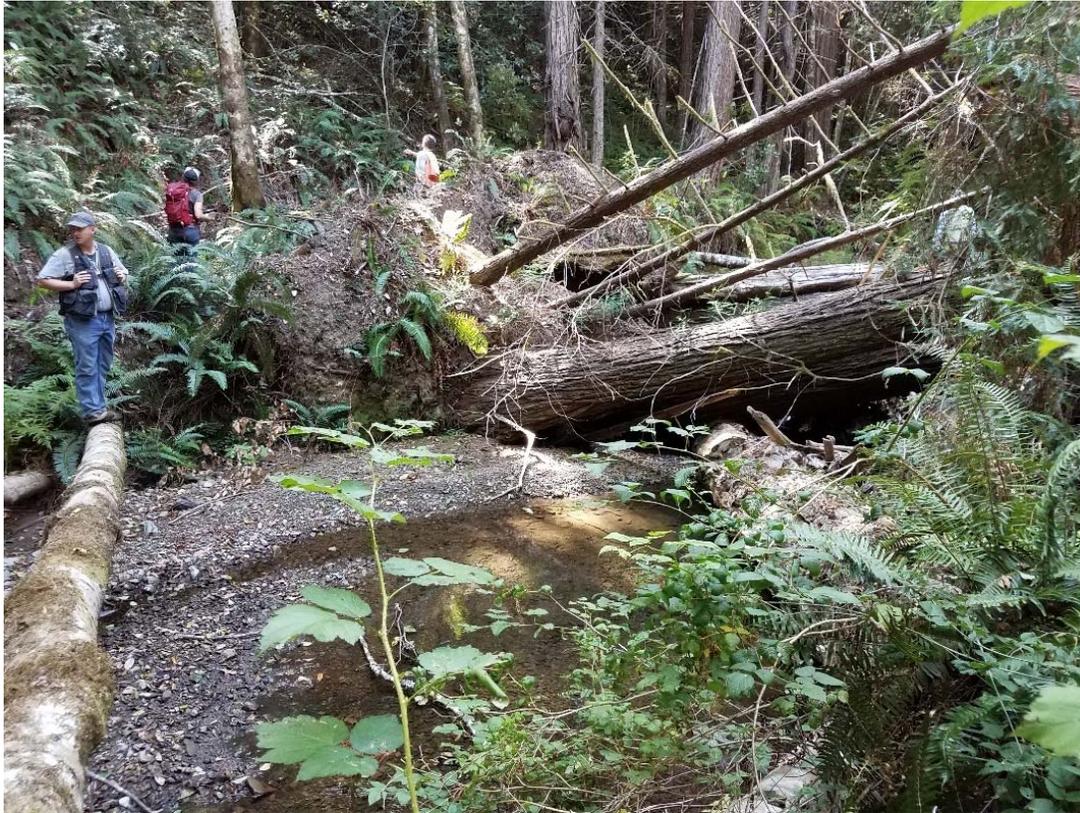
CAL FIRE WPP staff agree with the Dr. O'Connor's assessment. Staff noted silt lines of approximately 1.7 feet on the floodplain. However, there were no signs of abandoned channels in this area. Staff noted an area of bank erosion at a small bend in the Little North Fork of the Gualala River, but it appears relatively stable as the relative elevation model shows no signs of lateral erosion (e.g., meander scrolls) nearby. A clump of large redwood trees tipped into the channel during the winter of 2018-2019 here but has not caused channel movement (Figure 12).

Figure 12. Coast redwood trees that recently entered the Little North Fork of the Gualala River channel at Site 6.

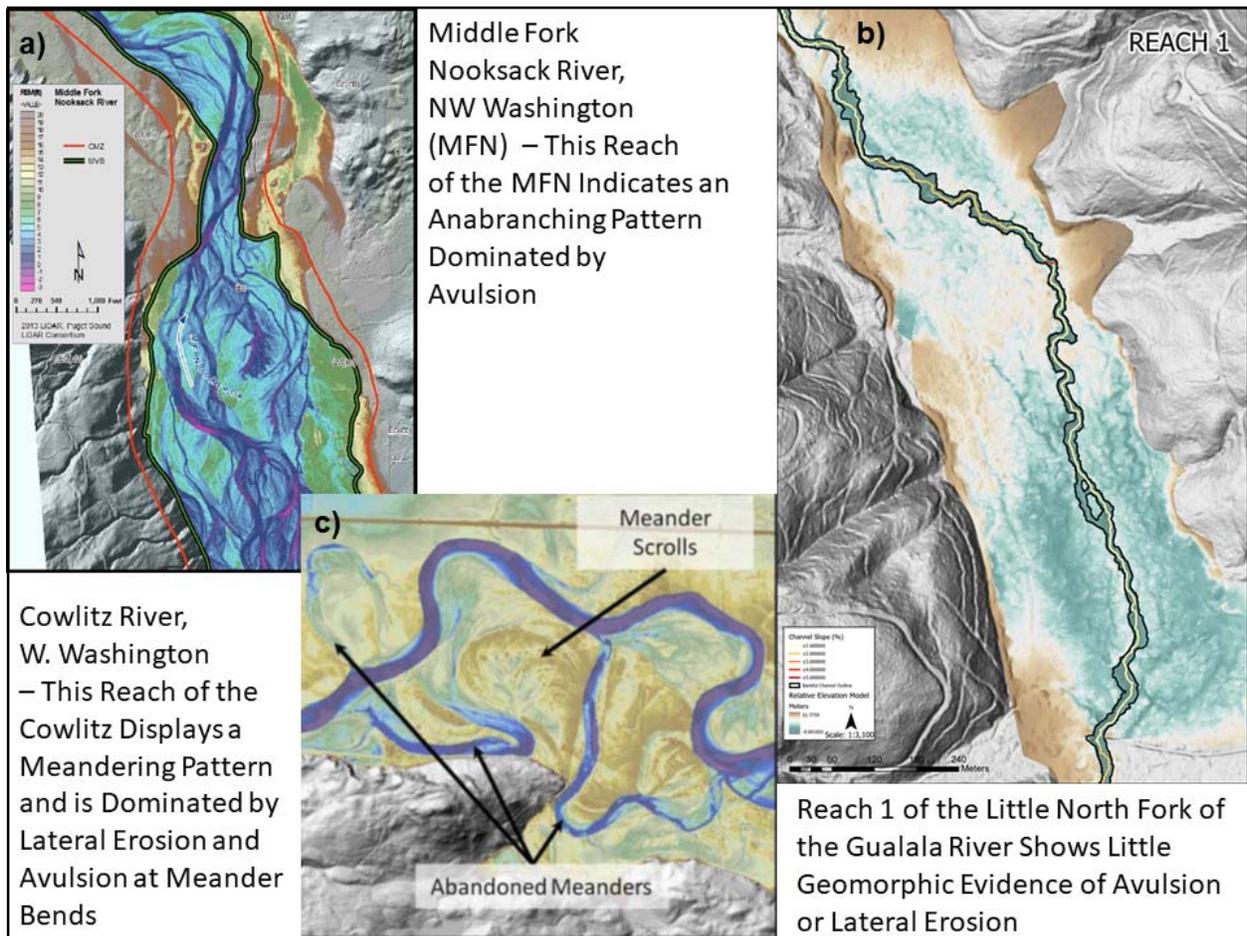
Other lines of evidence support the conclusion that the Little North Fork of the Gualala River is generally laterally stable and limited in its ability to migrate across its floodplain. For instance, Beechie et al. (2006) classified forested channels by their planform pattern, each with a characteristic rate of channel migration (Figure 14). In general, the authors found that straight channels (i.e., primarily single thread channel, sinuosity <1.5) had the lowest rate of lateral migration, and braided channels had the highest rate of migration. Analysis of the Little North Fork of the Gualala River using LiDAR data indicate that the Little North Fork of the Gualala River fits the definition of a straight channel as defined by Beechie et al. (2016) (Table 1), and therefore likely has a relatively low migration rate.

Figure 13. Relative elevation models for (a) the Middle Fork Nooksack River (MFNR) in northwest Washington; (b) the Little North Fork of the Gualala River; and (c) the Cowlitz River in western Washington. The MFNR and Cowlitz River show ample topographic evidence of channel migration processes, whereas the Little North Fork of the Gualala River shows limited evidence of channel migration.

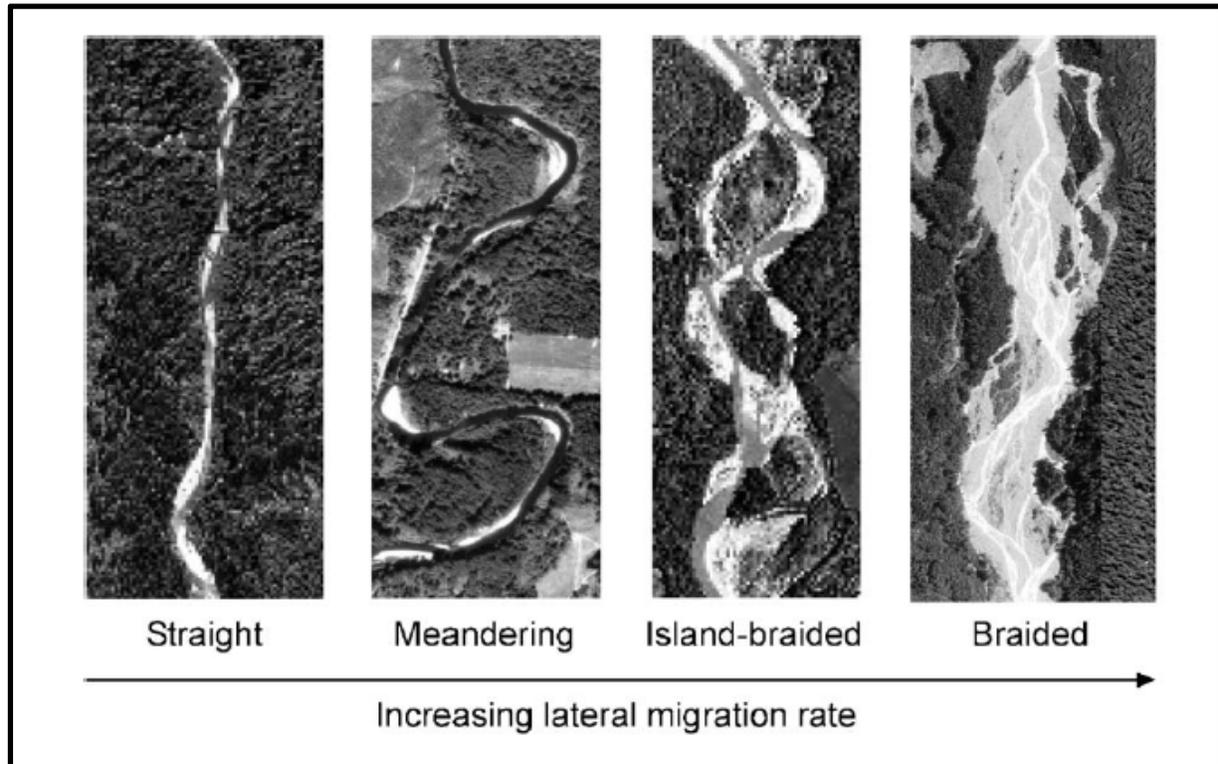
Figure 14. Illustration of the four channel patterns, indicating relative rates of lateral migration of the channel (i.e., migration that erodes floodplain surfaces). The Little North Fork of the Gualala River most resembles the straight channel pattern. Taken from Beechie et al. (2006).

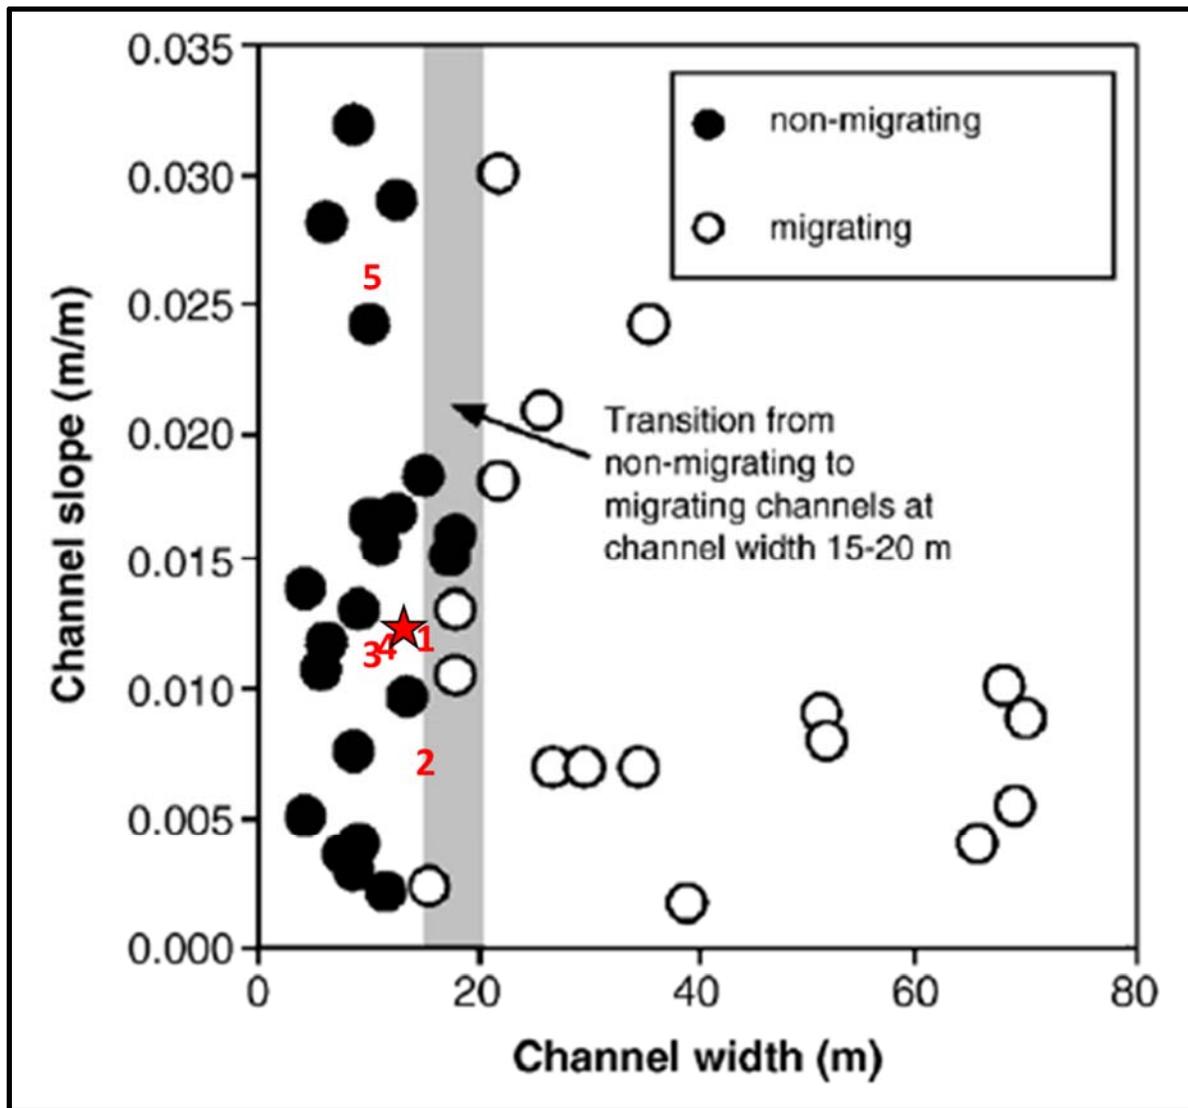
Beechie et al. (2006) found a bankfull channel width threshold for channel migration across forested floodplains in western Washington for channels between 15 and 20-m bankfull width. They speculated that the bankfull width threshold was related to the water depth necessary to erode the banks beneath the roots of riparian tree species, and that channel migration became an active process once channels were able to erode beneath the rooting zone of the bank trees. We did not see evidence of extensive bank erosion and/or recruitment of trees via bank erosion in the Little North Fork of the Gualala River. The analysis of the LiDAR digital elevation model (DEM) also indicated that the Little North Fork of the Gualala River was generally below the 15 to 20-m bankfull width threshold documented for western Washington (Table 1; Figure 15). Average bankfull width for reaches 1 and 2 fell within the documented threshold for transition from non-migrating to migrating channels, but did not fall within the range of “clearly” migrating channels.

Figure 15. Reach scale slope and bankfull channel width for various reaches of the Little North Fork of the Gualala River when plotted against data from western Washington. Red numbers represent specific reaches of the Little North Fork of the Gualala River, whereas the red star represents the average for all reaches. Figure modified from Beechie et al. (2006).

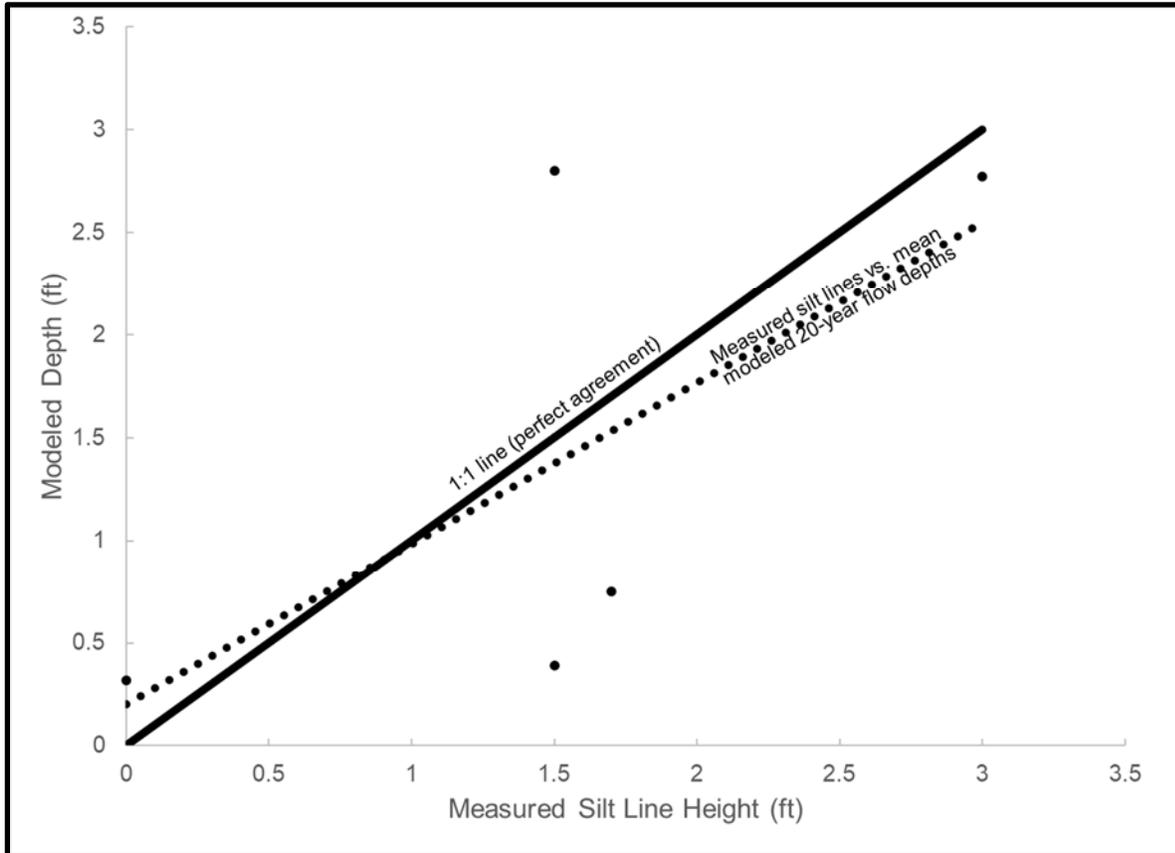
During the focused PHI, CAL FIRE WPP staff compared measured silt lines on trees to the water depth predicted by hydraulic model simulations using the Collector/Avenza applications on iPads. Due to accuracy of the iPad GPS under tree canopy, locations had potential errors ranging from approximately 15-40 feet. Because of this potential error, we averaged flow depths within a 20-foot radius of the measurement point. A linear regression between measured silt height and average modeled flow depth was

not significant. However, the regression line is relatively close to a 1:1 relationship (Figure 16).

Figure 16. Relationship between measured silt line height and average modeled flow depth for five points along the Little North Fork of the Gualala River. The lack of significance is likely due to the inaccuracy of the iPad GPS and the limited degrees of freedom in the regression. Despite this, the regression line is relatively close to a 1:1 agreement.

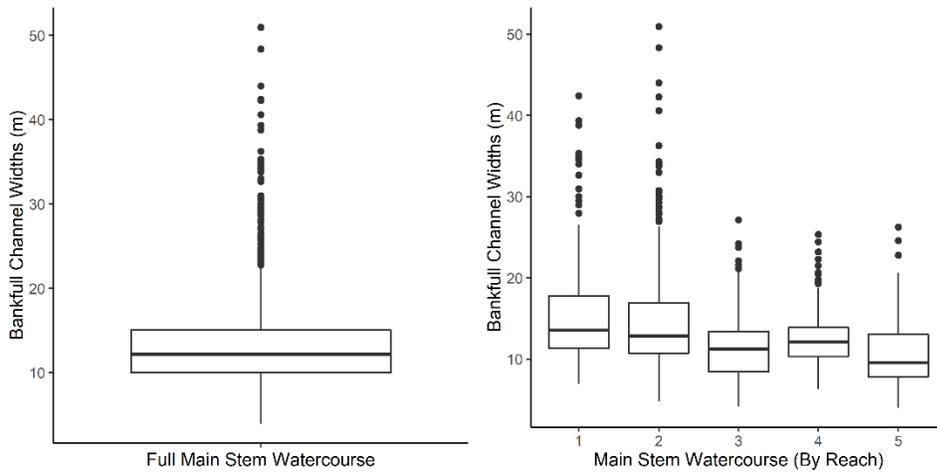
Boxplots of the channel transect lengths by the entire watercourse and by reach.

The results indicate that the full watercourse mean bankfull channel width falls below the 15-m threshold found by Beechie et al. (2006) for a migrating river channel. By reach, the mean widths for Reach 1 and Reach 2 break the 15-m threshold by 0.7 and 0.6-m, respectively, for a migrating river channel. All median bankfull channel widths by reach fail to exceed the migrating threshold. There are individual transects that exceed 15-m in length, more predominantly in the lower portion of the watershed.

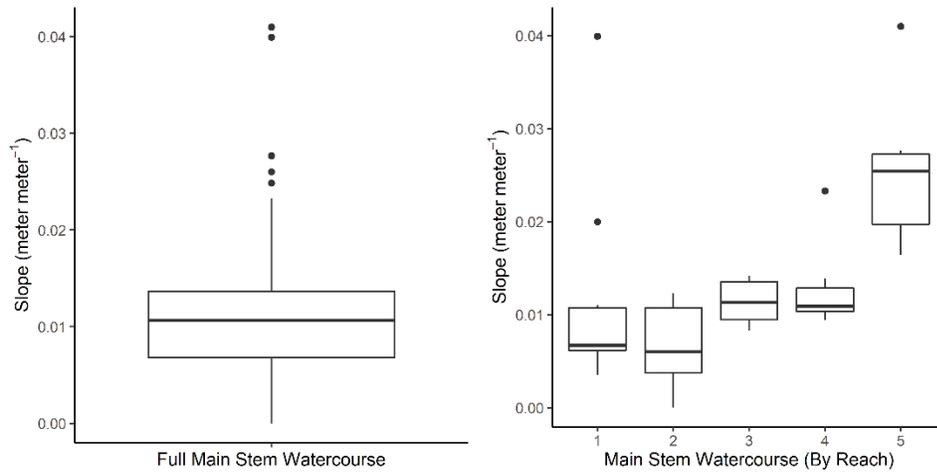
Boxplots of the segment channel slopes for the entire watercourse and by reach.

The entire watercourse has a mean slope of 1.2%, while the individual reaches range from 0.7% to 2.6% at the upper end of the watershed. The sinuosity for the entire watercourse channel is 1.24, which identifies the watercourse as either a sinuous but not meandering river (Ward and Trimble, 2004), or a single thread channel (Beechie et al., 2006). The individual reaches also all fall into the same sinuous-but-not-meandering or single-thread-channel classification.
