## Memorandum

From: Mark G. Smelser, PG, CEG  
Senior Engineering Geologist  
Department of Fish and Wildlife

Subject: **REVISED Flood Prone Area Assessment of the "Little" Timber Harvesting Plan (1-18-095 MEN), Mendocino County, California**

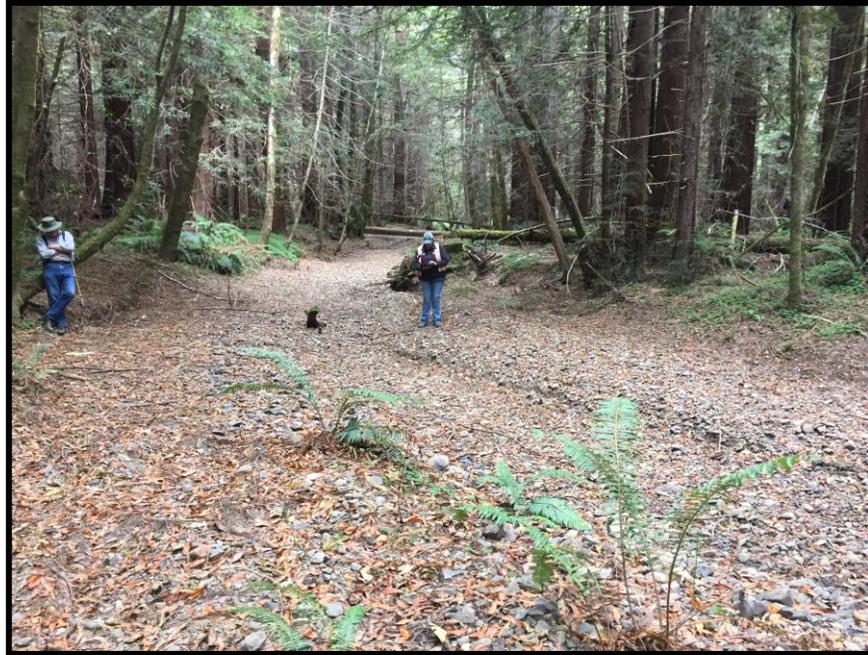
**Figure 1.** Looking upstream at a dry, well-established and self-formed alluvial secondary channel that empties into active channel just to the right of the photograph at Site #1. It is hypothesized that this channel was once that of the mainstem, but that a recent avulsion has resulted in it being abandoned.

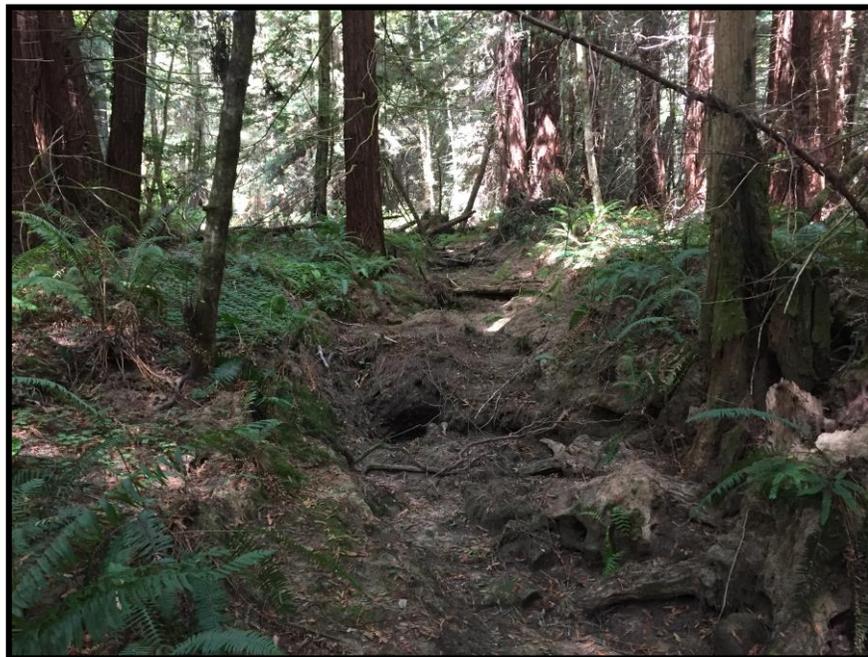
**Figure 2.** Looking upstream at a dry secondary channel recently carved into the floodplain at Site #3. Note the preponderance of roots that have been exhumed by the scouring. The head of this channel occurs at a sharp bend in the active channel that includes a channel spanning accumulation of large wood. This channel was likely scoured in response to the escape of water impounded behind the large wood accumulation.

additional racking of wood on the jam could in future years force an avulsion similar to that occurring at Site #3 (Figure 2) and that discussed by OEI at Site #4. Additionally, it appears even more likely that the landslide generated channel spanning log jam (Figure 3) will direct streamflow into the left (east) bank which will accelerate local bank erosion and channel migration around the log jam obstruction. The same sort of channel adjustments should be anticipated at all of the numerous large wood accumulations within the channel (Figure 4).

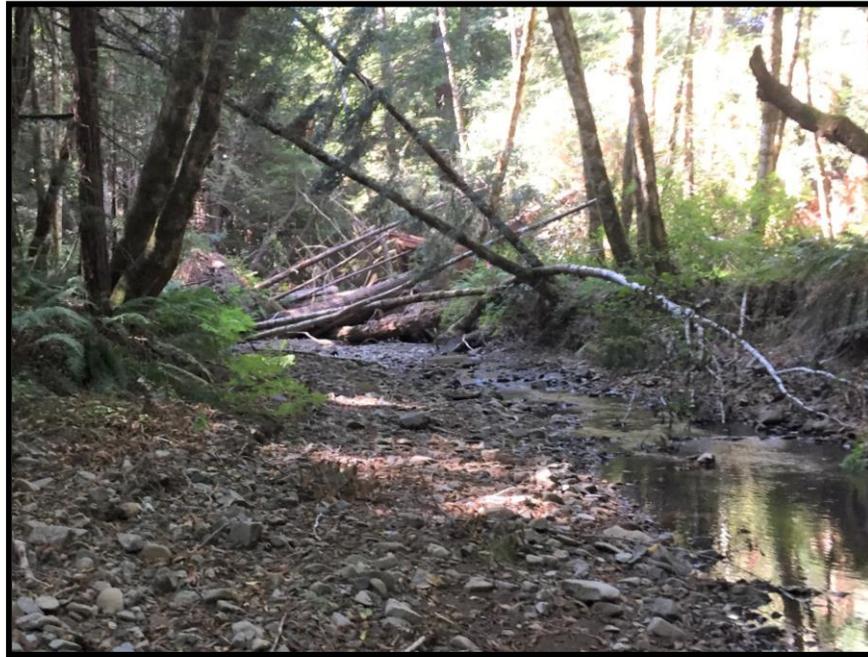
**Figure 3.** Looking upstream at the February 2019 landslide generated a channel-spanning multi-stemmed logjam in the Lower North Fork Gualala River at Site #6. Landslide failed out of the hillside along the left (west) side of the photograph. The landslide debris and root wad forces streamflow into the east bank.

OEI's CMZ evaluation includes a curious discussion of Site #6 that states: *“Despite the landslide that impinged on the LNFG and that tended to divert additional flow to the eastern floodplain, no avulsion occurred. The floodplain in this area is not considered a channel migration zone.”* This statement is curious for two reasons: 1) it appears that OEI is only considering avulsions to represent channel migration; and 2) while the landslide generated a channel-spanning log jam that did not force an avulsion, it is reasonable to consider that

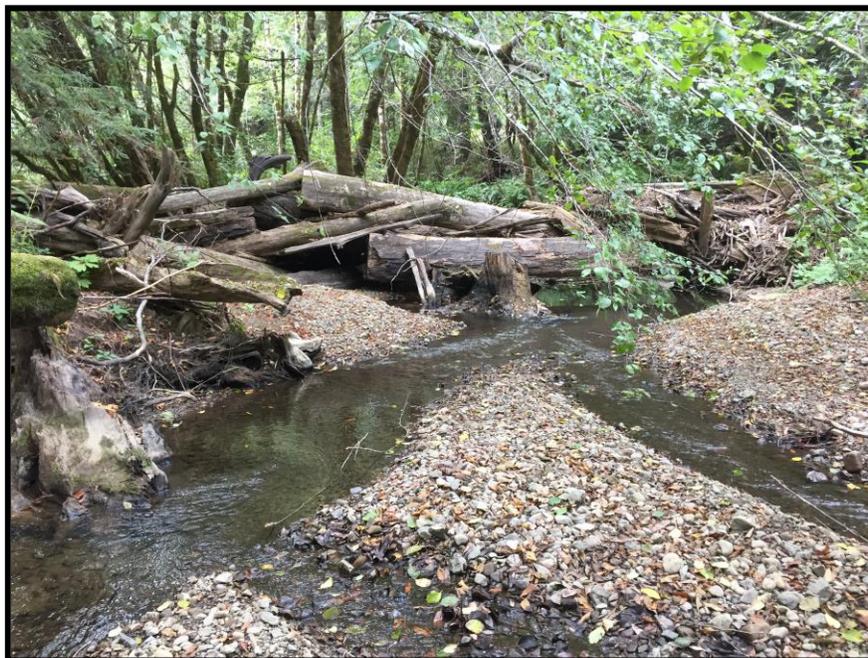
**Figure 4.** Looking downstream at a channel spanning large wood structure that is racking additional wood and capturing sediment (aggrading the bed) at Site #2. Note sawcut stump in middle of the photograph and another stump in the stream along the left side of the photograph.

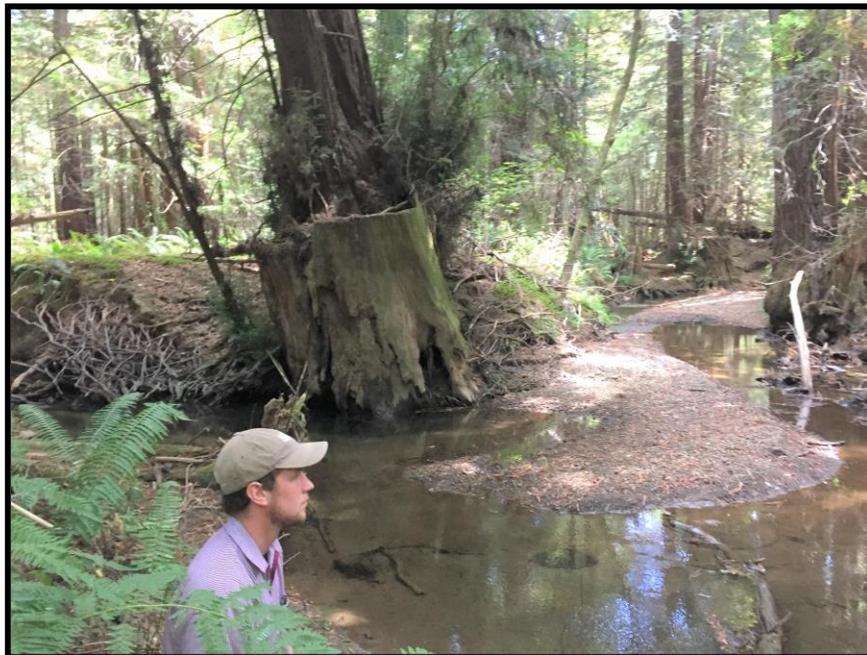
**Figure 5.** Looking downstream at exhumed sawcut old growth redwood stump within the active channel at Site 3. Note that the channel sediment is relatively fine-grained and the exposed roots to the left of the stump that indicate active bank erosion.

Significant channel and floodplain aggradation within the Little North Fork valley is exhibited by the presence of numerous sawcut old-growth tree stumps that appear once buried by three or four feet of sediment aggradation and are now in various stages of exhumation (Figures 5 and 6). These observations were documented at five of the six sites reconnoitered during the August PHI, and similar conditions are assumed to exist throughout the full width and length of the alluvial valley floor. The substantial floodplain aggradation and subsequent exhumation documents both historic and contemporary channel migration processes at work along the floor of the Little North Fork valley. Moreover, because the sediment comprising the aggradation was transported, deposited, and is now being reworked under the same general hydrologic regime, the Little North Fork can be considered a self-formed, self-adjusting, an unconfined alluvial channel. Contemporary channel migration is also exhibited by the numerous exhumed stumps that are found in the active channel (Figures 4, 5, and 6). More specifically, the upright tree stumps are assumed to be in their growth position and because old growth redwood trees do not grow in active channels, the fact that such a stump now exists in the active channel is clear evidence that the stream has migrated to that location.

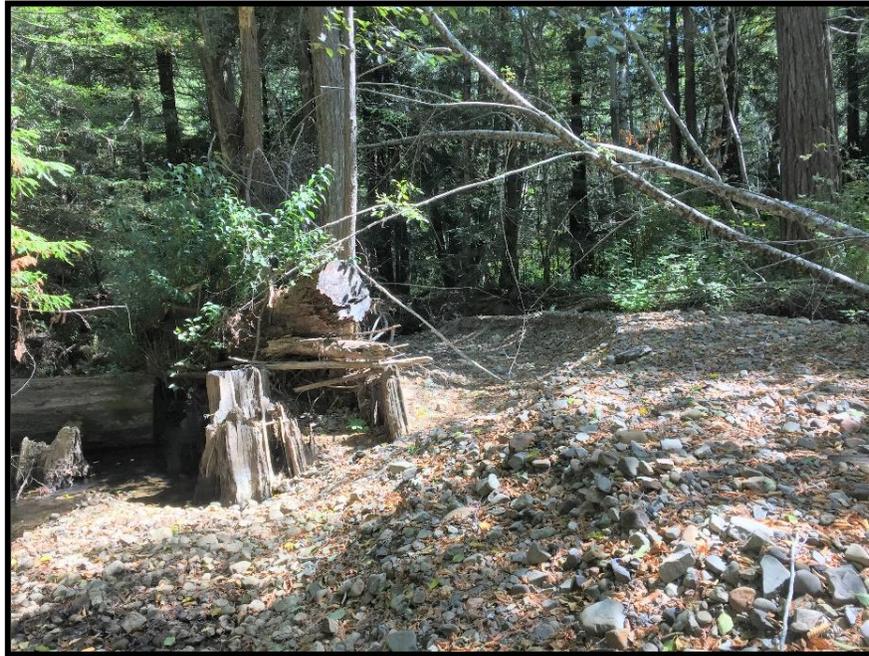
**Figure 6.** Looking downstream at exhumed sawcut old-growth redwood stump immediately adjacent to the active channel (lower left) at Site 5. Note the coarse-grained gravel deposits that have been recently eroded in response to streamflow around the stump.

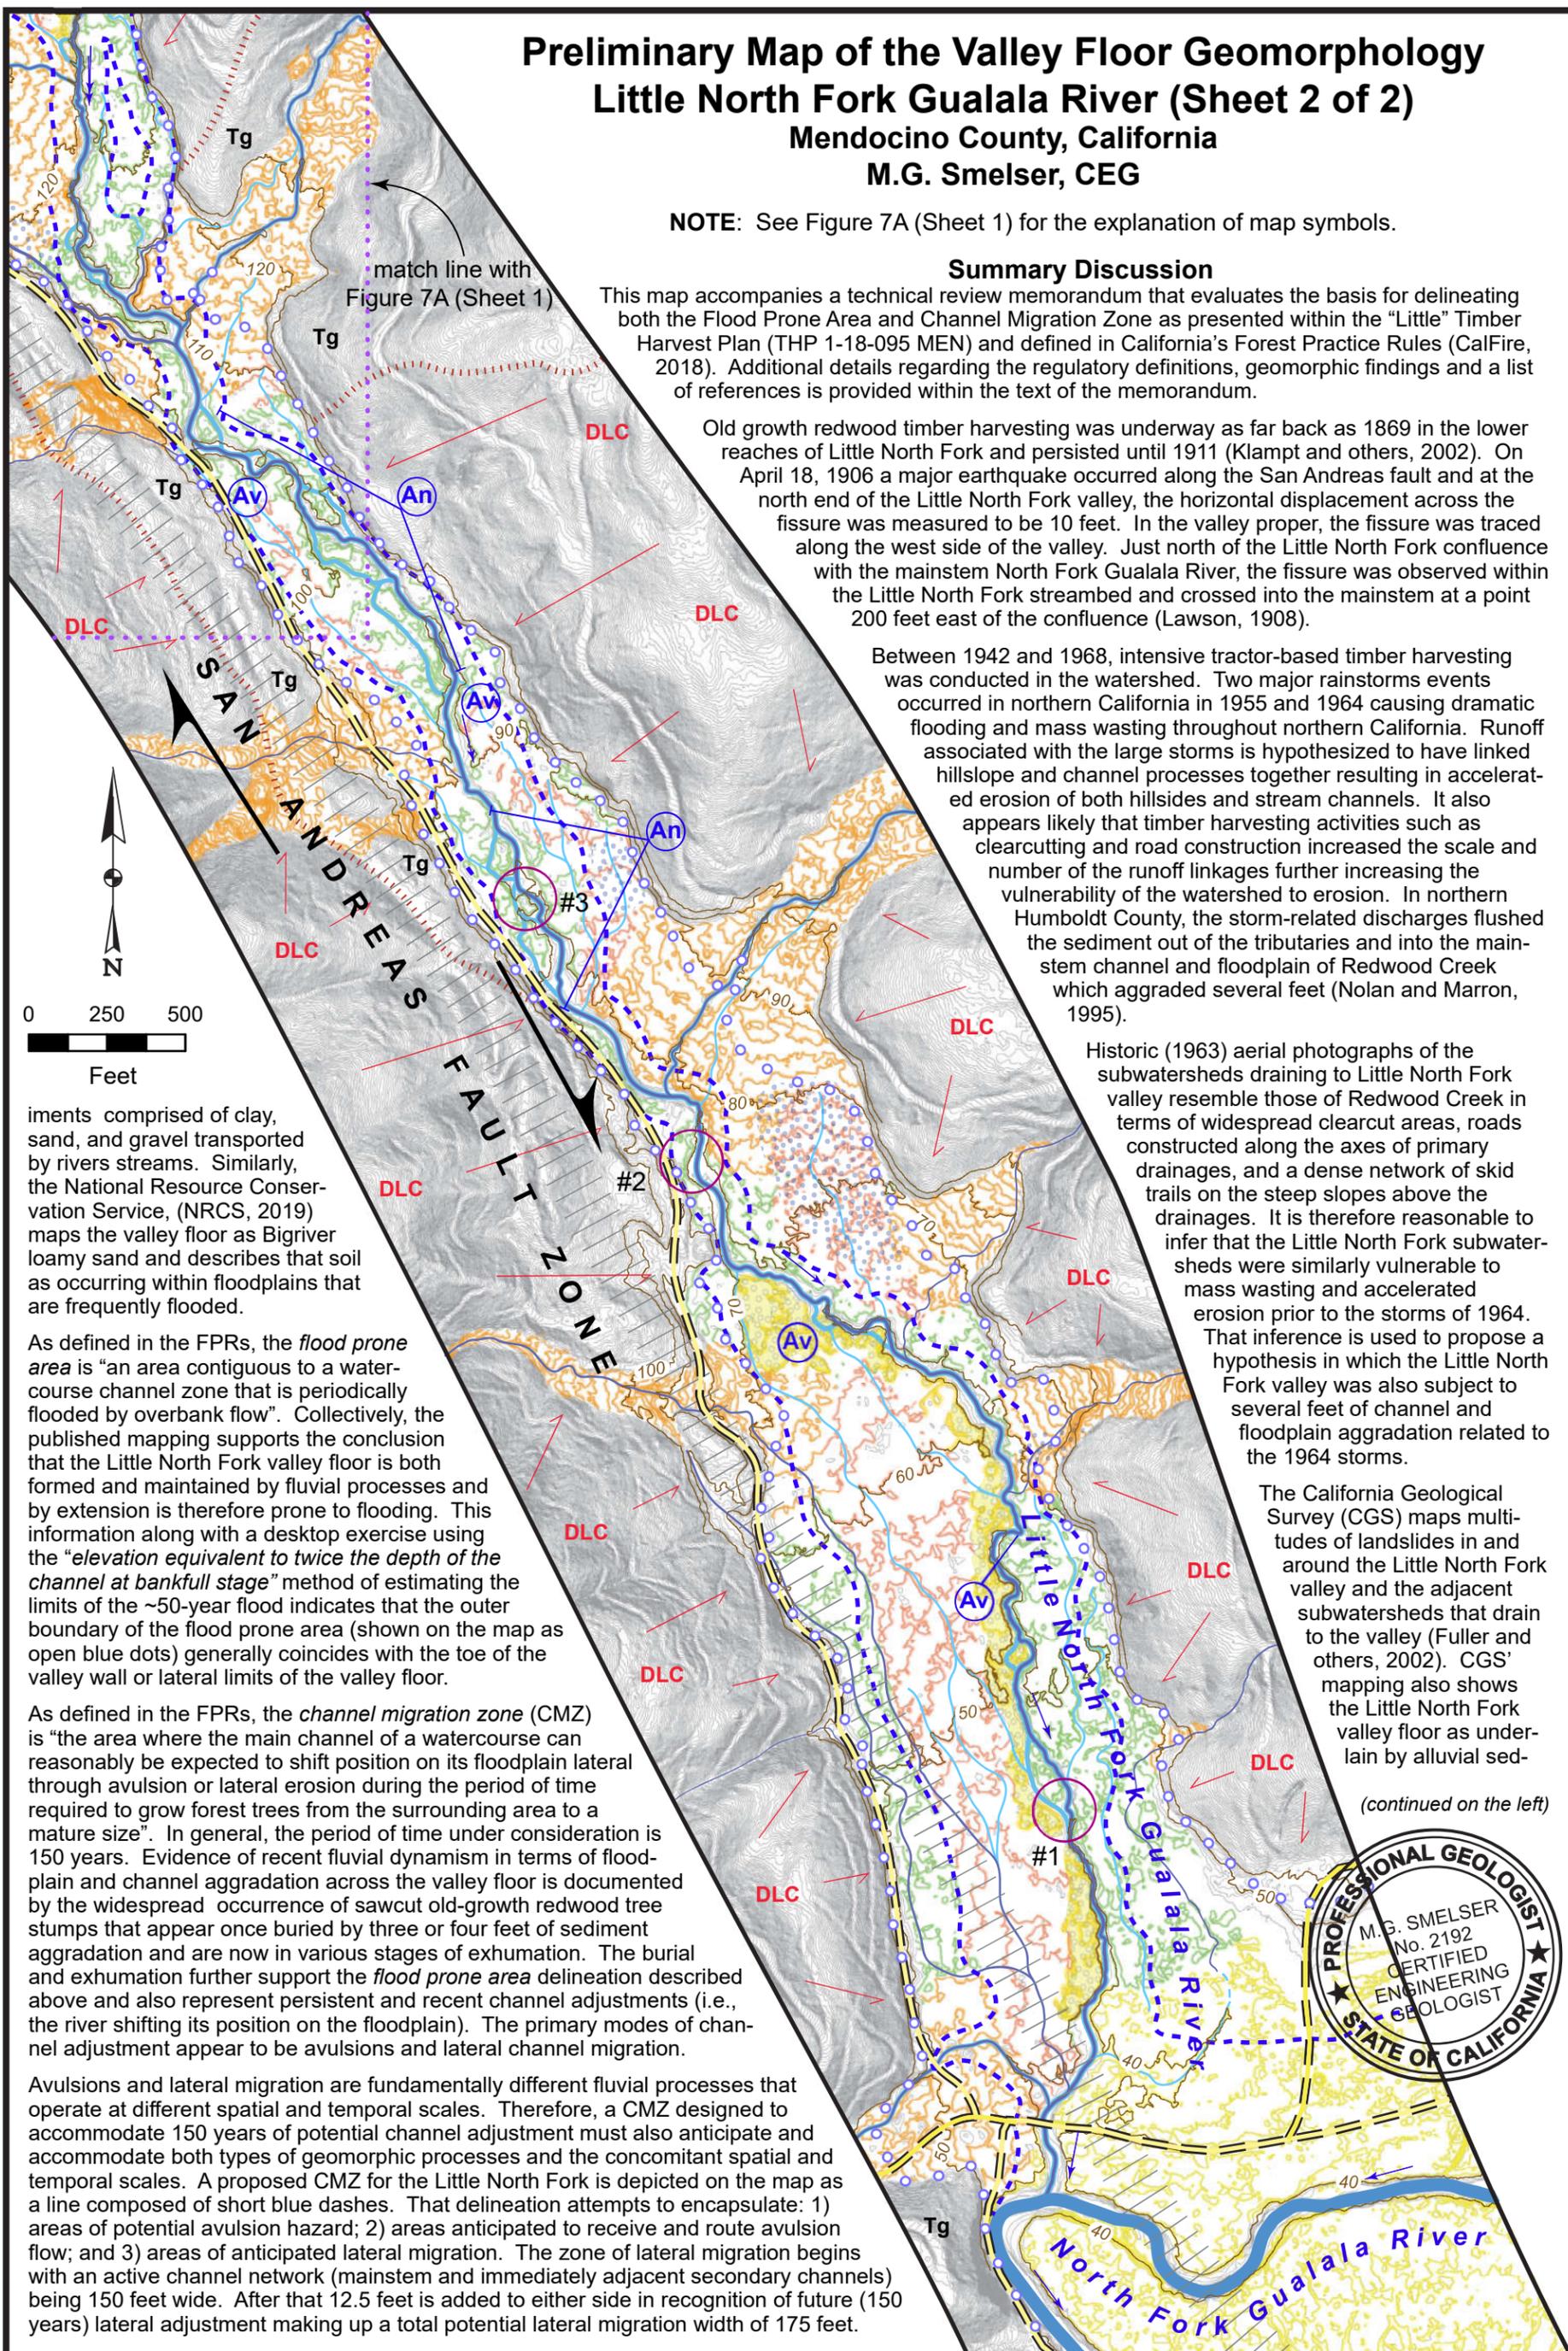
FIGURE:  
**7B**

iments comprised of clay, sand, and gravel transported by rivers streams. Similarly, the National Resource Conservation Service, (NRCS, 2019) maps the valley floor as Bigriver loamy sand and describes that soil as occurring within floodplains that are frequently flooded.

As defined in the FPRs, the *flood prone area* is "an area contiguous to a watercourse channel zone that is periodically flooded by overbank flow". Collectively, the published mapping supports the conclusion that the Little North Fork valley floor is both formed and maintained by fluvial processes and by extension is therefore prone to flooding. This information along with a desktop exercise using the "elevation equivalent to twice the depth of the channel at bankfull stage" method of estimating the limits of the ~50-year flood indicates that the outer boundary of the flood prone area (shown on the map as open blue dots) generally coincides with the toe of the valley wall or lateral limits of the valley floor.

As defined in the FPRs, the *channel migration zone* (CMZ) is "the area where the main channel of a watercourse can reasonably be expected to shift position on its floodplain lateral through avulsion or lateral erosion during the period of time required to grow forest trees from the surrounding area to a mature size". In general, the period of time under consideration is 150 years. Evidence of recent fluvial dynamism in terms of floodplain and channel aggradation across the valley floor is documented by the widespread occurrence of sawcut old-growth redwood tree stumps that appear once buried by three or four feet of sediment aggradation and are now in various stages of exhumation. The burial and exhumation further support the *flood prone area* delineation described above and also represent persistent and recent channel adjustments (i.e., the river shifting its position on the floodplain). The primary modes of channel adjustment appear to be avulsions and lateral channel migration.

Avulsions and lateral migration are fundamentally different fluvial processes that operate at different spatial and temporal scales. Therefore, a CMZ designed to accommodate 150 years of potential channel adjustment must also anticipate and accommodate both types of geomorphic processes and the concomitant spatial and temporal scales. A proposed CMZ for the Little North Fork is depicted on the map as a line composed of short blue dashes. That delineation attempts to encapsulate: 1) areas of potential avulsion hazard; 2) areas anticipated to receive and route avulsion flow; and 3) areas of anticipated lateral migration. The zone of lateral migration begins with an active channel network (mainstem and immediately adjacent secondary channels) being 150 feet wide. After that 12.5 feet is added to either side in recognition of future (150 years) lateral adjustment making up a total potential lateral migration width of 175 feet.

TITLE: Little North Fork Gualala River Valley Floor Geomorphology Sheet 2 of 2  
DATE: Revised November 11, 2019 SCALE: As shown

The contemporary morphology of the Little North Fork valley floor is characterized with a topographic contour map and longitudinal profile (Figures 7 and 8) that were derived from the USGS LiDAR dataset (USGS, 2018). Based upon the reconnaissance level investigations at six representative sites (shown on Figures 7A and B) during the August PHI, the LiDAR based topography appears highly accurate. The contour interval of the map is two feet, and the patterns exhibited by the contours depict the valley floor morphology in fine detail. Identifiable on the map along the west side of the valley are the trenches and lineaments generated by

suggested by the longitudinal profile (Figure 8), the stream appears well on its way toward achieving dynamic equilibrium in terms of vertical downcutting which suggests that future channel adjustments will likely be focused in a horizontal direction via lateral erosion. While much of the Little North Fork is a single-thread channel that is approximately 60 feet wide, it also includes numerous secondary channels that weave in and out and around the main channel. In adopting a conservative approach, the various secondary channels combined with the primary active channel are interpreted to represent the contemporary scale of active lateral migration currently underway and defines an active CMZ of approximately 150 feet in width. In anticipation of 150 years of future channel migration and a conservative approach, a nominal value of one inch per year of lateral erosion is assumed. This equates to 12.5 feet over that period of time. Adding 12.5 feet to either side of the contemporary CMZ equates to a proposed lateral migration CMZ width of 175 feet. The combined avulsion and lateral migration CMZ is delineated on the geomorphic map with heavy dashed dark blue line (Figures 7A and B).

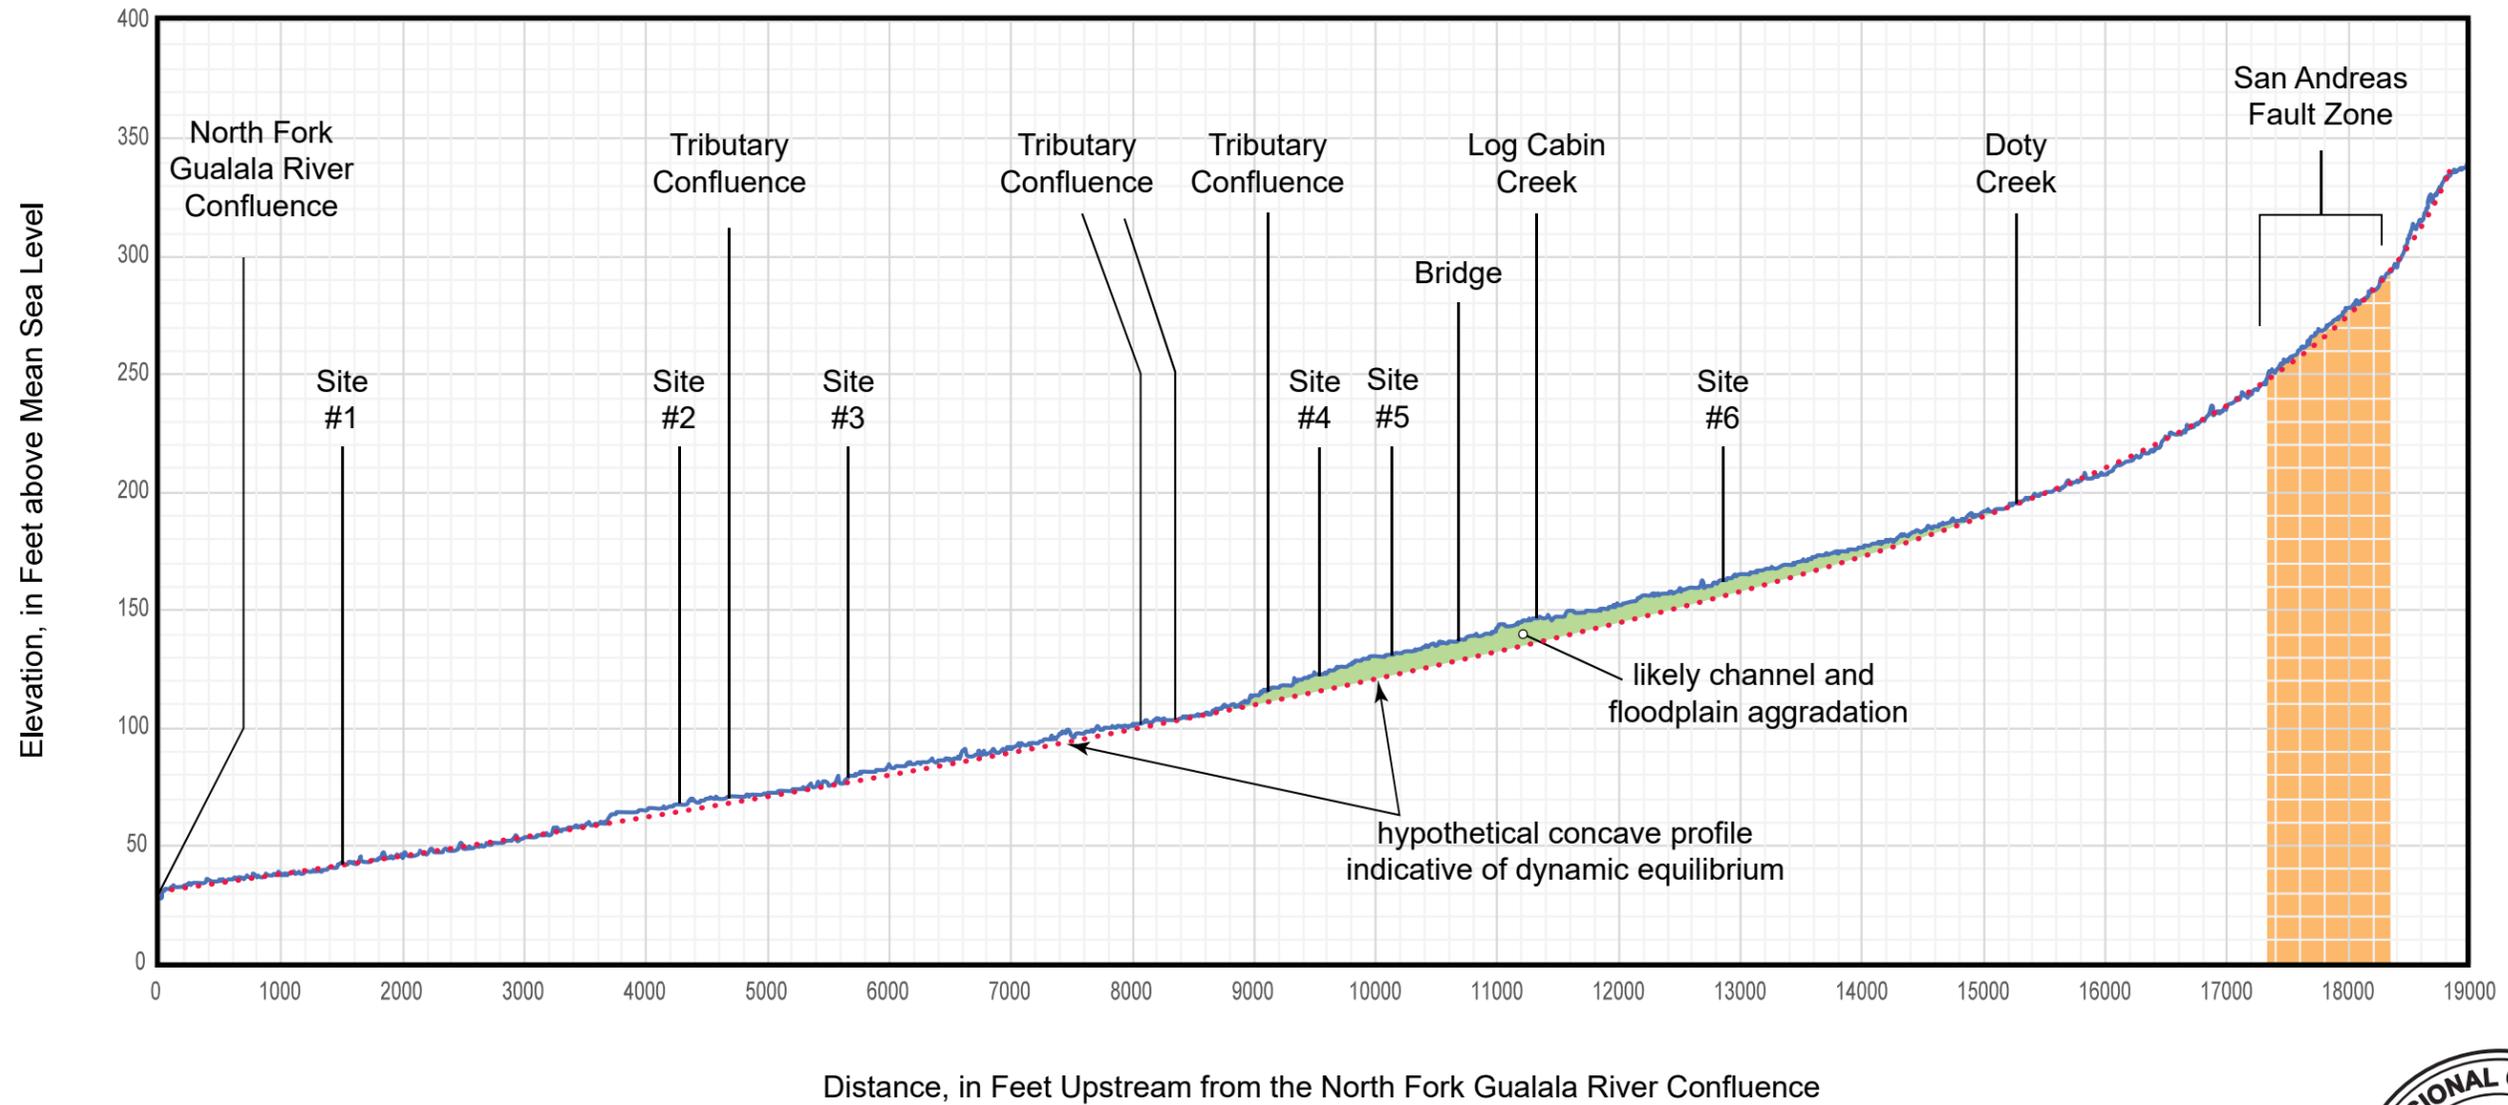
**TITLE:** Little North Fork Gualala River Longitudinal Profile  
**SCALE:** As shown  
**DATE:** Revised November 8, 2019
