ATTACHMENT A
Riparian road reconstruction impacts: floodplain (August 30, 2006)

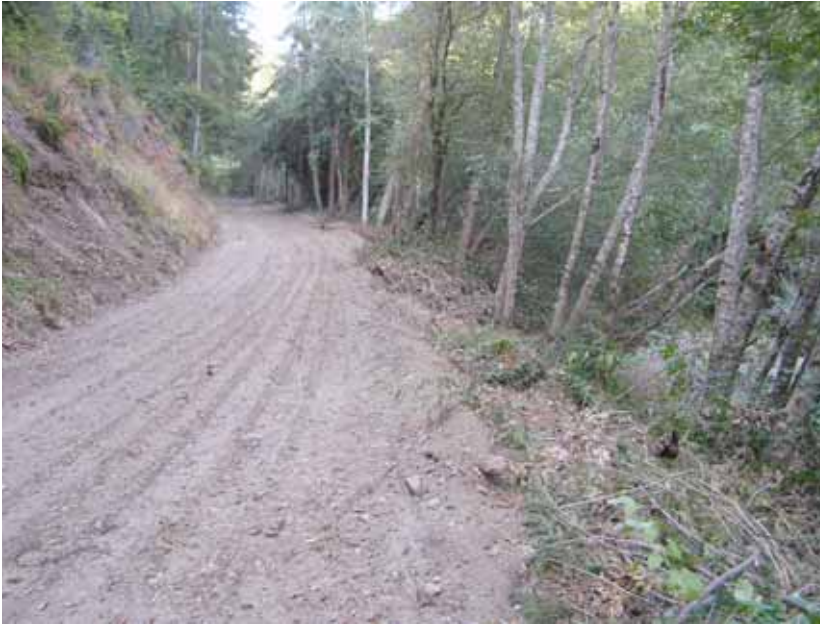
Fig. A-1. Red alder thicket is cut below the widened road edge. Slash, plant debris and loose graded silt is deposited over the bank, above the active winter overflow channel of the Wheatfield fork (right). Note the canopy gap through the mature riparian zone on both sides of road, leaving only alders below grading/”brush clearing” line to provide streamside canopy cover and shade. Road bank upslope is partially

devegetated, also lacking tree canopy.

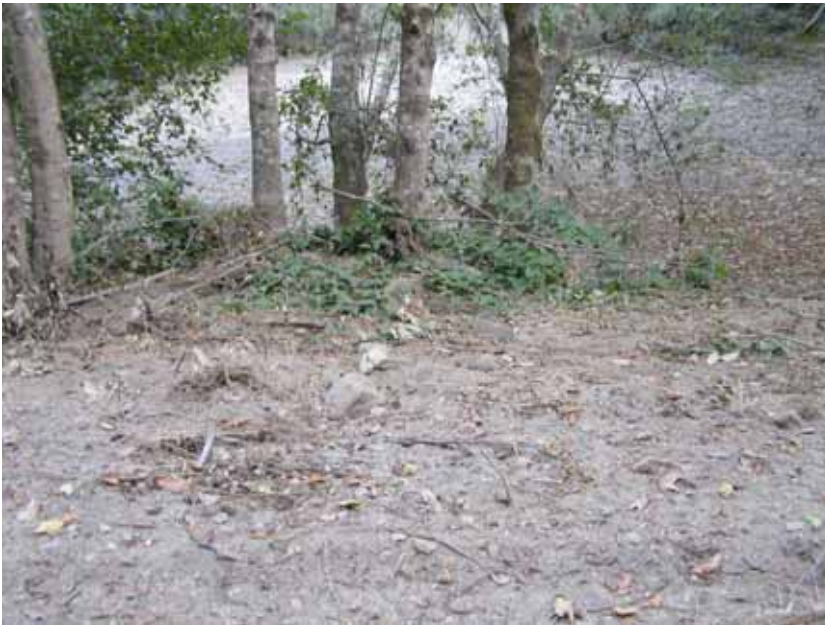
Fig. A-2. Riparian ground layer (California blackberry thicket) is buried by road grading sediments deposited on steep bank below the outer floodplain road edge, north bank of Wheatfield Fork; gravel bed of winter high flow channel is in background below channel bank-edge mature red alder trees. Riparian tree and shrub layer is missing. Debris and sediment extends to the bed. This bank was continuously vegetated

by California blackberry, alder, and horsetail (remnants of which persist at edge of spoils area). Bank top is below flood elevation, indicated by persistent flood debris in alder branches, and silt deposits on road.

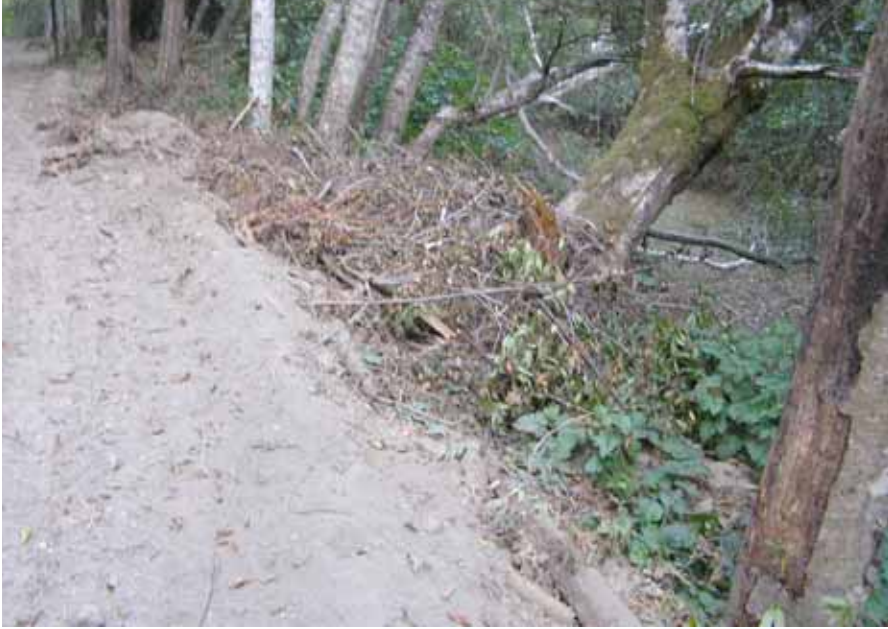
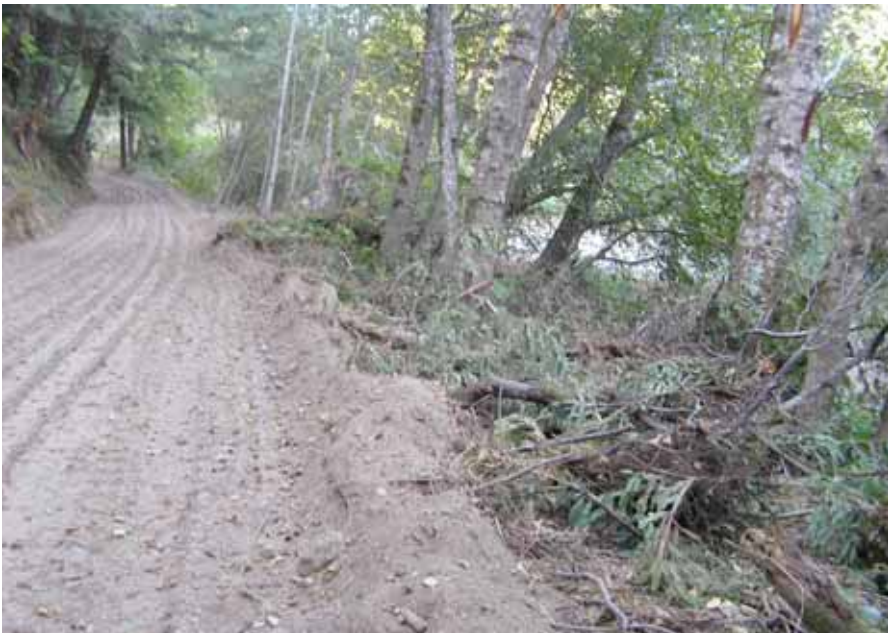
Fig A-3. Slash and loose sediment are deposited at top the widened road in the floodplain riparian zone; road now spills over the formerly vegetated riparian bank. Winter high flow channel bed is directly below. Bank top is below flood elevation, indicated by persistent flood debris in alder branches and silt deposits on road.

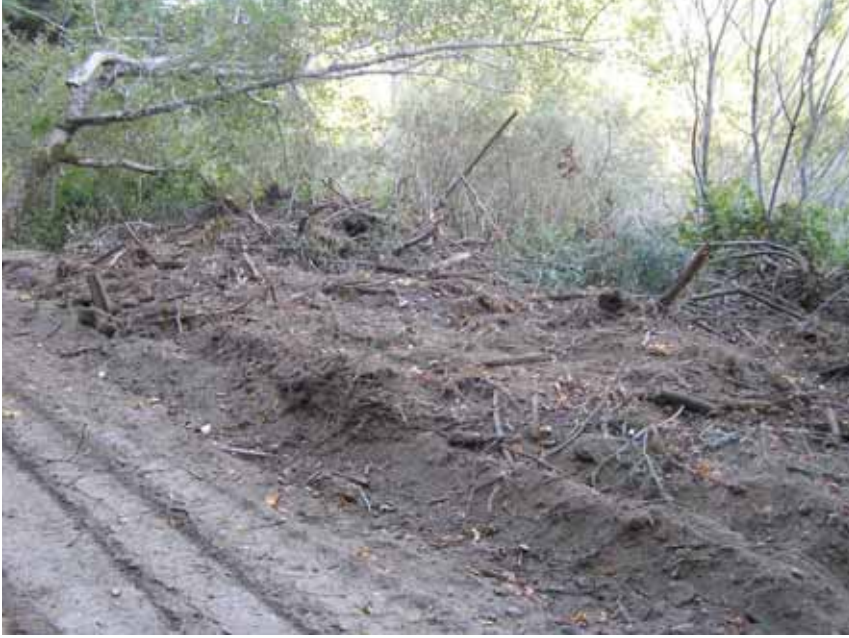
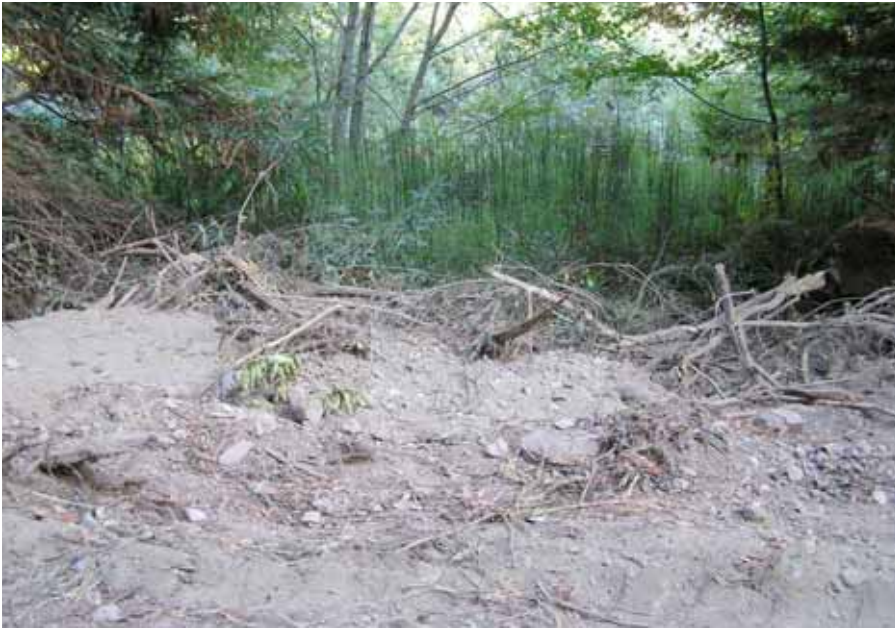
Fig. A-4. Slash and loose sediment are deposited in a wide swath from the widened road edge across the riparian floodplain vegetation, towards the winter high flow channel (background), covering over willows, alders, California blackberry, and horsetail. Large riparian canopy gap extends over graded area. This zone is below flood elevation, indicated by persistent flood debris in alder branches and thick silt deposits on road.

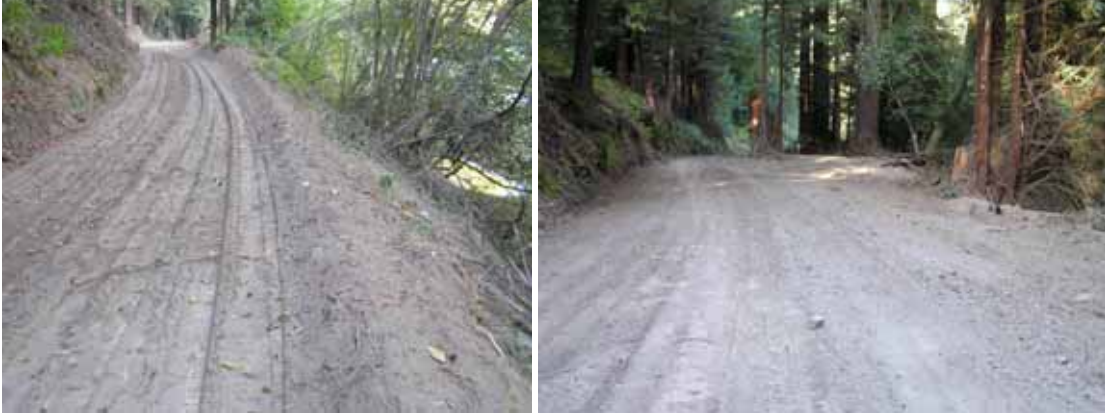
Fig. A-5. Single and double road widths. (a) Loose silt is deposited over road edge and into riparian woodland and forest. Side-cast graded silt spills over steep channel bank. Road here represents a single truck width, the approximate original width. Contrast with (b), widened road segment in right photo, almost double the width, extending into riparian forest. Note tree stumps (background) with fresh wood exposed.

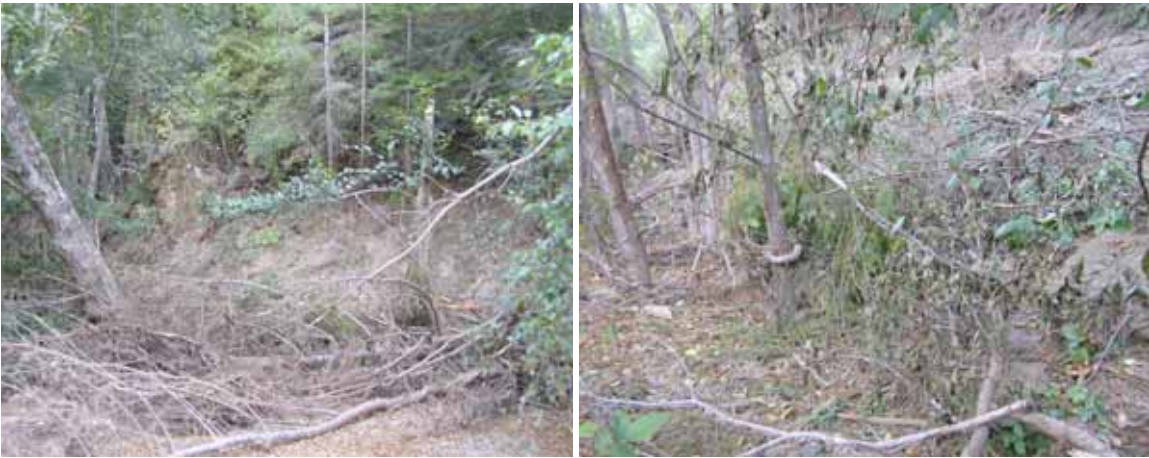
Fig. A-6. Road grading spoils and slash deposited over steep bank above winter flood channel, viewed from bed. Note riparian canopy gap.

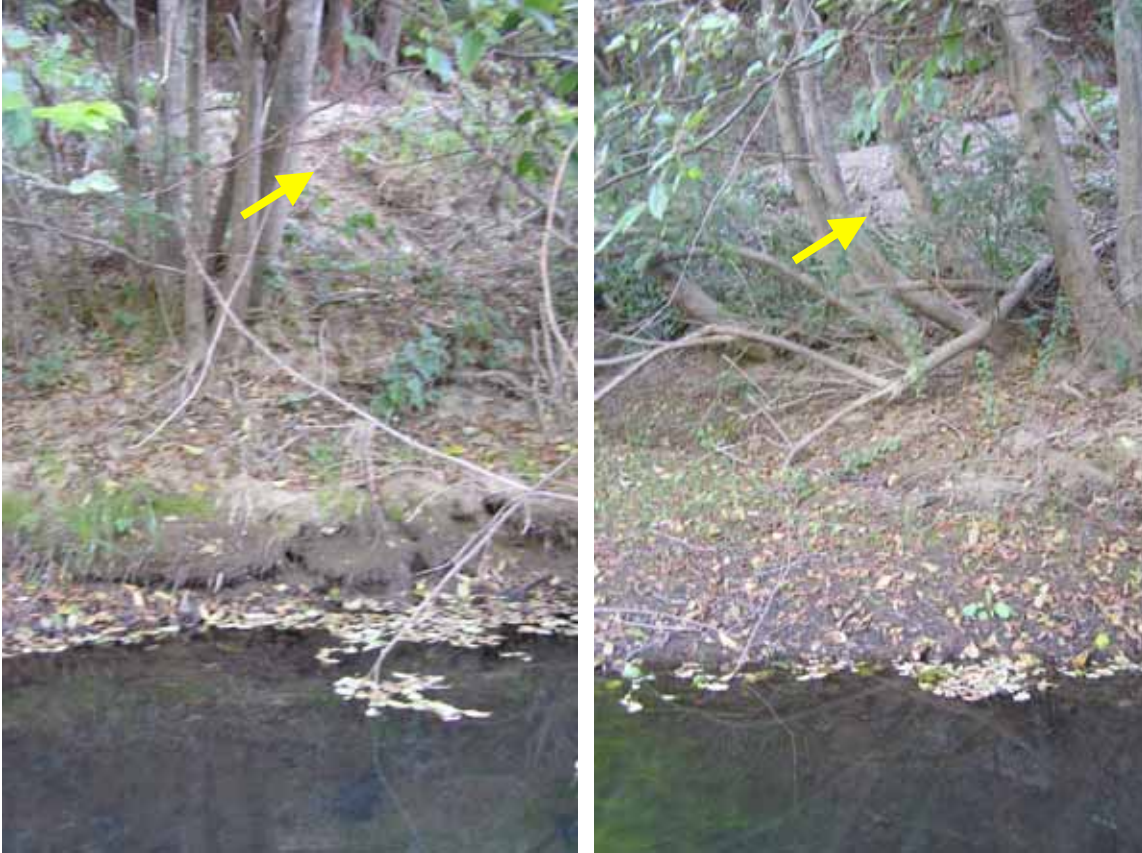
Fig. A-7. Road grading spoils (yellow arrow) deposited over steep bank above channel pool with fish and frogs, flood channel, viewed from channel pool.
