**ATTACHMENT B**

**Riparian road reconstruction impacts: forested slope above road, August 31, 2006**

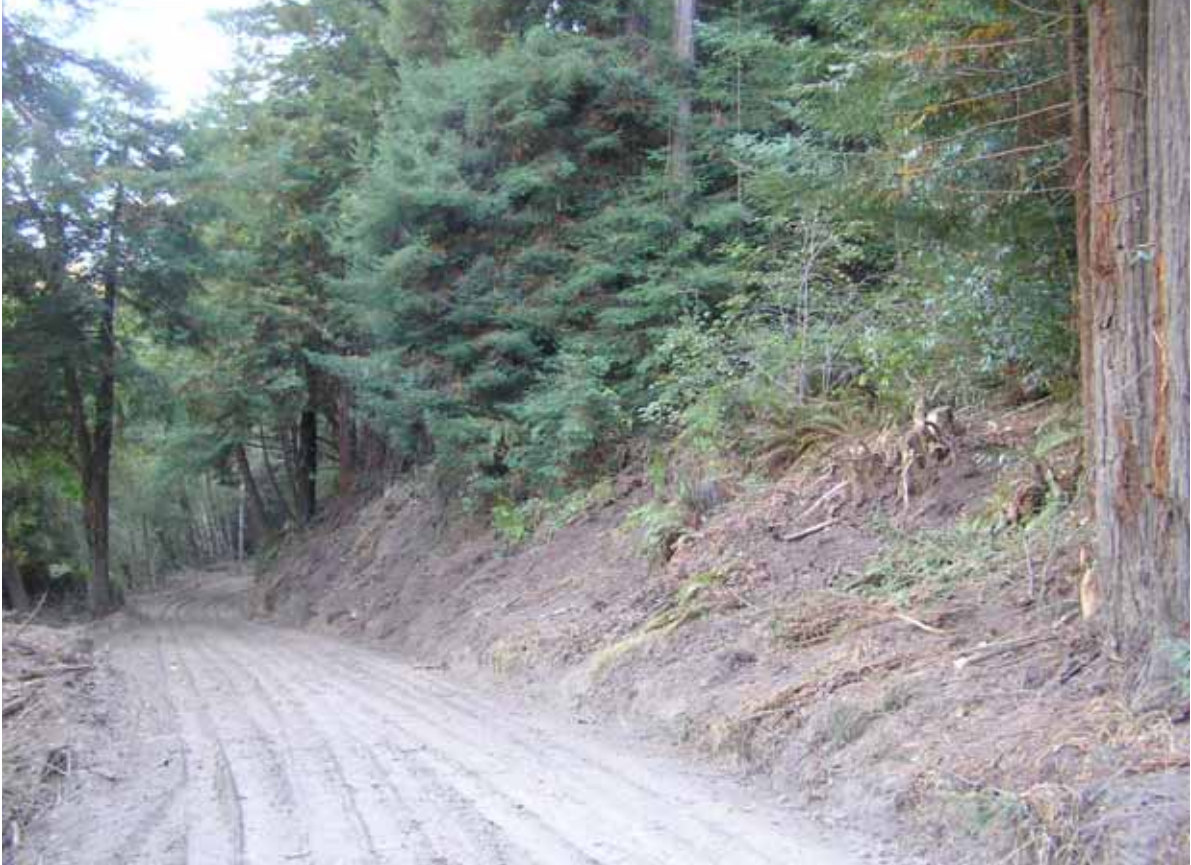
**Fig. B-1.** Large riparian tree canopy gap on both sides of road, to recent tree removal in riparian zone, including floodplain below road. Steep bank above road is devegetated, exposed soil, unstabilized. Note sediment and slash below road. Logs were apparently removed.

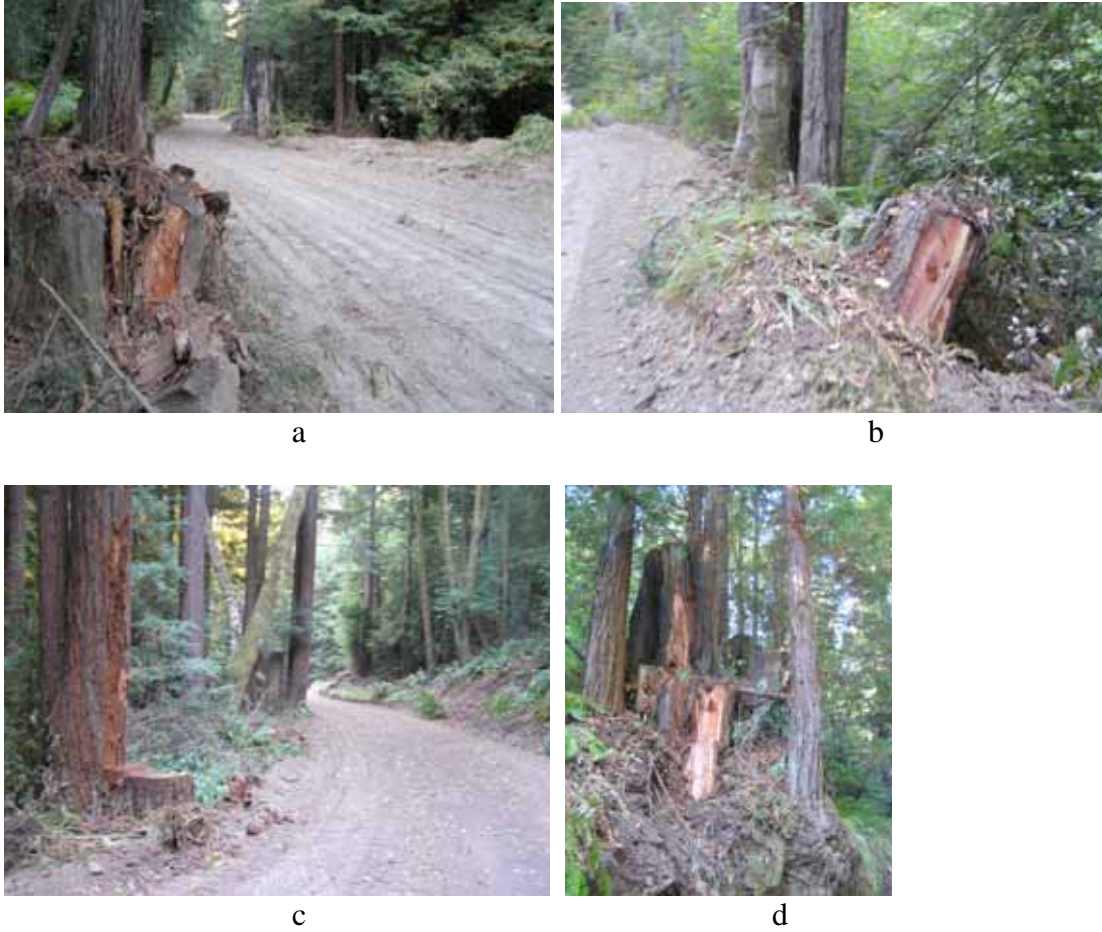
**Fig. B-2.** Conifers (including redwoods) in riparian floodplain zone cut and apparently harvested (no logs remaining in view) beyond widened road edge, enlarging riparian canopy gaps of dominant species and major shade sources. Note spoil deposition zone in floodplain and banks, (b).

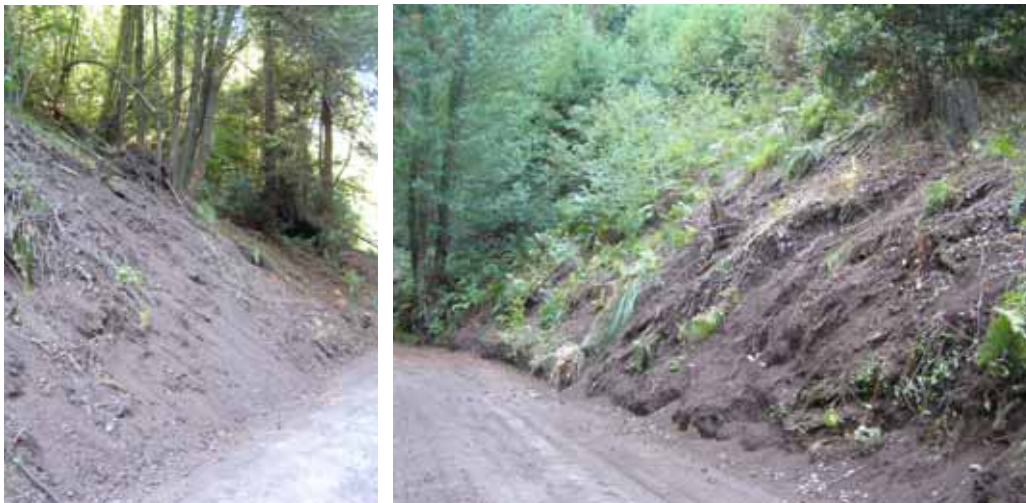
**Fig. B-3.** Freshly devegetated steep slope above road has shrubs, trees, and even ground layer removed up to approximately 6 m above floodplain, creating excessive erosion potential and enlarging canopy tree gaps. Note size of trees and extent of canopy beyond cleared areas.
