ATTACHMENT C

Riparian haul road reconstruction impacts: post-mining road treatment, Gualala River, Wheatfield Fork above Annapolis Road bridge, Valley Crossing (Oct. 5, 2006)

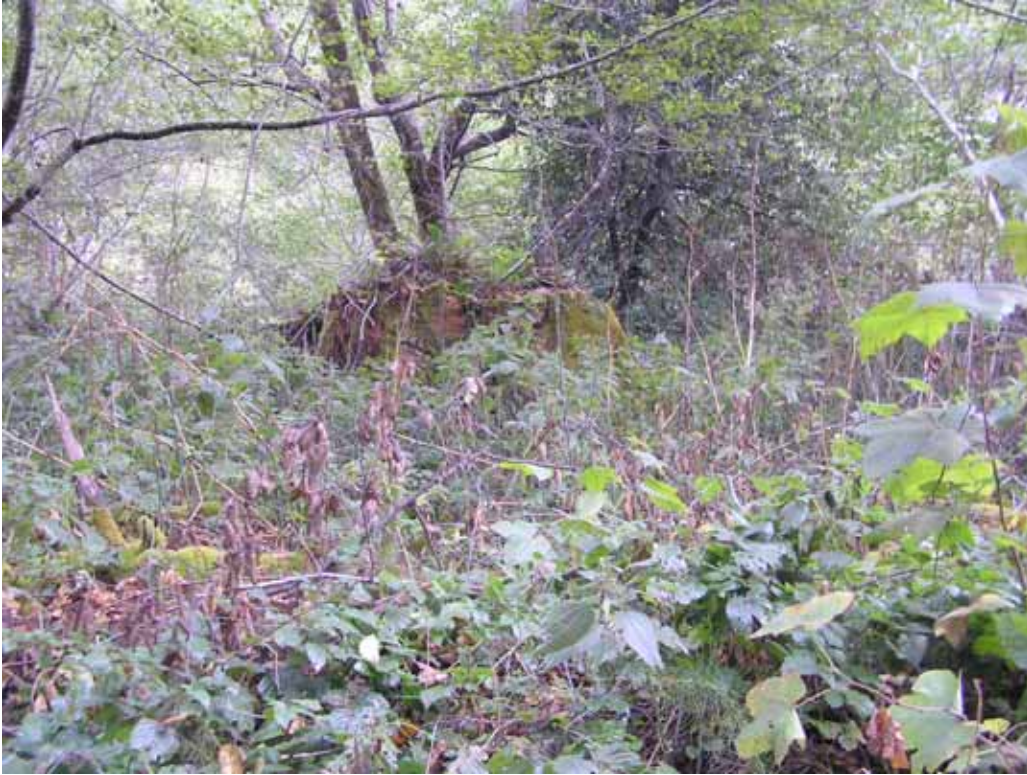
C-1-a

Fig. C-1 (a, b, above). Reference condition samples, riparian floodplain. Some reference conditions in riparian floodplain zone unaffected by road expansion. Views represent only a small sample of the variable vegetation, but indicate the maturity and density of cover at all layers. (a) willow-alder woodland (overstory) with nettle, blackberry, thimbleberry, horsetail, species dominant in ground layer and shrub layer. Channel is bright background. (b) swordfern, sedges, occur under dense mixed canopy of bigleaf maple, willow, alder, and redwood, with well-developed litter layer and coarse woody debris. Channel is bright background.

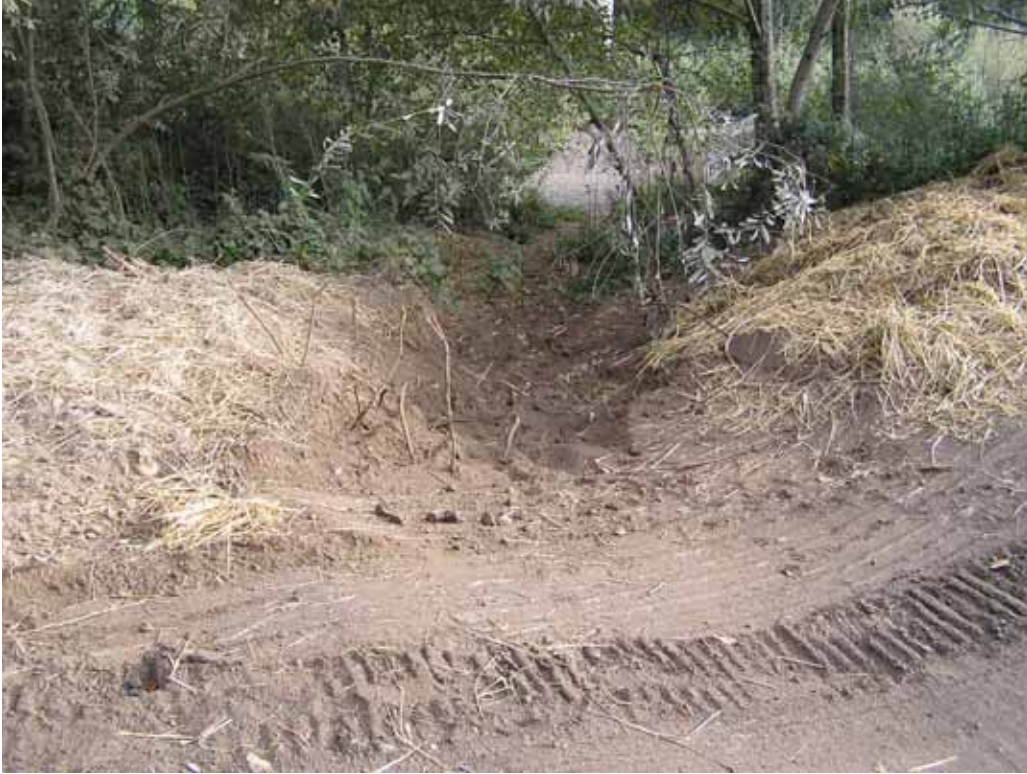
C-2-a

Fig. C-2. New drainage of road and floodplain to river; unconsolidated fine sediment source. New drainage trenches/ditches cross road and seasonal wetlands of forested floodplain. (a, b) Two views of unarmored drain across graded road adjacent to channel bank. Road surface is re-graded flood-deposited silt mixed with coarser underlying road bed material. Drain forms chute for eroded, suspended unconsolidated silts to flow into channel and pools below during runoff or high-energy flood events. Straw mulch at edge of road does not affect erosion of silt from extensively graded road. (c) natural silt levee (note laminar internal bedding) in floodplain is breached to depth of over 1 meter, draining road and adjacent floodplain to channel. This trench is likely to dewater portions of the floodplain that would naturally form seasonal wetlands, as indicated by dominant stands of California blackberry, willow, horsetail, fern stands.

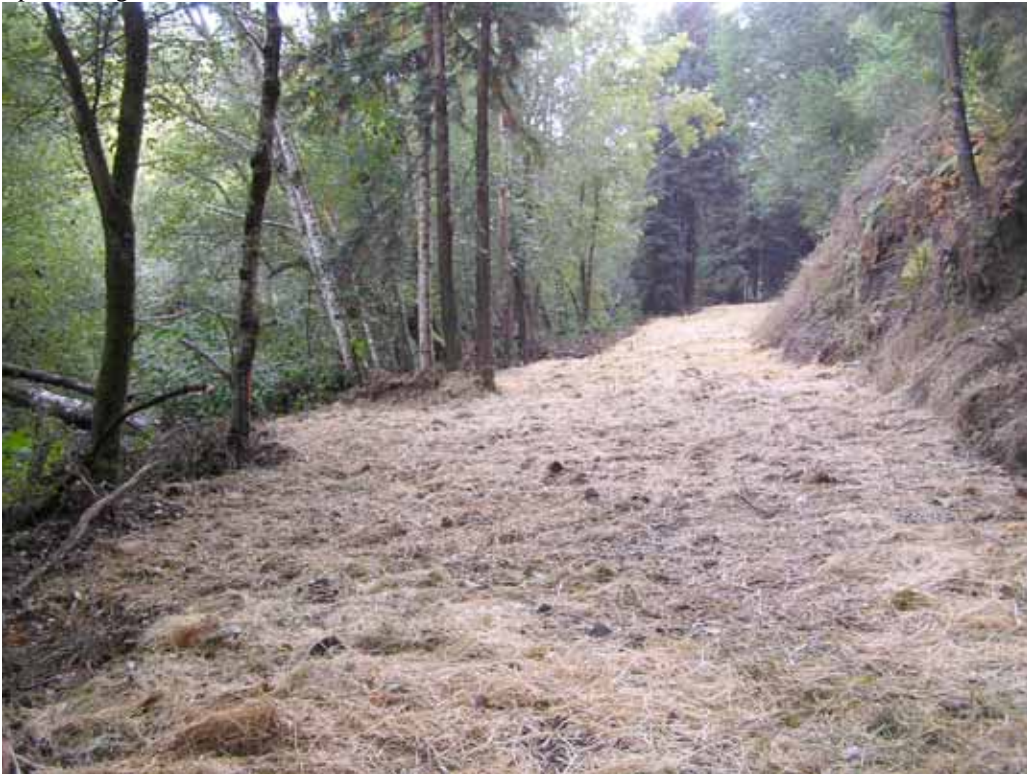
C-3-a

Figure C-3. Road widening beyond original one-lane footprint into floodplain or edge of bank above channel; spoil placement, soil destabilization, major riparian vegetation removal. 3a-d. Road graded beyond original edge to form wide shoulder of unconsolidated flood-deposited sediment placed up to and over edge of road cut above channel pool with resident fish (species undetermined) and yellow-legged frogs (adults and juveniles; garter snakes intermittent). Straw mulch is placed within flood zone submerged at peak flows. Alder-willow woodland was “brushed” away; note bent and broken young trees in 3c. 3e-g. Unstable, unconsolidated graded fill placed at edge of road cut on extremely steep, high slope above large, deep meander bend channel segment with resident steelhead.

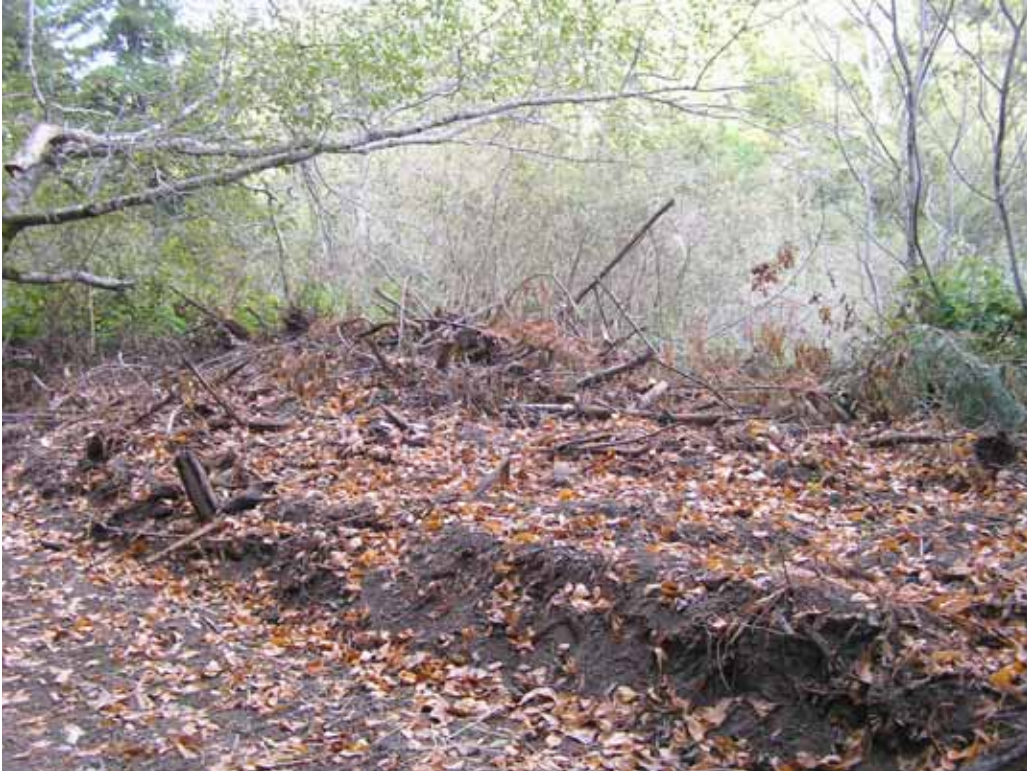
C-4-a

Figure C-4. Sediment/debris spoil disposal piles and turn-out/bypass lanes beyond original one-lane road, encroaching forested floodplain or terrace, riparian canopy gap impacts. 4a-b: loose graded sediment and debris pile placed over devegetated channel bank edge; willow riparian and alder-maple woodland riparian canopy removed; possible redwood removal beyond road edge (see right, b). 4c: construction of new turnout/bypass lane (double road segment), including removal of redwoods beyond road edge (note multiple fresh cuts). 4d: graded area larger than road width with loose sediment and debris; large canopy gap in redwood forest.

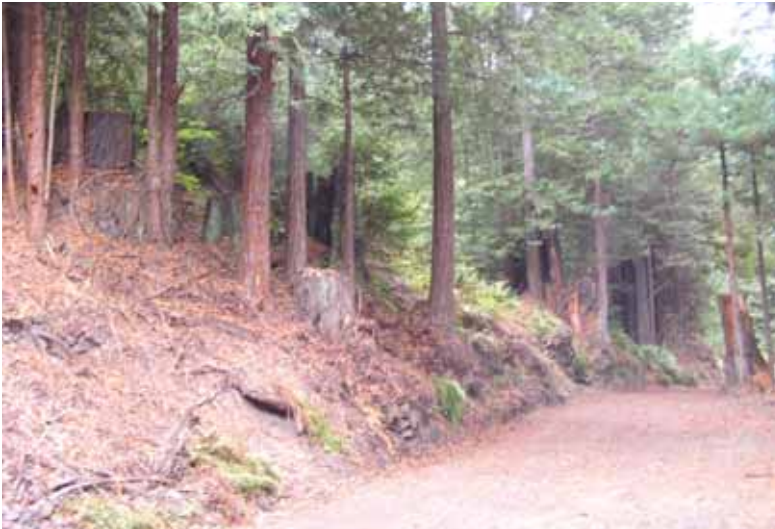
Figure C-5. Example of “brushing” consisting of tree removal (and canopy gap) upslope beyond road edge.
