SUBJECT: CDP #55-2006, Gualala, Mendocino County: Bower Ltd. Trust, Bower Ltd. Partnership (agent: Rau and Associates); proposed Gualala Bluff concrete block retaining wall multiple CEQA and Coastal Commission policy issues.

Please consider the following comments regarding permitting and CEQA issues related to the proposed concrete block retaining wall above the Gualala River mouth lagoon (seasonal/intermittent estuary), Mendocino County.

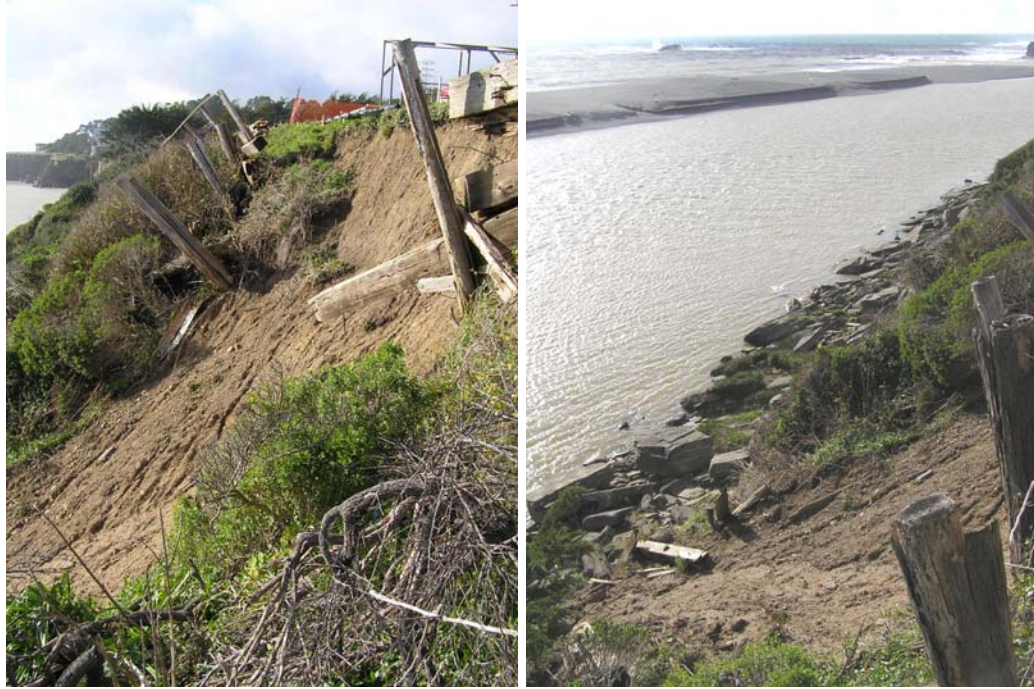
In contrast, there may be some justification for stabilization (or other appropriate remedy) for two localized, shallow slope failures at the top of the bluff. The larger one occurs behind the Surf Supermarket next to a concrete sewer box (Figure 1), and a smaller one occurs at the west end of the bluff, near the small overlook park. Both shallow slope failures appear to have originated as saturated earthflows; no slump-block structure was evident in the larger slide in the winter of 2006 when it formed. The composition and texture of the sediments, and the remnants of a decayed wooden retaining wall, indicate that the ultimate cause of the larger slide was unstable, unengineered placement of past artificial fill.

Figure 1. Slope failure (debris flow) behind Surf Supermarket, exposing artificial fill. Note boulder armor beach with marsh pockets at toe of slope. March 17, 2006.

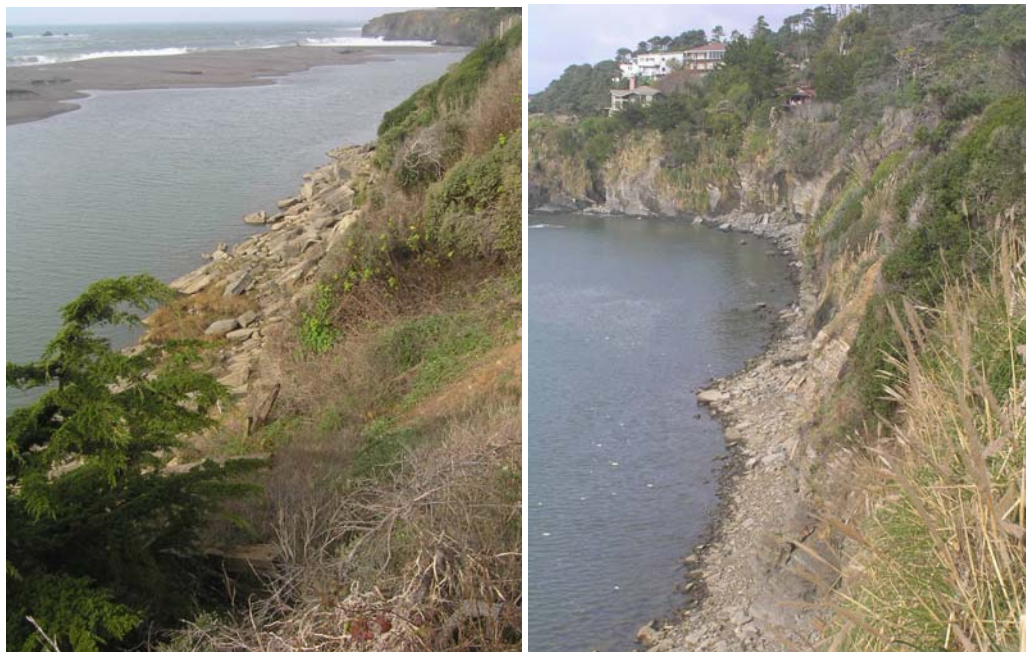
For the remaining length of the project area, there is no evidence of deep or shallow slope instability in the bedrock base of the cliff, or the mature coastal scrub vegetation of the bluff above it.). The lower slope of the cliff along the banks of the lagoon/estuary is composed of bedrock, relatively erosion-resistant Cretaceous sedimentary rocks (Figure 2). Wave-polished old slabs of bedrock form a boulder armor beach at the base of the cliff, with pockets of old fresh-brackish marsh among them. If the cliff were actively eroding and unstable, boulder fragments would be angular, unpolished, and only young patches of marsh plants (no peat formation) would occur. This is not the case.

Figure 2. Cretaceous sedimentary bedrock forms a stable boulder armor beach at toe of cliff, and an erosion-resistant, near-vertical cliff below the bluff. The bluff above bedrock is composed of Pliocene marine sediment and surficial artificial fill. December 2006-January 2007.

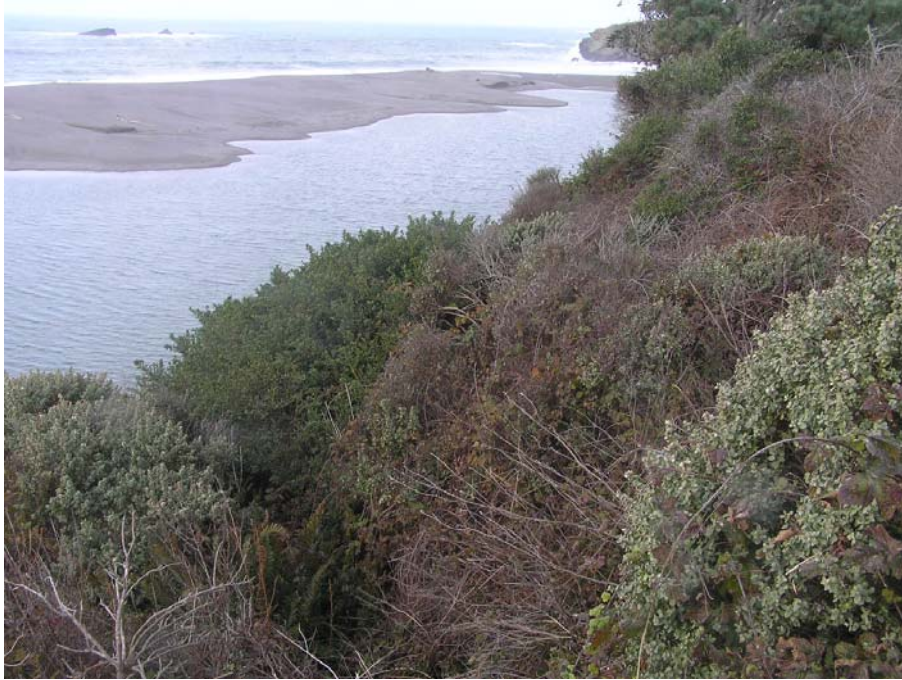
The coastal bluff vegetation also indicates stability and maturity of the cliff and bluff. The majority of the bluff supports dense, continuous cover of mature coastal scrub vegetation, dominated by coyote-brush (*Baccharis pilularis*), California-lilac (*Ceanothus thyrsiflorus*), silk-tassel (*Garrya elliptica*), and California blackberry (*Rubus ursinus*), with locally abundant *Toxicodendron quercifolium*, *Scrophularia californica*, and many forb species (Figure 3). The shrubs are large and old, including multiple excellent specimens of large, mature wind-sheared coast silk-tassel (*Garrya elliptica*), an infrequent native species (Figure 4). The non-native invasive vegetation (Himalayan blackberry, *Rubus discolor*, = *R. armeniacus*), poison-hemlock (*Conium maculatum*), nasturtium (*Tropaeolum majus*) is concentrated mostly in the artificial fill edge at the top of the bluff/parking lot edge, but jubata grass (*Cortaderia jubata*) is widespread on the cliff and bluff. Even the exposed bedrock within the wave splash zone supports large specimens of long-lived, stress-tolerant coastal cliff forbs (live-forever, *Dudleya farinosa*; sea-daisy, *Erigeron glaucus*; paintbrush, *Castilleja wightii*).

Figure 3. Dense, closed, mature coastal scrub on the bluff within the project area. In view: coyote-brush, California blackberry, silk-tassel, sword fern. January 2007.

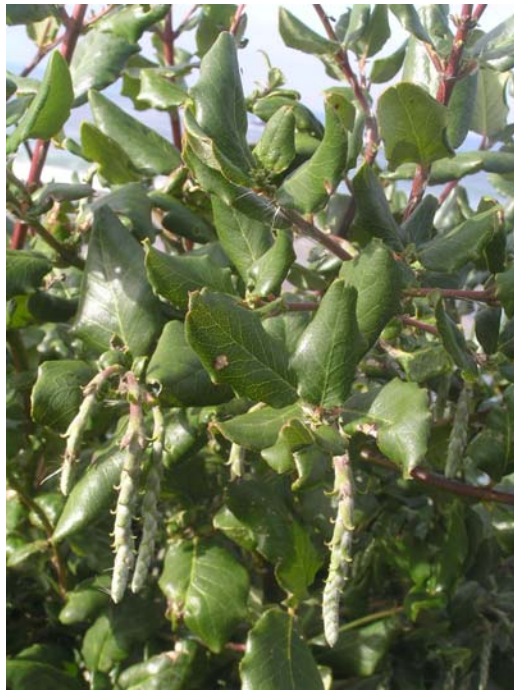
Figure 4. silk-tassel (*Garrya elliptica*).

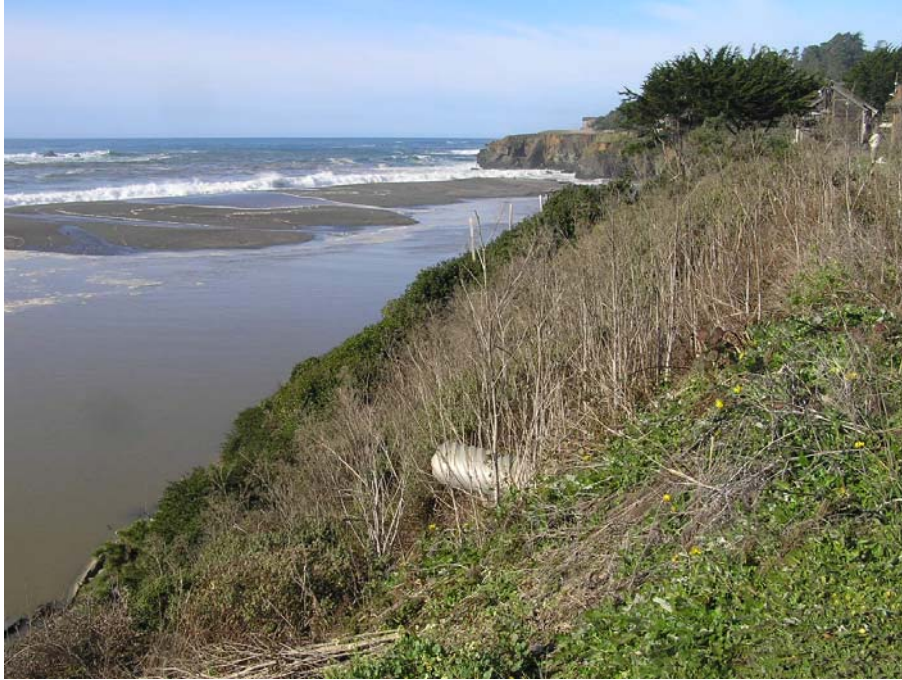
3. The existing bluff within the project area has pipes or culverts (Figure 5) that discharge into the Gualala River lagoon. These pipes appear to be a potential point-source of pollution, and they appear to run under the project parcel. The nature of the effluents they discharge, and the drainage plan of the parcel protected by the proposed retaining wall, should be disclosed and analyzed as a cumulative ongoing impact to water quality of the lagoon (particularly when the tidal inlet is closed), as well as part of the environmental baseline. Of particular concern is the potential for discharges to contain cleaning solvents such as commercial detergents. The presence of even low levels of detergents (surfactants) within the lagoon during periods of inlet closure could result in toxic, sublethal or lethal effects on federally listed steelhead smolts. Depending on the nature of contaminants in surface runoff, channelized or culverted drainage water, the drainage design of any project at this location should incorporate mitigation measures such as detention basins or bioswales (grass/rush/sedge-lined surface drainage swales with microbially active soils to trap sediment and reduce toxicity of runoff)

Figure 5. Culvert embedded in artificial fill of project area, under non-native vegetation, discharging above Gualala River lagoon. December 22, 2006.
