**SUBJECT: Gualala River gravel mining (File No. UPE04-0040, Gualala Instream), Sonoma County; Draft Negative Declaration (California Environmental Quality Act) comments** regarding significant impacts of 2005 unauthorized gravel mining to channel stability and fish habitat quality at the confluence of the South Fork and Wheatfield Fork, Gualala River.

**ATTACHMENT: Gualala River Valley Crossing,  
South Fork Gualala River – Wheatfield Fork confluence, 2005-2007**

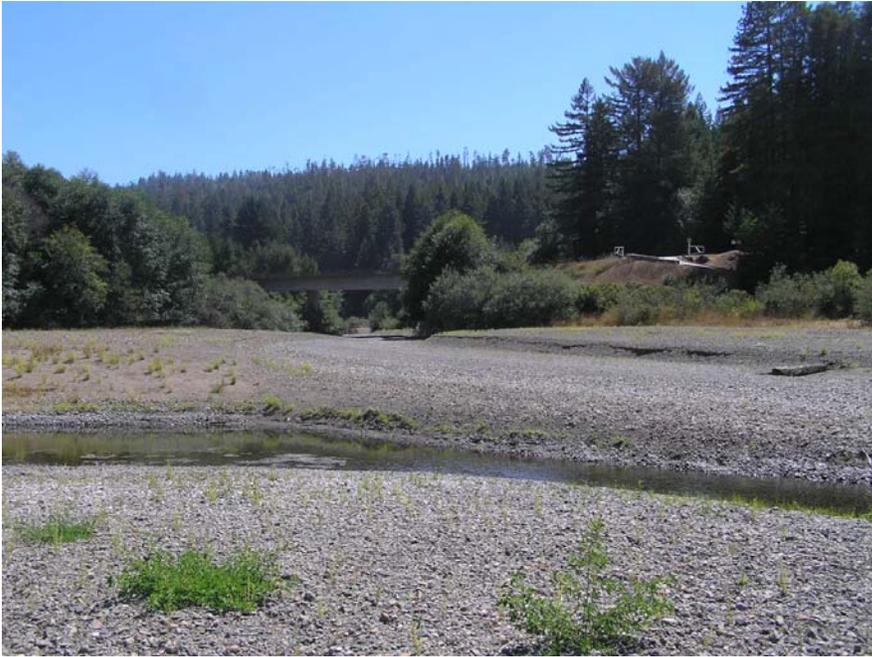
08/15/07. View upstream at confluence with Wheatfield Fork; dry bed of South Fork thalweg above confluence, bisecting low bar flats, approximately 1 m above low-flow (drought year) water surface elevation of Wheatfield Fork. Note presence of white sun-bleached algal mat and absence of vascular vegetation on dry channel bed, *Chenopodium* and *Melilotus* (vascular annual vegetation) on gravel bar emergent in spring.

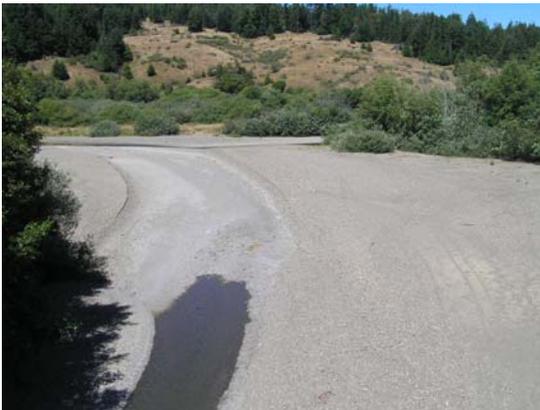
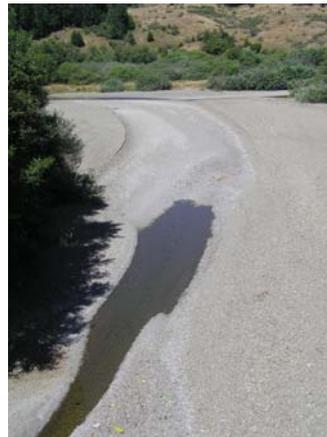
7/13/07. View downstream at confluence with Wheatfield Fork; diminished summer low flows descend below emerging bed of South Fork channel above confluence; shallow (<20 cm), warm (>24°C) surface flows support few Gualala Roach.

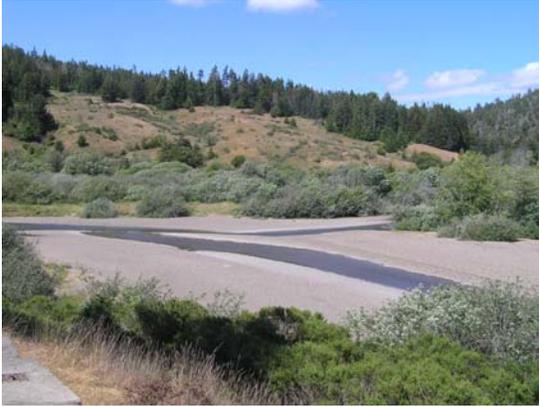
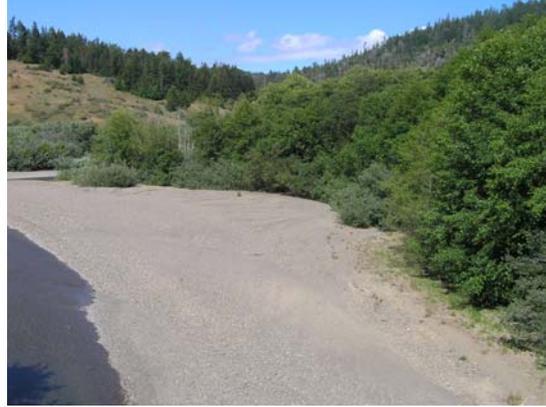
06/05/07. View downstream at confluence with Wheatfield Fork; bar bisected by channel; pre-2005 South Fork relict riparian woodland-edged channel remains infilled by gravel, reduced to off-channel pool segments below riparian woodland canopy. Channel condition: shallow, warm run, riffle at confluence. Gualala roach and juvenile steelhead present in channel (personal observation).

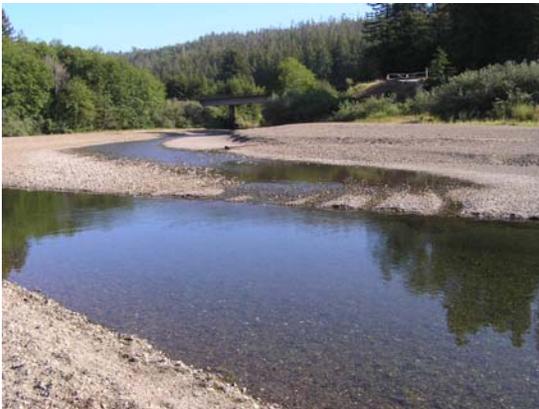
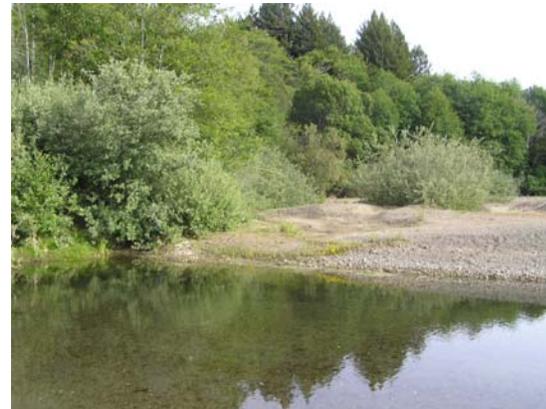
06/03/07. View upstream at confluence with Wheatfield Fork. Wheatfield temperature 17°C, thalweg > 50 cm deep at confluence. South Fork descends into gravel at thalweg in sloping bar edge. Pre-2005 South Fork relict riparian woodland-edged channel is infilled by sand and gravel, reduced to off-channel pool segments below riparian woodland and scrub canopy.

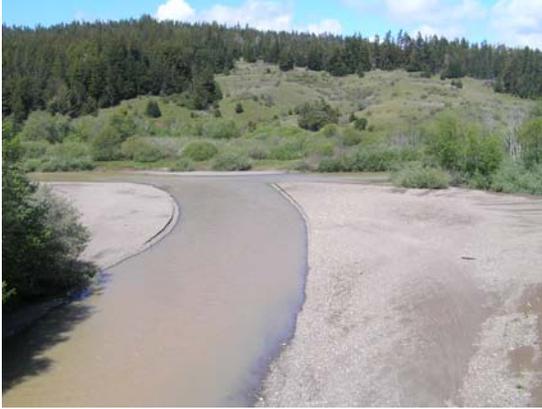
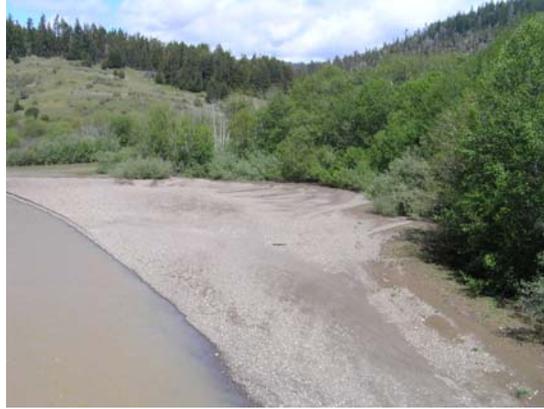
04/22/07. View downstream at confluence with Wheatfield Fork; recent flows cut a small scarp in gravel bar channel bank; note turbidity pulse. Pre-2005 South Fork riparian channel is actively infilled by silty sand (brown-gray) and gravel (gray) during this moderate discharge event, reducing it to off-channel pool segments choked with fine sediment below riparian woodland canopy.

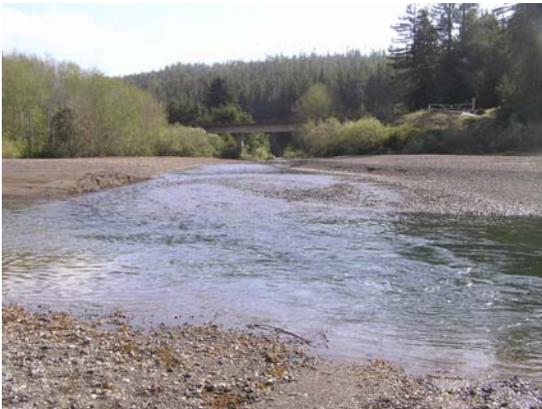
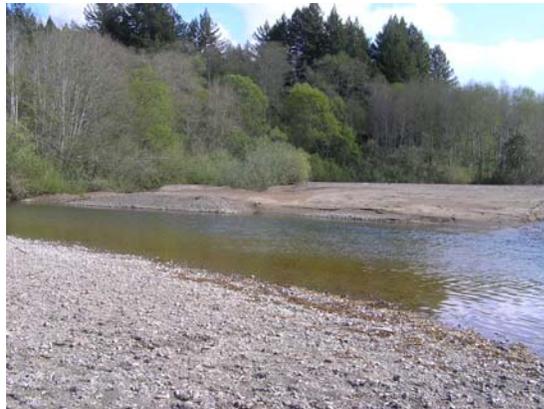
03/27/07. View upstream at confluence with Wheatfield Fork. South Fork channel bisects gravel bar flats; slight recent meandering to east is indicated by recent low (<0.5 m) scarp cut in bar at confluence with Wheatfield Fork. Pre-2005 South Fork riparian woodland-edged relict channel is infilled by sand and gravel, reducing it to off-channel pool segments below riparian woodland canopy. South Fork channel at confluence is reduced to shallow riffle.

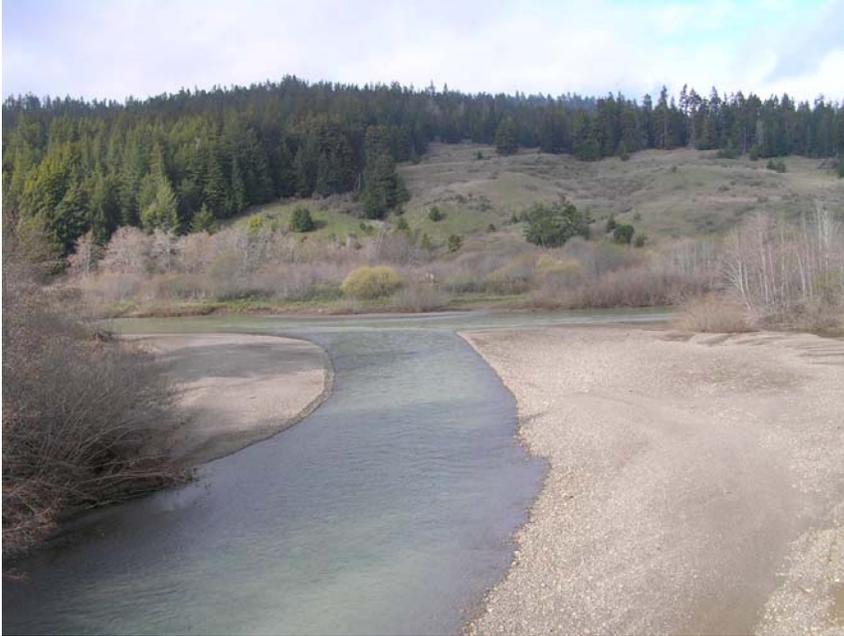
03/01/07. View downstream at confluence with Wheatfield Fork. Shallow, wide south Fork channel bisects gravel bar flats; note braided pattern in gravel bar flats across former channel position at east (view right) end of bar, formed during high flows. Mouth at confluence with Wheatfield Fork curves (deflected by Wheatfield Fork gravel deposition) slightly west compared with relatively rectilinear January 2007 channel configuration established under peak winter flows. Pre-2005 South Fork riparian woodland-edged relict channel is infilled by sand and gravel, reducing it to off-channel pool segments below riparian woodland canopy.

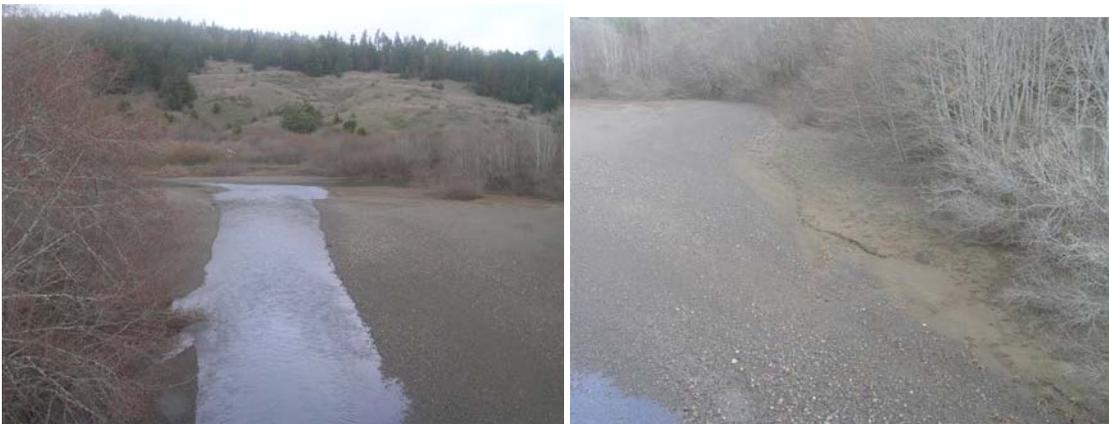
1/06/07. View downstream at confluence with Wheatfield Fork; recently deposited sand and gravel surface of degraded bar flats, with South Fork channel again bisecting the wide, low terminal bar. Channel bed is less than 1 m below elevation of adjacent bar flats, with gently sloping sand/gravel gradient replacing pre-2005 slipface and scarp profile of former channel bank.

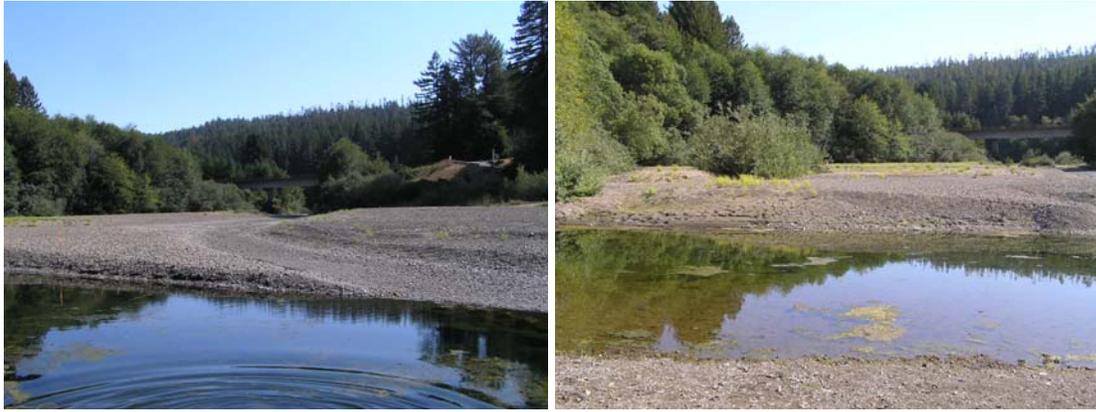
8/8/06. View upstream at confluence with Wheatfield Fork. Pre-2005 South Fork riparian woodland-edged relict channel is infilled by sand and gravel, reducing it to off-channel pool segments below riparian woodland canopy. Thalweg is reduced to emergent, dry gravel bed with hyporhoeic flows. Note low (<0.5 m) elevation difference between late summer low-flow water surface elevation of Wheatfield Fork and adjacent South Fork gravel flats near thalweg confluence, increasing to only approximately 1.0 m at the position of the aggraded, infilled relict channel position along riparian woodland edge.

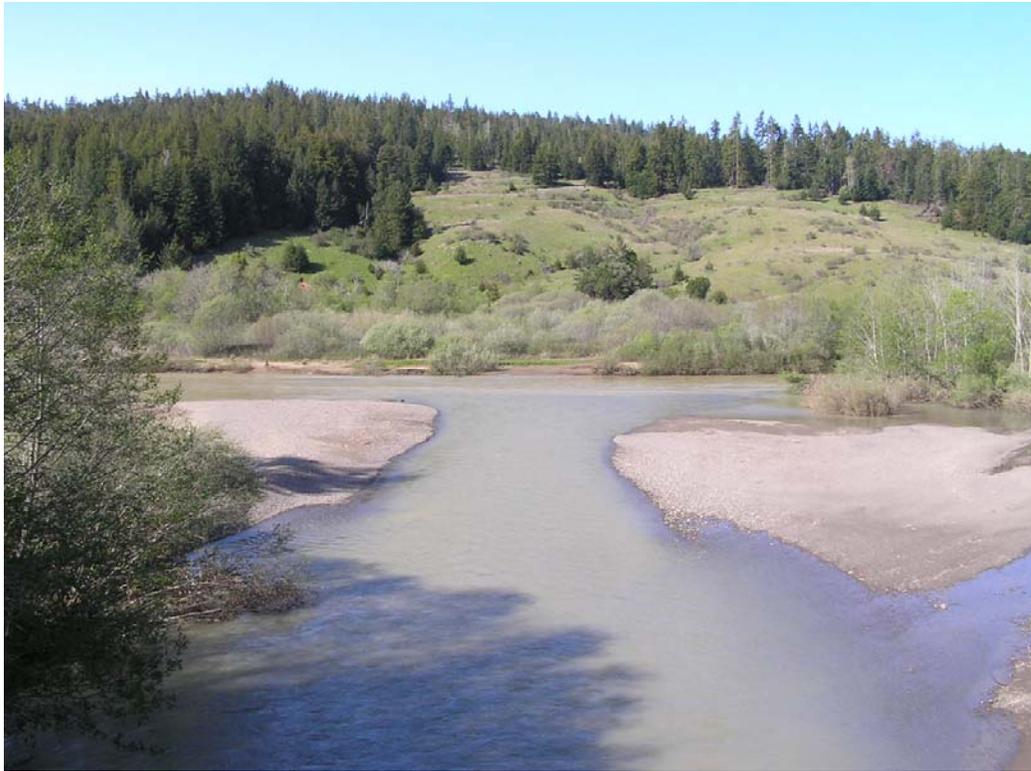
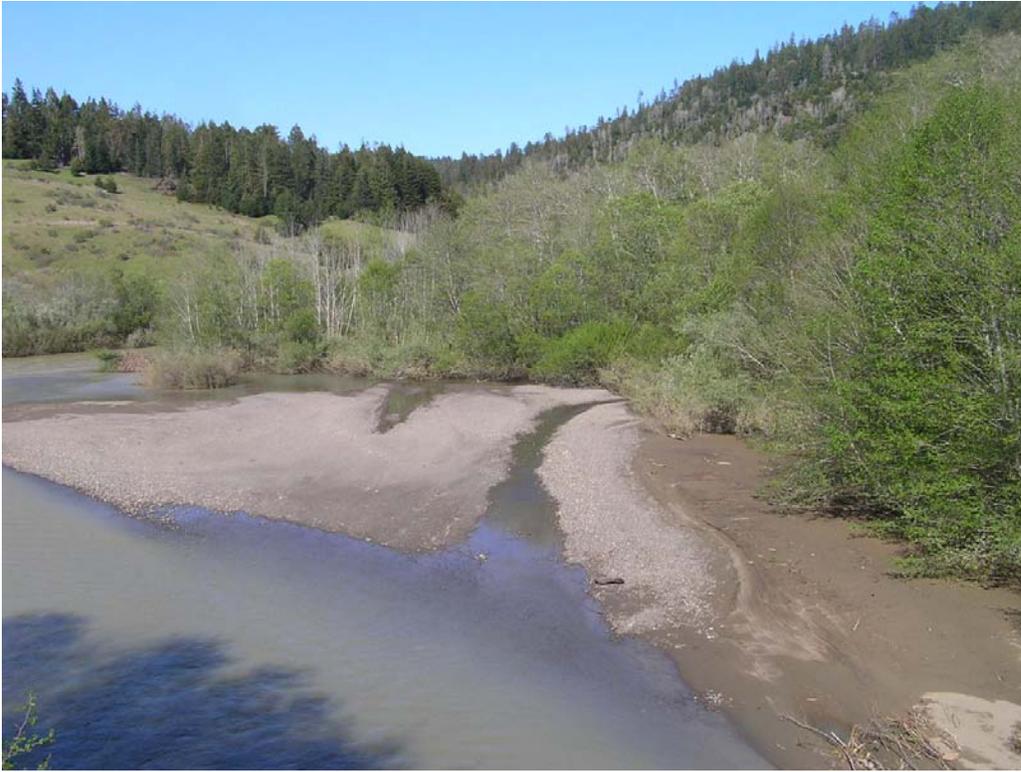
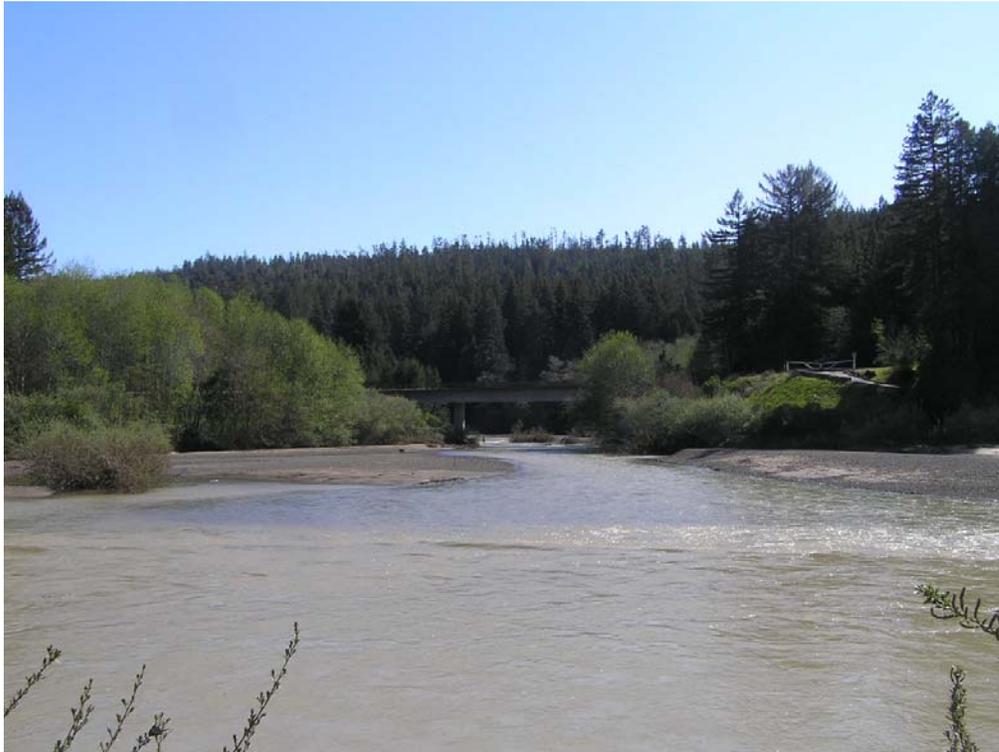
4/14/06 **BAR BREACHING, CHANNEL SWITCHING EVENT.** Views downstream (a, b) and upstream (c) at confluence with Wheatfield Fork following recent bar-flooding discharge that bisected the low, degraded bar flats. Note recent spreading of branched high flow distributary channels across bar flats, actively depositing sand and gravel into the aggraded, infilled, segmented former channel (thalweg) along the riparian woodland edge (b), as mined, depleted gravel bar loses form. Note low topographic relief of diminished South Fork bar at confluence, failure of gravel/sand recharge within mined area during moderate high spring flows.

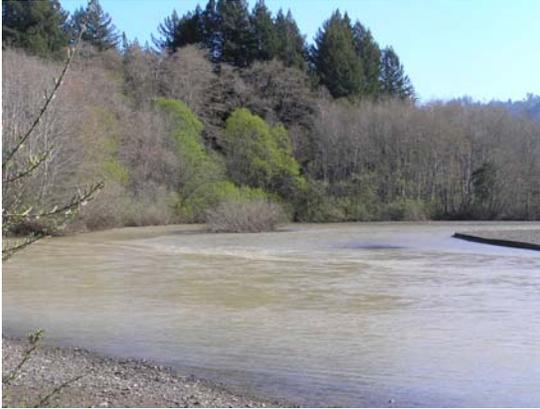
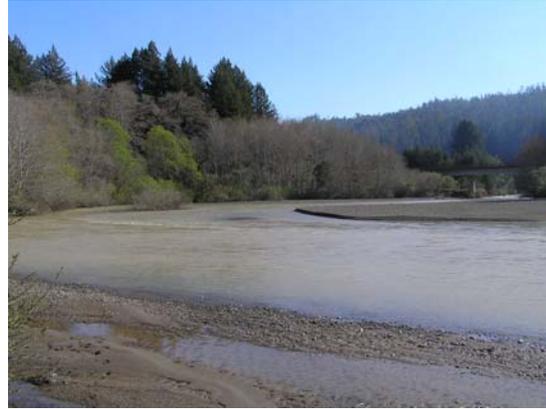
03/17/06. **INCIPIENT CHANNEL SWITCHING.** View upstream from Wheatfield Fork confluence. The terminal South Fork bar degrades along the bend, forming a set of branched channels across the east end of the 2005 mining area, which has failed to regenerate bar height and form during and following high winter flows. Note the widened, stepped channel profile (multiple scarps; compare 2/20/06)

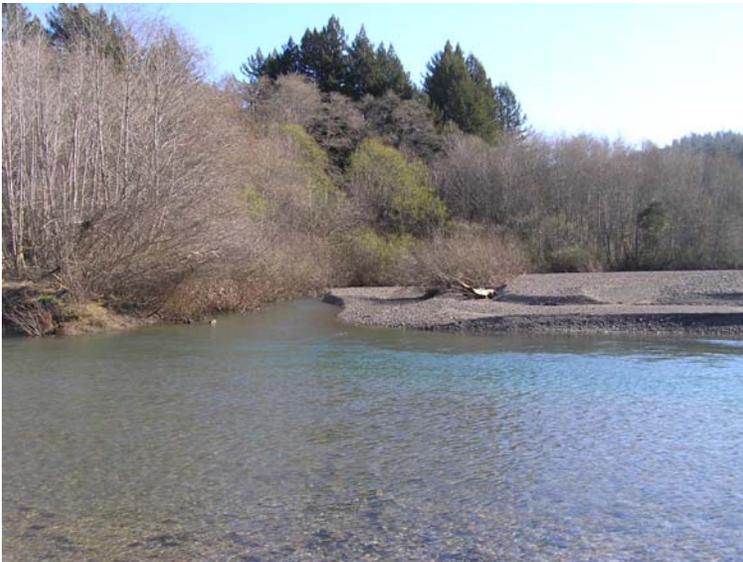
02/20/06. **INCIPIENT CHANNEL SWITCHING, INFILLING OF THALWEG.** View upstream from Wheatfield Fork confluence, showing the last remaining post-mining position of the South Fork thalweg incised as a perennial channel beneath the riparian woodland canopy (alder-willow) at

the east end of the degraded South Fork terminal bar flats. Note the multiple slipface-edged lobes of gravel (sediment fans dissected by multiple high-flow branched shallow channels prograding towards the channel edge; incipient infilling of thalweg occurs while the top of the low, flat, degraded gravel bar conveys and dissipates high flows rather than confine them mostly within the previously channelized profile. Note low turbidity (lack of recent rainfall)

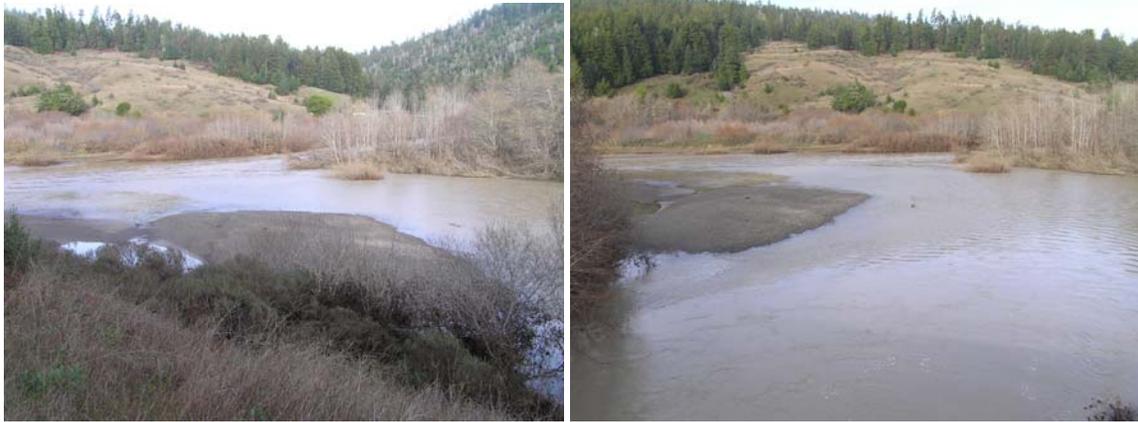
**01/02/06. INCIPIENT CHANNEL SWITCHING.** View downstream from Wheatfield Fork confluence following recent high flows (note high turbidity). Terminal South Fork bar is degraded to low sand/gravel flats within and above the 2005 mining pit, where sediment recharge is failing. Thalweg remains at traditional eastern edge of terminal South Fork bar, but the degraded bar is developing branched channels, gravel/sand lobes and fans across the 2005 mining pit, dissipating high flows, and initiating progradation of the bar edge across the thalweg.

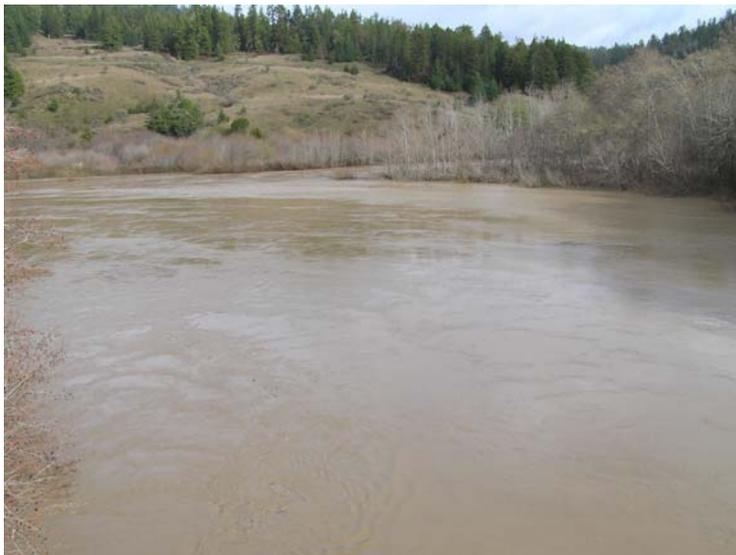
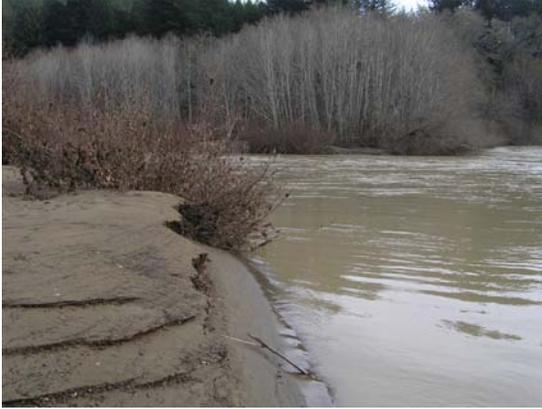
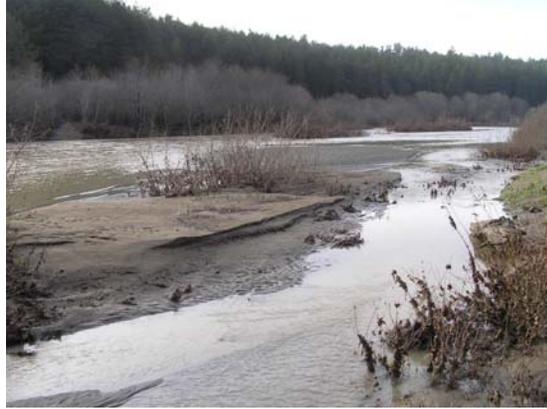
12/31/05. View downstream at confluence with Wheatfield Fork. Turbid discharge over submerged bar (a). New Years storm flood flows caused significant sediment accretion (silt, sand) in vegetated riparian floodplain and channel bars of the Wheatfield Fork (b) and South Fork (c) on bank opposite the confluence.

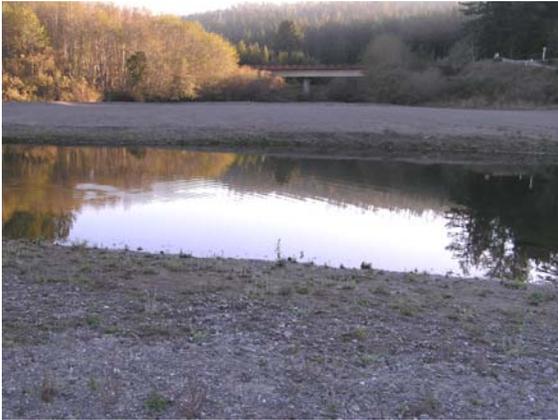
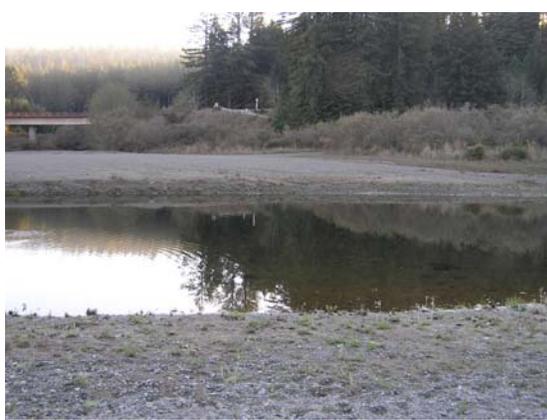
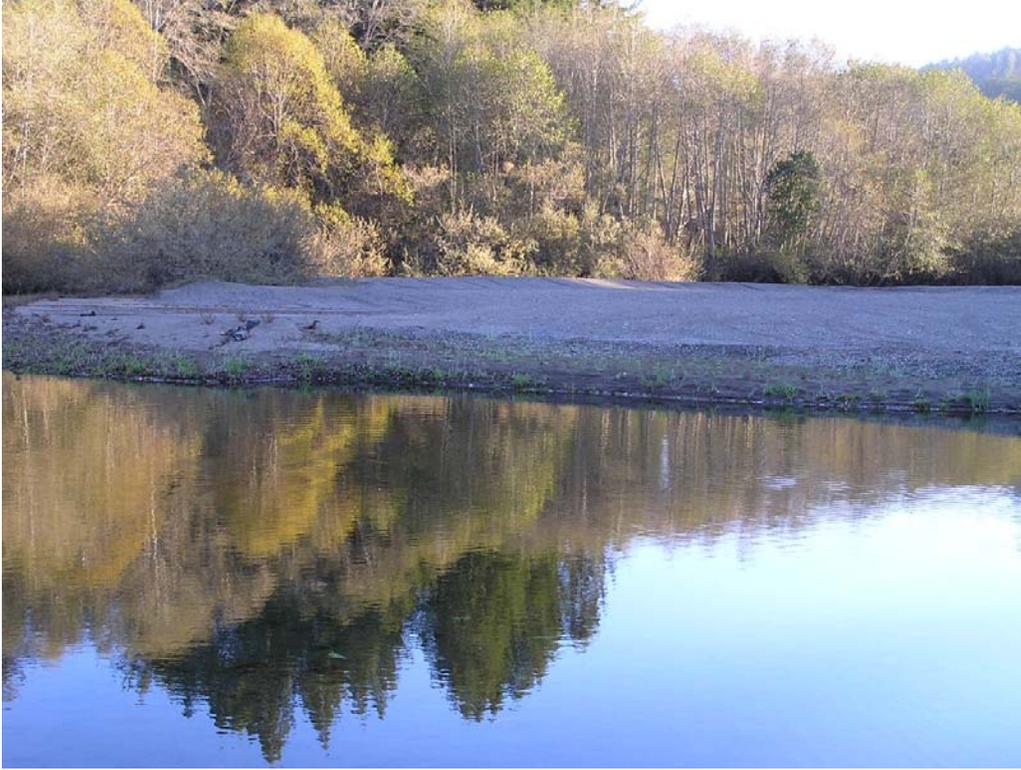
11/15/05. View upstream from Wheatfield Fork confluence, showing degraded post-mining condition of South Fork terminal bar. Note flattened, sloping, low bar crest elevation (less than 0.5 m above water surface in late fall low flow condition) along Wheatfield Fork and bank of South Fork channel. Note also the graded, mined bar edges (c; pushed into willows along edge of bar, towards South Fork thalweg; excavated area extends to within approximately 4-5 m from edge of South Fork channel at confluence point!) establishing topography for an efficient flow path during high flows that overtopped the terminal South Fork bar in January-April 2006. Note tire tracks persisting on gravel flats; no flows have yet overtopped the degraded bar.

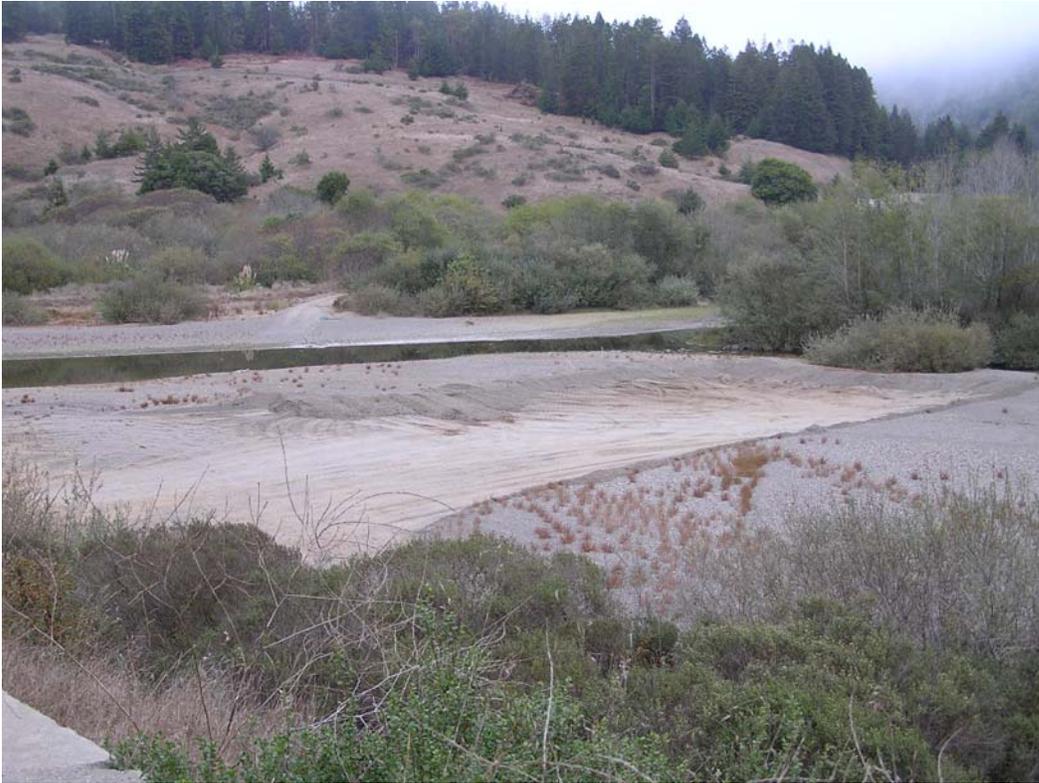
10/24/05. View downstream at confluence with Wheatfield Fork; apparent active or very recent mining (compare with 11/15; not final post-mining condition). Large scraped pit is established at downstream end of terminal bar, within approximately 5 meters of the South Fork channel bank, and mining or grading operations are apparently not complete (see 11/15/06 photo). Extraction is cumulative with previous mining here.

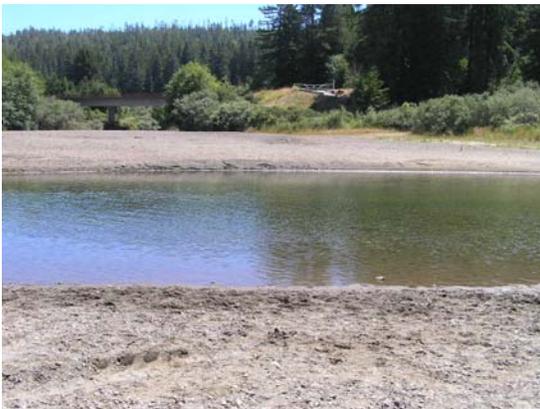
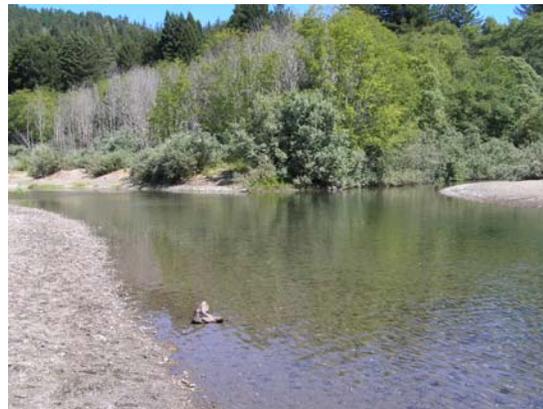
07/07/05. Views upstream on South Fork (a) and Wheatfield Fork (b), showing pre-mining 2005 condition of terminal South Fork bar. Note perennial channel of South Fork within willow-alder riparian woodland or beneath its canopy. Note bar crest elevation relative to low-flow channel water surface elevation.

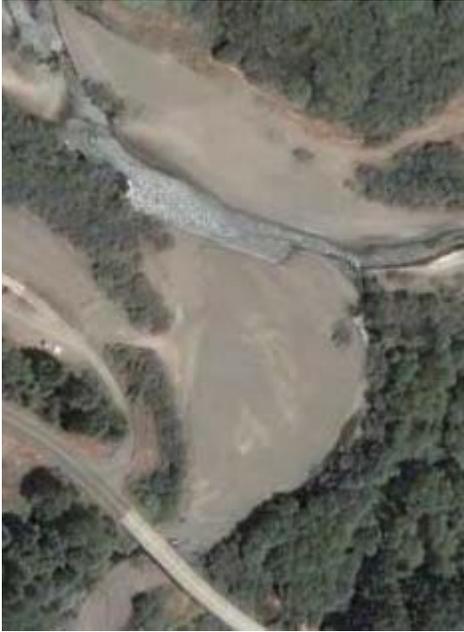
Google Earth aerial photo of South Fork at confluence with Wheatfield Fork (accessed 08/27/07; photo circa 2003), showing traditional, long-stable channel and bar configuration; perennial low-flow channel bend is located within or contiguous with alder-willow riparian woodland at eastern end of bar. Note deltaic gravel lobe constricting channel at confluence, mouth of South Fork low flow channel.
