MISC. ADDENDUMS

SECTION V INDEX

ESTIMATED SURFACE SOIL EROSION HAZARD

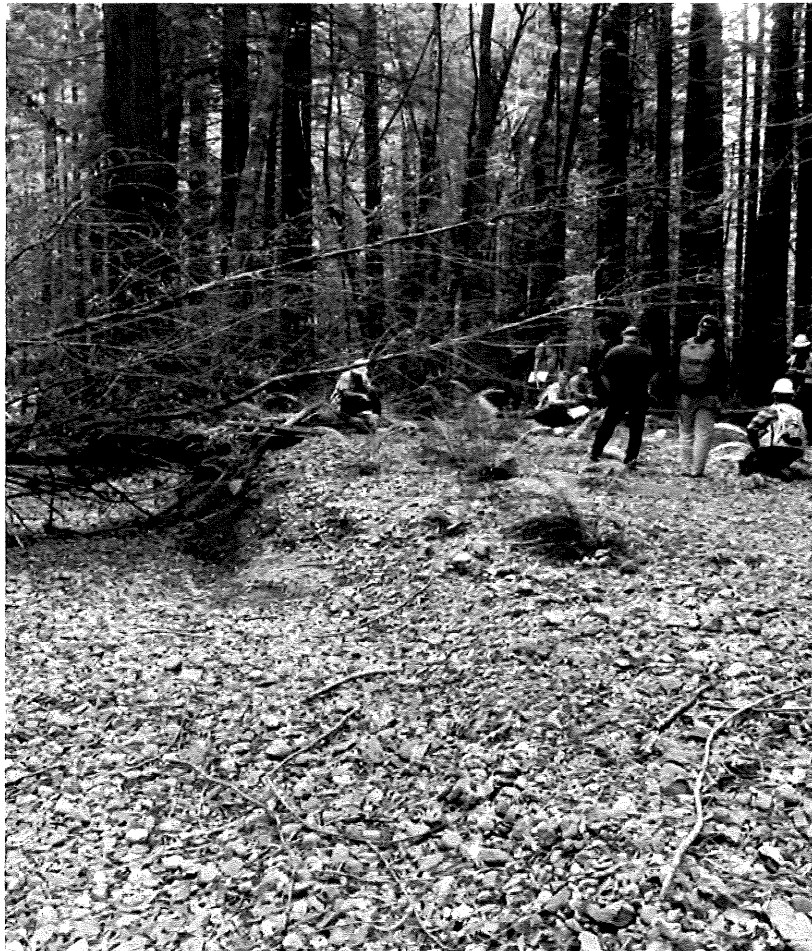
Figure 4. The secondary channel and broadly convergent right-bank floodplain surface at Site 1.

Dr. O'Connor noted the presence of secondary channels that create small vegetated islands upstream of Site 1, and noted it as a form of small scale channel migration that is characteristic throughout the Little North Fork Gualala River. He also suggested that the secondary channel be given Class I watercourse protection. Dr. O'Connor noted that a right-bank² linear to curvilinear swale was present down gradient of the secondary channel (Figure 4), but stated that the flowpath was distributary in nature and did not reconnect with the primary channel. He concluded that the swale did not have the erosive power to create a new primary/secondary channel. CAL FIRE WPP staff observations were consistent with those noted by Dr. O'Connor. Avulsion potential is greatly increased when the floodplain flowpath gradient is 3-5 times greater than that of the primary/secondary channel (WFPB, 2004). Staff measured the slope of the secondary channel and swale feature and found them to be approximately equal ($\approx 1\%$), indicating a relatively low potential for avulsion.

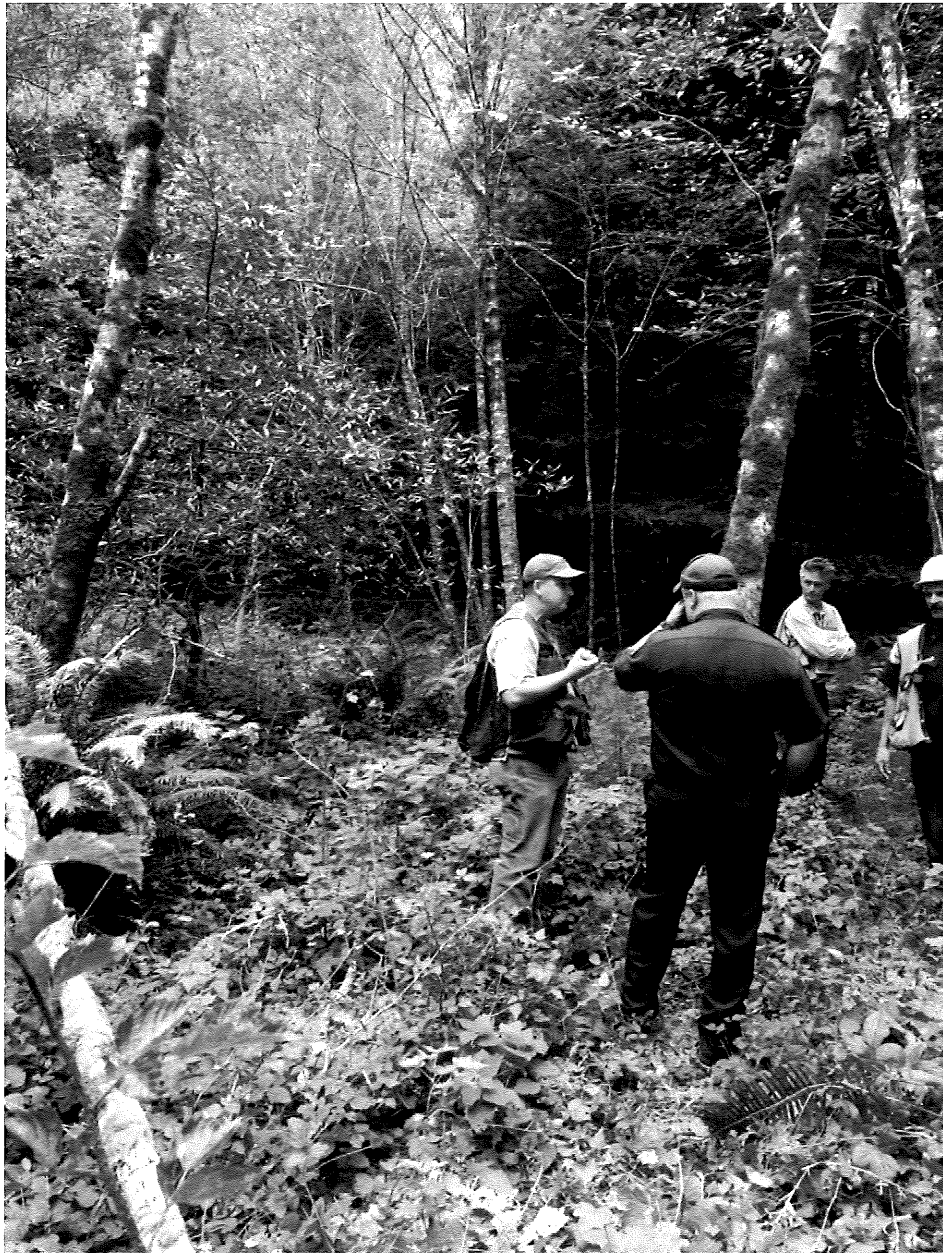
Figure 5. A view of the potential flowpath at Site 2. The water surface elevation would have to rise 5 to 6 feet to reach the elevation of this floodplain surface.

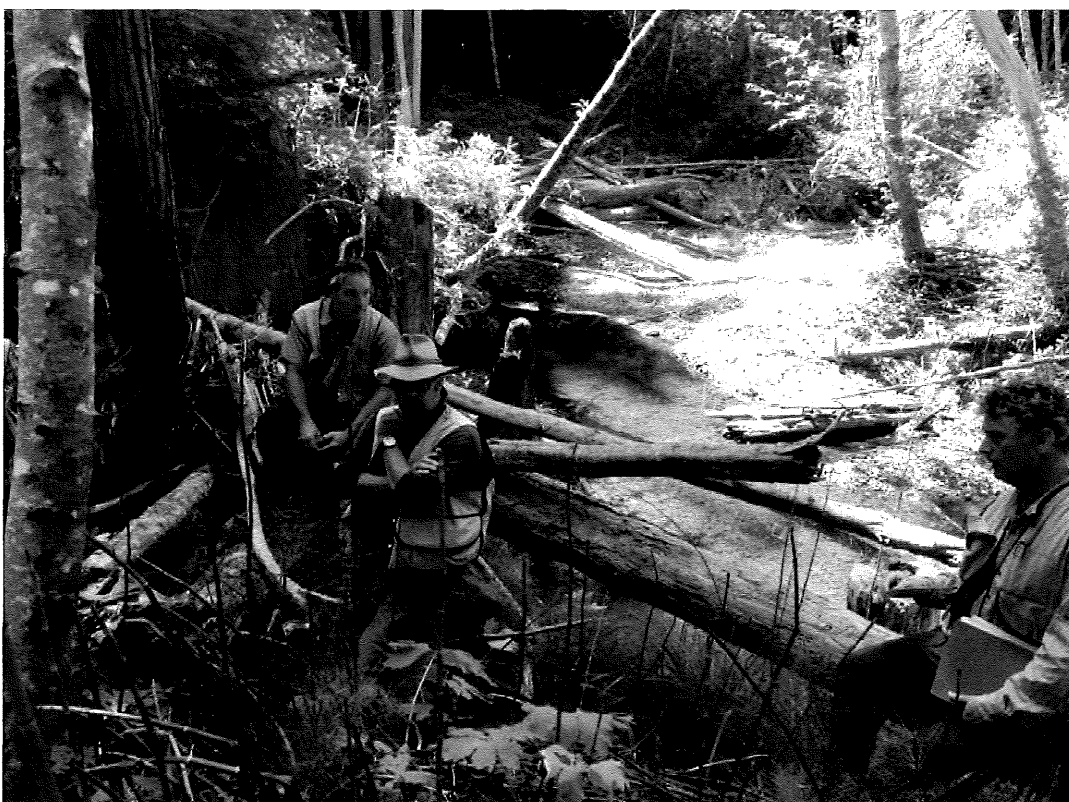
Figure 9. The upstream end of the Site 4 flowpath. Note the large woody debris jam in the background.

CAL FIRE WPP staff agree with this assessment. Staff noted that the upstream end of this flowpath is approximately three feet higher than the existing channel, and is located within a bend in the channel with a large woody debris jam directly downstream. Form roughness in combination with in-channel large woody debris roughness (Figure 9) has the potential to cause a rise in water surface elevation which could shift the main flow to this left-bank flowpath.

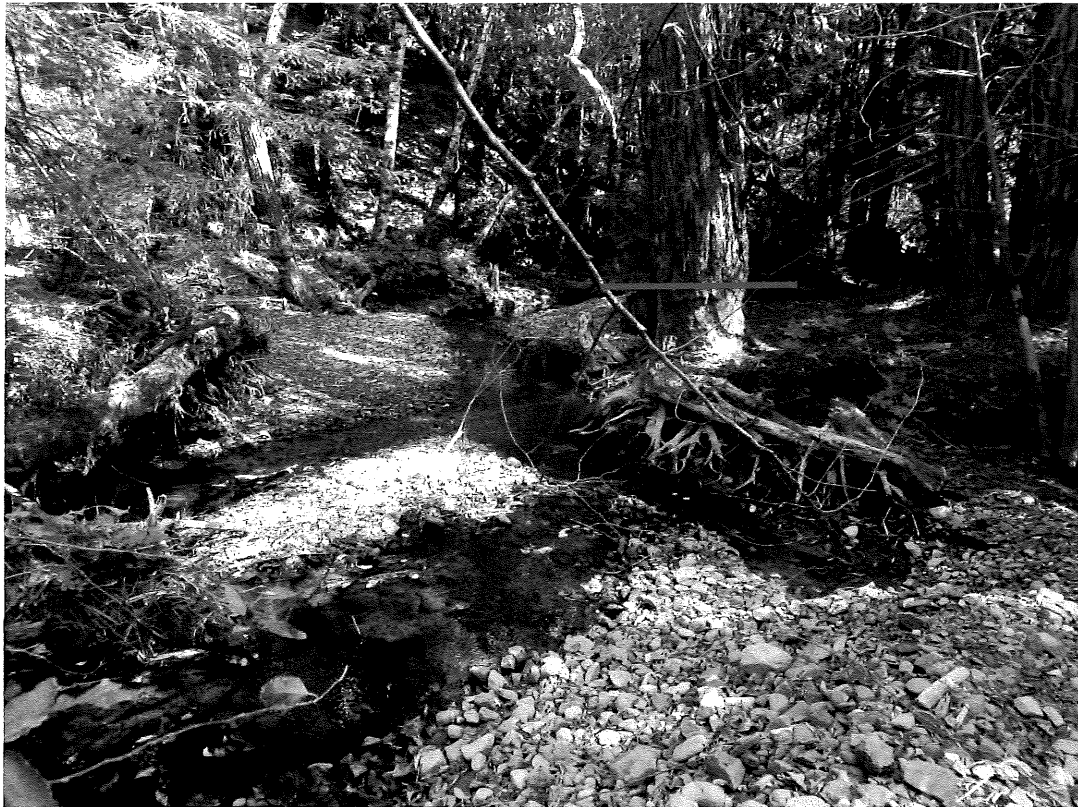
Figure 10. Evidence of abrasion on the base of a snag illustrating floodplain depths can reach two feet above the bankfull elevation (red line).

CAL FIRE WPP staff agree with the assessment provided by Dr. O'Connor. Evidence of abrasion on the base of snags showed that floodplain depths can reach two feet above the bankfull elevation (Figure 10). There was no evidence of abandoned channels that could act as potential avulsion flowpaths.

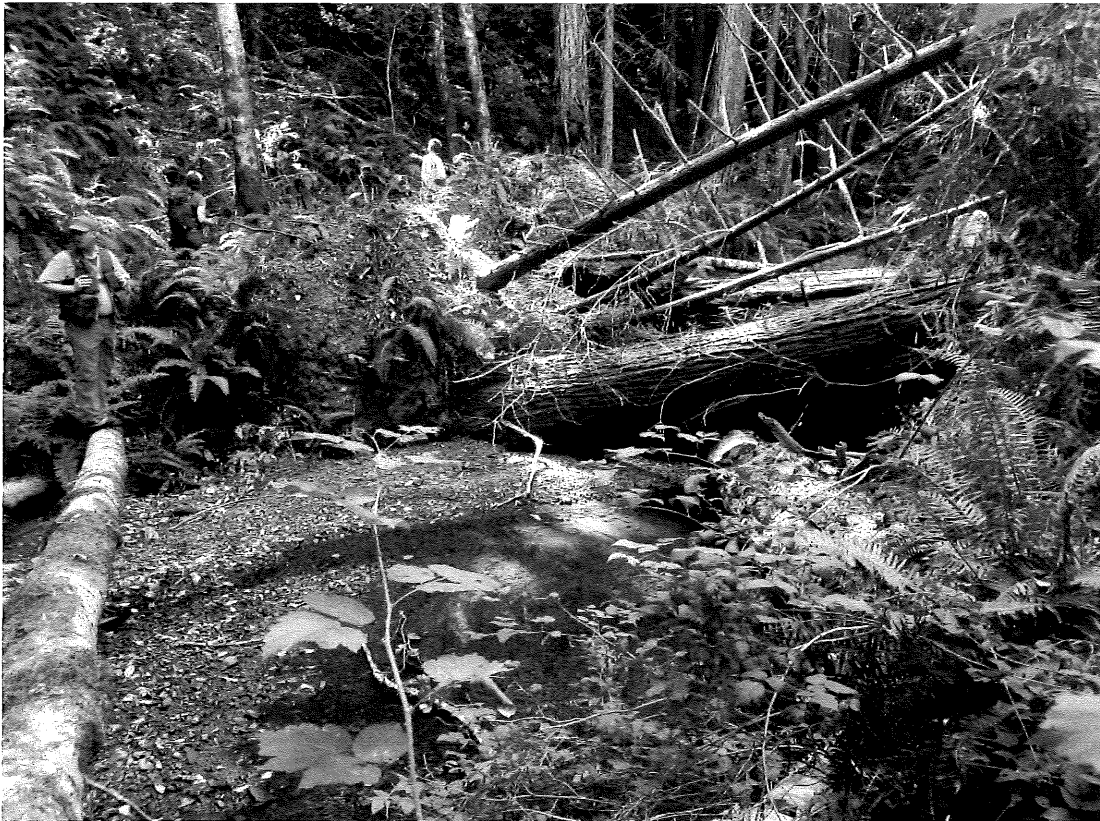
Figure 12. Coast redwood trees that recently entered the Little North Fork of the Gualala River channel at Site 6.

CAL FIRE WPP staff agree with the Dr. O'Connor's assessment. Staff noted silt lines of approximately 1.7 feet on the floodplain. However, there were no signs of abandoned channels in this area. Staff noted an area of bank erosion at a small bend in the Little North Fork of the Gualala River, but it appears relatively stable as the relative elevation model shows no signs of lateral erosion (e.g., meander scrolls) nearby. A clump of large redwood trees tipped into the channel during the winter of 2018-2019 here but has not caused channel movement (Figure 12).

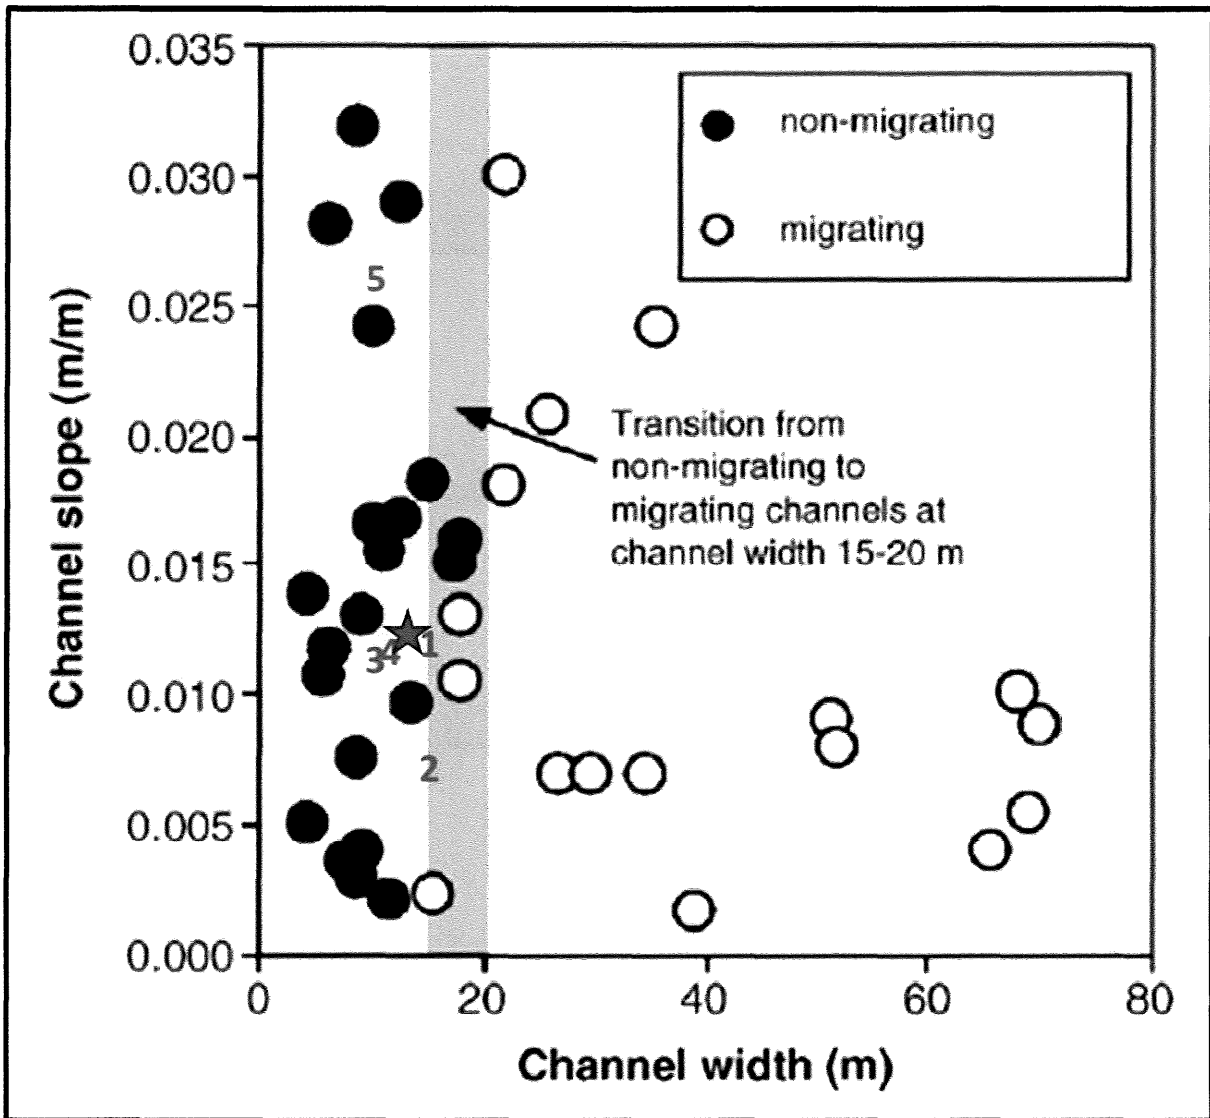
Figure 15. Reach scale slope and bankfull channel width for various reaches of the Little North Fork of the Gualala River when plotted against data from western Washington. Red numbers represent specific reaches of the Little North Fork of the Gualala River, whereas the red star represents the average for all reaches. Figure modified from Beechie et al. (2006).

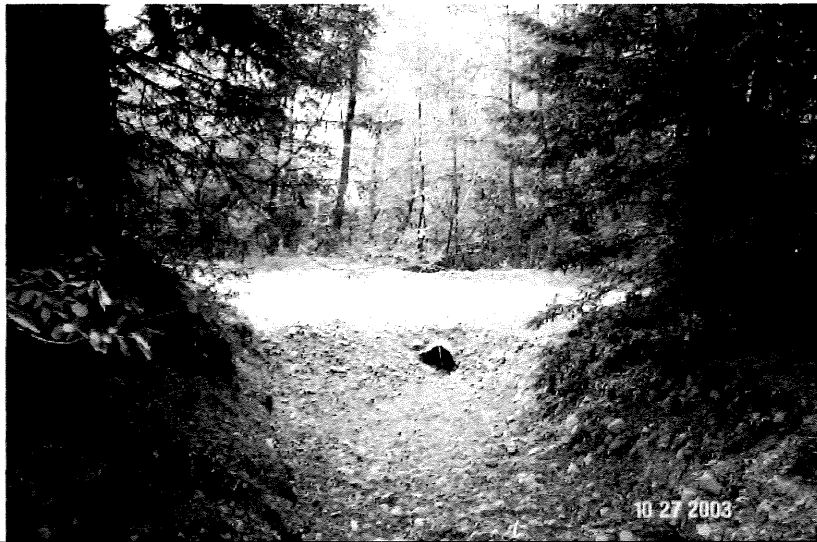
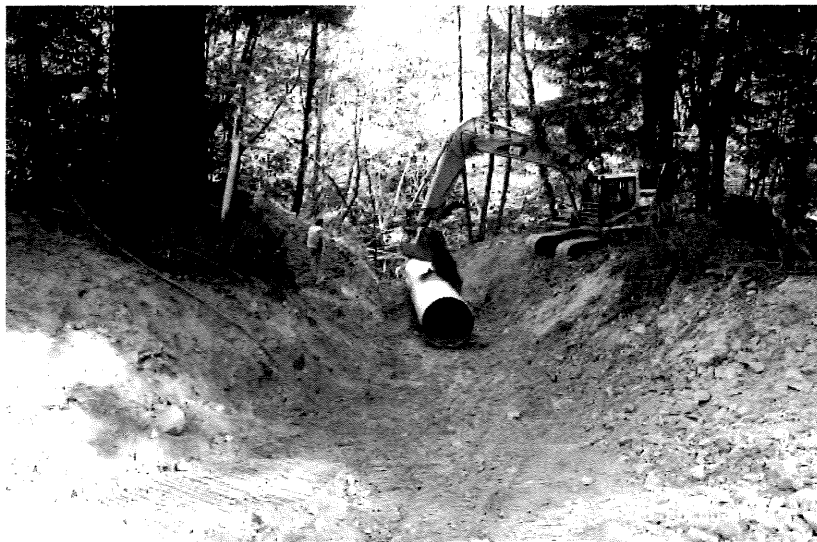
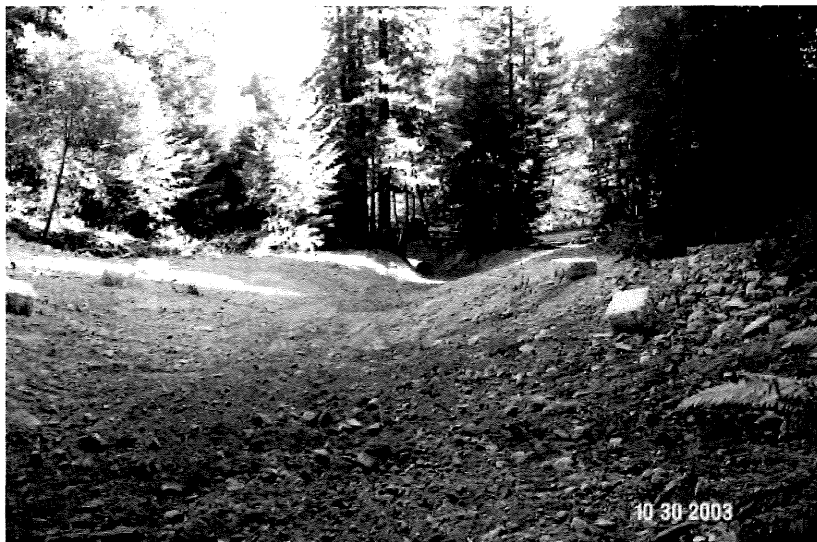
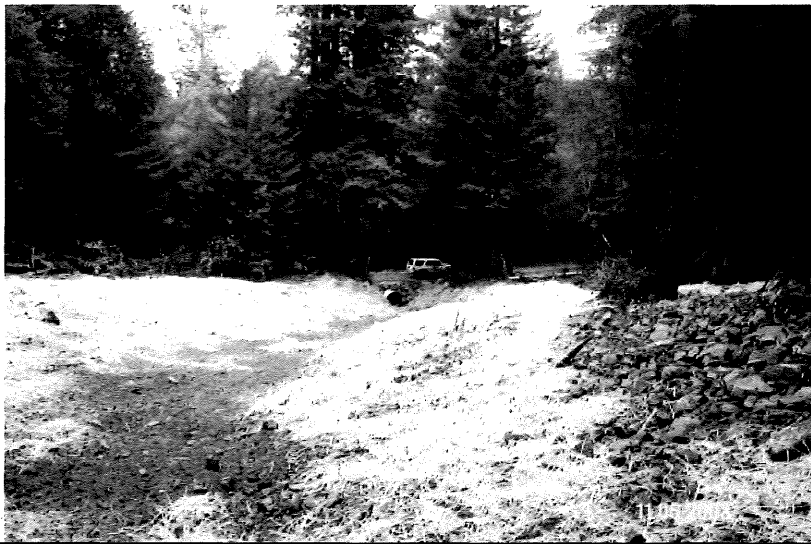
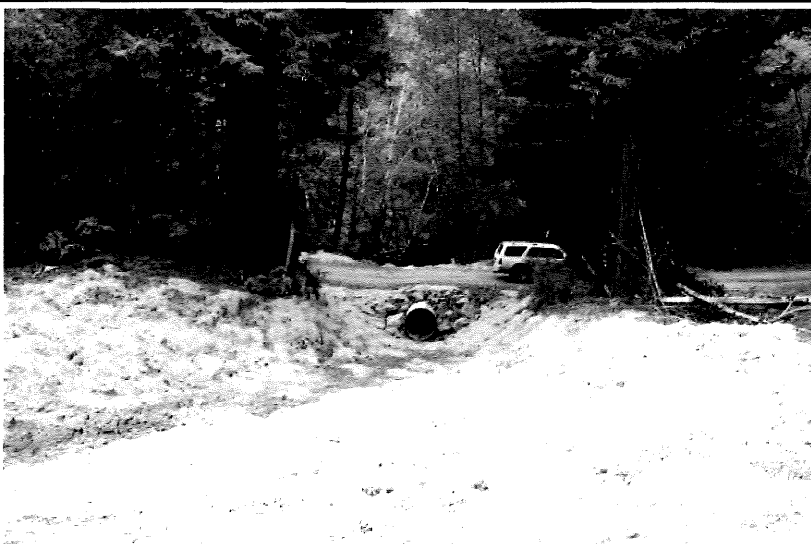
Road Upgrading Photo # 1825
 10/27/03
 Map Pt 2300 Road 60 Mi. 3.12
 Culv. Replace Old 30" New 48"
 PPt down Dir PW Robinson Cr
 THP 271 LNF LNF P01030405A
 PID 0 LWD
 Monitoring 0

Road Upgrading Photo # 1842
 10/30/03
 Map Pt 2300 Road 60 Mi. 3.12
 Culv. Replace Old 30" New 48"
 PPt down Dir PW Robinson Cr
 THP 271 LNF LNF P01030405A
 PID 0 LWD
 Monitoring 0

Road Upgrading Photo # 1843
 10/30/03
 Map Pt 2300 Road 60 Mi. 3.12
 Culv. Replace Old 30" New 48"
 PPt down Dir PW Robinson Cr
 THP 271 LNF LNF P01030405A
 PID 0 LWD
 Monitoring 0

Road Upgrading Photo # 1869
 11/5/03
 Map Pt 2300 Road 60 Mi. 3.12
 Culv. Replace Old 30" New 48"
 PPt down Dir PW Robinson Cr
 THP 271 LNF LNF P01030405A
 PID 0 LWD
 Monitoring 0

Road Upgrading Photo # 1870
 11/5/03
 Map Pt 2300 Road 60 Mi. 3.12
 Culv. Replace Old 30" New 48"
 PPt down Dir PW Robinson Cr
 THP 271 LNF LNF P01030405A
 PID 0 LWD
 Monitoring 0

Road Upgrading Photo # 1827
 10/27/03
 Map Pt 2300 Road 60 Mi. 3.12
 Culv. Replace Old 30" New 48"
 PPt left Dir PW Robinson Cr
 THP 271 LNF LNF P01030405A
 PID 0 LWD
 Monitoring 0

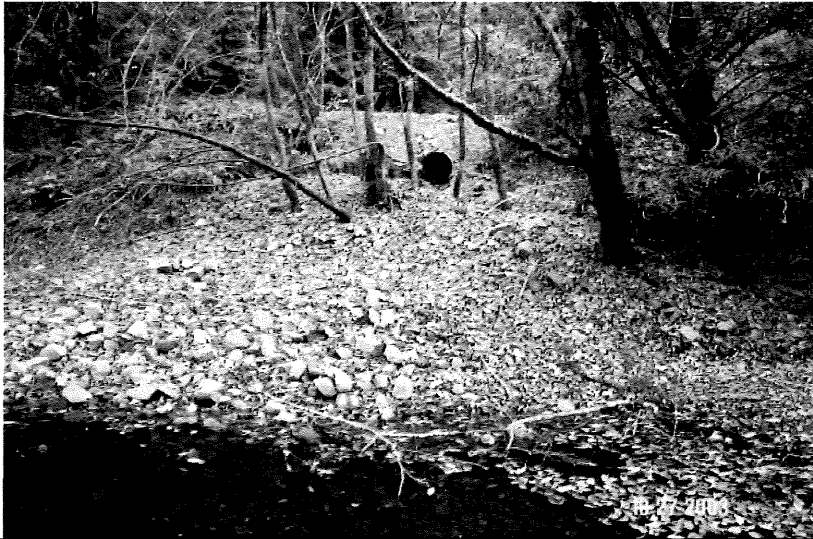
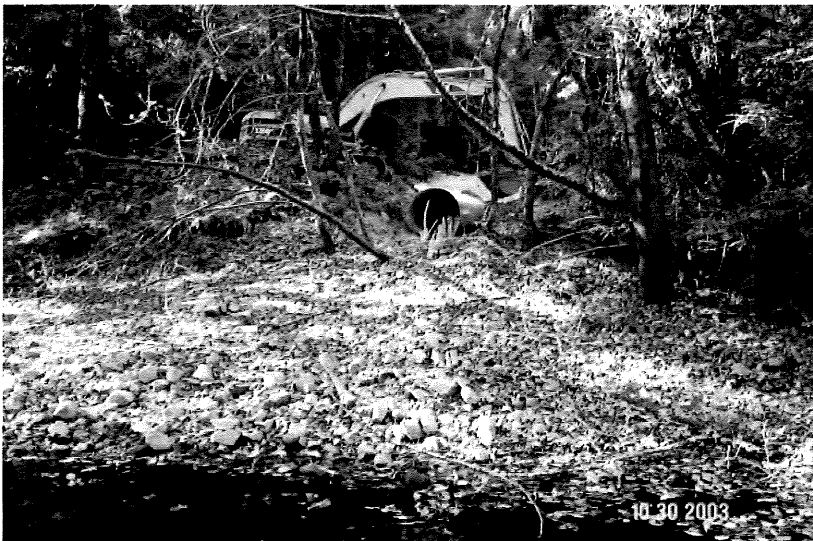
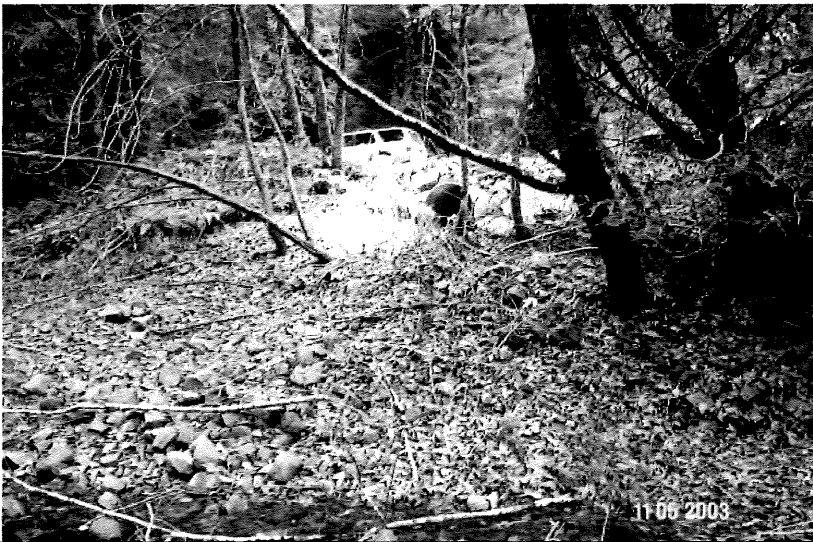
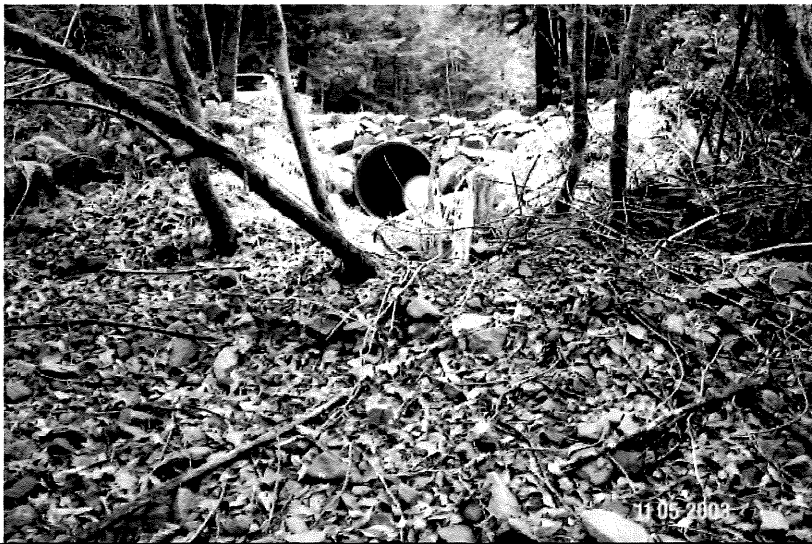
Road Upgrading Photo # 1826
 10/27/03
Map Pt 2300 Road 60 Mi. 3.12
 Culv. Replace Old 30" New 48"
 PPt Up Dir PW Robinson Cr
 THP 271 LNF LNF P01030405A
 PID 0 LWD
 Monitoring 0

Road Upgrading Photo # 1844
 10/30/03
Map Pt 2300 Road 60 Mi. 3.12
 Culv. Replace Old 30" New 48"
 PPt Up Dir PW Robinson Cr
 THP 271 LNF LNF P01030405A
 PID 0 LWD
 Monitoring 0

Road Upgrading Photo # 1871
 11/5/03
Map Pt 2300 Road 60 Mi. 3.12
 Culv. Replace Old 30" New 48"
 PPt Up Dir PW Robinson Cr
 THP 271 LNF LNF P01030405A
 PID 0 LWD
 Monitoring 0

Road Upgrading Photo # 1872
 11/5/03
 Map Pt 2300 Road 60 Mi. 3.12
 Culv. Replace Old 30" New 48"
 PPt Up Dir PW Robinson Cr
 THP 271 LNF LNF P01030405A
 PID 0 LWD
 Monitoring 0

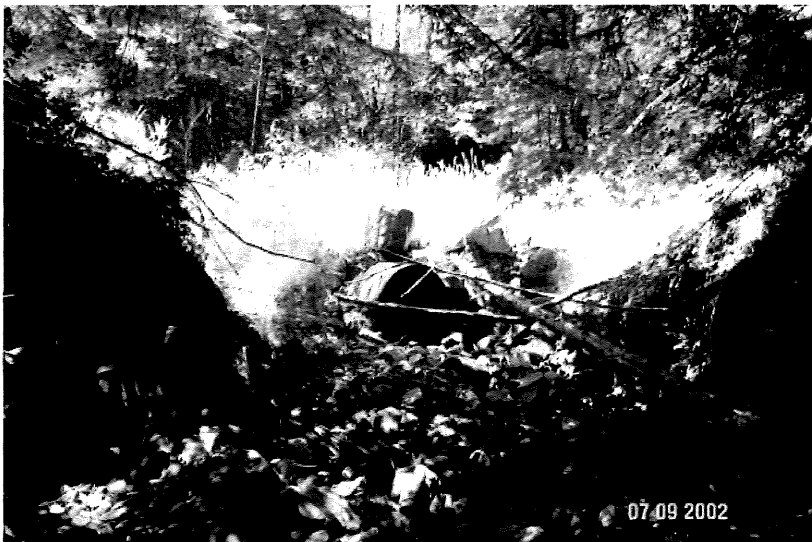
Road Upgrading Photo # 1023
 7/9/02
 Map Pt 1519 Road 60.39 Mi. 0.210
 Culv. Maintenance Old 48" New 84"
 PPt down Dir PW Doty Creek
 THP 271 LNF LNF P01030405A
 PID 0 LWD
 Monitoring 0

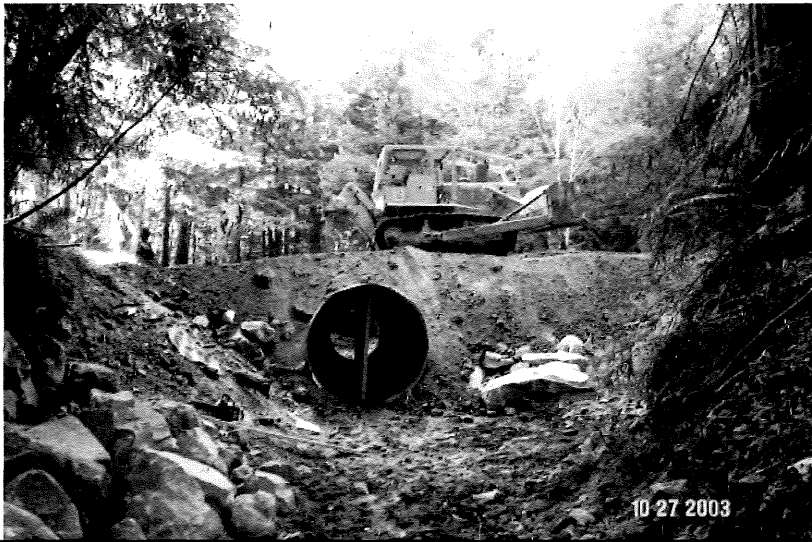
Road Upgrading Photo # 1817
 10/27/03
 Map Pt 1519 Road 60.39 Mi. 0.210
 Culv. Maintenance Old 48" New 84"
 PPt down Dir PW Doty Creek
 THP 271 LNF LNF P01030405A
 PID 0 LWD
 Monitoring 0

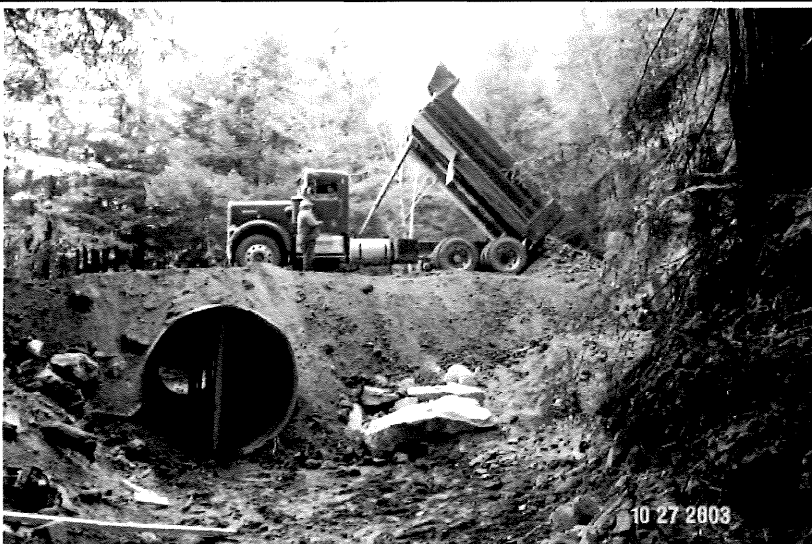
Road Upgrading Photo # 1818
 10/27/03
 Map Pt 1519 Road 60.39 Mi. 0.210
 Culv. Maintenance Old 48" New 84"
 PPt down Dir PW Doty Creek
 THP 271 LNF LNF P01030405A
 PID 0 LWD
 Monitoring 0

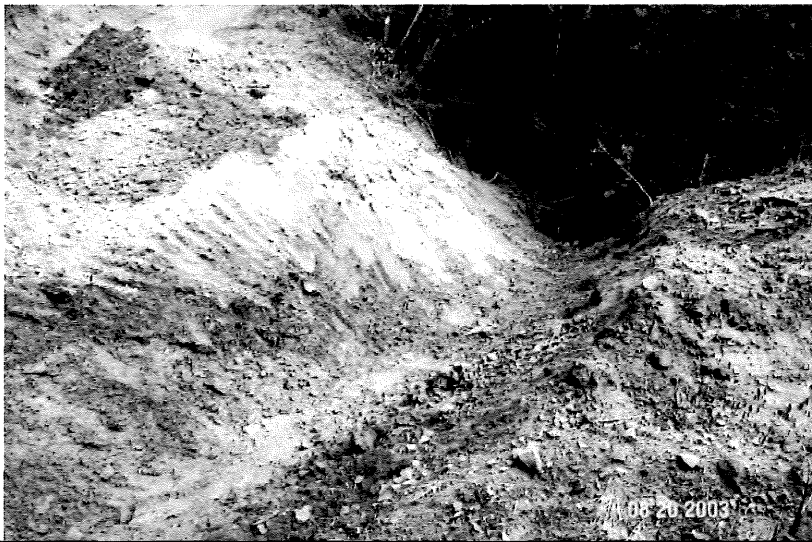
Road Upgrading Photo # 1562
 8/20/03
 Map Pt 1494 Road 60.39 Mi. 1.515
 Other Old 18" New 24"
 PPt down Dir PW Doty Creek
 THP 271 LNF LNF P01030405A
 PID 0 LWD
 Monitoring 0

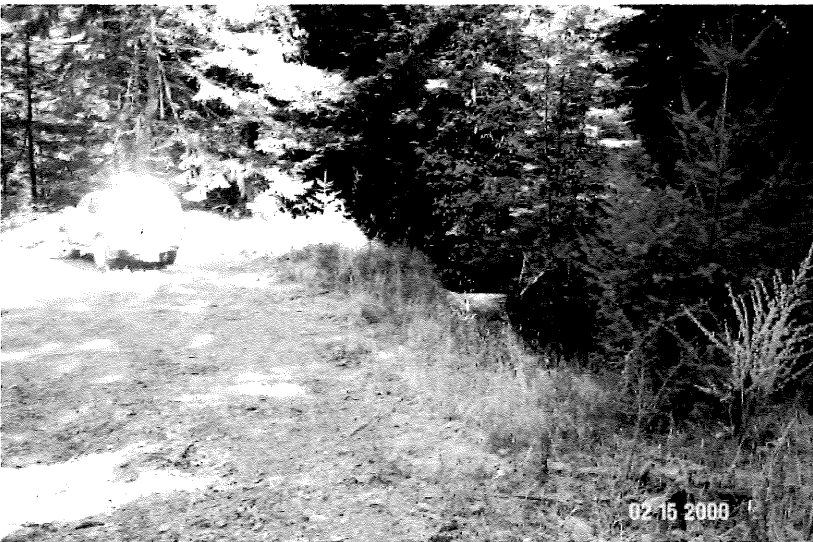
Road Upgrading Photo # 1535
 8/11/03
 Map Pt 1516 Road 60.3915 Mi. 0.520
 Other Old New 60"
 PPt down Dir PW Doty Creek
 THP 271 LNF LNF P01030405A
 PID 0 LWD
 Monitoring 0

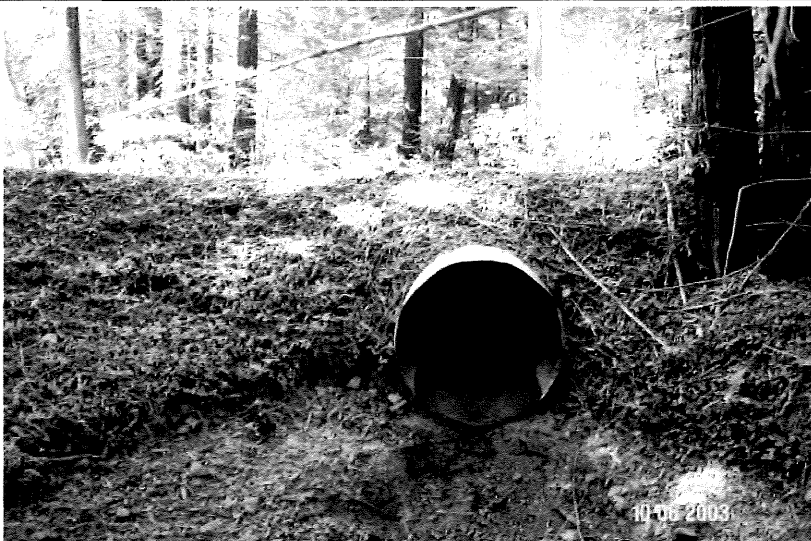
Road Upgrading Photo # 1655
 10/5/03
 Map Pt 1473 Road 60.4 Mi. 0.960
 Other Old 36" New 60"
 PPt Up Dir PW Doty Creek
 THP 271 LNF LNF P01030405A
 PID 0 LWD
 Monitoring 0
 Note the bottom is worn out.

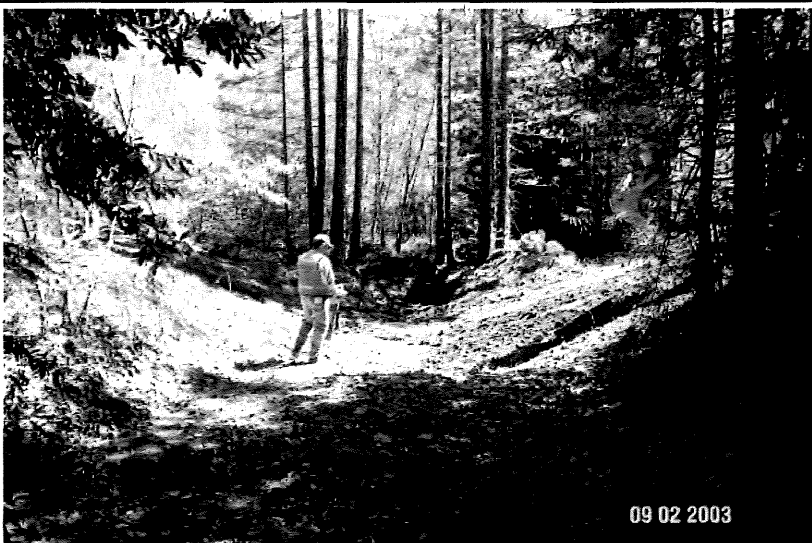
Road Upgrading Photo # 1604
 9/2/03
 Map Pt 1470 Road 60.4 Mi. 1.610
 Bridge - Perm Old 48" New 1Br
 PPt down Dir PW Doty Creek
 THP 271 LNF LNF P01030405A
 PID 0 LWD
 Monitoring 0
 Bridge installation.

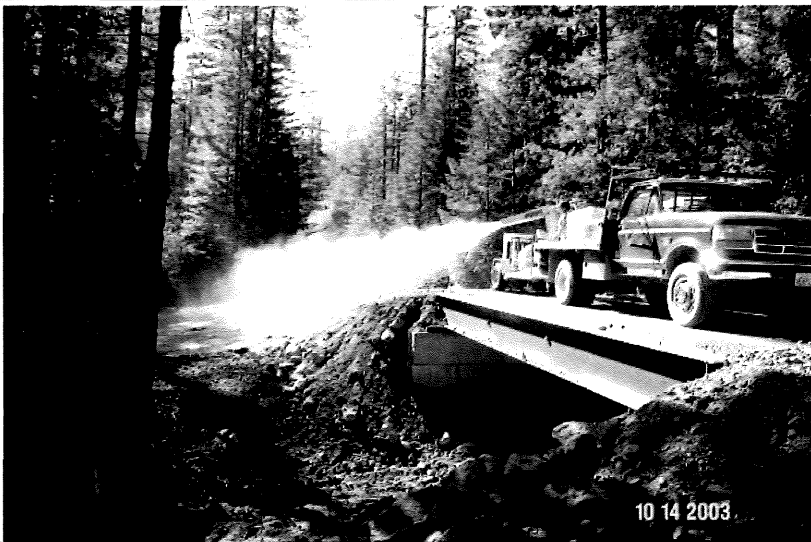
Road Upgrading Photo # 1713
 10/14/03
 Map Pt 1470 Road 60.4 Mi. 1.610
 Bridge - Perm Old 48" New 1Br
 PPt down Dir PW Doty Creek
 THP 271 LNF LNF P01030405A
 PID 0 LWD
 Monitoring 0
 Blowing straw.

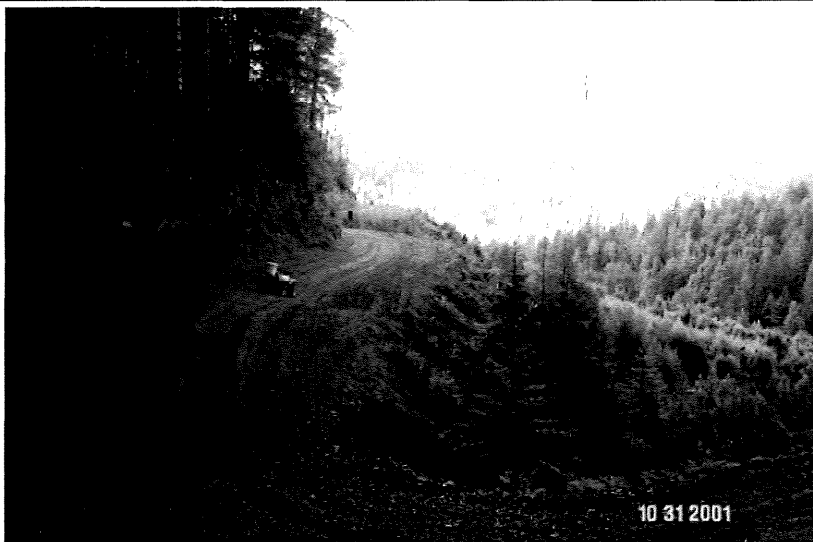
Road Upgrading Photo # 764
 9/10/01
 Map Pt 1580 Road 60.402005 Mi. 0.770
 Other Old - New -
 PPt left Dir PW Doty Creek
 THP 271 LNF LNF P01030405A
 PID 0 LWD
 Monitoring 0
 This is a rocked dip in a class III

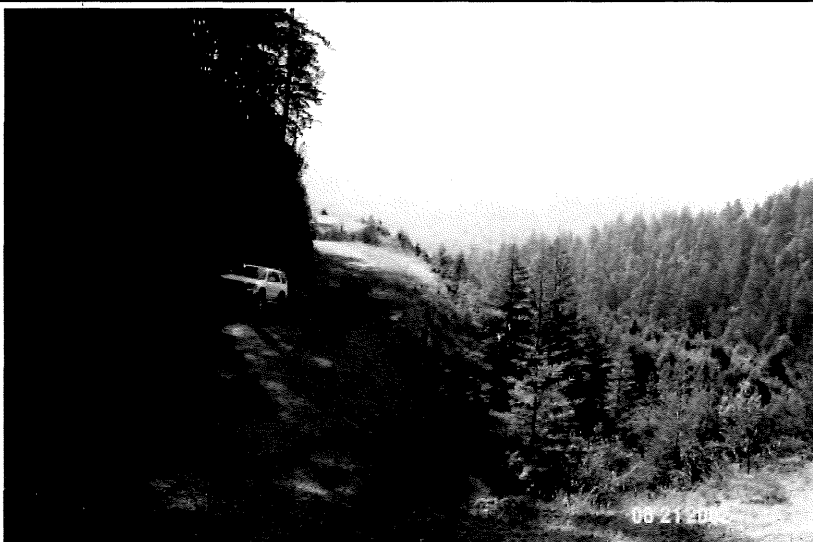
Road Upgrading Photo # 792
 10/20/01
 Map Pt 1580 Road 60.402005 Mi. 0.770
 Other Old - New -
 PPt left Dir PW Doty Creek
 THP 271 LNF LNF P01030405A
 PID 0 LWD
 Monitoring 0
 This is a rocked Ford with outsloping and dips on either side to disconnect the road from the Class III.

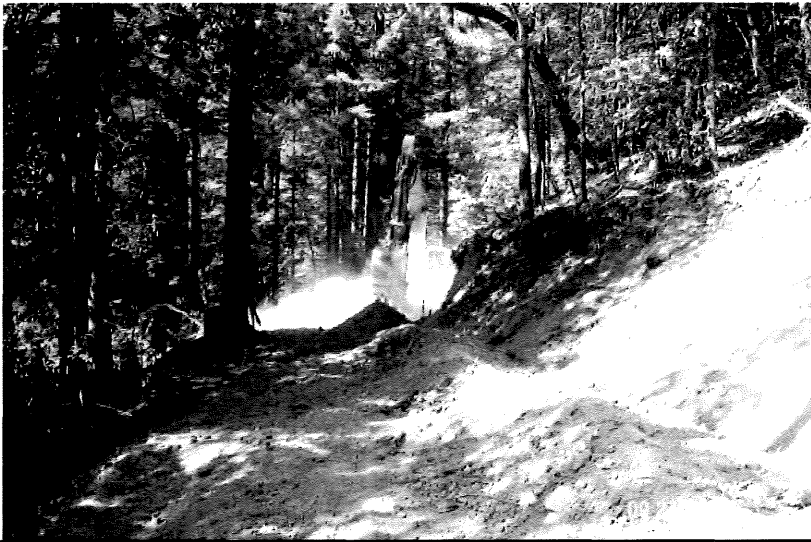
Road Upgrading Photo # 791
 10/20/01
 Map Pt 1580 Road 60.402005 Mi. 0.770
 Other Old - New -
 PPt Right Dir PW Doty Creek
 THP 271 LNF LNF P01030405A
 PID 0 LWD
 Monitoring 0
 This is a rocked Ford with outsloping and dips on either side to disconnect the road from the Class III.

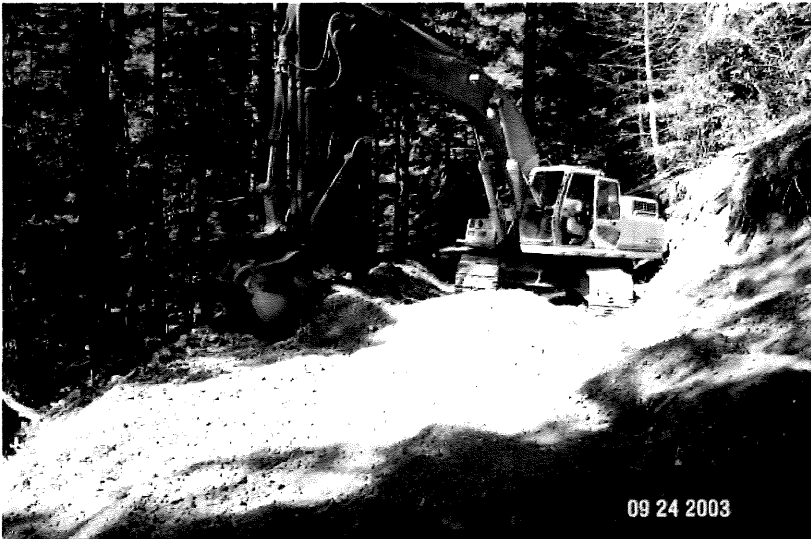
Road Upgrading Photo # 1634
 9/24/03
 Map Pt 2258 Road 60.40200501 Mi. 0
 Dip Rolling Old - New -
 PPt down Dir PW Doty Creek
 THP 271 LNF LNF P01030405A
 PID 0 LWD
 Monitoring 0
 The outside berm is moved to the inside.

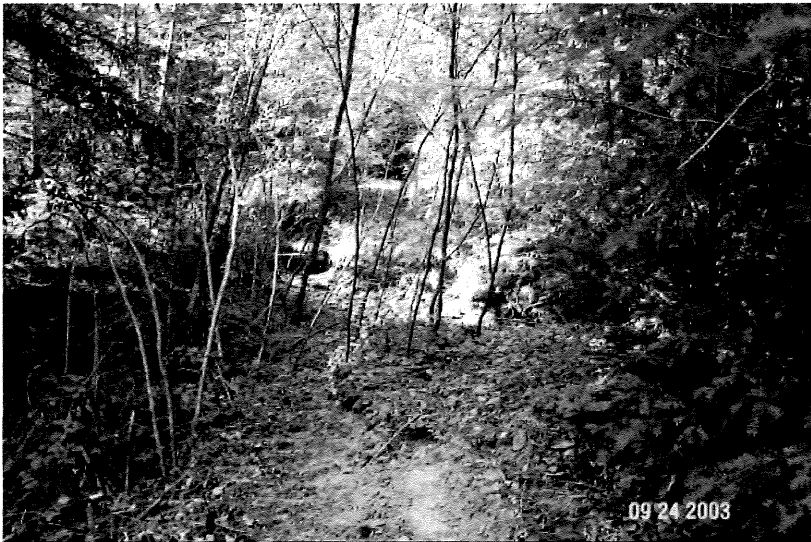
Road Upgrading Photo # 1648
 9/30/03
 Map Pt 2258 Road 60.40200501 Mi. 0
 Dip Rolling Old - New -
 PPt Up Dir PW Doty Creek
 THP 271 LNF LNF P01030405A
 PID 0 LWD
 Monitoring 0
 The road is outsloped and a dip has been installed about where the excavator was sitting

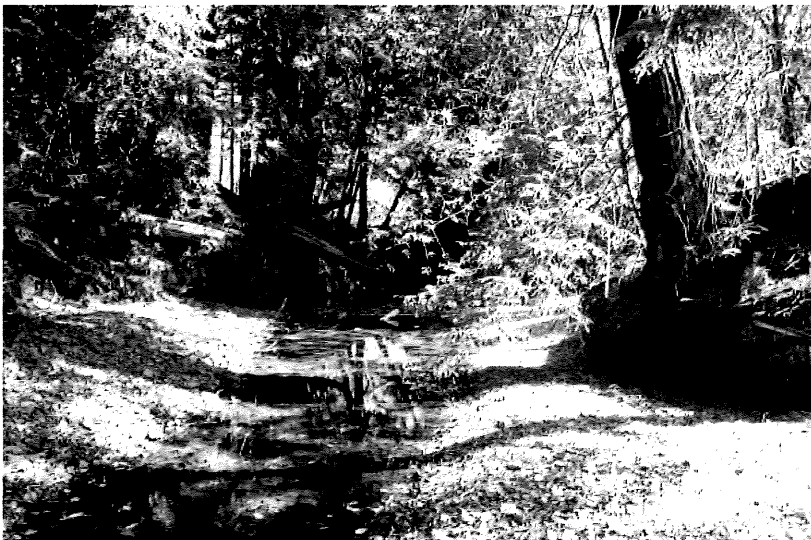
Road Upgrading Photo # 701
 8/21/01
 Map Pt 1596 Road 60.4020051886 Mi. 0.1
 Other Old - New -
 PPt Up Dir PW Doty Creek
 THP 271 LNF LNF P01030405A
 PID 0 LWD
 Monitoring 0
 Excavated class III crossing.

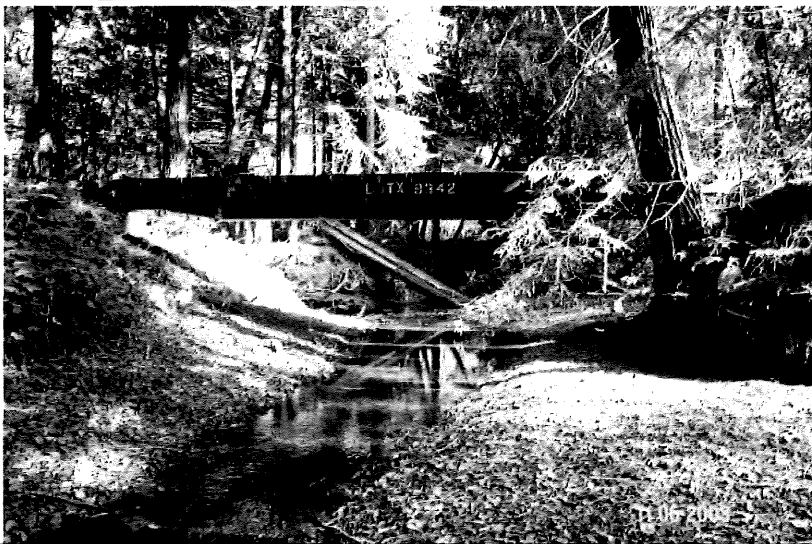
Road Upgrading Photo # 1846
 10/30/03
 Map Pt 2293 Road 60.4024 Mi. 0.03
 Bridge - Perm Old - New 1Br
 PPt down Dir PW Doty Creek
 THP 271 LNF LNF P01030405A
 PID 0 LWD
 Monitoring 0
 Keying in riprap for the bridge abutment.

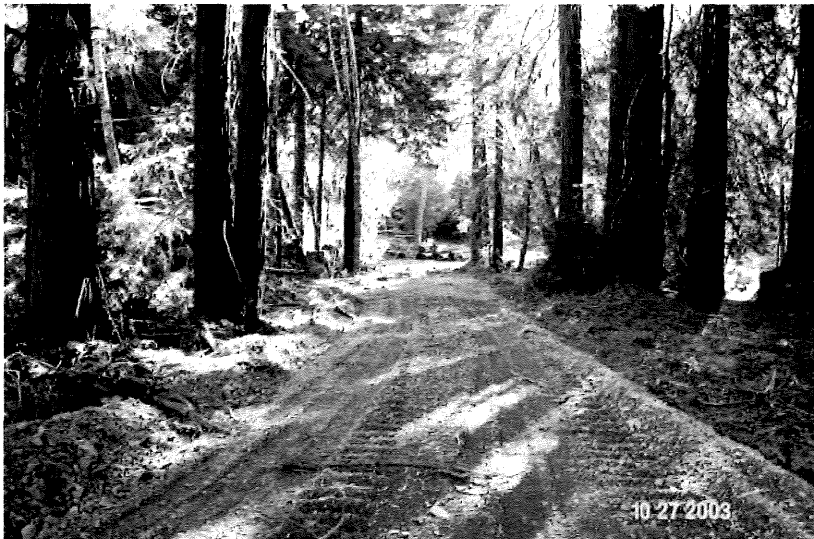
Road Upgrading Photo # 1845
 10/30/03
 Map Pt 2293 Road 60.4024 Mi. 0.03
 Bridge - Perm Old - New 1Br
 PPt left Dir PW Doty Creek
 THP 271 LNF LNF P01030405A
 PID 0 LWD
 Monitoring 0
 The 67' railroad car bridge is ready to place.

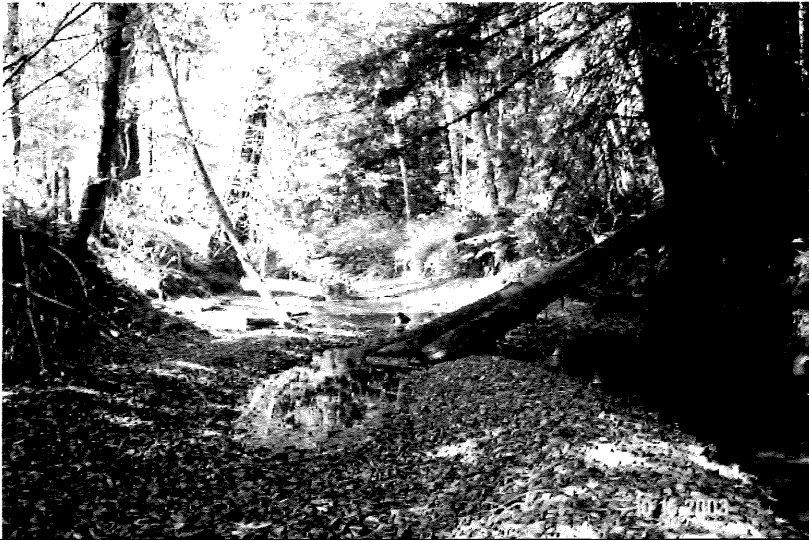
Road Upgrading Photo # 1847
 10/30/03
 Map Pt 2293 Road 60.4024 Mi. 0.03
 Bridge - Perm Old - New 1Br
 PPt Right Dir PW Doty Creek
 THP 271 LNF LNF P01030405A
 PID 0 LWD
 Monitoring 0
 Keying in riprap for the bridge abutment. Vic directs Rick as to proper placement.

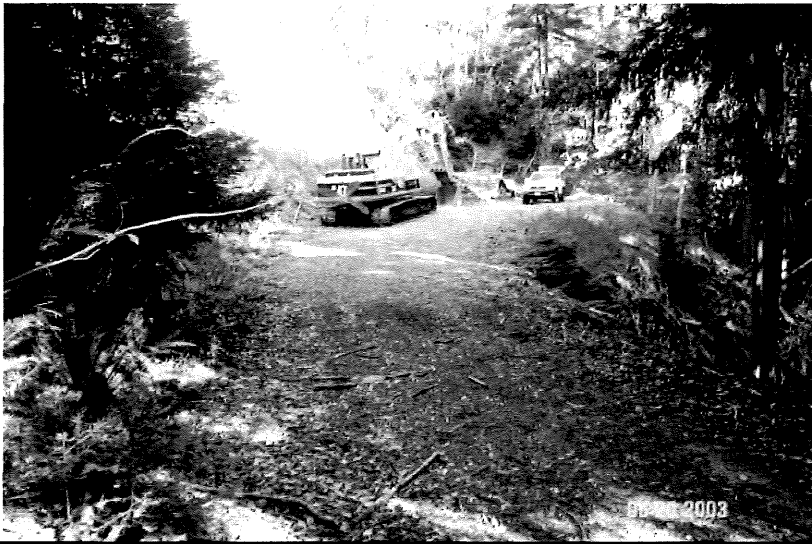
Road Upgrading Photo # 1428
 5/20/03
 Map Pt 1624 Road 80.32 Mi. 0.04
 Other Old 24" New 36"
 PPt left Dir PW Doty Creek
 THP 271 LNF LNF P01030405A
 PID 0 LWD
 Monitoring 0

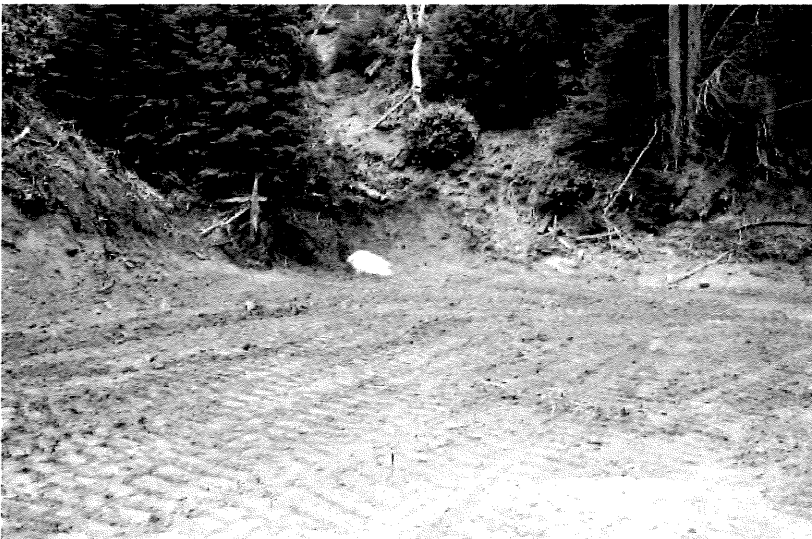
Road Upgrading Photo # 1463
 6/5/03
 Map Pt 1624 Road 80.32 Mi. 0.04
 Other Old 24" New 36"
 PPt left Dir PW Doty Creek
 THP 271 LNF LNF P01030405A
 PID 0 LWD
 Monitoring 0
 The inlet is too high, above the road surface.

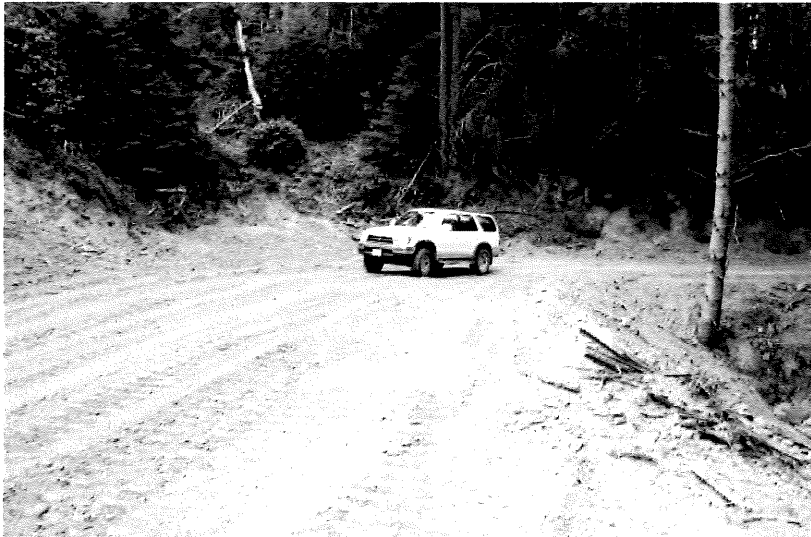
Road Upgrading Photo # 1465
 6/9/03
 Map Pt 1624 Road 80.32 Mi. 0.04
 Other Old 24" New 36"
 PPt left Dir PW Doty Creek
 THP 271 LNF LNF P01030405A
 PID 0 LWD
 Monitoring 0
 The inlet is fixed with a dam.

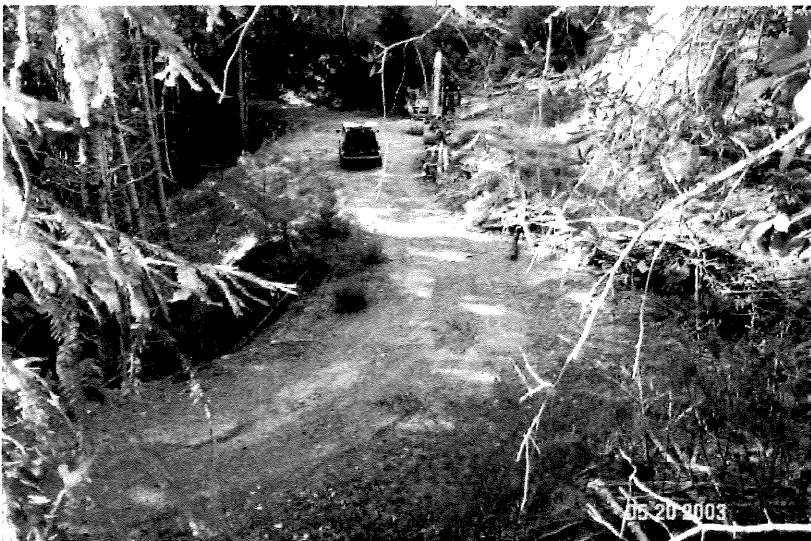
Road Upgrading Photo # 1426
 5/20/03
 Map Pt 1624 Road 80.32 Mi. 0.04
 Other Old 24" New 36"
 PPt Right Dir PW Doty Creek
 THP 271 LNF LNF P01030405A
 PID 0 LWD
 Monitoring 0

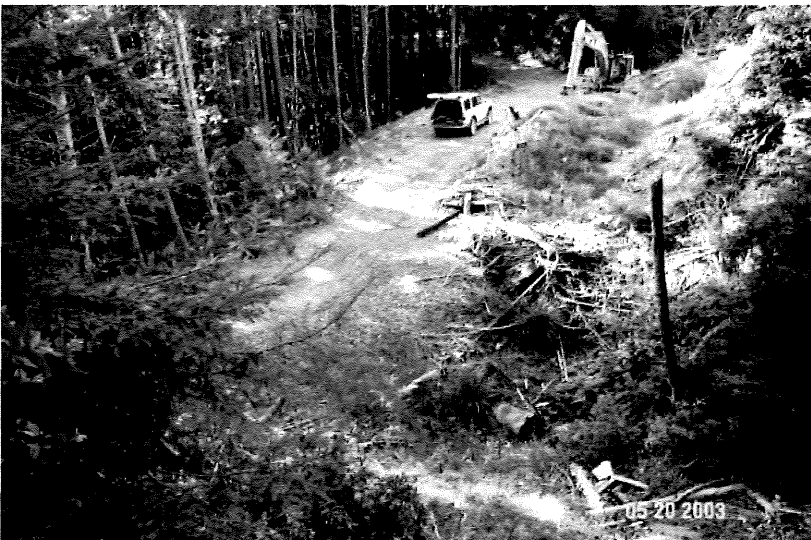
Road Upgrading Photo # 1427
 5/20/03
 Map Pt 1624 Road 80.32 Mi. 0.04
 Other Old 24" New 36"
 PPt Right Dir PW Doty Creek
 THP 271 LNF LNF P01030405A
 PID 0 LWD
 Monitoring 0

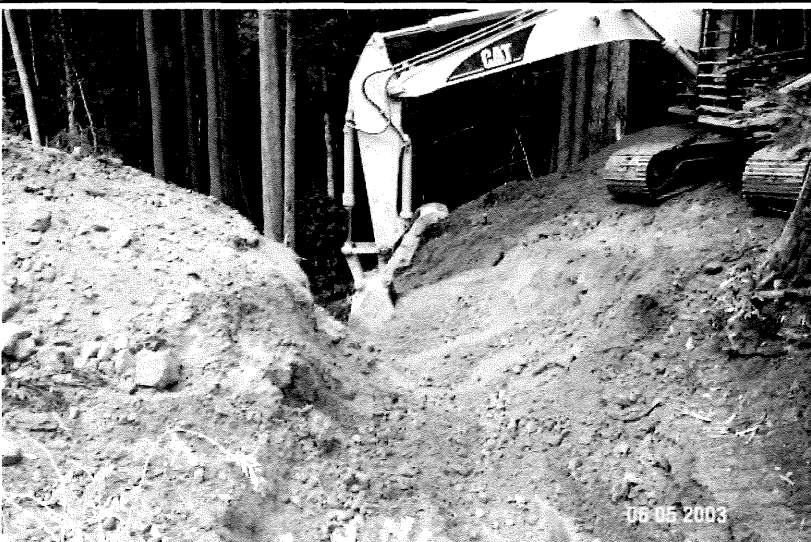
Road Upgrading Photo # 1461
 6/5/03
 Map Pt 1623 Road 80.32 Mi. 0.070
 Other Old 18" New 24"
 PPt down Dir PW Doty Creek
 THP 271 LNF LNF P01030405A
 PID 0 LWD
 Monitoring 0
