MISC. ADDENDUMS

SECTION V INDEX

ESTIMATED SURFACE SOIL EROSION HAZARD

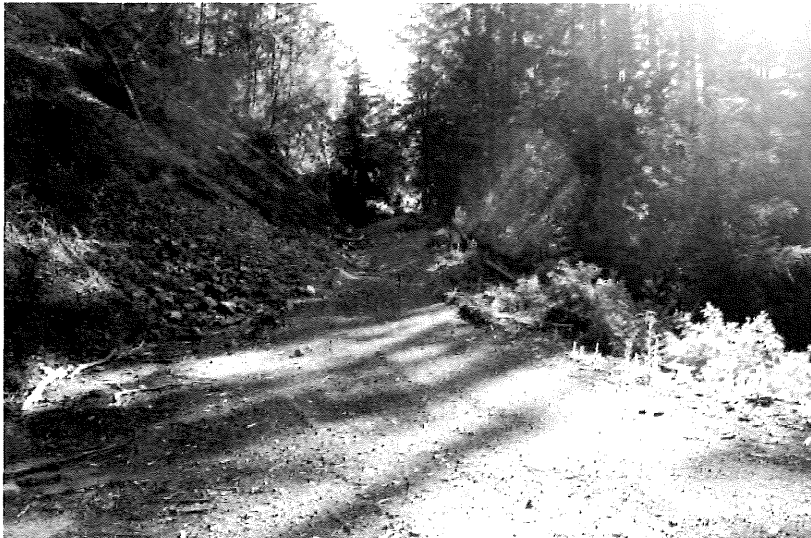
Road Upgrading Photo # 1429
 5/20/03
 Map Pt 1621 Road 80.32 Mi. 0.470
 Culv. Maintenance Old 72" New 1Br
 PPt 0 Dir PW Doty Creek
 THP 271 LNF LNF P01030405A
 PID 0 LWD
 Monitoring 0

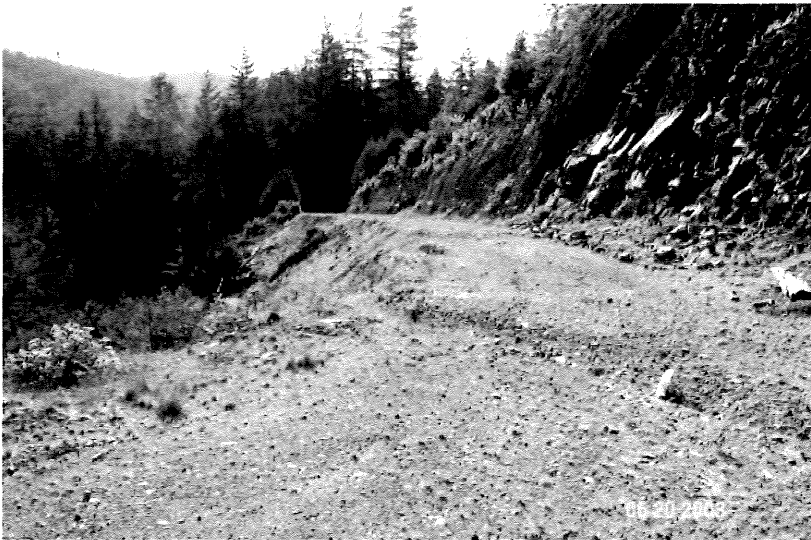
Road Upgrading Photo # 1432
 5/20/03
 Map Pt 1621 Road 80.32 Mi. 0.470
 Culv. Maintenance Old 72" New 1Br
 PPt 0 Dir PW Doty Creek
 THP 271 LNF LNF P01030405A
 PID 0 LWD
 Monitoring 0

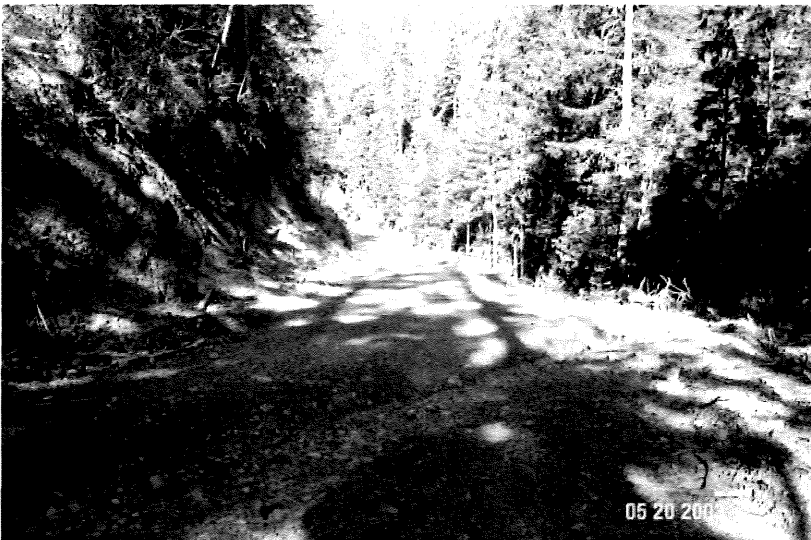
Road Upgrading Photo # 1433
 5/20/03
 Map Pt 1621 Road 80.32 Mi. 0.470
 Culv. Maintenance Old 72" New 1Br
 PPt 0 Dir PW Doty Creek
 THP 271 LNF LNF P01030405A
 PID 0 LWD
 Monitoring 0

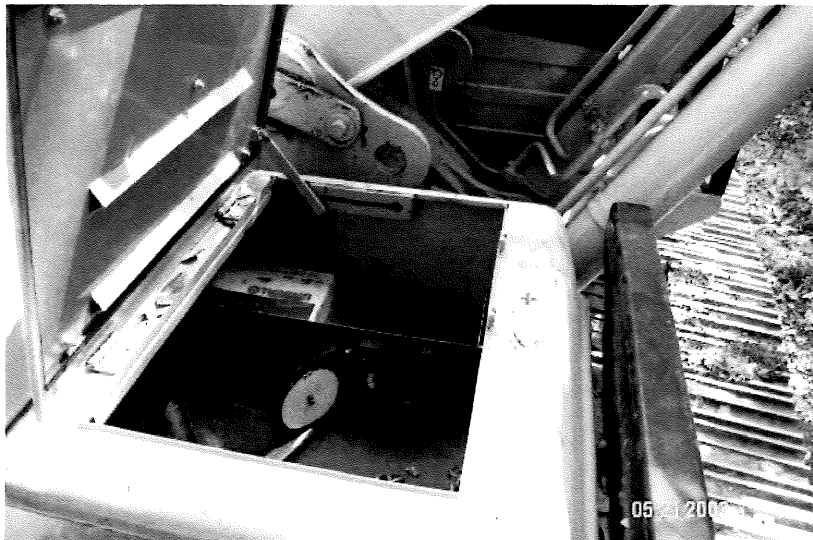
Road Upgrading Photo # 1435
 5/21/03
 Map Pt 1621 Road 80.32 Mi. 0.470
 Culv. Maintenance Old 72" New 1Br
 PPt 0 Dir PW Doty Creek
 THP 271 LNF LNF P01030405A
 PID 0 LWD
 Monitoring 0

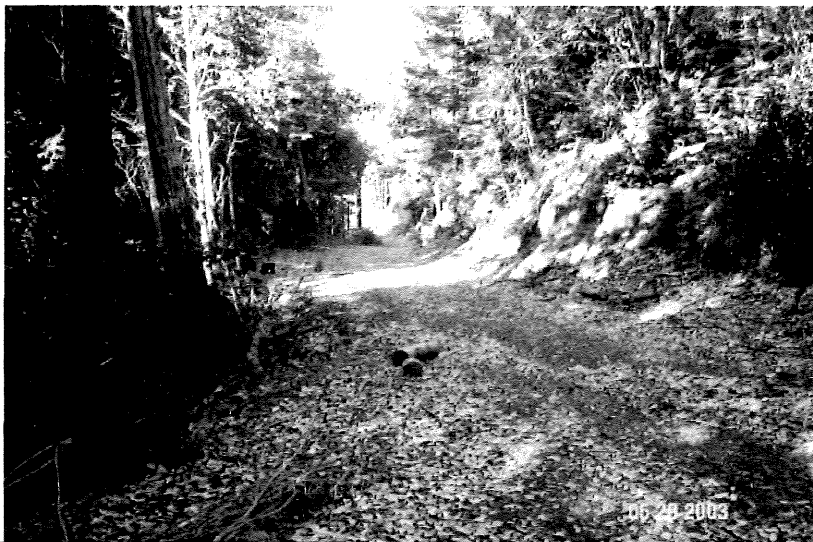
Road Upgrading Photo # 1430
 5/20/03
 Map Pt 1621 Road 80.32 Mi. 0.470
 Culv. Maintenance Old 72" New 1Br
 PPt down Dir PW Doty Creek
 THP 271 LNF LNF P01030405A
 PID 0 LWD
 Monitoring 0

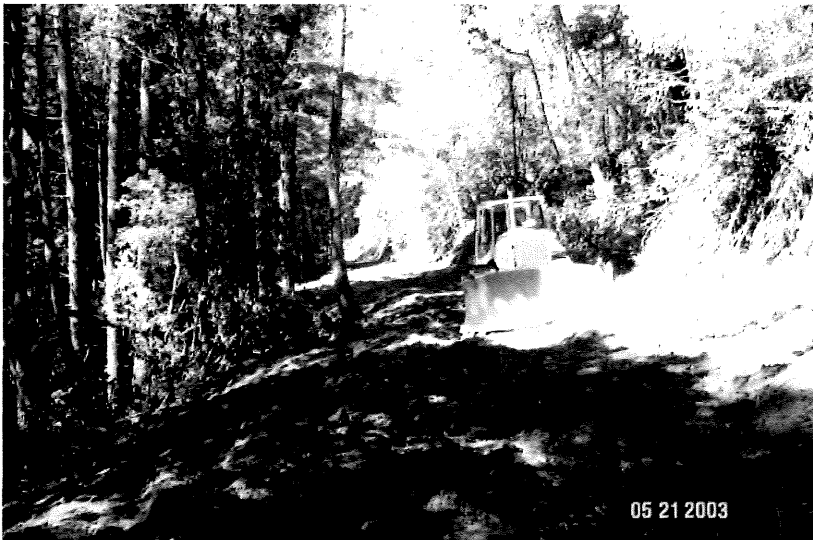
Road Upgrading Photo # 1434
 5/21/03
 Map Pt 1621 Road 80.32 Mi. 0.470
 Culv. Maintenance Old 72" New 1Br
 PPt down Dir PW Doty Creek
 THP 271 LNF LNF P01030405A
 PID 0 LWD
 Monitoring 0
 There can be too much outslope. This was 22%.

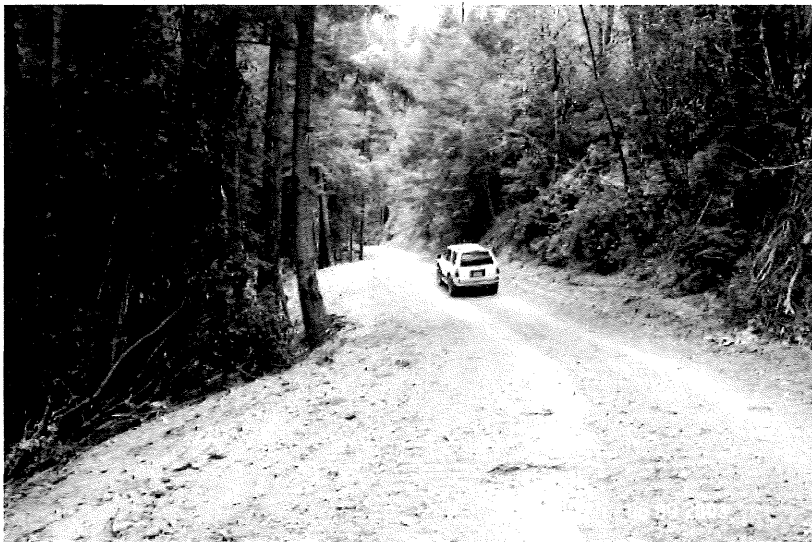
Road Upgrading Photo # 1466
 6/9/03
 Map Pt 1621 Road 80.32 Mi. 0.470
 Culv. Maintenance Old 72" New 1Br
 PPt down Dir PW Doty Creek
 THP 271 LNF LNF P01030405A
 PID 0 LWD
 Monitoring 0

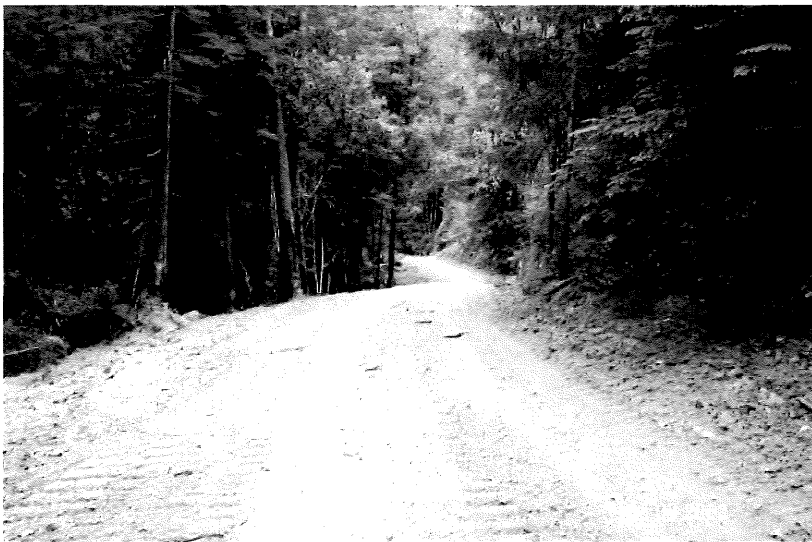
Road Upgrading Photo # 1470
 6/9/03
 Map Pt 1621 Road 80.32 Mi. 0.470
 Culv. Maintenance Old 72" New 1Br
 PPt down Dir PW Doty Creek
 THP 271 LNF LNF P01030405A
 PID 0 LWD
 Monitoring 0

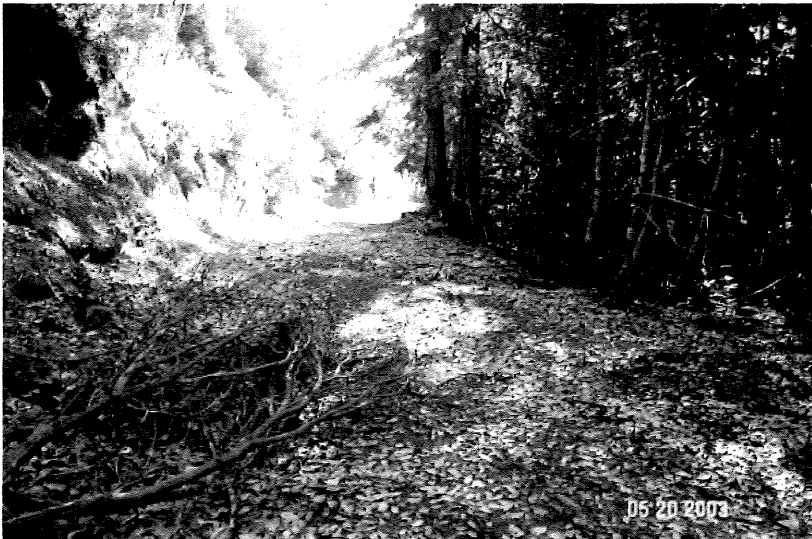
Road Upgrading Photo # 1431
 5/20/03
 Map Pt 1621 Road 80.32 Mi. 0.470
 Culv. Maintenance Old 72" New 1Br
 PPt Up Dir PW Doty Creek
 THP 271 LNF LNF P01030405A
 PID 0 LWD
 Monitoring 0

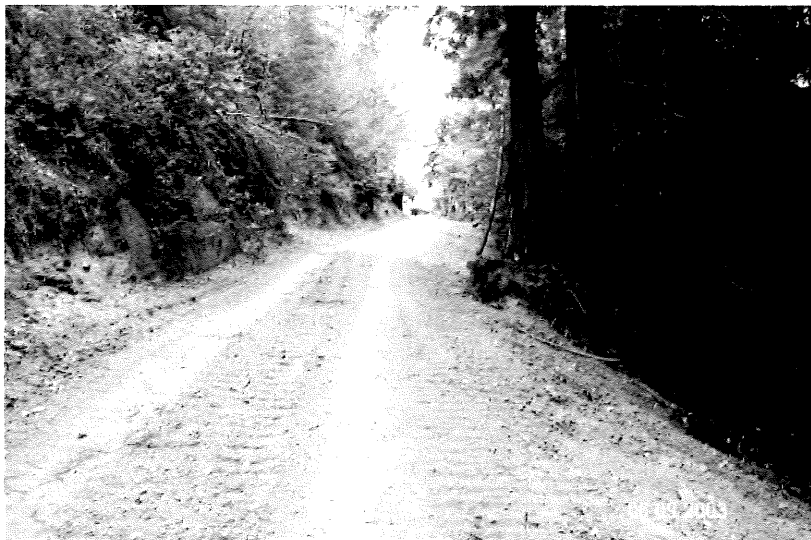
Road Upgrading Photo # 1467
 6/9/03
 Map Pt 1621 Road 80.32 Mi. 0.470
 Culv. Maintenance Old 72" New 1Br
 PPt Up Dir PW Doty Creek
 THP 271 LNF LNF P01030405A
 PID 0 LWD
 Monitoring 0

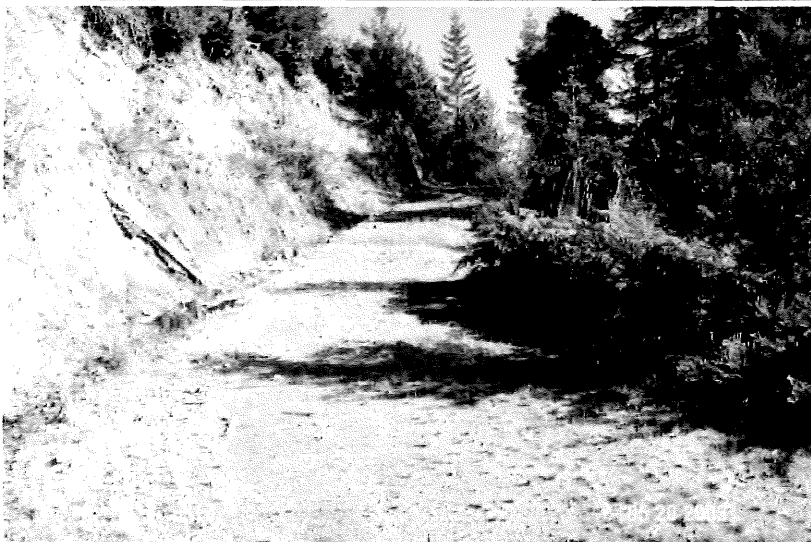
Road Upgrading Photo # 1436
 5/20/03
 Map Pt 1620 Road 80.32 Mi. 0.74
 Other Old 36" New 36"
 PPt 0 Dir PW Doty Creek
 THP 271 LNF LNF P01030405A
 PID 0 LWD
 Monitoring 0

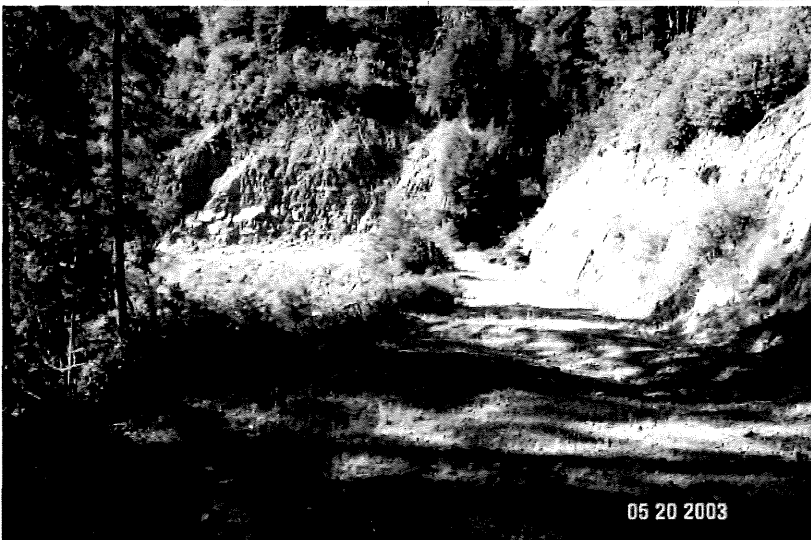
Road Upgrading Photo # 1437
 5/20/03
 Map Pt 1620 Road 80.32 Mi. 0.74
 Other Old 36" New 36"
 PPt 0 Dir PW Doty Creek
 THP 271 LNF LNF P01030405A
 PID 0 LWD
 Monitoring 0

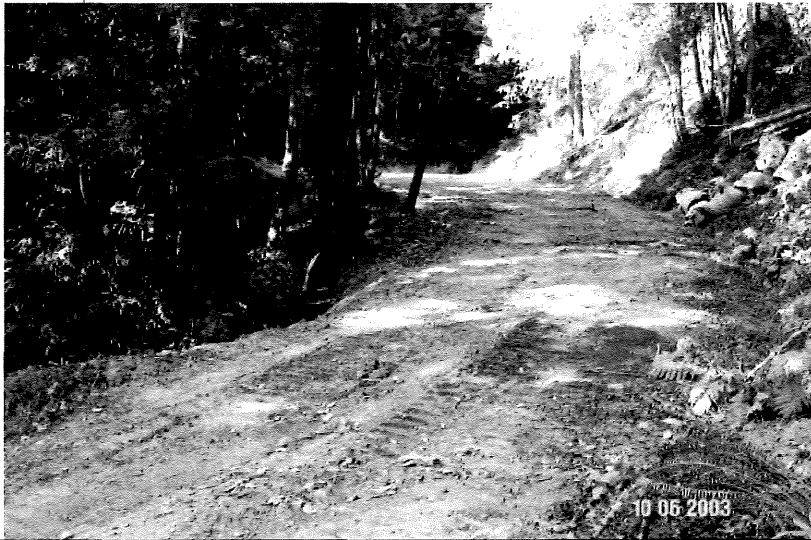
Road Upgrading Photo # 1663
 10/6/03
 Map Pt 1433 Road 80.4 Mi. 0.245
 Other Old 24" New 36"
 PPt 0 Dir PW Doty Creek
 THP 271 LNF LNF P01030405A
 PID 0 LWD
 Monitoring 0

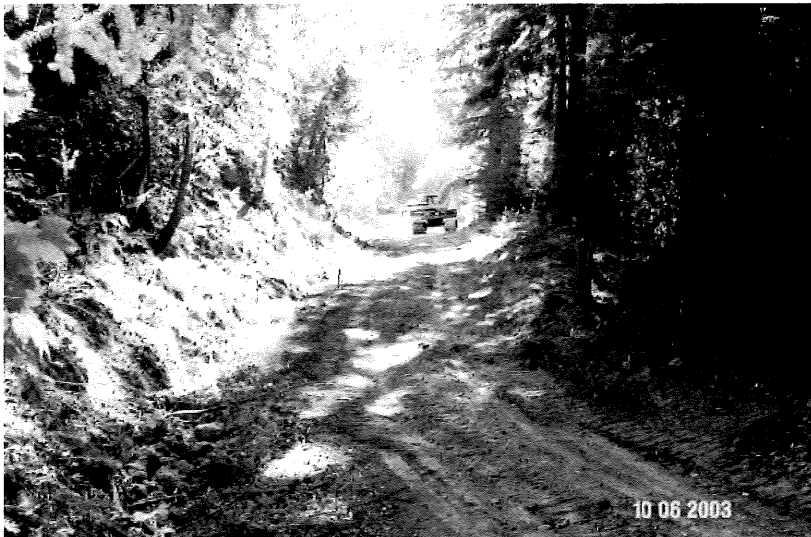
Road Upgrading Photo # 1664
 10/6/03
 Map Pt 1433 Road 80.4 Mi. 0.245
 Other Old 24" New 36"
 PPt 0 Dir PW Doty Creek
 THP 271 LNF LNF P01030405A
 PID 0 LWD
 Monitoring 0
 Note the inside ditch and the large outside berm.

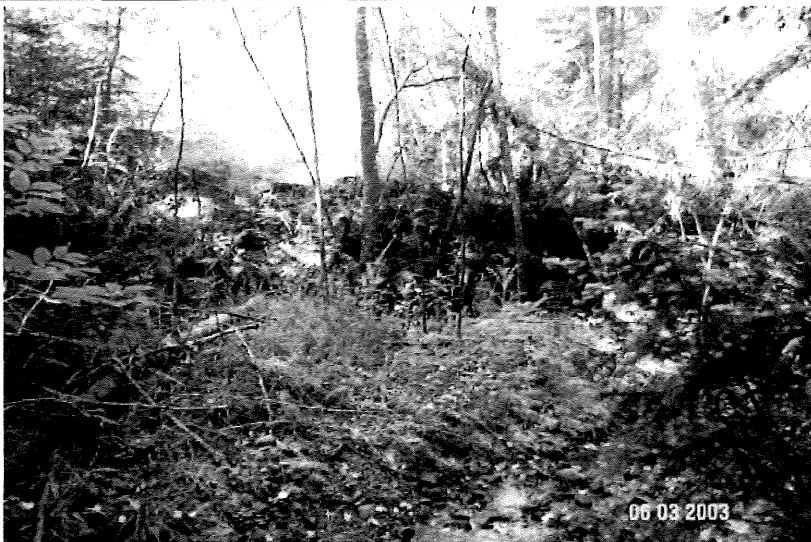
Road Upgrading Photo # 1455
 6/2/03
 Map Pt 1436 Road 80.4 Mi. 0.49
 Other Old 36" New 60"
 PPt down Dir PW Doty Creek
 THP 271 LNF LNF P01030405A
 PID 0 LWD
 Monitoring 0
 Culvert inlet

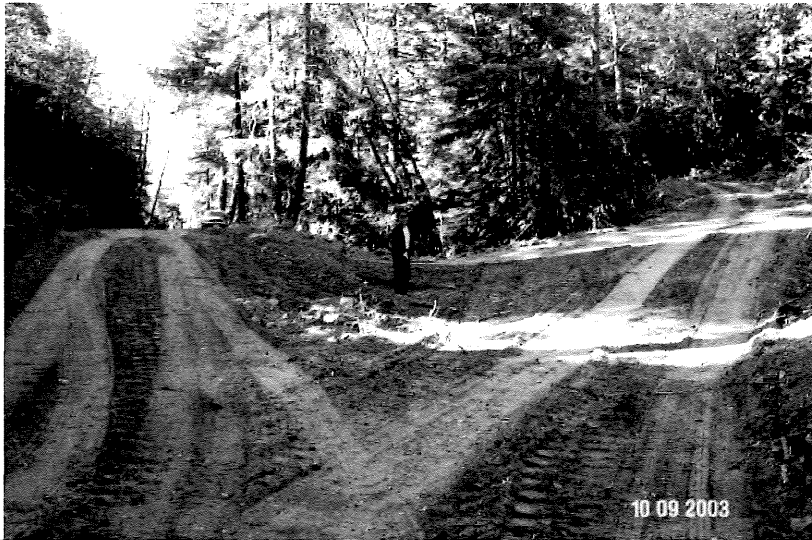
Road Upgrading Photo # 1688
 10/9/03
 Map Pt 1436 Road 80.4 Mi. 0.49
 Other Old 36" New 60"
 PPt down Dir PW Doty Creek
 THP 271 LNF LNF P01030405A
 PID 0 LWD
 Monitoring 0

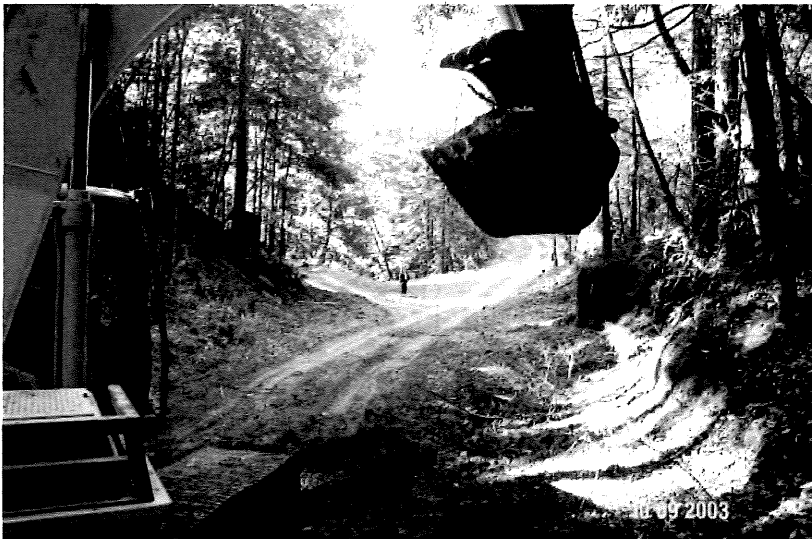
Road Upgrading Photo # 1689
 10/9/03
 Map Pt 1436 Road 80.4 Mi. 0.49
 Other Old 36" New 60"
 PPt down Dir PW Doty Creek
 THP 271 LNF LNF P01030405A
 PID 0 LWD
 Monitoring 0

This is looking downstream from where the old channel disappears.

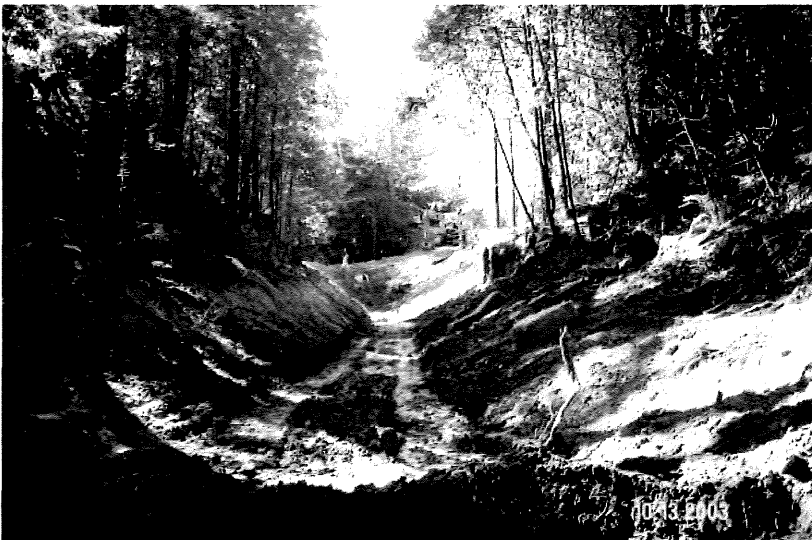
Road Upgrading Photo # 1702
 10/13/03
 Map Pt 1436 Road 80.4 Mi. 0.49
 Other Old 36" New 60"
 PPt down Dir PW Doty Creek
 THP 271 LNF LNF P01030405A
 PID 0 LWD
 Monitoring 0

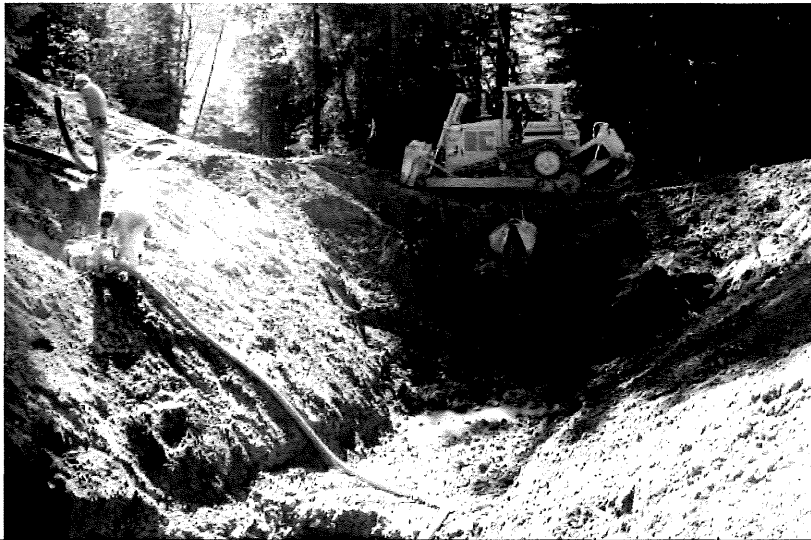
Road Upgrading Photo # 1703
 10/13/03
 Map Pt 1436 Road 80.4 Mi. 0.49
 Other Old 36" New 60"
 PPt down Dir PW Doty Creek
 THP 271 LNF LNF P01030405A
 PID 0 LWD
 Monitoring 0

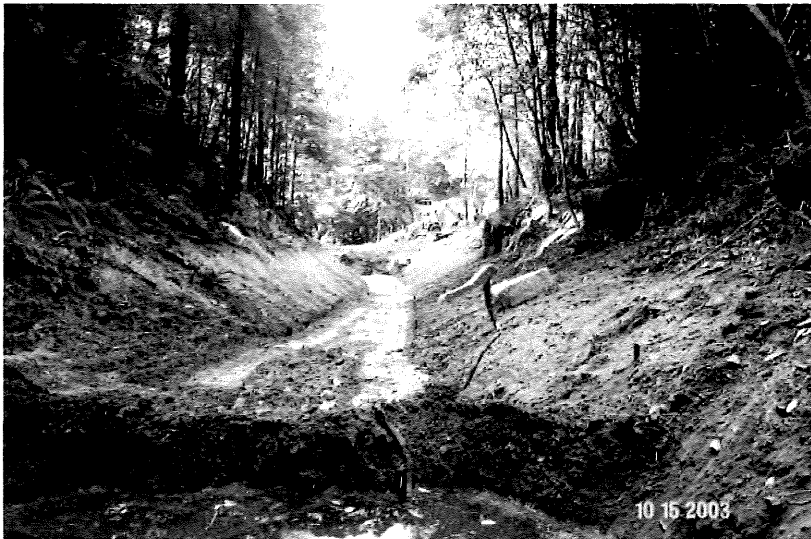
Road Upgrading Photo # 1715
 10/15/03
 Map Pt 1436 Road 80.4 Mi. 0.49
 Other Old 36" New 60"
 PPt down Dir PW Doty Creek
 THP 271 LNF LNF P01030405A
 PID 0 LWD
 Monitoring 0

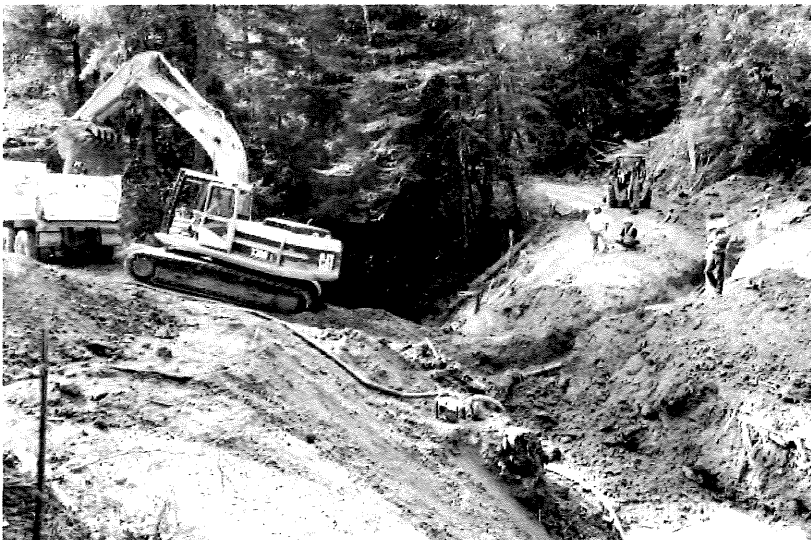
Road Upgrading Photo # 1717
 10/15/03
 Map Pt 1436 Road 80.4 Mi. 0.49
 Other Old 36" New 60"
 PPt down Dir PW Doty Creek
 THP 271 LNF LNF P01030405A
 PID 0 LWD
 Monitoring 0

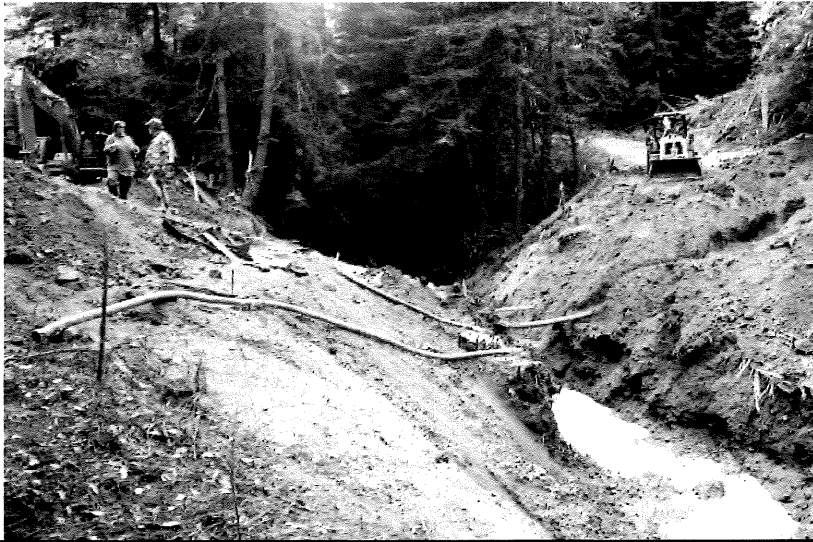
Road Upgrading Photo # 1718
 10/15/03
 Map Pt 1436 Road 80.4 Mi. 0.49
 Other Old 36" New 60"
 PPt down Dir PW Doty Creek
 THP 271 LNF LNF P01030405A
 PID 0 LWD
 Monitoring 0

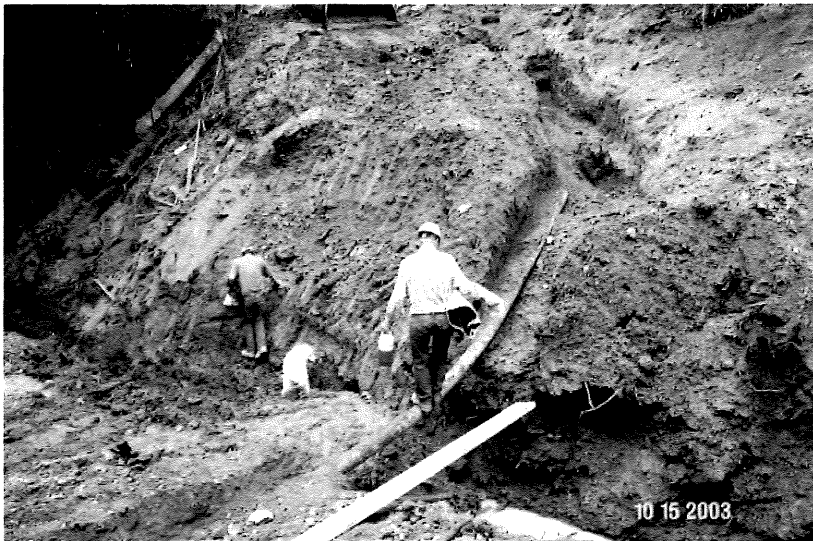
Road Upgrading Photo # 1719
 10/15/03
 Map Pt 1436 Road 80.4 Mi. 0.49
 Other Old 36" New 60"
 PPt down Dir PW Doty Creek
 THP 271 LNF LNF P01030405A
 PID 0 LWD
 Monitoring 0
 Clarence walks the walk

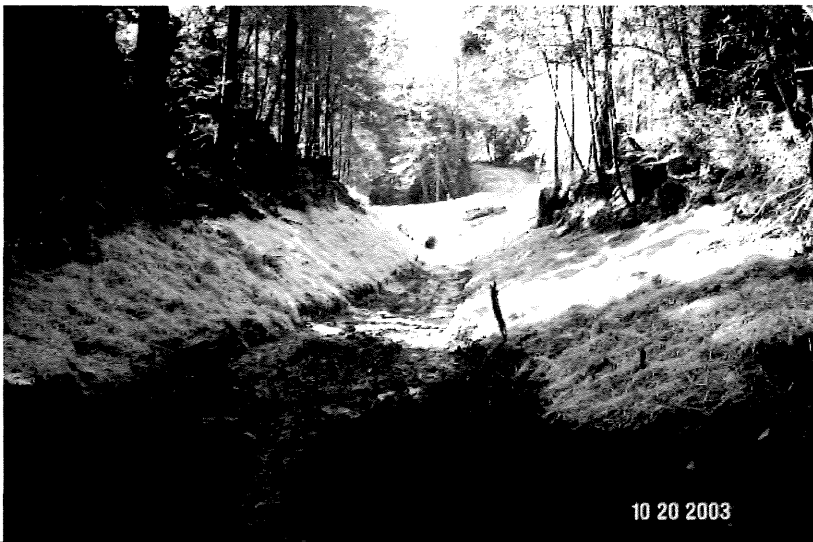
Road Upgrading Photo # 1733
 10/20/03
 Map Pt 1436 Road 80.4 Mi. 0.49
 Other Old 36" New 60"
 PPt down Dir PW Doty Creek
 THP 271 LNF LNF P01030405A
 PID 0 LWD
 Monitoring 0

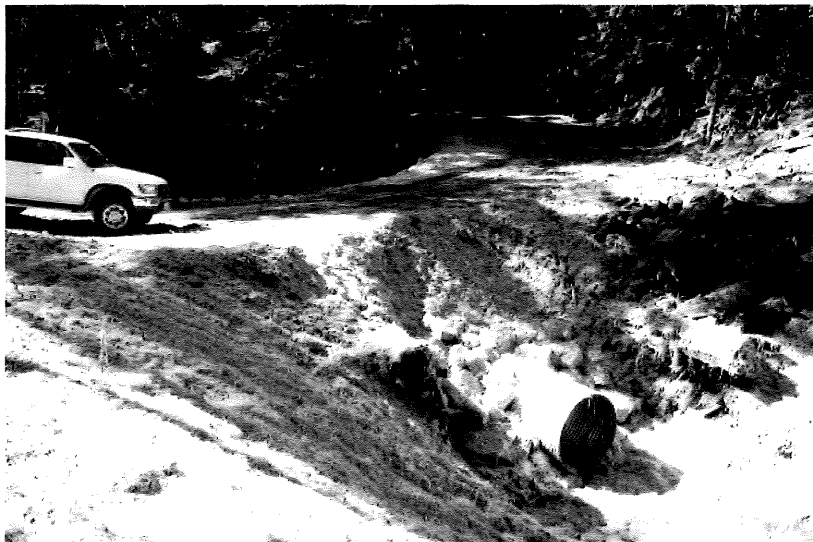
Road Upgrading Photo # 1735
 10/20/03
 Map Pt 1436 Road 80.4 Mi. 0.49
 Other Old 36" New 60"
 PPt down Dir PW Doty Creek
 THP 271 LNF LNF P01030405A
 PID 0 LWD
 Monitoring 0

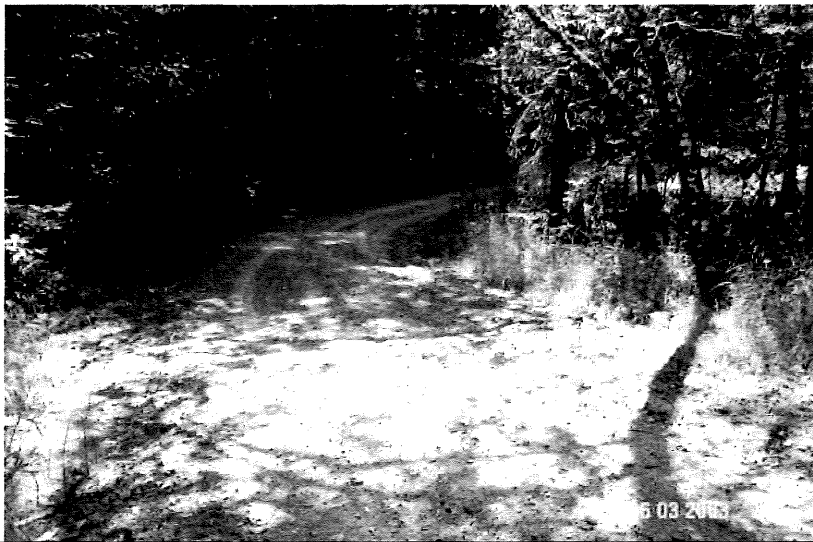
Road Upgrading Photo # 1452
 6/2/03
 Map Pt 1436 Road 80.4 Mi. 0.49
 Other Old 36" New 60"
 PPt left Dir PW Doty Creek
 THP 271 LNF LNF P01030405A
 PID 0 LWD
 Monitoring 0

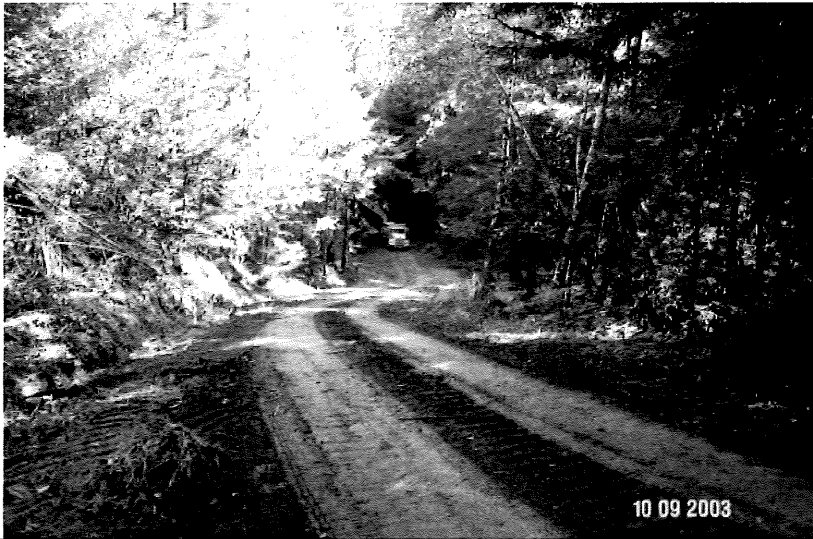
Road Upgrading Photo # 1685
 10/9/03
 Map Pt 1436 Road 80.4 Mi. 0.49
 Other Old 36" New 60"
 PPt left Dir PW Doty Creek
 THP 271 LNF LNF P01030405A
 PID 0 LWD
 Monitoring 0

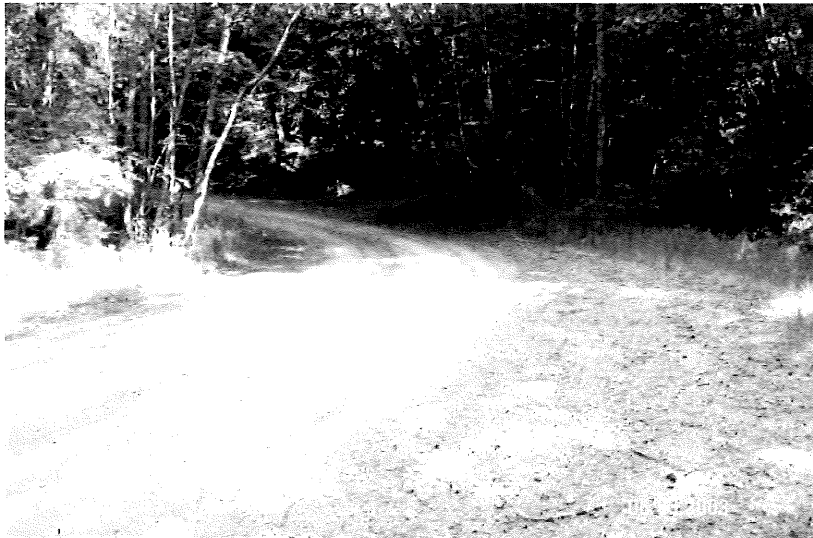
Road Upgrading Photo # 1454
 6/2/03
 Map Pt 1436 Road 80.4 Mi. 0.49
 Other Old 36" New 60"
 PPt Right Dir PW Doty Creek
 THP 271 LNF LNF P01030405A
 PID 0 LWD
 Monitoring 0

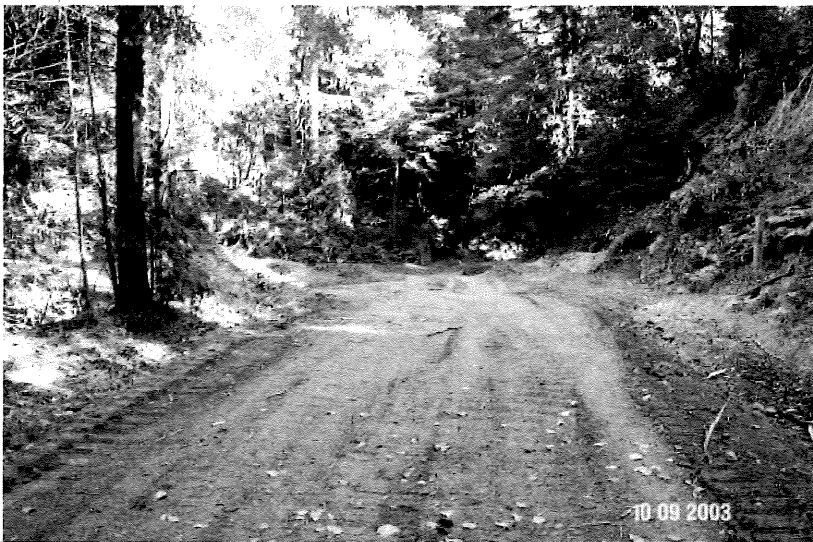
Road Upgrading Photo # 1687
 10/9/03
 Map Pt 1436 Road 80.4 Mi. 0.49
 Other Old 36" New 60"
 PPt Right Dir PW Doty Creek
 THP 271 LNF LNF P01030405A
 PID 0 LWD
 Monitoring 0

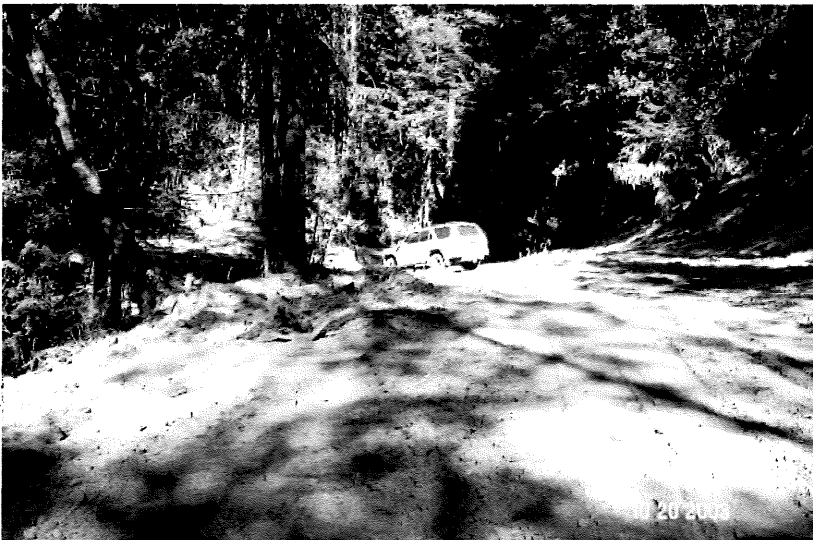
Road Upgrading Photo # 1736
 10/20/03
 Map Pt 1436 Road 80.4 Mi. 0.49
 Other Old 36" New 60"
 PPt Right Dir PW Doty Creek
 THP 271 LNF LNF P01030405A
 PID 0 LWD
 Monitoring 0

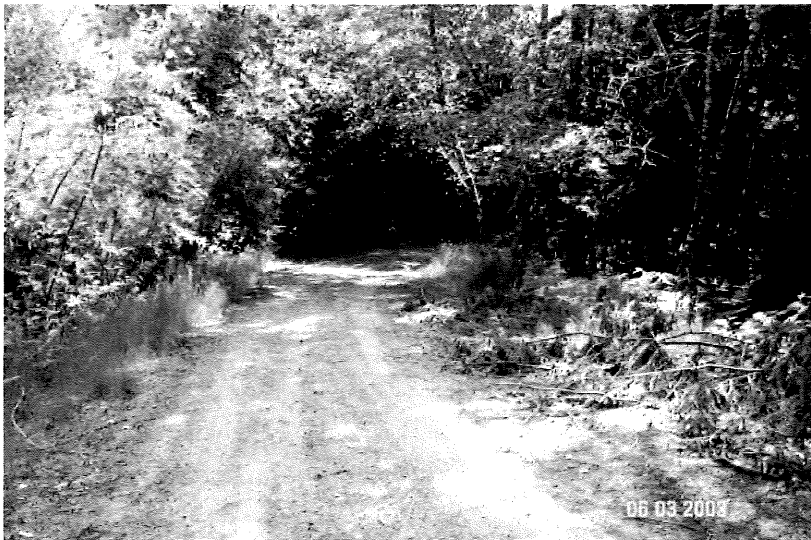
Road Upgrading Photo # 1451
 6/2/03
 Map Pt 1436 Road 80.4 Mi. 0.49
 Other Old 36" New 60"
 PPt Up Dir PW Doty Creek
 THP 271 LNF LNF P01030405A
 PID 0 LWD
 Monitoring 0

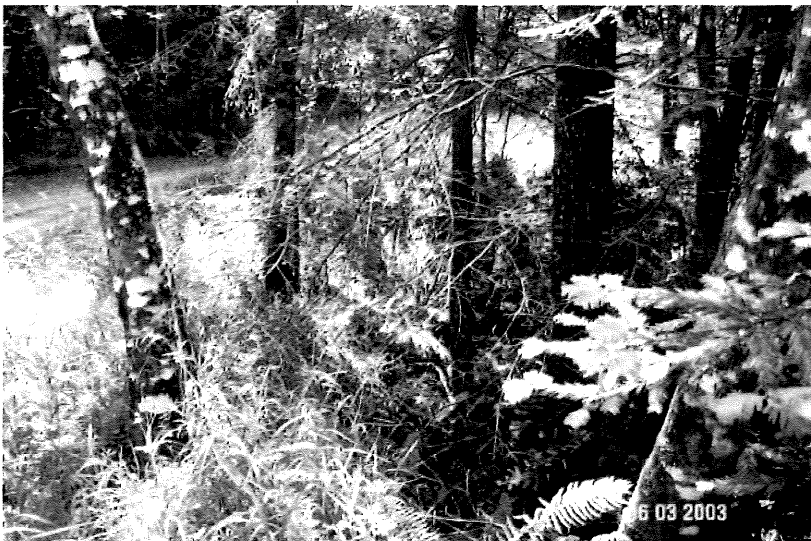
Road Upgrading Photo # 1453
 6/2/03
 Map Pt 1436 Road 80.4 Mi. 0.49
 Other Old 36" New 60"
 PPt Up Dir PW Doty Creek
 THP 271 LNF LNF P01030405A
 PID 0 LWD
 Monitoring 0
 Culvert outlet

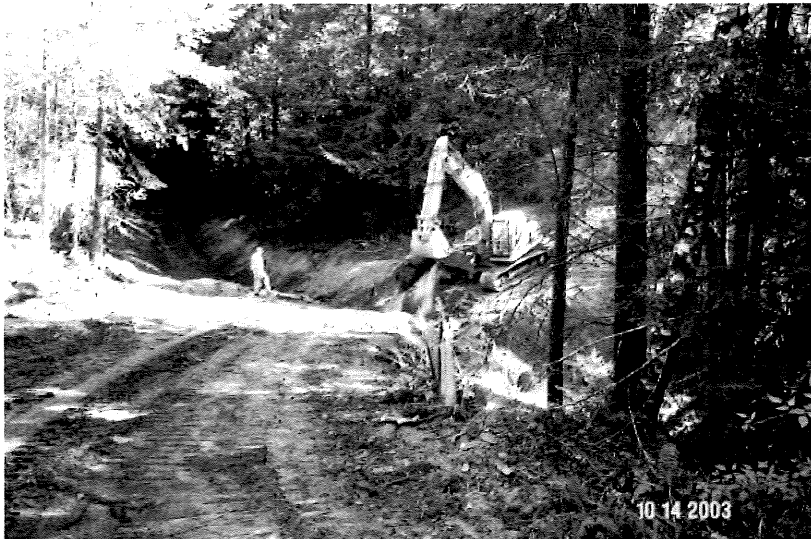
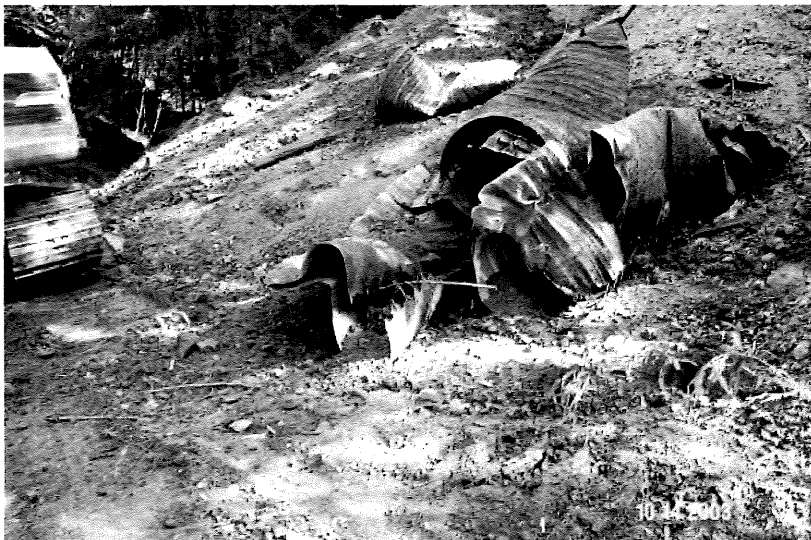
Road Upgrading Photo # 1705
 10/14/03
 Map Pt 1436 Road 80.4 Mi. 0.49
 Other Old 36" New 60"
 PPt Up Dir PW Doty Creek
 THP 271 LNF LNF P01030405A
 PID 0 LWD
 Monitoring 0

Road Upgrading Photo # 1706
 10/14/03
 Map Pt 1436 Road 80.4 Mi. 0.49
 Other Old 36" New 60"
 PPt Up Dir PW Doty Creek
 THP 271 LNF LNF P01030405A
 PID 0 LWD
 Monitoring 0

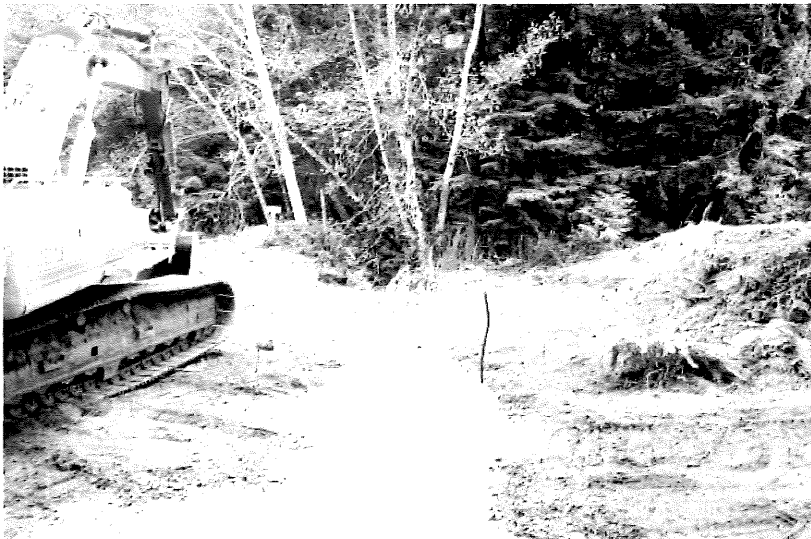
Road Upgrading Photo # 1612
 9/2/03
 Map Pt 1467 Road 80.4 Mi. 1.58
 Bridge - Perm Old 60" New 1Br
 PPt down Dir PW Doty Creek
 THP 271 LNF LNF P01030405A
 PID 0 LWD
 Monitoring 0
 Bridge installation.

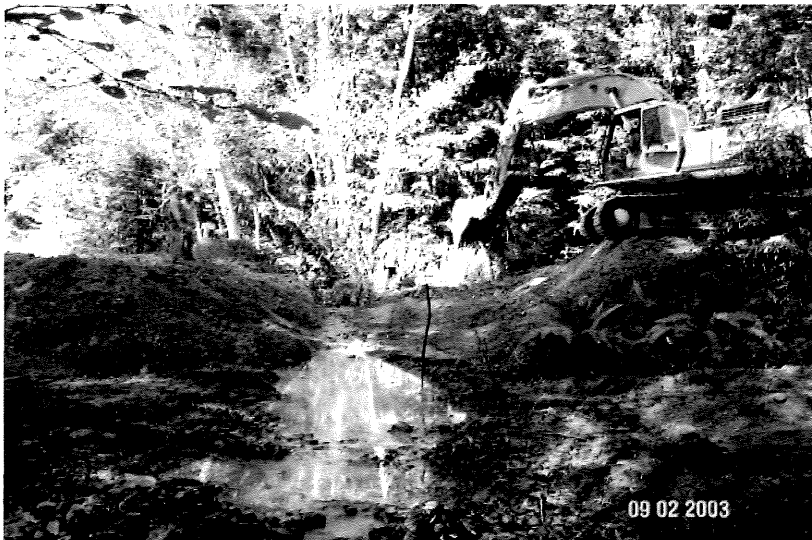
Road Upgrading Photo # 1611
 9/2/03
 Map Pt 1467 Road 80.4 Mi. 1.58
 Bridge - Perm Old 60" New 1Br
 PPt Up Dir PW Doty Creek
 THP 271 LNF LNF P01030405A
 PID 0 LWD
 Monitoring 0
 Bridge installation.

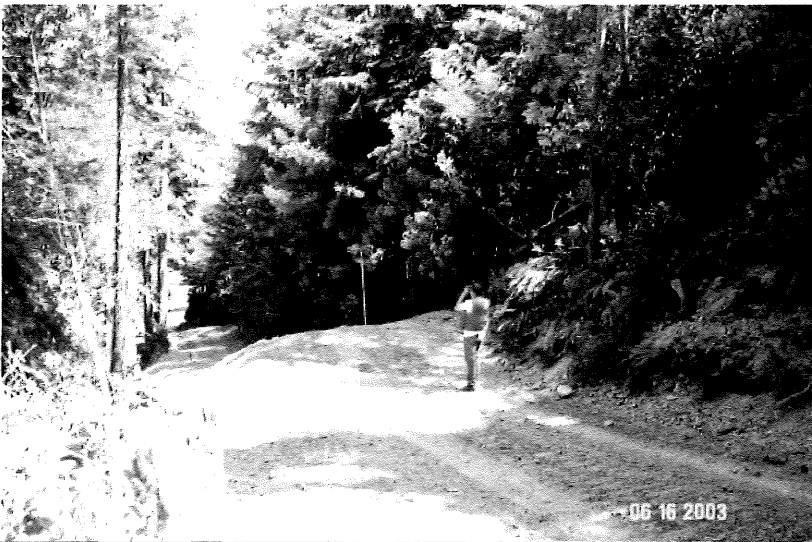
Road Upgrading Photo # 1495
 6/16/03
 Map Pt 0 Road 80.4046 Mi. 0
 Old New
 PPt 0 Dir PW Doty Creek
 THP 271 LNF LNF P01030405A
 PID 0 LWD
 Monitoring 0
 Scott is using a clinometer and a eye hight staff to make sure the dip reverses grade.

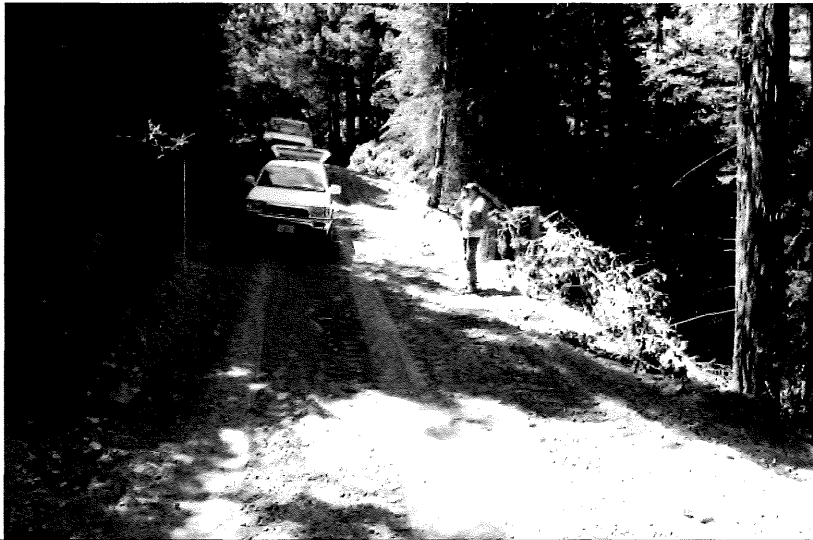
Road Upgrading Photo # 1496
 6/16/03
 Map Pt 0 Road 80.4046 Mi. 0
 Old New
 PPt 0 Dir PW Doty Creek
 THP 271 LNF LNF P01030405A
 PID 0 LWD
 Monitoring 0
 Scott is using a clinometer and a eye hight staff to make sure the road has the proper outslope.

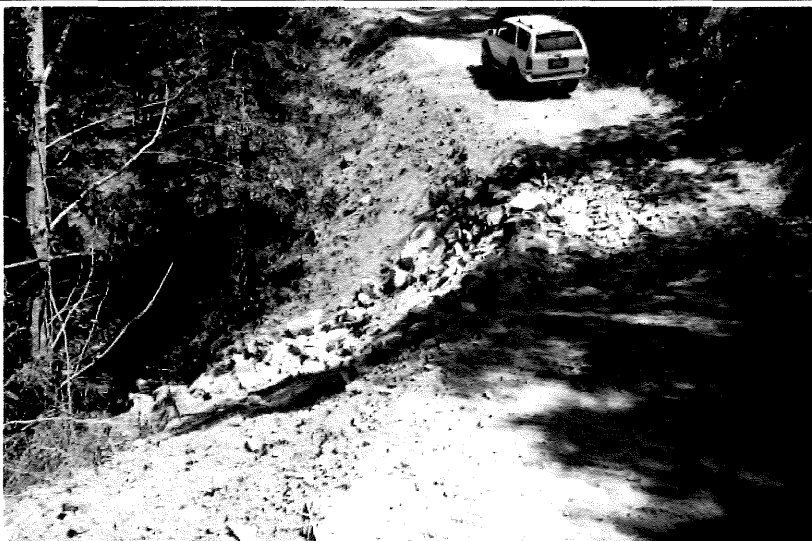
Road Upgrading Photo # 1525
 7/23/03
 Map Pt 1660 Road 80.404652 Mi. 0.04
 Other Old - New -
 PPt 0 Dir PW Doty Creek
 THP 271 LNF LNF P01030405A
 PID 0 LWD
 Monitoring 0
 Signal Ridge site 103 and fill that was pulled back

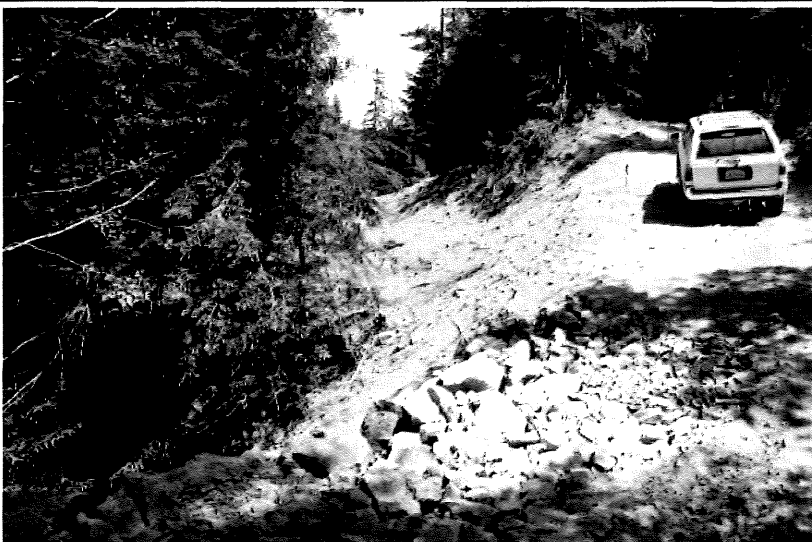
Road Upgrading Photo # 1526
 7/23/03
 Map Pt 1660 Road 80.404652 Mi. 0.04
 Other Old - New -
 PPt 0 Dir PW Doty Creek
 THP 271 LNF LNF P01030405A
 PID 0 LWD
 Monitoring 0
 Signal Ridge site 103 and fill that was pulled back

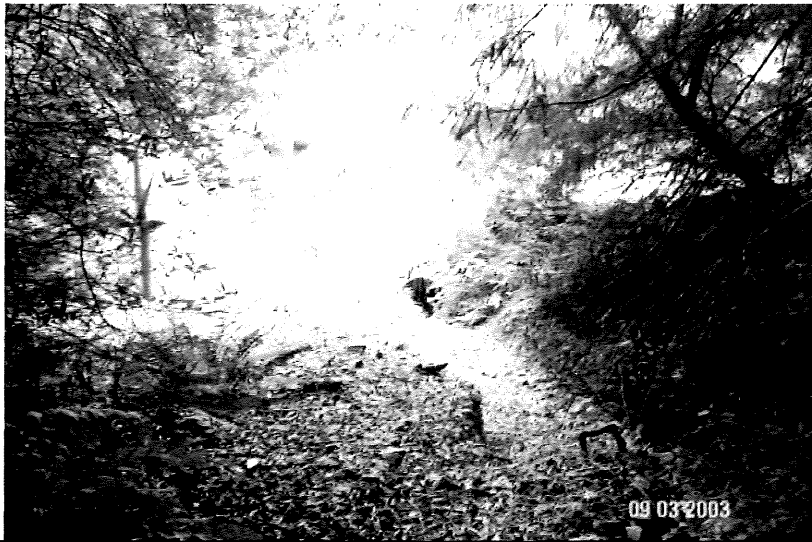
Road Upgrading Photo # 1614
 9/2/03
 Map Pt 1501 Road 80.4051 Mi. 1.310
 Other Old 36" New Pull
 PPt down Dir PW Doty Creek
 THP 271 LNF LNF P01030405A
 PID 0 LWD
 Monitoring 0
 This is the inlet to the upper culvert

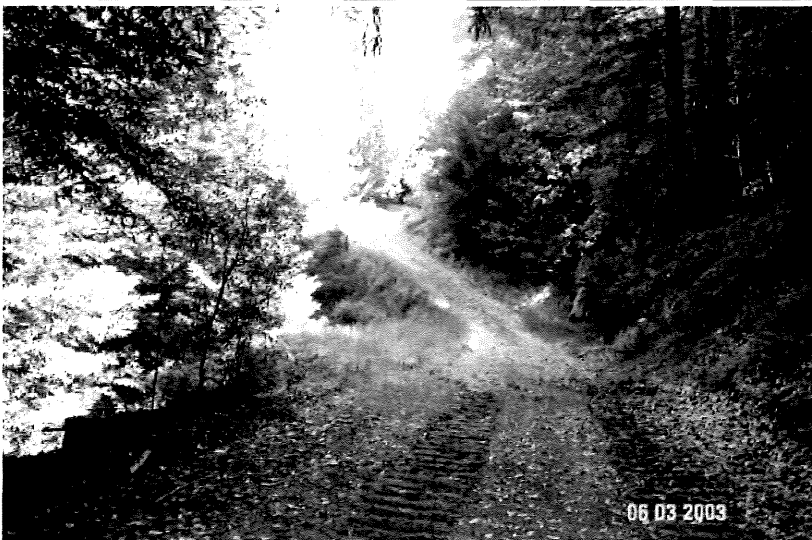
F:\GRI Photos\Small\BigNum\1444 DCP_2522.jpg

Road Upgrading Photo # 1444
 6/2/03
 Map Pt 1462 Road 80.4071 Mi. 1.310
 Other Old 24" New 30"
 PPt Right Dir PW Doty Creek
 THP 271 LNF LNF P01030405A
 PID 0 LWD
 Monitoring 0

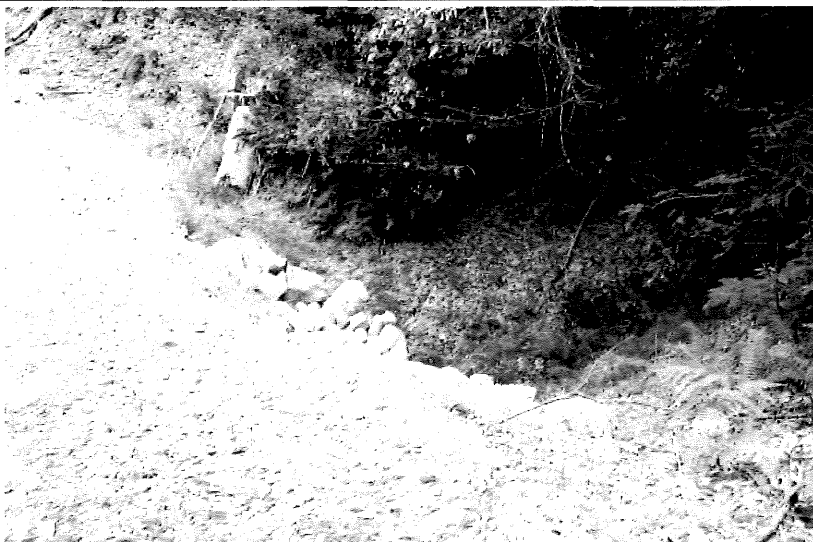
F:\GRI Photos\Small\BigNum\1446 DCP_2524.jpg

Road Upgrading Photo # 1446
 6/2/03
 Map Pt 1462 Road 80.4071 Mi. 1.310
 Other Old 24" New 30"
 PPt Right Dir PW Doty Creek
 THP 271 LNF LNF P01030405A
 PID 0 LWD
 Monitoring 0

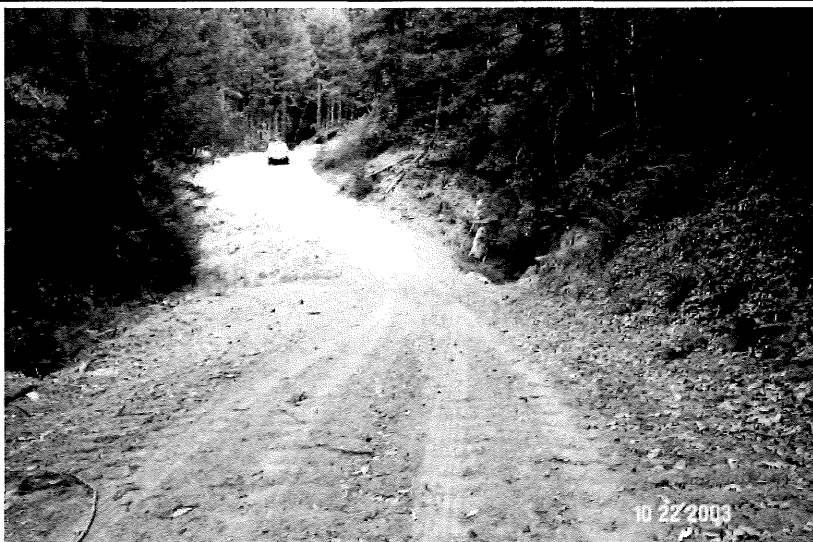
F:\GRI Photos\Small\BigNum\1744 DCP_1512.jpg

Road Upgrading Photo # 1744
 10/22/03
 Map Pt 1462 Road 80.4071 Mi. 1.310
 Other Old 24" New 30"
 PPt Right Dir PW Doty Creek
 THP 271 LNF LNF P01030405A
 PID 0 LWD
 Monitoring 0

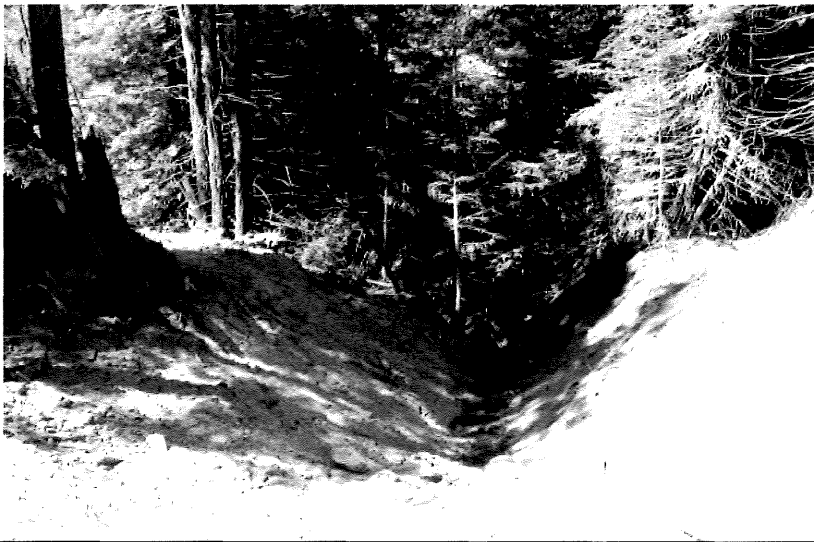
F:\GRI Photos\Small\BigNum\1488 DCP_2590.jpg

Road Upgrading Photo # 1488
 6/16/03
 Map Pt 1463 Road 80.4071 Mi. 1.370
 Other Old 18" New 24"
 PPt down Dir PW Doty Creek
 THP 271 LNF LNF P01030405A
 PID 0 LWD
 Monitoring 0

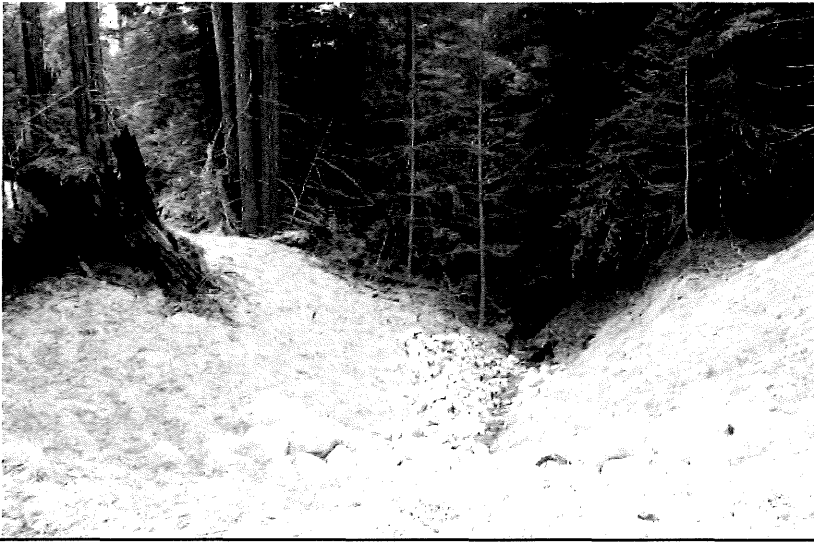
F:\GRI Photos\Small\BigNum\1500 DCP_2609.jpg

Road Upgrading Photo # 1500
 6/24/03
 Map Pt 1463 Road 80.4071 Mi. 1.370
 Other Old 18" New 24"
 PPt down Dir PW Doty Creek
 THP 271 LNF LNF P01030405A
 PID 0 LWD
 Monitoring 0
