MISC. ADDENDUMS

SECTION V INDEX

ESTIMATED SURFACE SOIL EROSION HAZARD

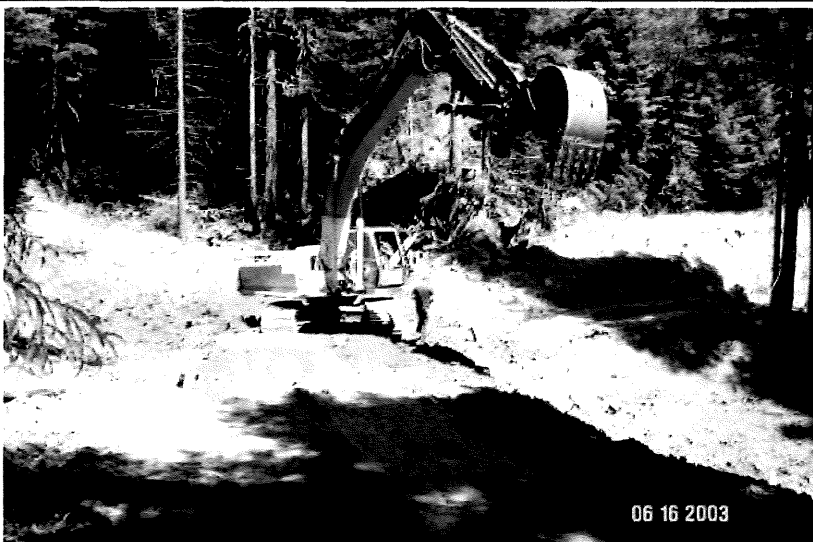
F:\GRI Photos\Small\BigNum\1450 DCP_2528.jpg

Road Upgrading Photo # 1450
 6/2/03
 Map Pt 1463 Road 80.4071 Mi. 1.370
 Other Old 18" New 24"
 PPt left Dir PW Doty Creek
 THP 271 LNF LNF P01030405A
 PID 0 LWD
 Monitoring 0

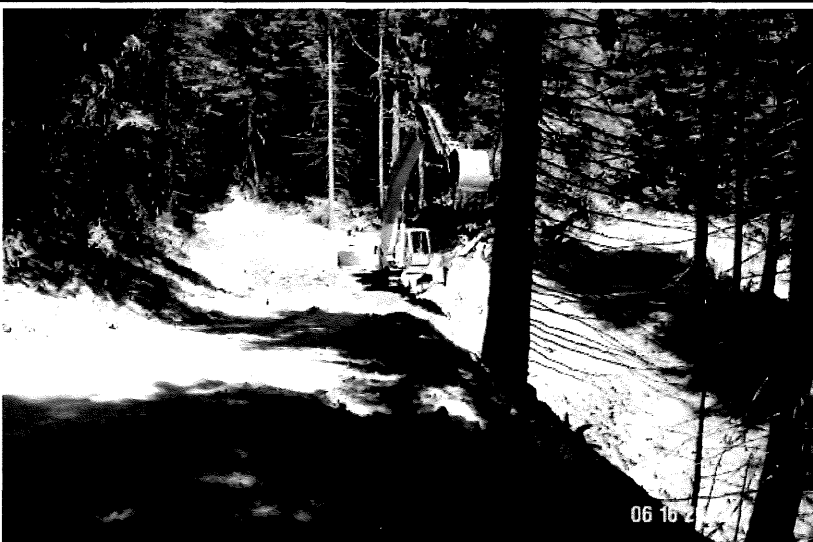
F:\GRI Photos\Small\BigNum\1485 DCP_2587.jpg

Road Upgrading Photo # 1485
 6/16/03
 Map Pt 1463 Road 80.4071 Mi. 1.370
 Other Old 18" New 24"
 PPt left Dir PW Doty Creek
 THP 271 LNF LNF P01030405A
 PID 0 LWD
 Monitoring 0
 Rick is digging our a large old Humboldt.

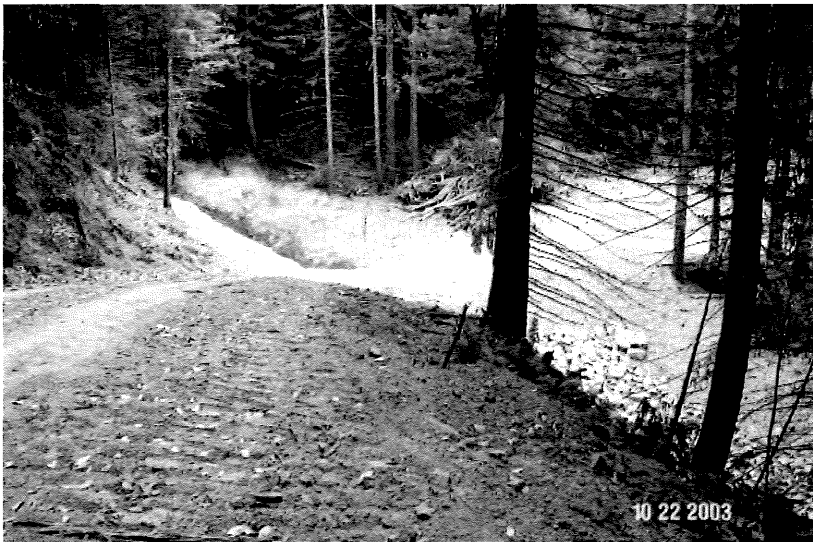
F:\GRI Photos\Small\BigNum\1498 DCP_2604.jpg

Road Upgrading Photo # 1498
 6/24/03
 Map Pt 1463 Road 80.4071 Mi. 1.370
 Other Old 18" New 24"
 PPt left Dir PW Doty Creek
 THP 271 LNF LNF P01030405A
 PID 0 LWD
 Monitoring 0

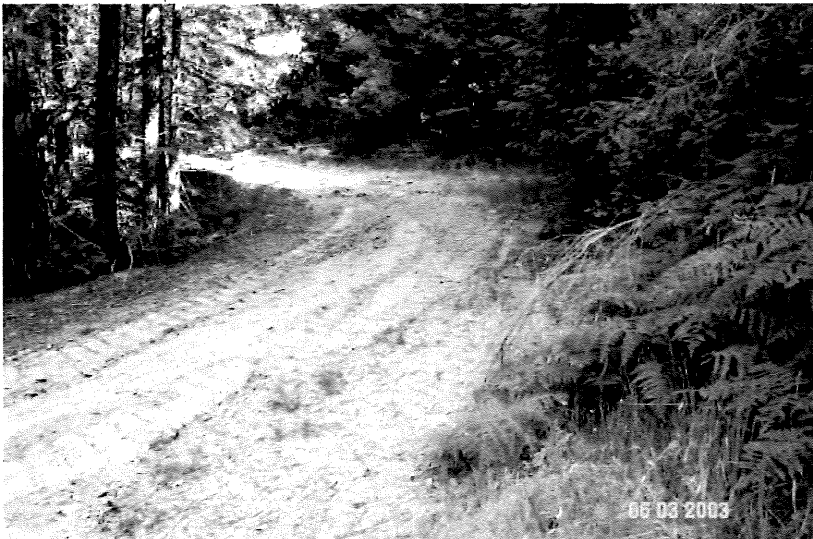
F:\GRI Photos\Small\BigNum\1748 DCP_1517.jpg

Road Upgrading Photo # 1748
 10/22/03
 Map Pt 1463 Road 80.4071 Mi. 1.370
 Other Old 18" New 24"
 PPt left Dir PW Doty Creek
 THP 271 LNF LNF P01030405A
 PID 0 LWD
 Monitoring 0

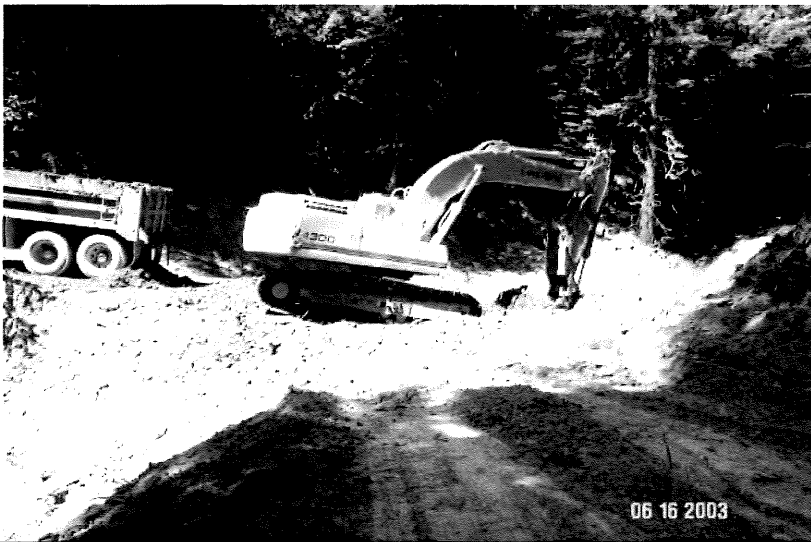
Road Upgrading Photo # 1489
 6/16/03
 Map Pt 1463 Road 80.4071 Mi. 1.370
 Other Old 18" New 24"
 PPt Right Dir PW Doty Creek
 THP 271 LNF LNF P01030405A
 PID 0 LWD
 Monitoring 0

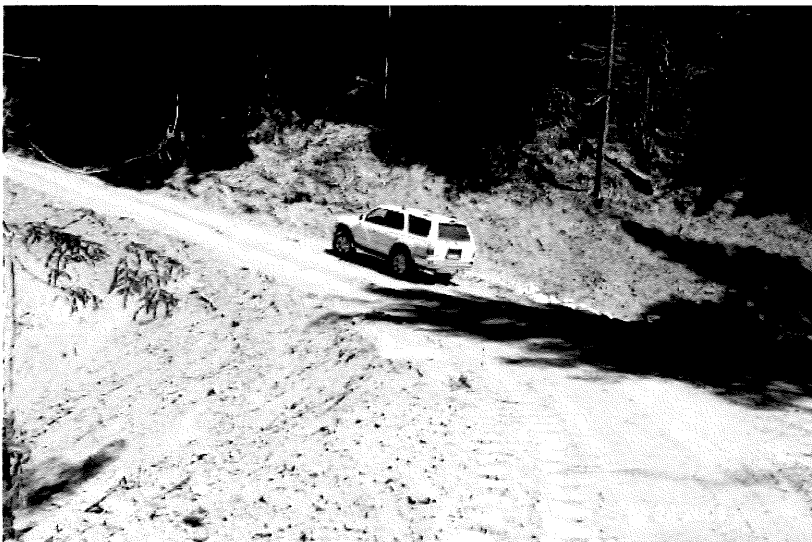
F:\GRI Photos\Small\BigNum\1491 DCP_2594.jpg

Road Upgrading Photo # 1491
 6/16/03
 Map Pt 1463 Road 80.4071 Mi. 1.370
 Other Old 18" New 24"
 PPt Right Dir PW Doty Creek
 THP 271 LNF LNF P01030405A
 PID 0 LWD
 Monitoring 0

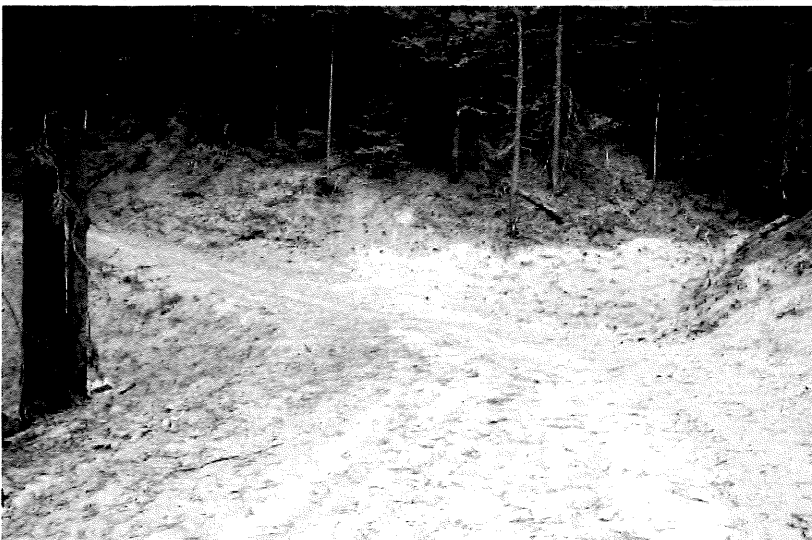
F:\GRI Photos\Small\BigNum\1499 DCP_2606.jpg

Road Upgrading Photo # 1499
 6/24/03
 Map Pt 1463 Road 80.4071 Mi. 1.370
 Other Old 18" New 24"
 PPt Right Dir PW Doty Creek
 THP 271 LNF LNF P01030405A
 PID 0 LWD
 Monitoring 0

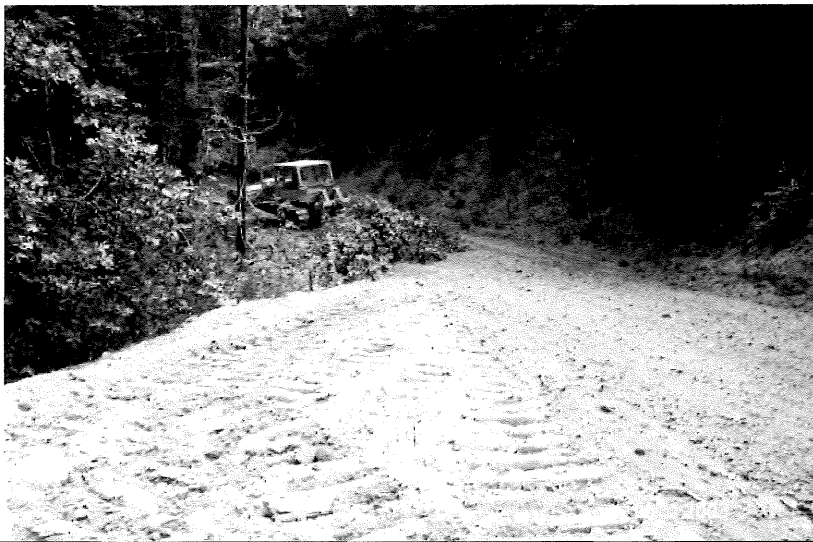
F:\GRI Photos\Small\BigNum\1481 DCP_2573.jpg

Road Upgrading Photo # 1481
 6/11/03
 Map Pt 0 Road 80.4071 Mi. 2
 Old New
 PPt 0 Dir PW Doty Creek
 THP 271 LNF LNF P01030405A
 PID 0 LWD
 Monitoring 0
 Knocking off small berm and smoothing the road.

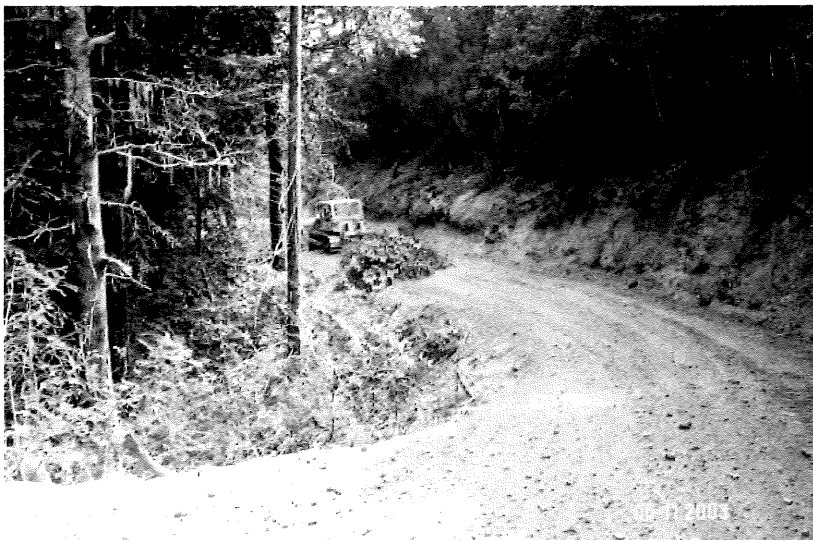
F:\GRI Photos\Small\BigNum\1482 DCP_2578.jpg

Road Upgrading Photo # 1482
 6/11/03
 Map Pt 0 Road 80.4071 Mi. 2
 Old New
 PPt 0 Dir PW Doty Creek
 THP 271 LNF LNF P01030405A
 PID 0 LWD
 Monitoring 0
 Knocking off small berm and smoothing the road.

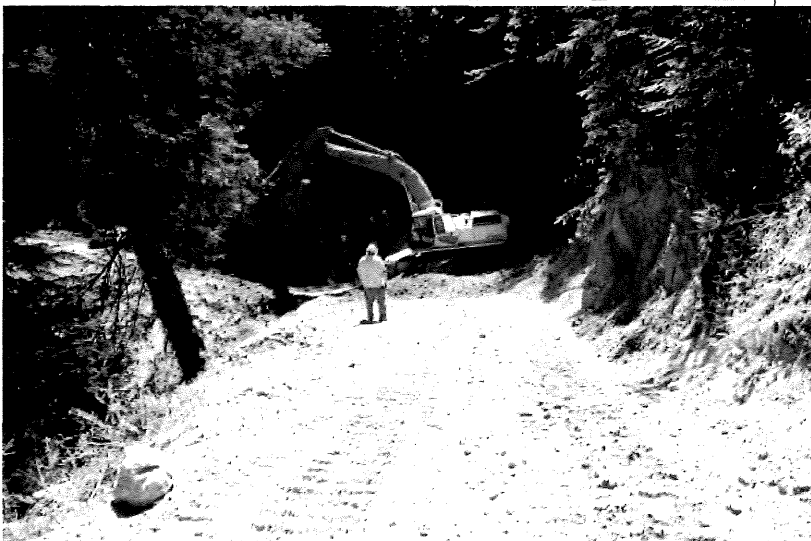
F:\GRI Photos\Small\BigNum\1518 DCP_1186.jpg

Road Upgrading Photo # 1518
 7/21/03
 Map Pt 1476 Road 80.4071 Mi. 2.3
 Other Old - New 36"
 PPt 0 Dir PW Doty Creek
 THP 271 LNF LNF P01030405A
 PID 0 LWD
 Monitoring 0

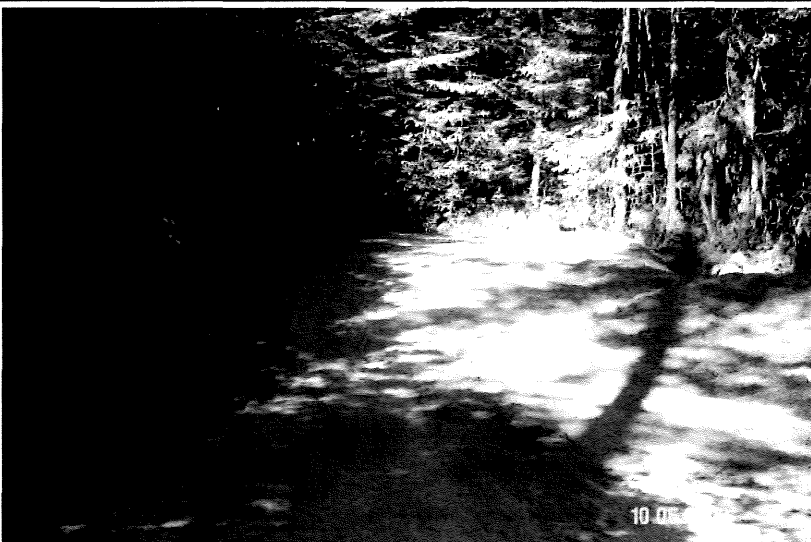
F:\GRI Photos\Small\BigNum\1501 DCP_2612.jpg

Road Upgrading Photo # 1501
 6/23/03
 Map Pt 1476 Road 80.4071 Mi. 2.3
 Other Old - New 36"
 PPt Right Dir PW Doty Creek
 THP 271 LNF LNF P01030405A
 PID 0 LWD
 Monitoring 0
