Steam Donkey Timber Harvest Plan

Section V

Steam Donkey THP
Soils Map

Erosion Control Plan

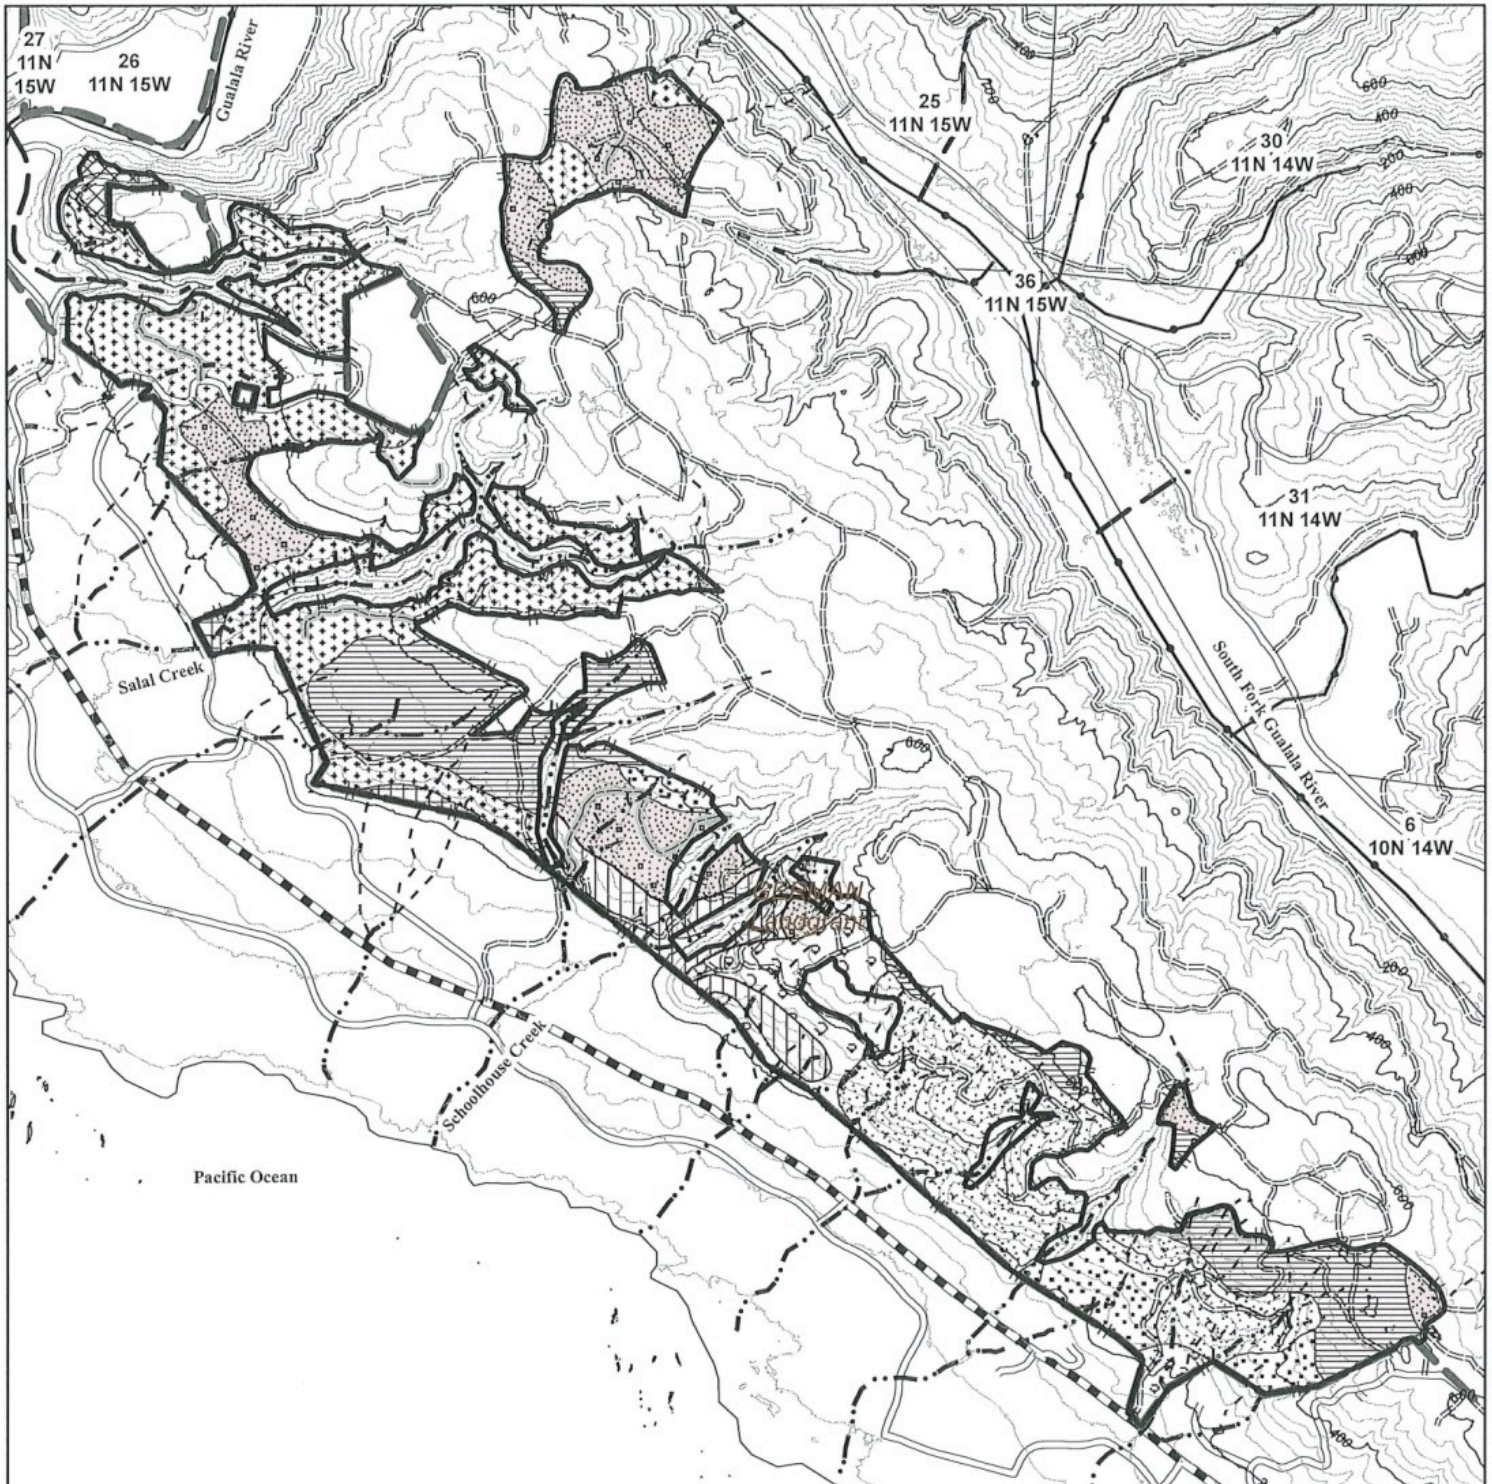
Soils
 Caspar sandy loam, 15 to 30 percent slopes
 Caspar sandy loam, 30 to 50 percent slopes
 Empire loam, 30 to 50 percent slopes
 Hely silt loam, 30 to 50 percent slopes
 Hugo loam, 30 to 50 percent slopes
 Mendocino sandy clay loam, 30 to 50 percent slopes
 Josephine loam, 50 to 75 percent slopes
 Noyo coarse sandy loam, 0 to 15 percent slopes
 Kneeland loam, 9 to 15 percent slopes
 Rohnerville loam, 9 to 15 percent slopes

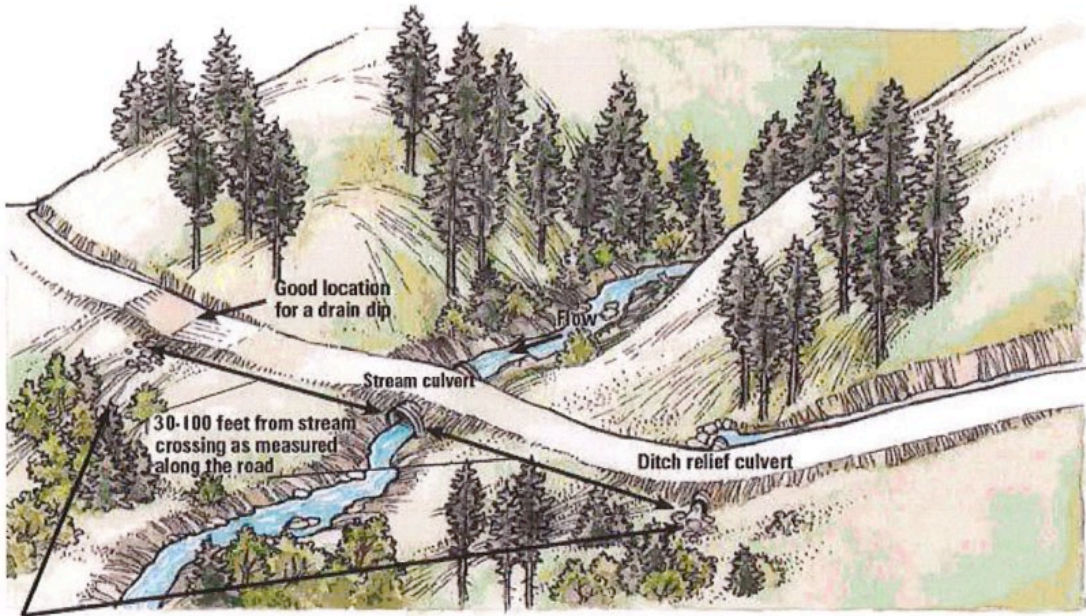
Ditch drainage should be directed into vegetation and undisturbed soil filter, and not allowed to continue flowing down the ditch and into the stream.

Figure 1. Diagram showing implementation of road drainage disconnection facilities/structures to limit sediment delivery into a watercourse. Note the absence of an apparent critical dip at the crossing. (modified from Oregon Forest Resources Institute 2011, 2nd Ed., used with permission).

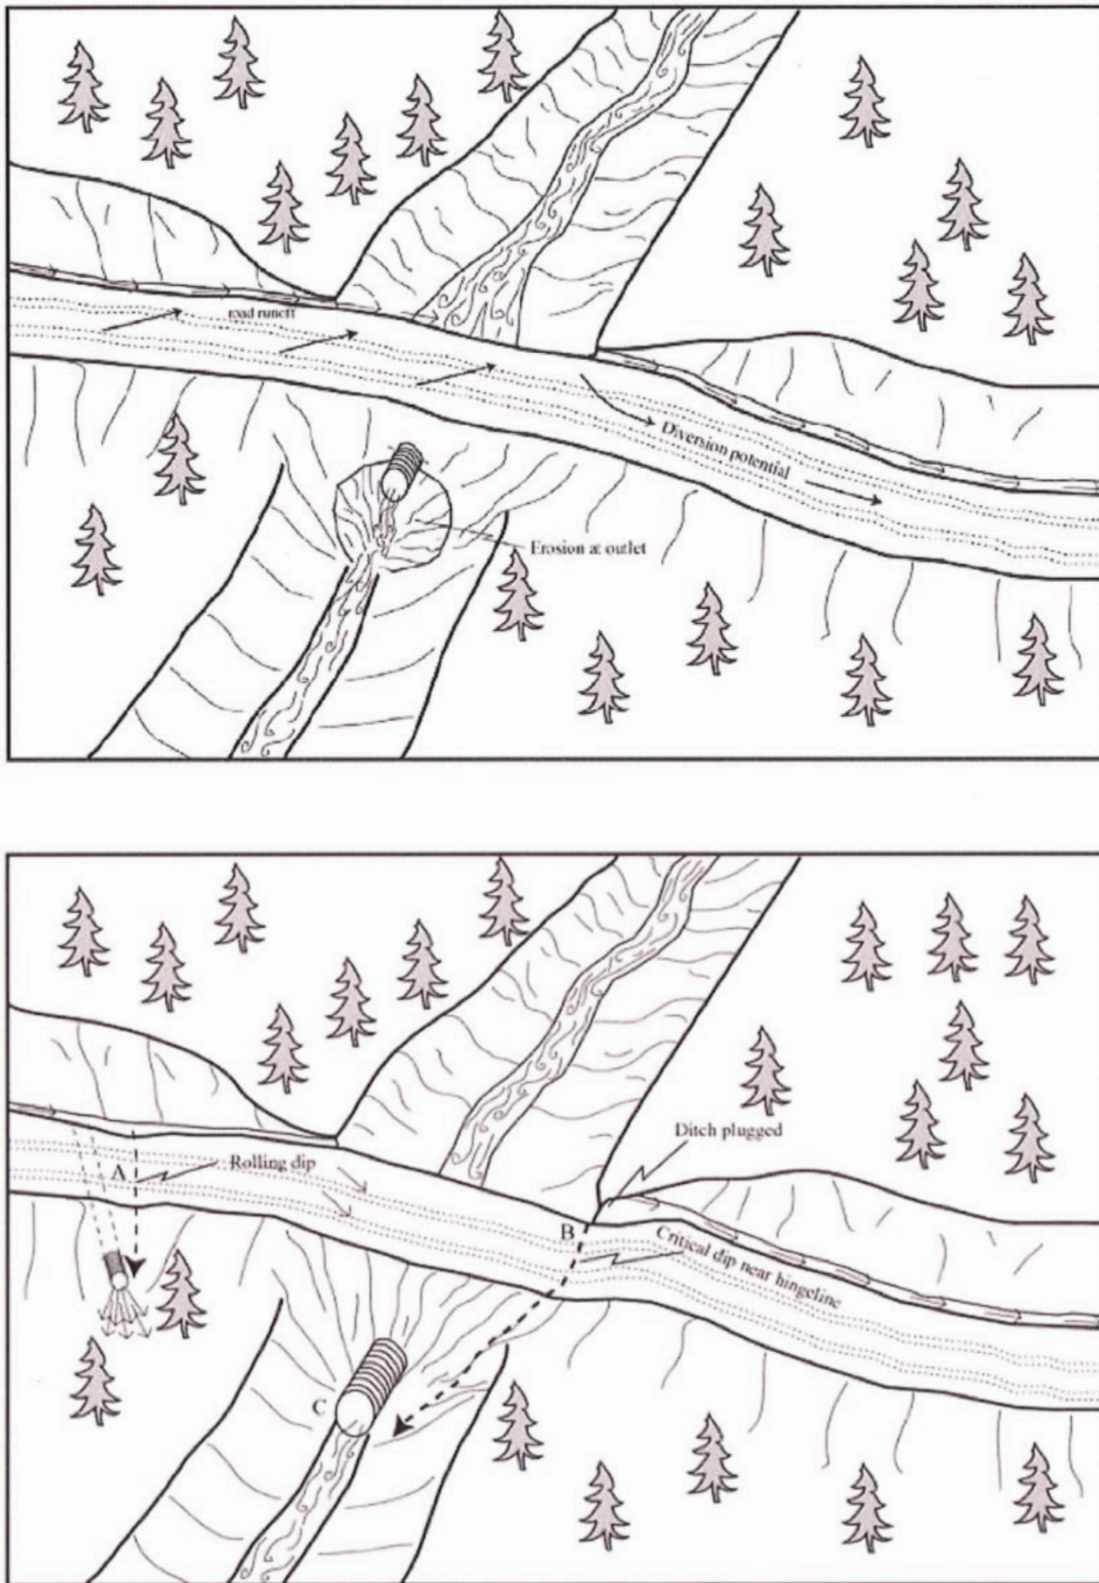
Point G.1 Critical Dip Installation

Figure 2. Illustration of a critical dip installed at a watercourse crossing to remove diversion potential (from DFG 2006). The critical dip should be constructed at the point where the potential for erosion and the loss of fill is minimized.
