**REPORT on the
GEOLOGIC and GEOMORPHIC
CHARACTERISTICS of the
GUALALA RIVER WATERSHED,
CALIFORNIA**

Michael Fuller (CEG) and Kit Custis (CEG, CHG)

December 2002

Prepared in cooperation with the
CALIFORNIA RESOURCES AGENCY'S
NORTH COAST WATERSHED ASSESSMENT PROGRAM

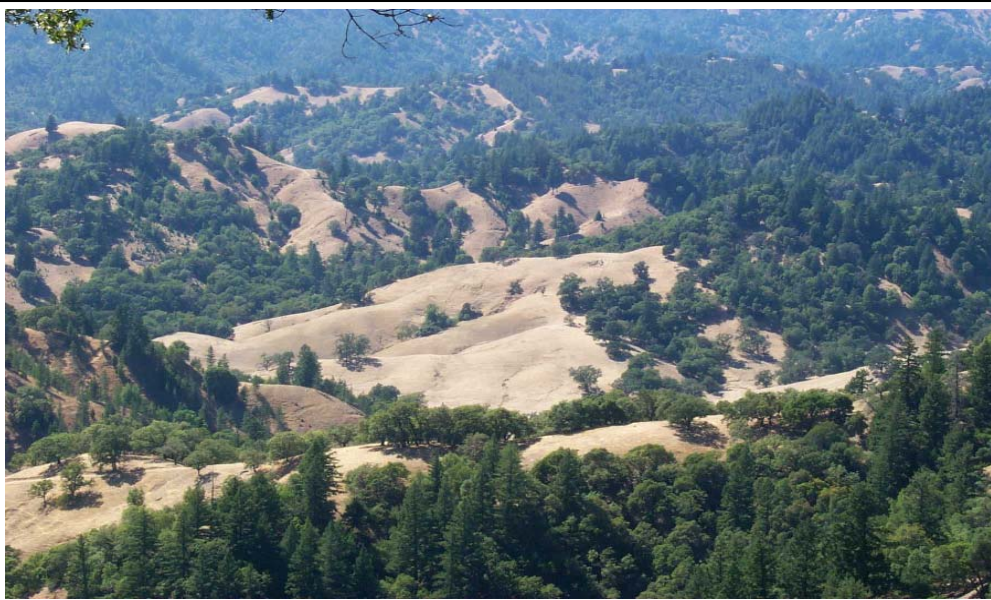
Figure 12: Photo from Oak Mountain showing typical topography of the Southern subdivision. Note hummocky slopes, gullies, and earthflows.

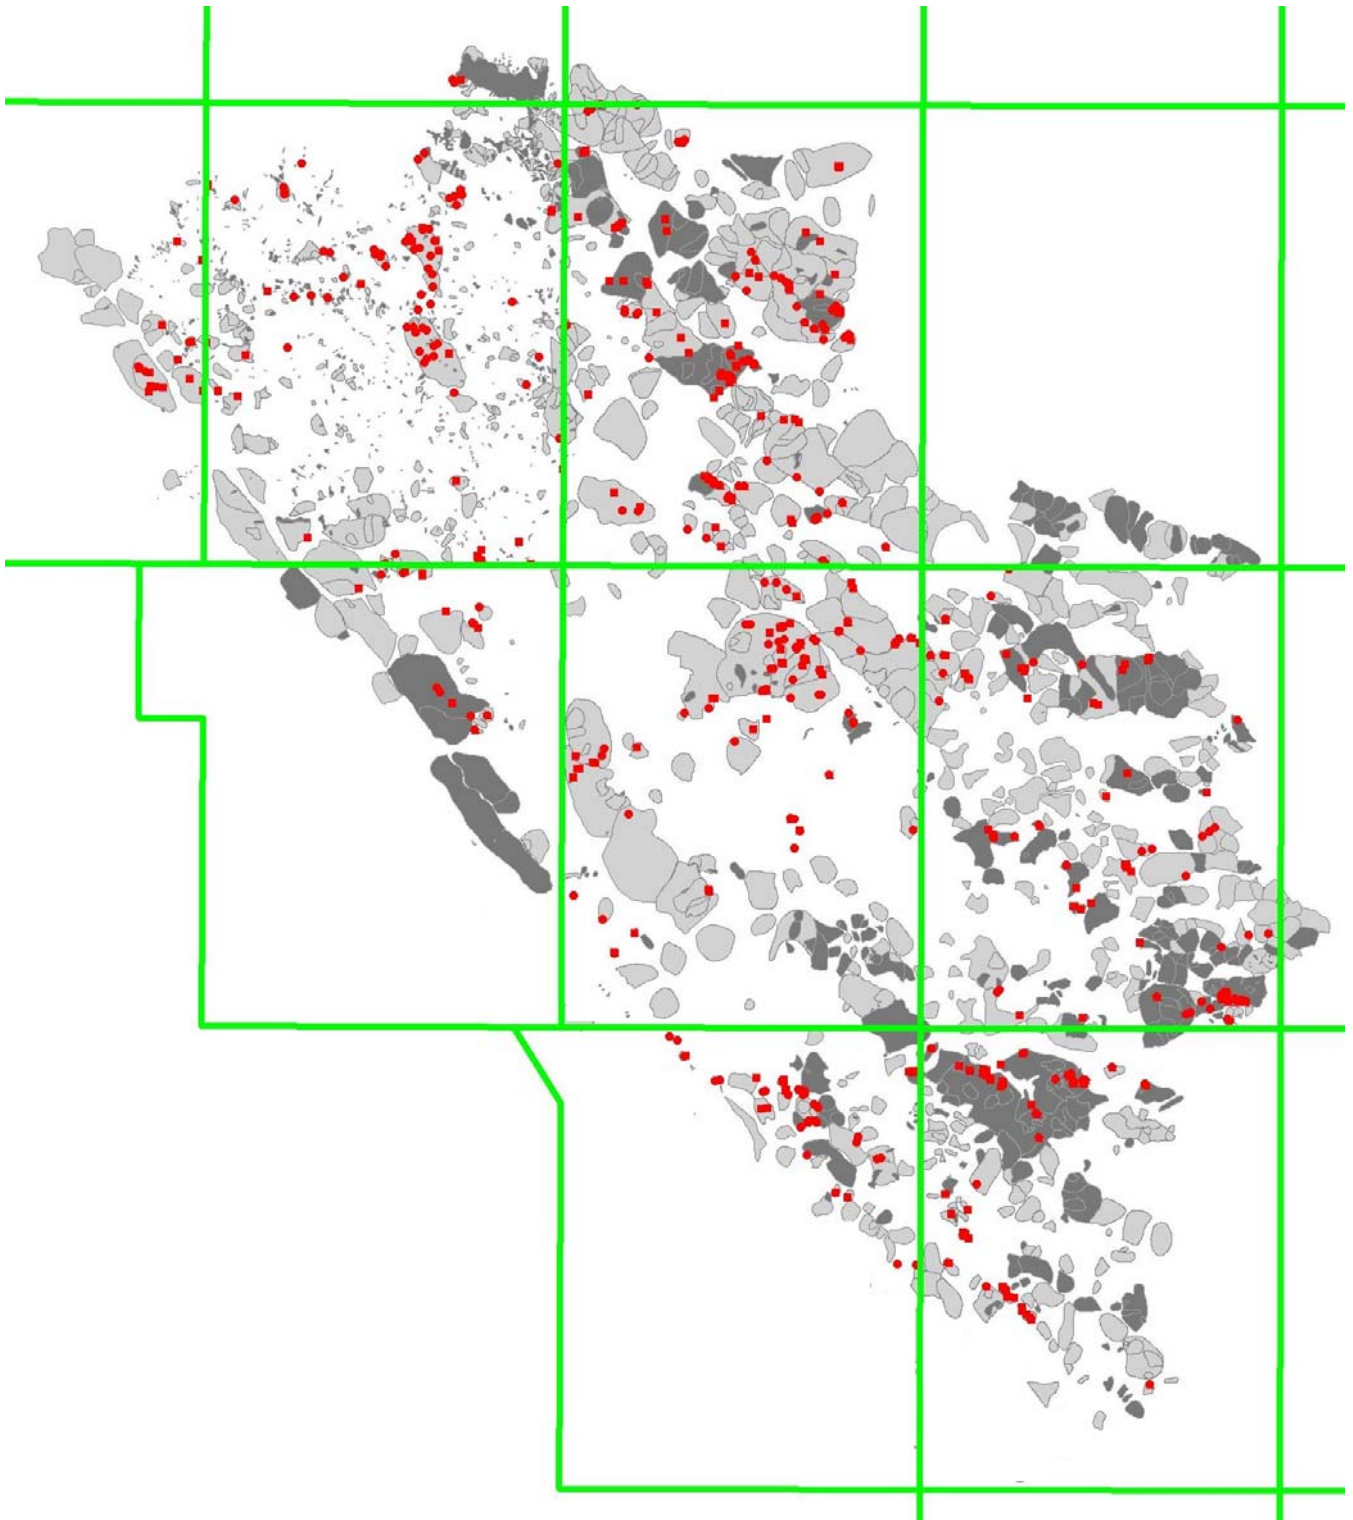
Figure 25. Gualala River watershed showing the 552 of 2190 (25%) mapped shallow point slides that lie within an active or dormant deep seated landslide. The additional 872 point slides (40%) that lie on debris slide slopes are also shown. Light gray polygons are dormant and dark gray are active deep seated landslides. For clarity, the debris slide slope polygons are not shown on this figure. Green grid is USGS topographic 7-1/2 minute boundaries.

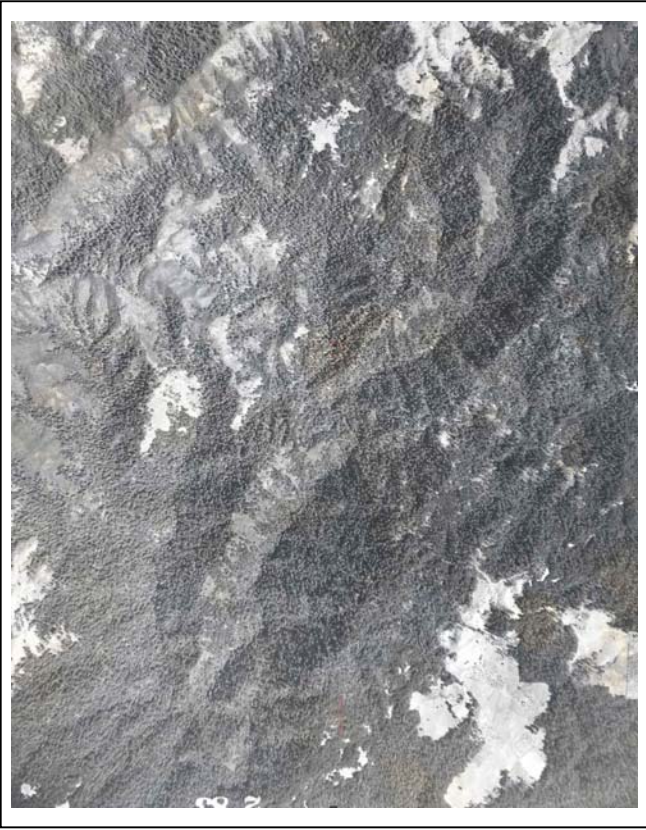
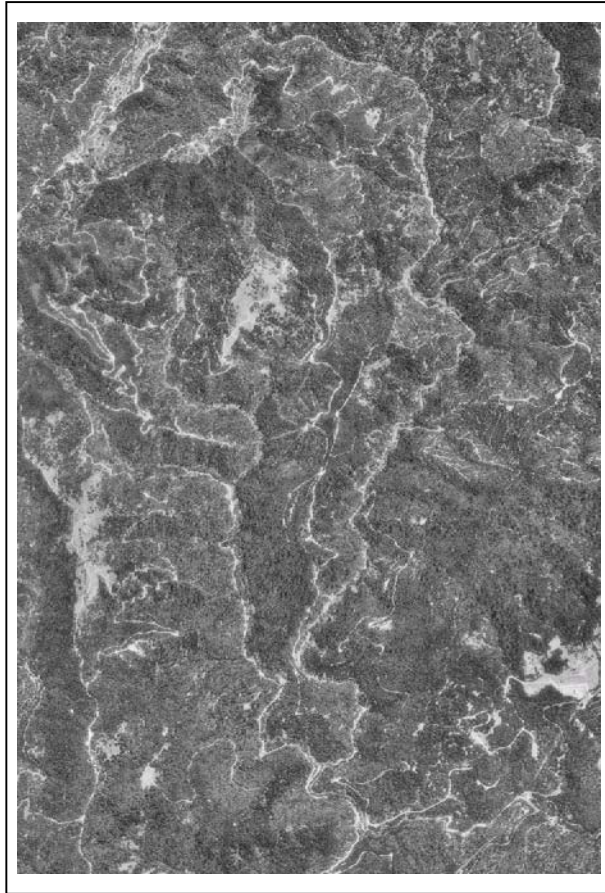
Upper Fuller Creek watershed in 1942 and 1993

Comparison shows a persistent elevation in landslide activity. According to CDF photoanalysis, landsliding increased shortly after tractor logging on these steep slopes.

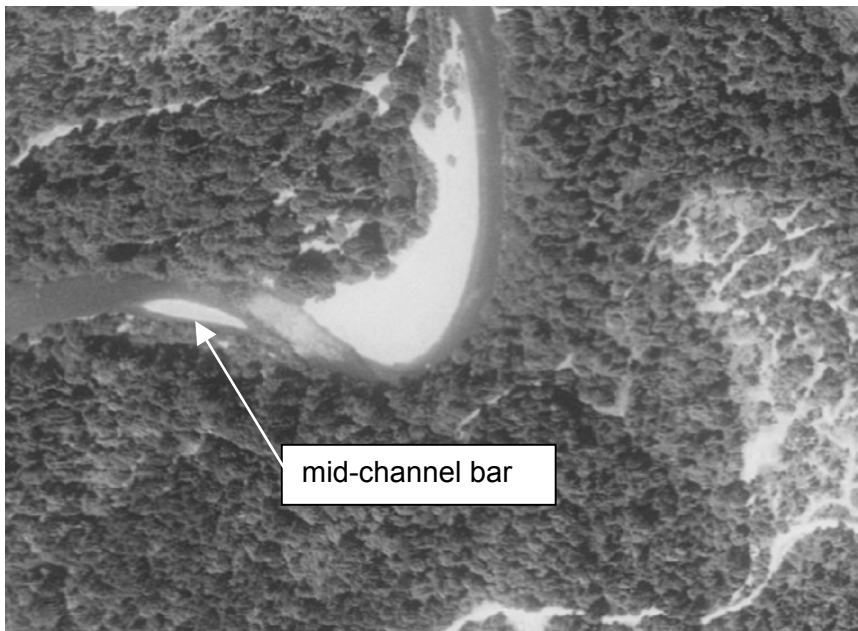
Bar at junction of channels (jb) – characteristic is mapped when a bar develops at the mouth of tributary stream. This bar may be within main or tributary channel. This characteristic is considered detrimental to optimum habitat for anadromous salmonids because these bars generally indicate excess sediment and they can block fish passage at low flows.

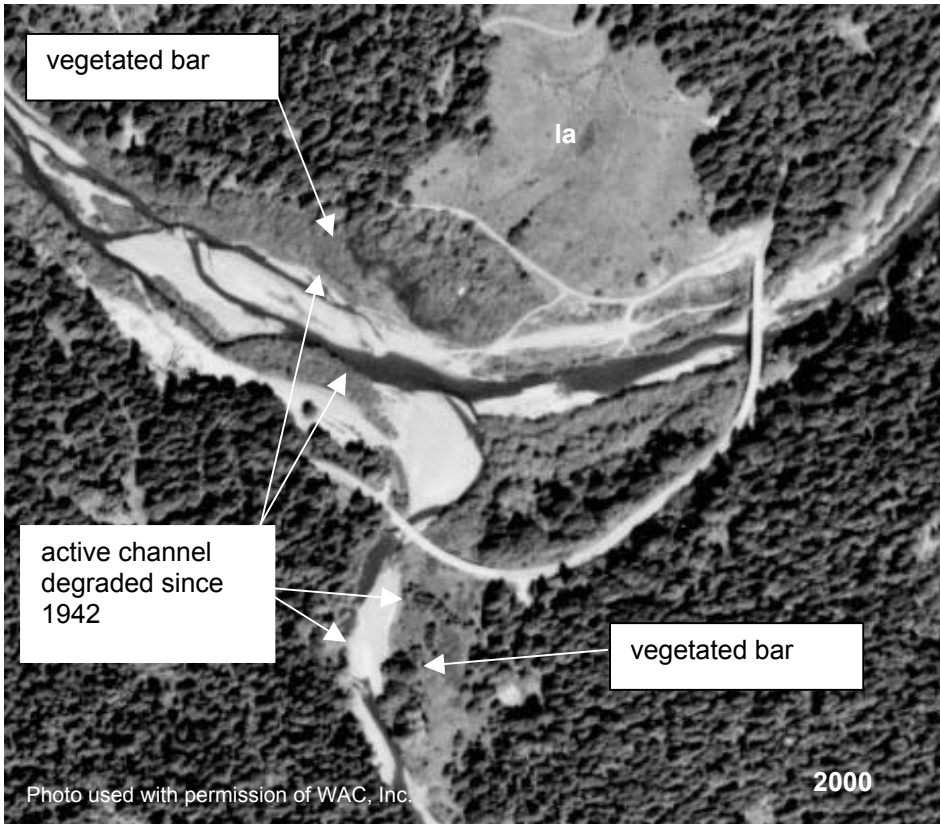
INCISED (IN) – CHARACTERISTIC IS MAPPED WHEN ONE OR BOTH BANKS OF A CHANNEL HAVE ERODED VERTICALLY SUCH THAT THE ACTIVE CHANNEL IS ENTRENCHED. BECAUSE OF THE RECONNAISSANCE SCALE OF AERIAL PHOTOS, HEIGHT OF THE VERTICAL BANK MUST BE SUFFICIENT AND THE SUN ANGLE APPROPRIATE TO CAST A OBSERVABLE SHADOW. THIS CHARACTERISTIC MAY OR MAY NOT BE DETRIMENTAL TO OPTIMUM HABITAT FOR ANADROMOUS SALMONIDS.

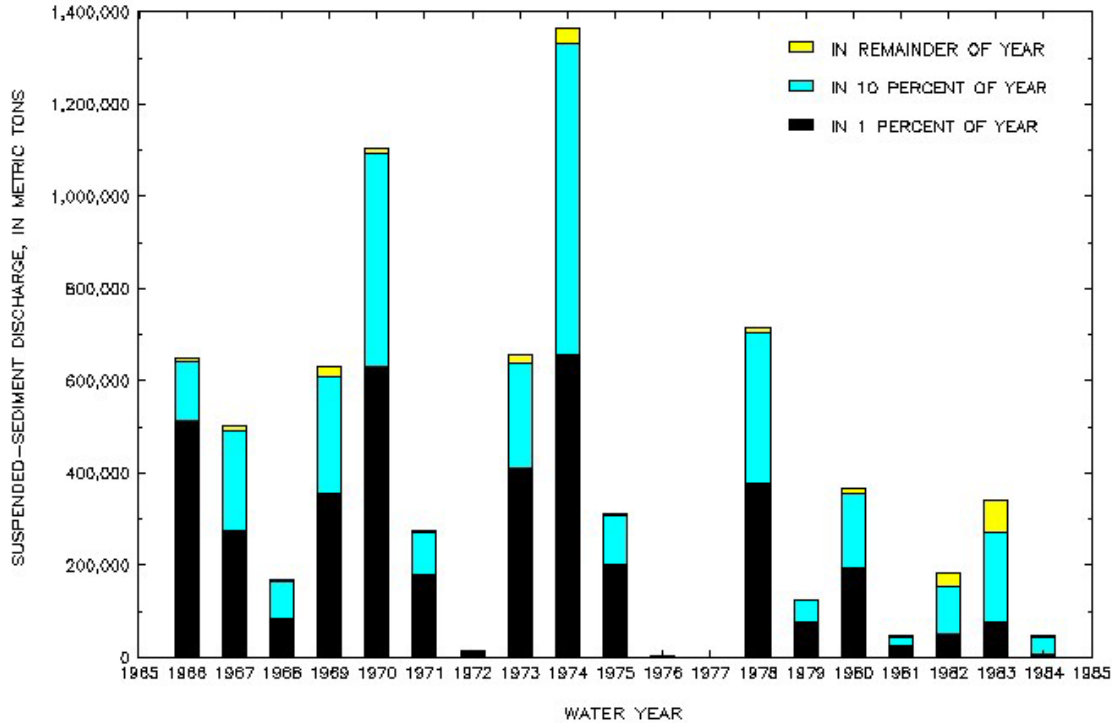
Figure 1. Histogram of suspended-sediment discharge at USGS gage 11465200, Dry Creek from 1966 to 1984. Web source:<http://co.water.usgs.gov/sediment/>.
