LAND USE HISTORY OF THE GUALALA WATERSHED

**BY
DONALD MORSE RPF 2158
CALIFORNIA DEPARTMENT OF FORESTRY AND FIRE PROTECTION**

**PREPARED IN COOPERATION WITH THE CALIFORNIA RESOURCES AGENCY'S
NORTH COAST WATERSHED ASSESSMENT PROGRAM**

APPENDIX 3: LAND USE HISTORY OF THE GUALALA WATERSHED

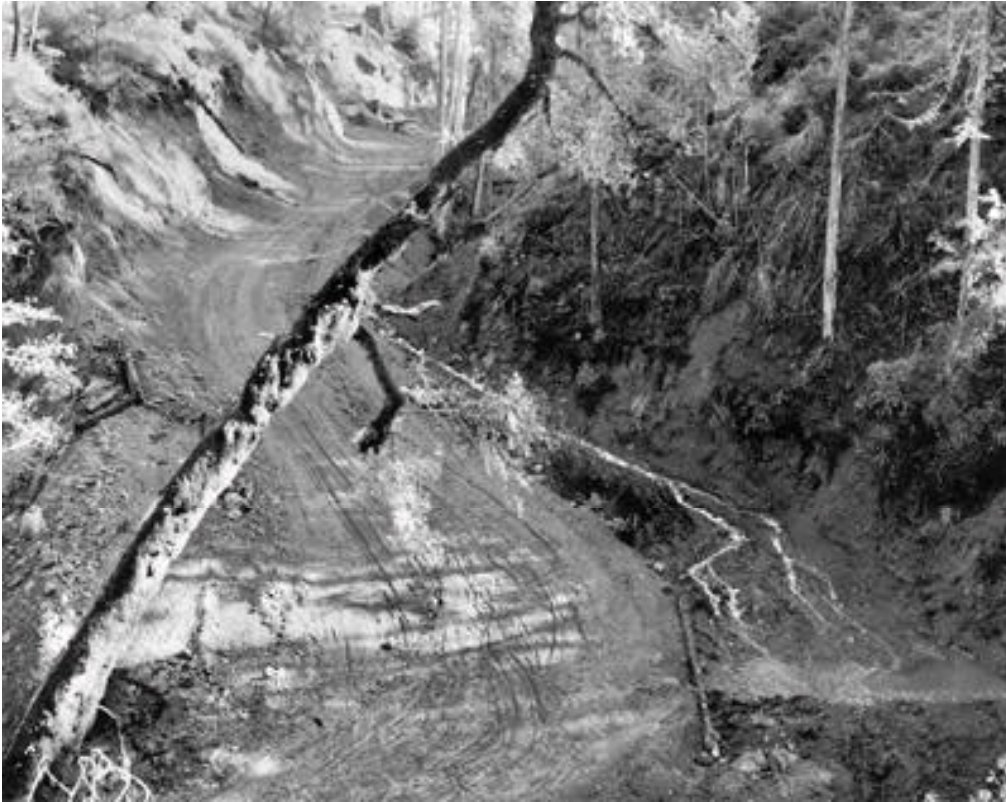
Photo Inset On Title Page: A road following the streambed, November 21, 1955, forcing the creek to flow under the road (center) and then across the road sidecast (right).

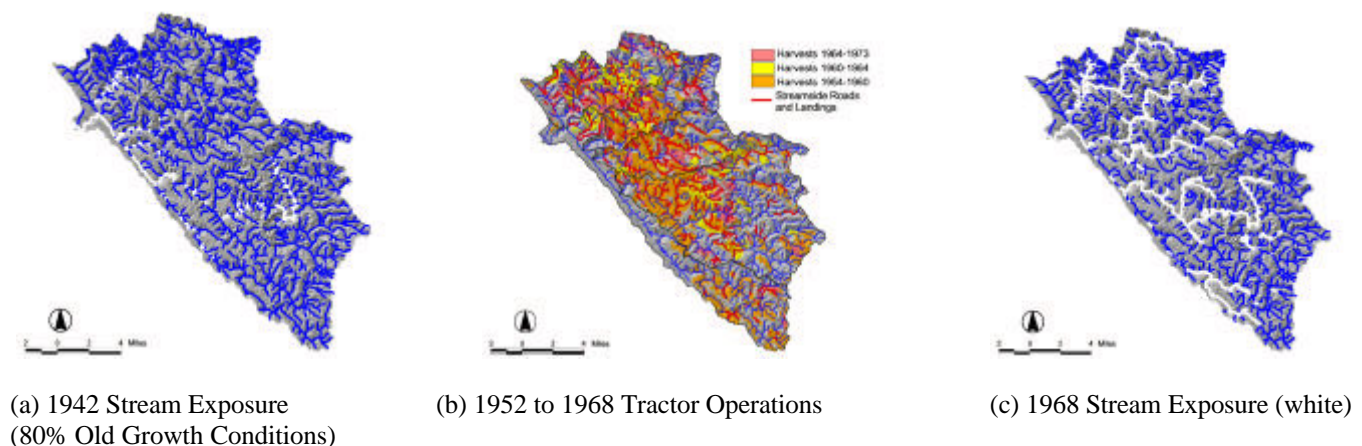
Figure 1: Overstory riparian shade canopy elimination throughout the Gualala Watershed by 1968

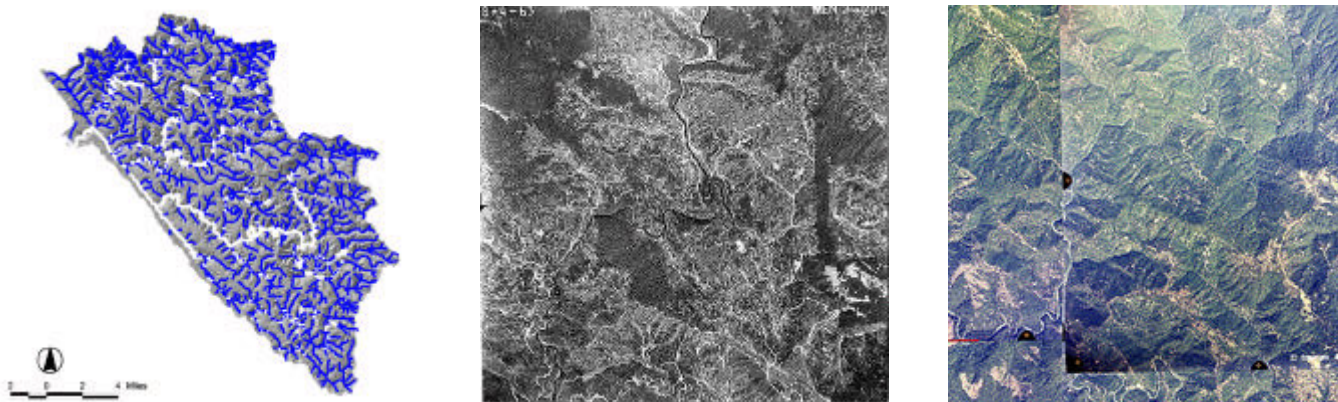
Figure 2: (a) 1999/ 2000 stream exposure (white) (b) Central Rockpile Subbasin 1963 (c) Central Rockpile Subbasin 1999

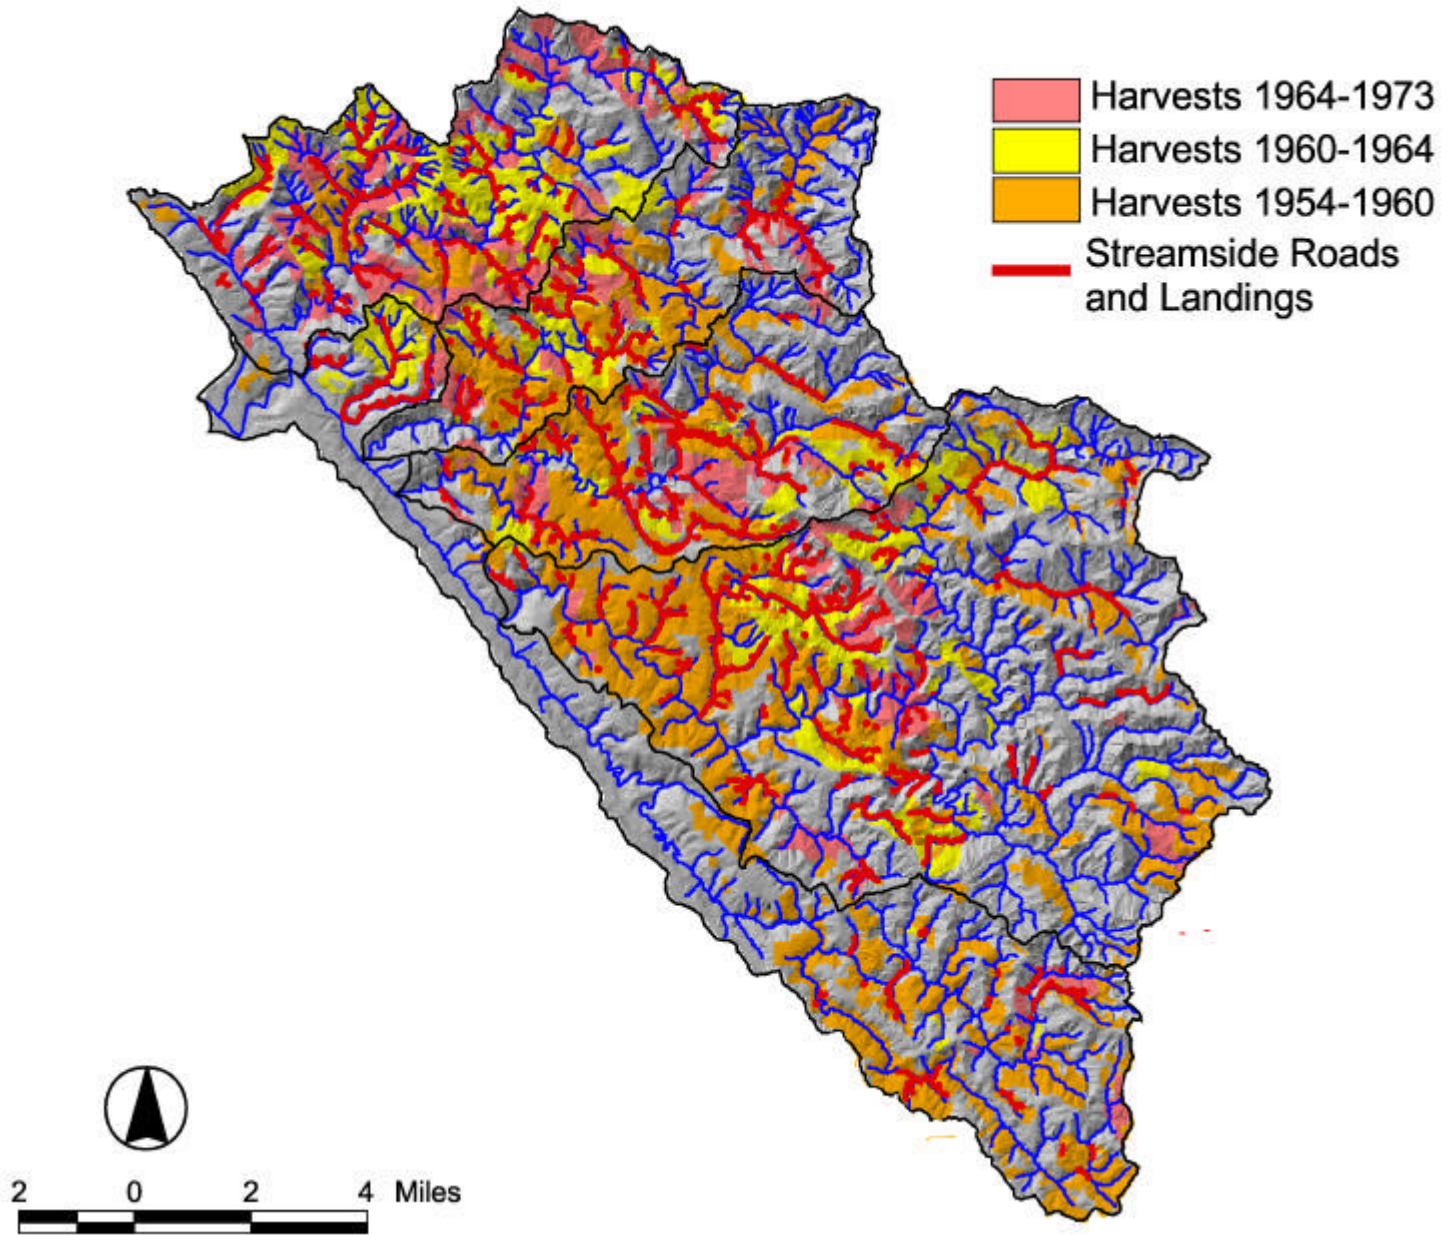
Figure 5: Streamside Roads and Landings 1968. Red lines show where the road or landing (circles) are built either in or immediately adjacent to the stream channel. Road fill has been pushed over the streambank into the watercourse at these locations.

Modern roads cross streams at a perpendicular rather than following the stream to one side. This makes modern road sediment inputs more related to the immediate road watercourse crossing sites and road approaches to streams. Historic roads following the creek are prone to failure where streambanks underlying the road collapse during storms as a function of fluvial velocity, steepness, and geologic instabilities (see Figure 5).

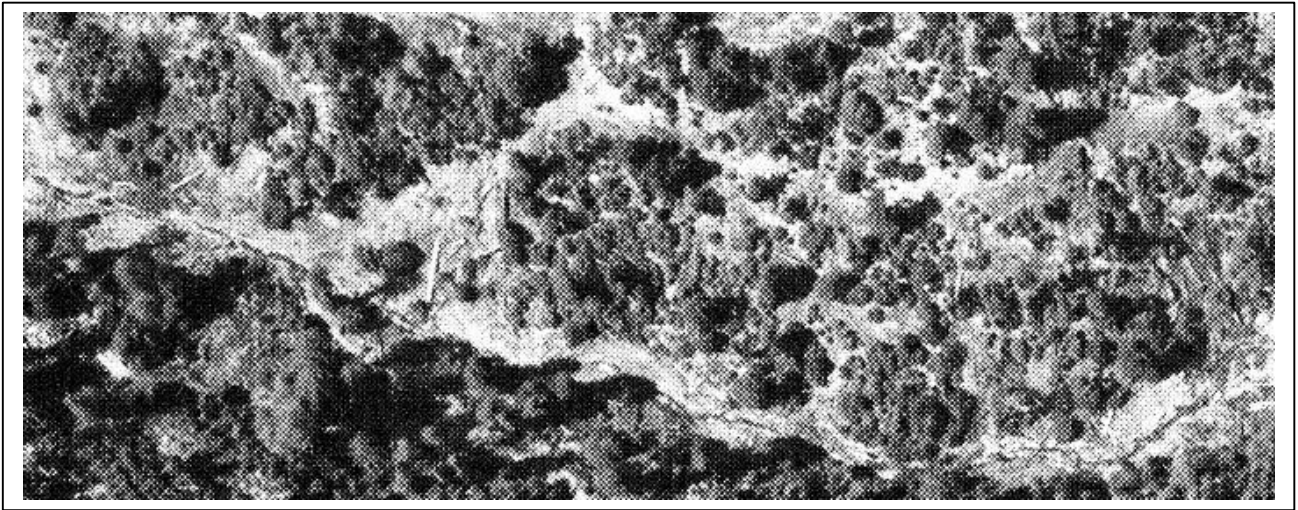
Figure 8: The in stream road in a tributary stream to Grasshopper Creek eliminated natural channel structure. The 1964 storms washed soil debris onto the stream channel already impacted by the in stream road construction. This caused the stream channel to meander through the logging debris, finding a new course (1965).

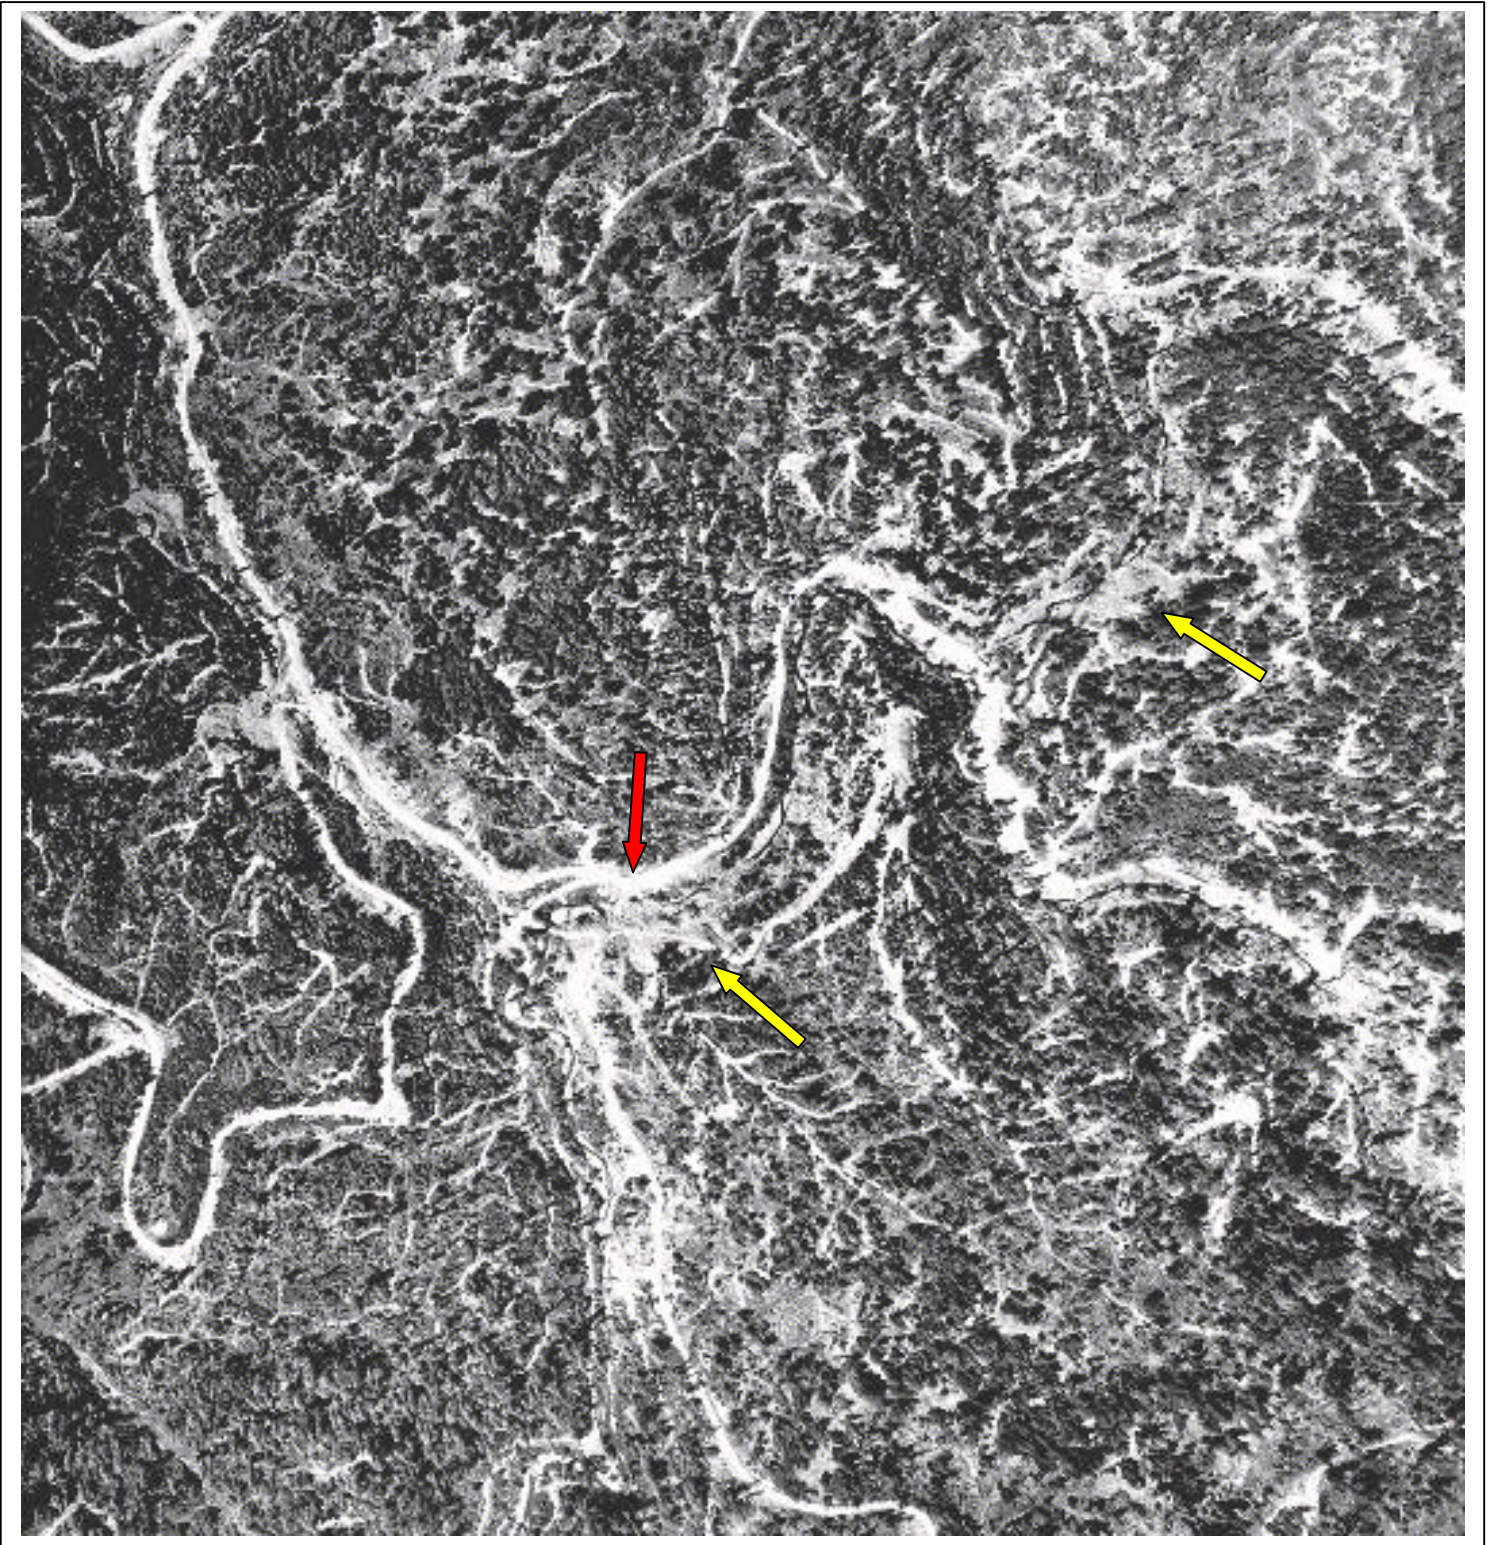
Figure 9: Central Landing Complex Built Over The Main Stem Fuller Creek, and Streamside Roads, June, 1965. High storm flows during the 1964 flood event incised the landing complex (lower left, yellow arrow) and undercut the lower North Fork Fuller Creek road (upper right, yellow arrow), collapsing a one quarter section of the road into the creek.. Note meandering stream flow patterns over filled channel substrate (red arrow) By 1984, most of this debris had washed downstream, and Fuller Creek flowed straight through the original V-shaped stream channel bordering the landing. The 1996 storms washed remaining debris out to expose the graveled substrate seen today

In addition, new streamside roads pushed fresh road fill towards the creek over the streambank. This sidecast is especially prone to failure during high flows. Historic road related debris slide failures accessing streams have been identified as a major source of land use induced sediment sources. Major storm events can trigger multiple road debris slide failures accessing streams (Figures 9, 14, 17, and 20).

The 1965 photos show that most of the point source sediment discharges consist of road debris slides accessing streams activated during large storm events. Figures 9, 14, and 20 show multiple road debris slides accessing watercourse over relatively short sections of the stream. Fresh debris slides fanned out over the channel, forcing the stream to meander around the slide mass. These meandering stream channel patterns in Fuller Creek returned to a more lineal pattern in observed in mid 1984 photos, and again with 1999 photos (see Figure 39, below). Meandering channel patterns in Sullivan and Grasshopper Creeks also returned to a more lineal pattern thru 1984 and more so by 1999. In Fuller and Sullivan Creeks, a graveled stream substrate can be found today in contrast with a silt and sand dominated substrate indicated in the 1965 photos. The Fuller Creek basin has been particularly targeted by the Gualala River Restoration Council for rehabilitation work. Stabilizing sediment sources has apparently allowed residual in-stream sediment loads to be washed downstream, reexposing the graveled substrate seen today. 1965 air photo coverage is only available in the east portion of the watershed.

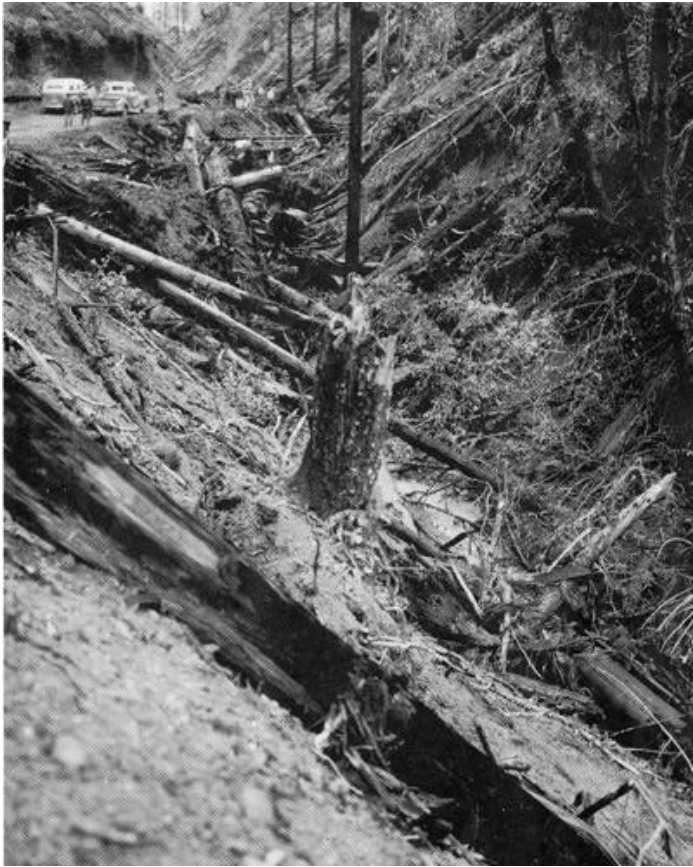
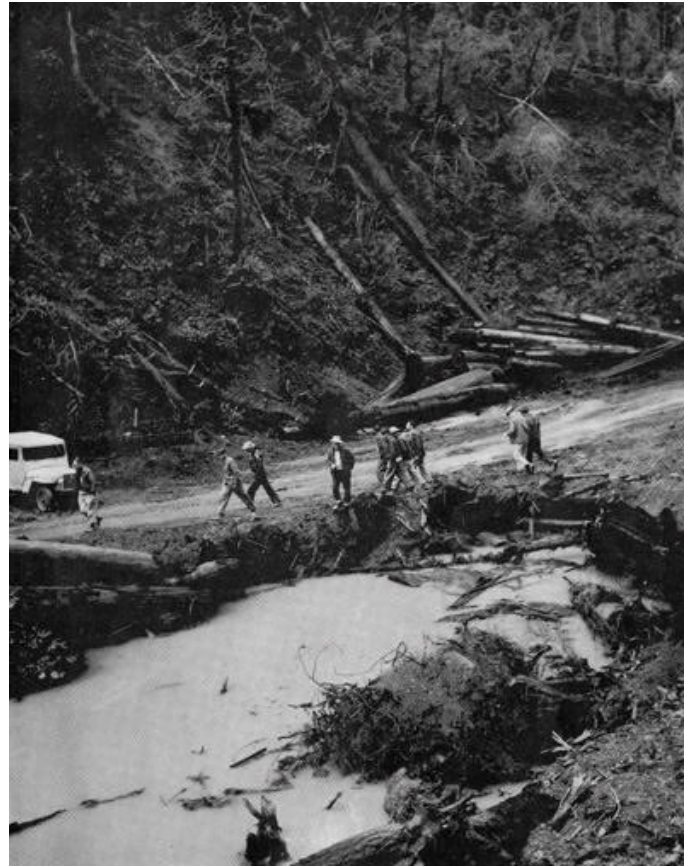
Figure 10: Left: Logging debris sidecast from the main streamside road in Grasshopper Creek, left, November 21, 1955. This road is now abandoned and vegetated. Right: A primitive log chunk road crossing in Grasshopper Creek, right, November 21, 1955. The stream flows through the logs and debris pushed into Grasshopper Creek to make the road bed. These substandard road crossings generally failed during large storm events (lower right).

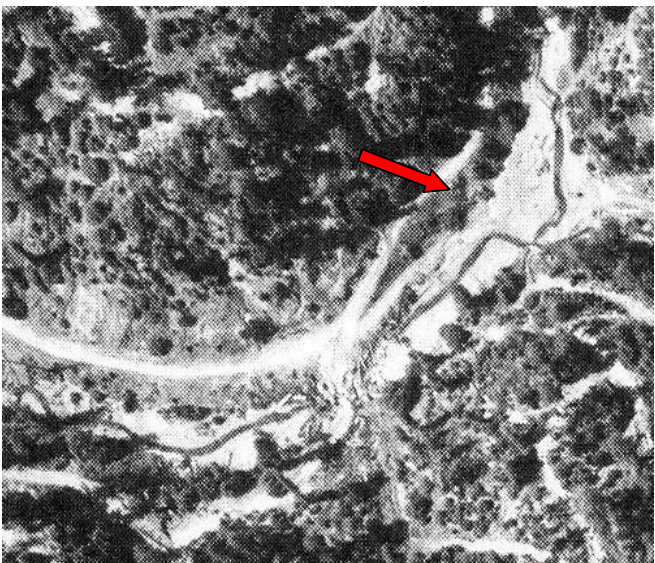
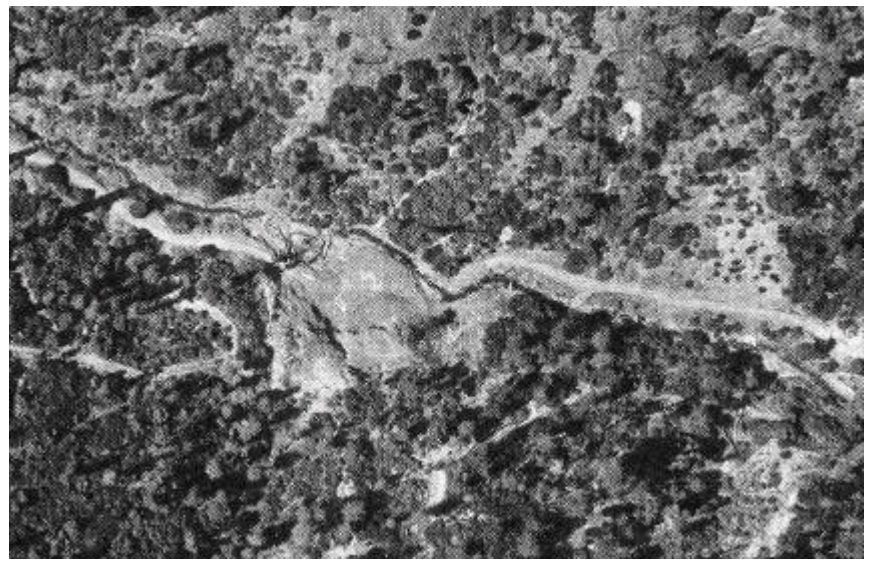
Figure 11: Left: Log debris blocked the inlet of a primitive log dirt crossing of Grasshopper Creek (left) from the 1964 flood, causing the creek to divert onto the south road approach, then route back to the main channel through a debris slide. The abrupt turn in the creek (red arrow) follows a long term geologic terrace per 1942 photos. Right: One half mile downstream, Grasshopper Creek washed out a primitive log debris road crossing (June, 1965).

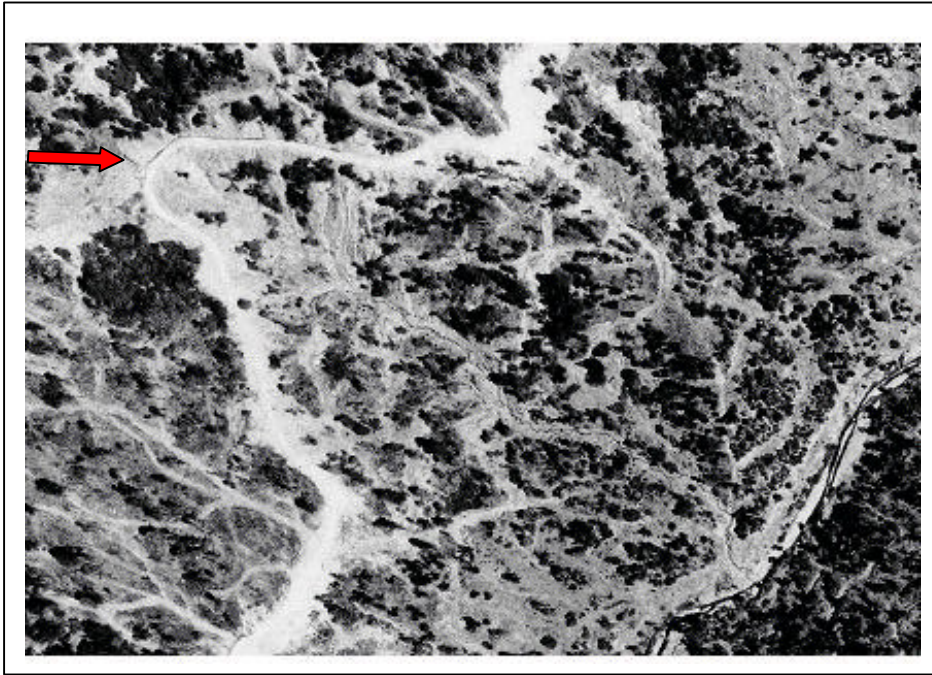
Figure 12: Watercourse diversion down the main road (left) discharged down several skid trails to the lower in stream road. This is a tributary creek to the North Fork Wheatfield, June, 1965.

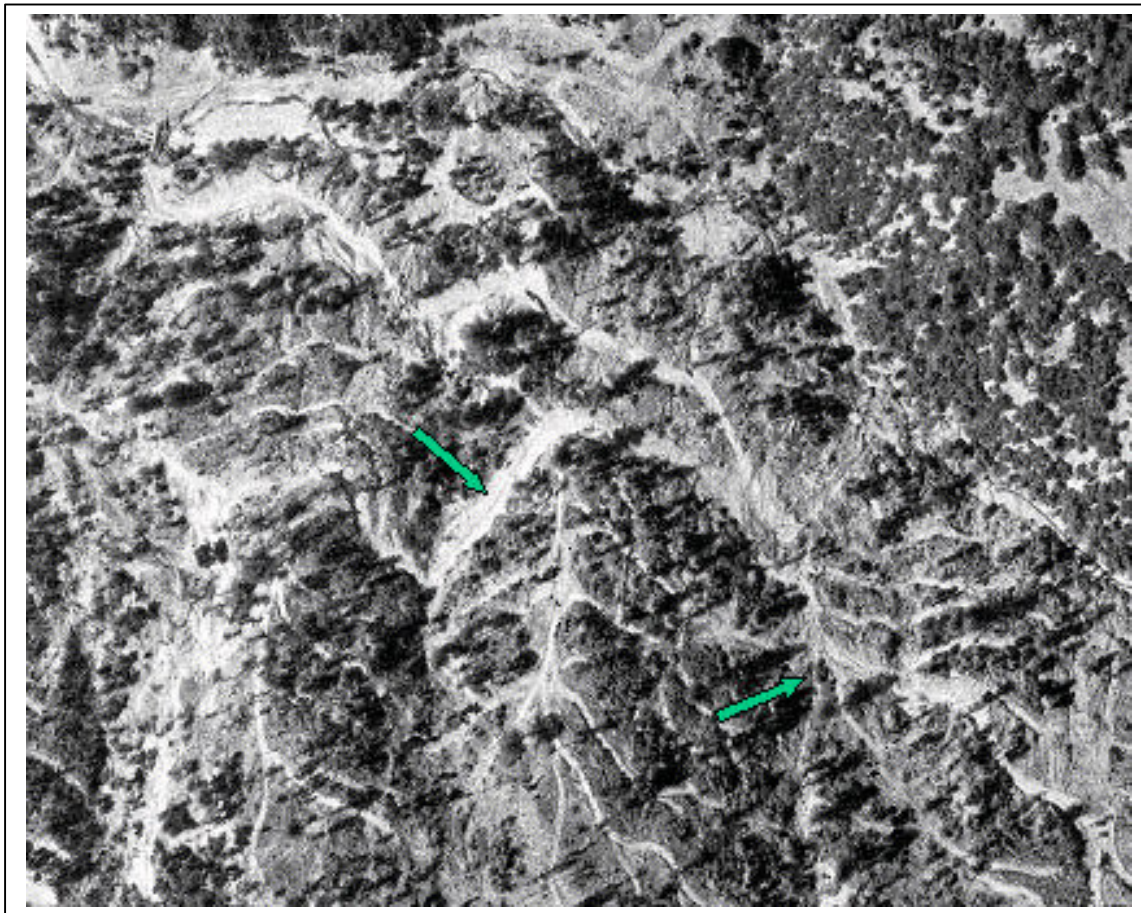
Figure 13: Road and skid trail terraced network on steep north facing sideslopes in Wolfe Creek, east Wheatfield basin. Green arrows show gullying down the roads.

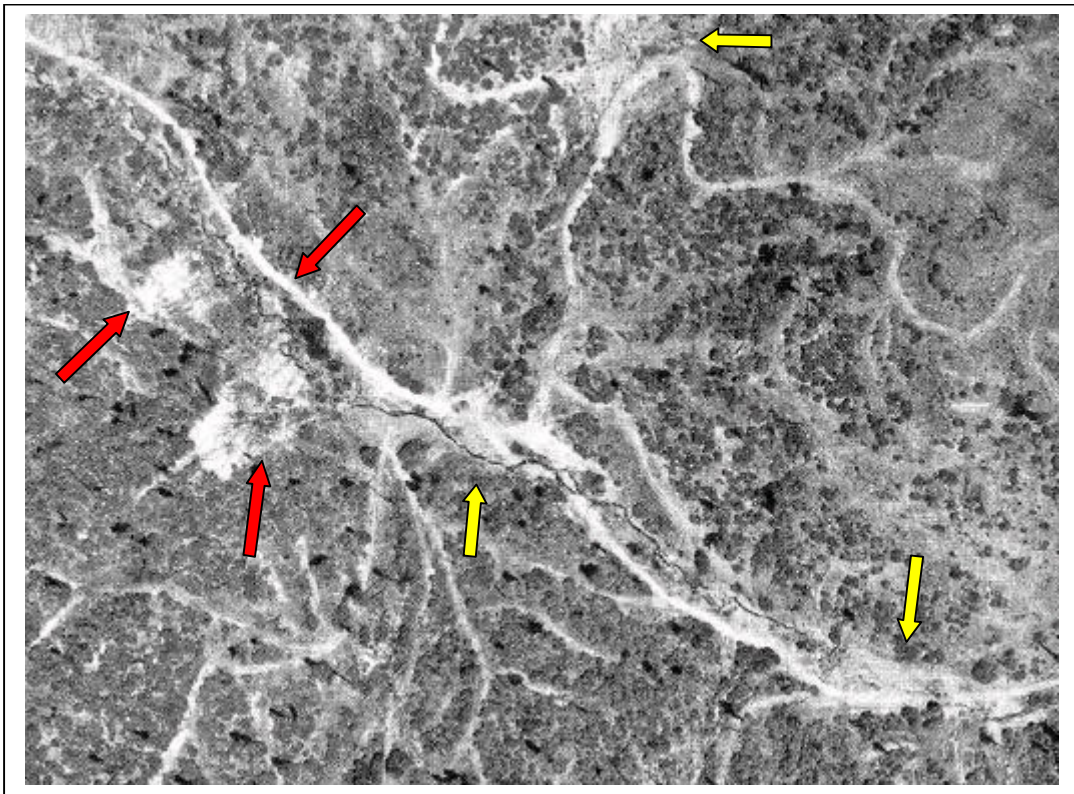
Figure 14: Multiple road debris slides accessing Tobacco Creek (red arrows). Three in-stream landings (yellow arrows) consist of wood chunks pushed into the stream channel and topped over with dirt fill. These are located at the confluence of several streams. The left landing (center) and top landing have incised down while the right landing shows overflow patterns.

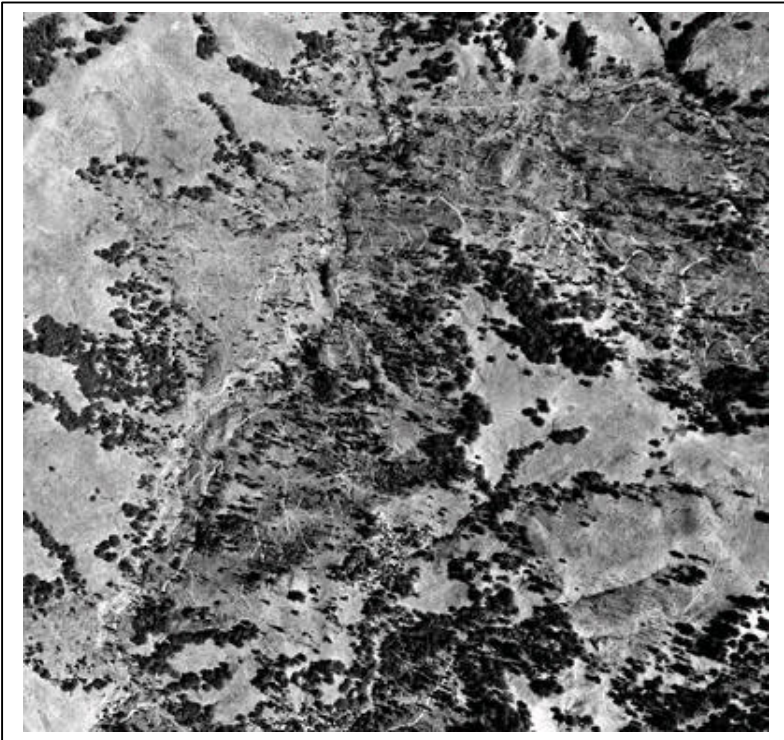
Figure 15: Canopy removal in a tributary to Marshall Creek , 1965. The road was constructed down a steep ravine making numerous switchback turns.to the streamside road following the central channel.

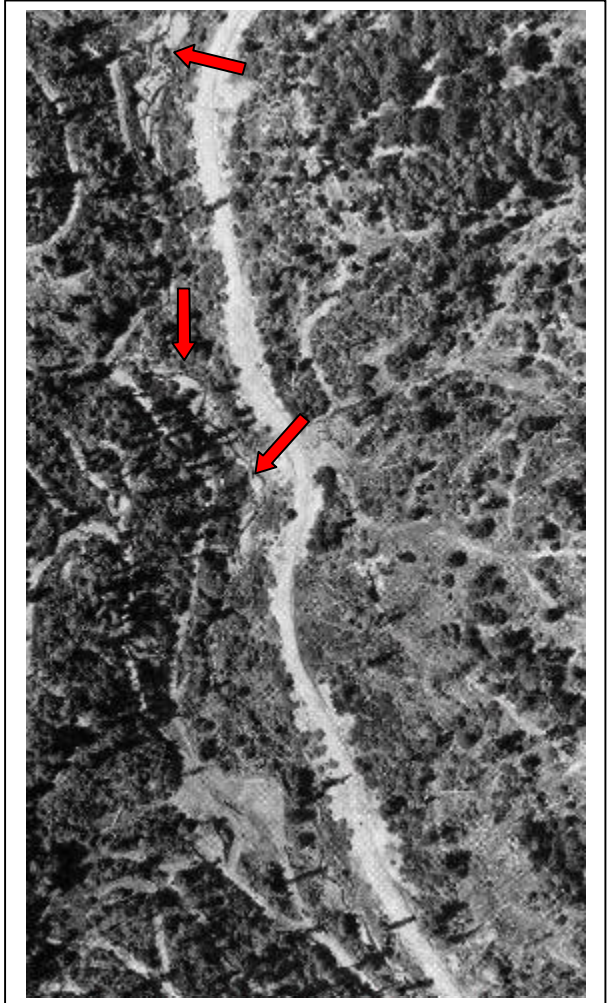
Figure 16: Braided channel patterns and sediment step fans, Fuller Creek

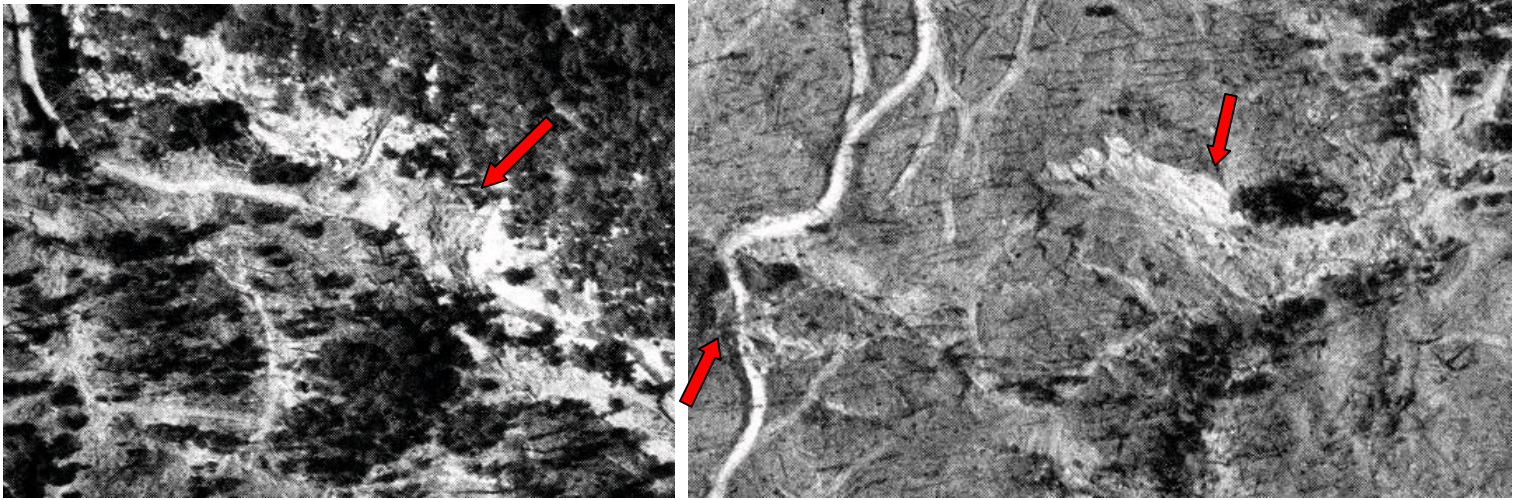
Figure 17: Left: The 1964 flood event undermined the streamside road, causing a massive debris slide into Wolfe Creek. Note meandering angular channel patterns through the slide debris (red arrow) 1965. Right: Debris slides and debris flows in an operations area in the Danfield Creek tributary subbasin

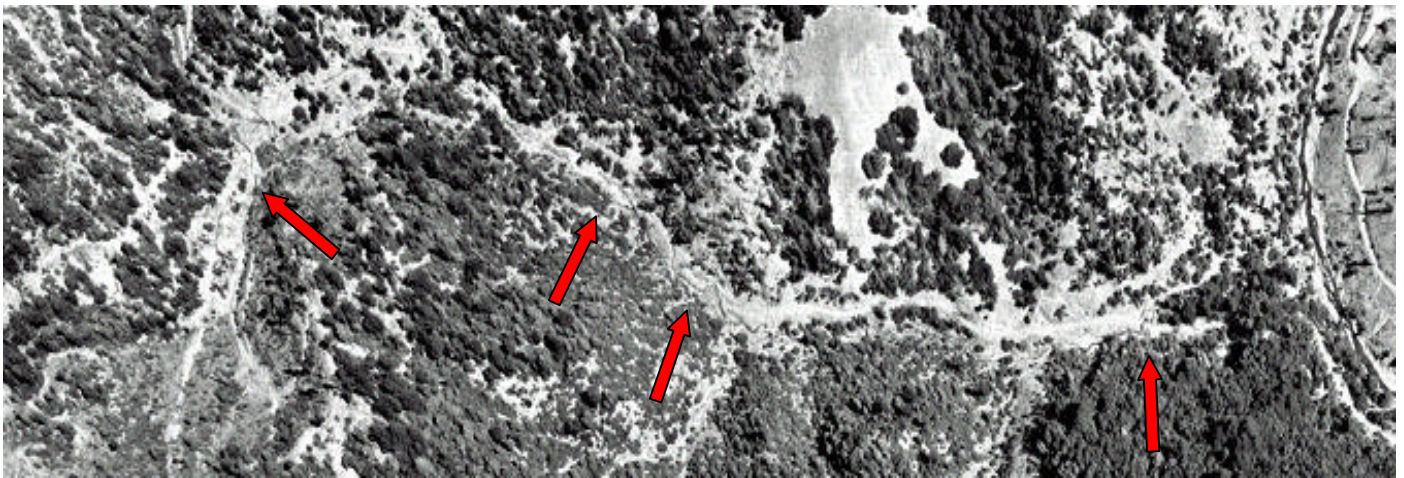
Figure 21: Stream diversions and washouts of a streamside road following a tributary stream to lower House Creek, 1965.

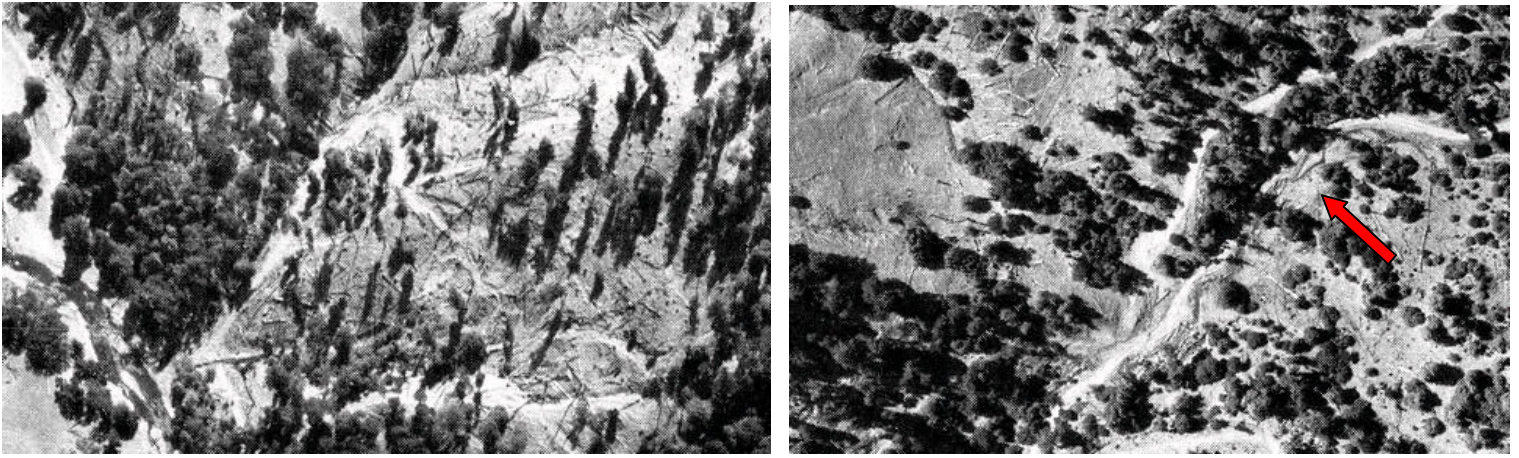
Figure 23: Left: Streamside road along an unnamed tributary to the main stem Wheatfield Fork Right: Road washout slightly upstream.

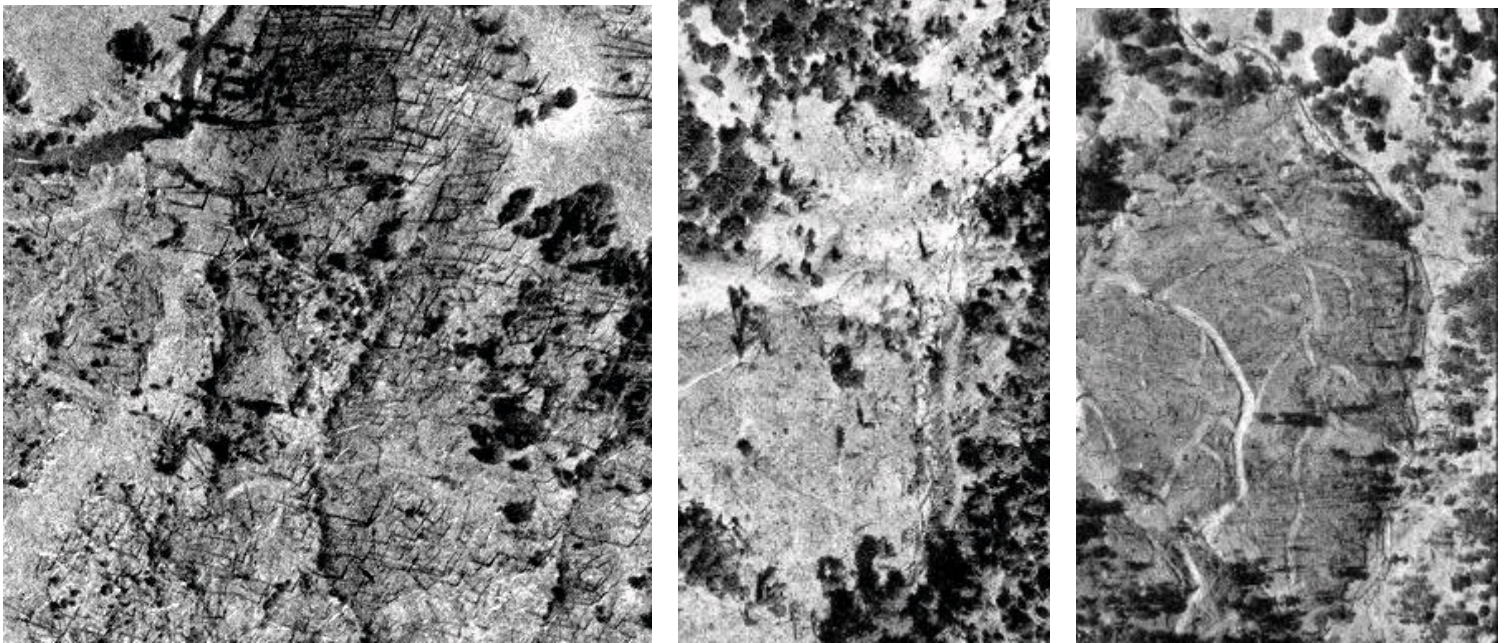
Figure 24: Riparian canopy removal and streamside road networks along the North Fork McKenzie Creek (center) and in the Danfield Creek tributary subbasin (left and right)

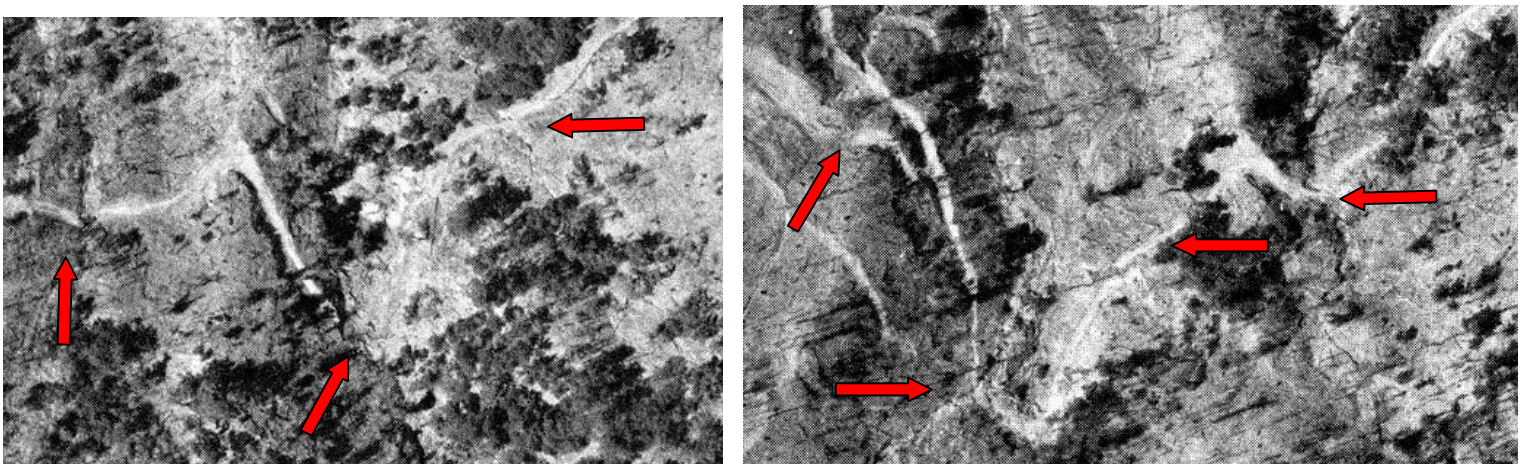
Figure 25: Road debris slides and road crossing failures in the Danfield Creek tributary subbasin. Most of the road crossings in this area show signs of failure.

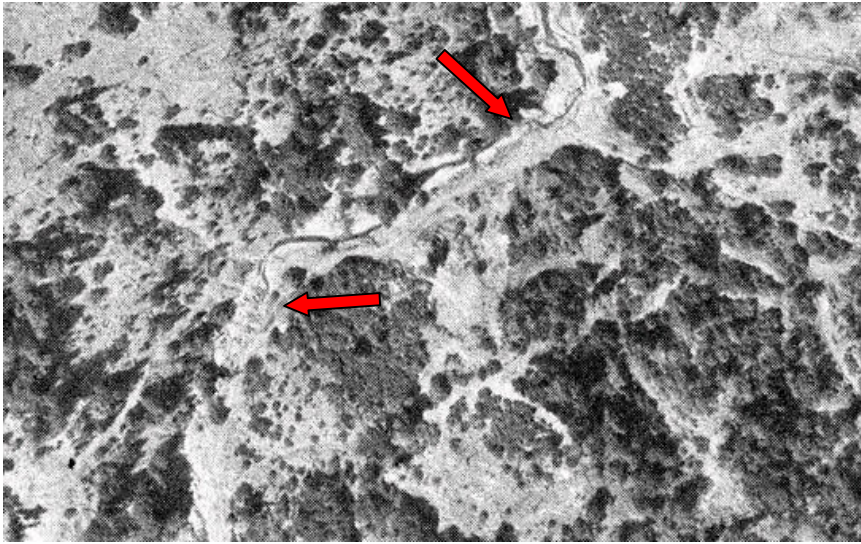
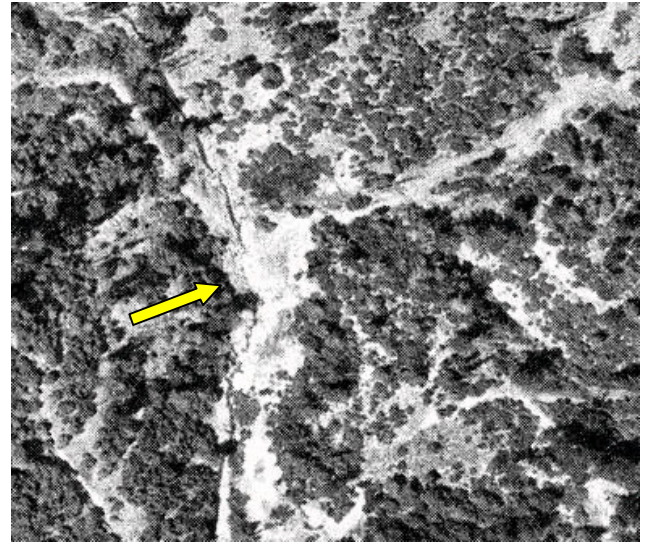
Figure 26: In inner gorge canyons, road building was often confined to the streambed by the steep inner canyon walls. Tractors graded the channel zone flat to one side, often burying the watercourse with fill sidecast. This forced the stream to meander through the road fill, finding a new course offset from the original channel. The 1965 photos show a disrupted channel pattern in these areas, characterized by frequent channel braiding, (red arrows) and abrupt turns in the channel (yellow arrows). Upstream of the disturbance, the channel typically shows a well defined central channel. Turns in the channel are comparatively gradual. In disrupted channel areas, the channel narrows down as the stream spreads through the debris and disturbed ground in angular, dissected patterns (Upper South Fork, top left and right) .

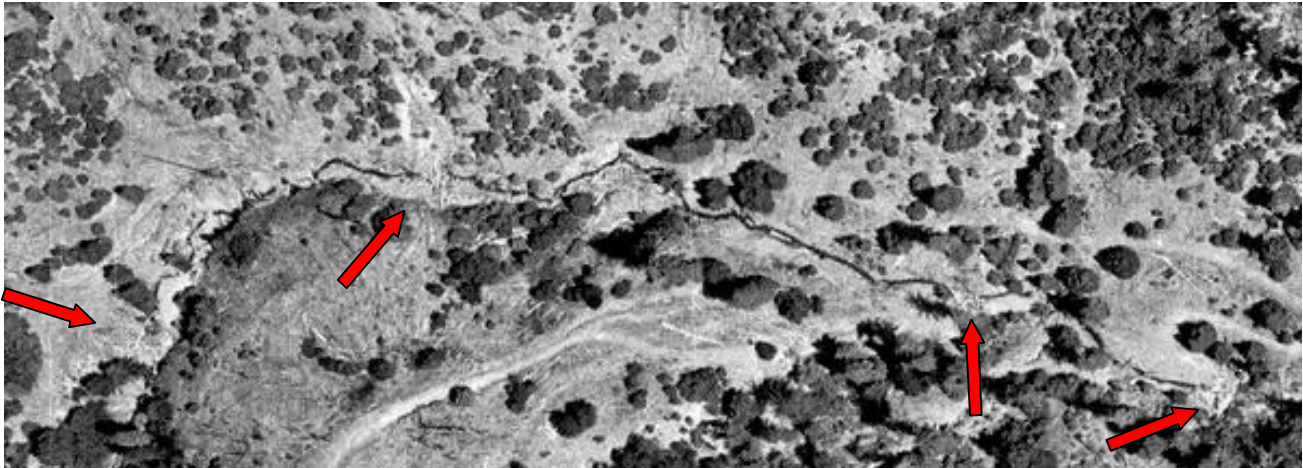
Figure 32 Riparian stream clearance removed coniferous cover in a lower tributary stream to House Creek. These stream crossings (red arrows) also used log chunks pushed into the channel and were topped with dirt fill. The meandering stream channel patterns at the crossings shows the depth of these structures where the stream makes abrupt switchback turns.

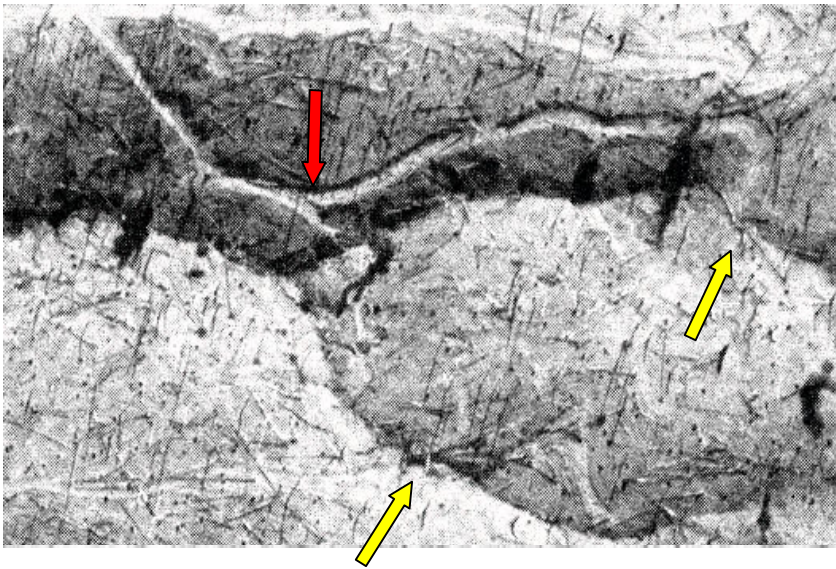
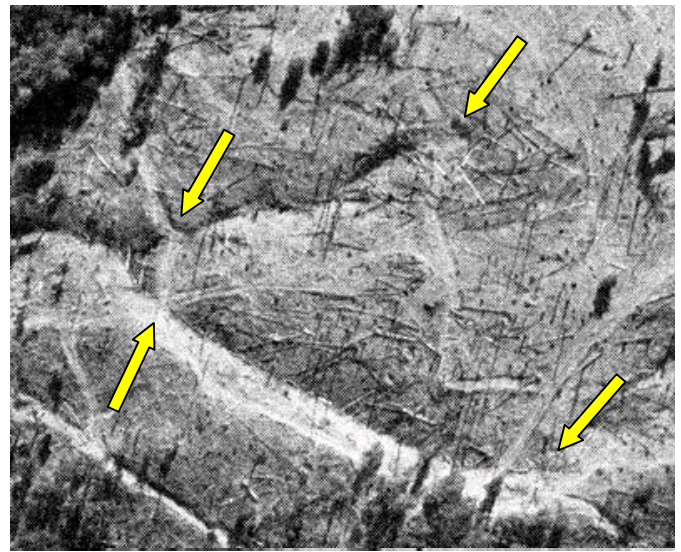
Figure 34: Reentry of the mid century tractor areas under a Timber Harvest Plan typically requires the repair of legacy impacts that continue to represent present day sediment sources. In this case above, the THP could require installation of cross ditches along the abandoned seasonal roads. This would disperse runoff away from the low point in the road and resulting debris slide covering the creek where flows had concentrated. (red arrow). Timber Harvest Plans frequently require removal and stabilization of failing stream crossings left abandoned (yellow arrows). Typical procedures include (1) removing of the decaying log chunks and soil debris from the channel crossing point, (2) grading back the road approaches and (3) applying grass seed and mulch to the exposed ground. Similar repairs have been effected throughout the watershed where covered under a Timber Harvest Plan, substantially reducing sediment point sources and contributing to improving channel sediment conditions noted in the CGS geofluvial analysis.

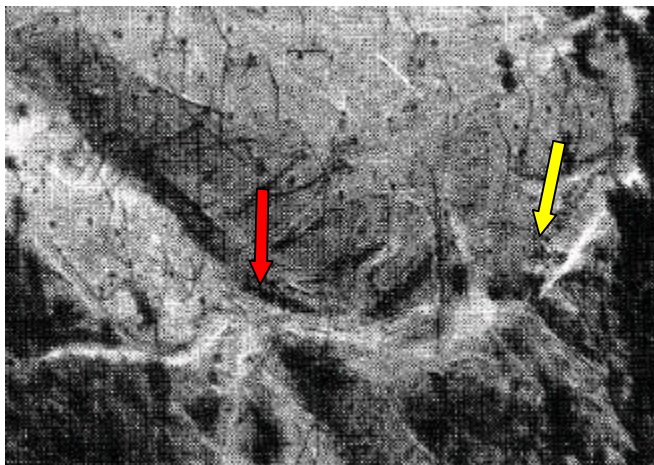
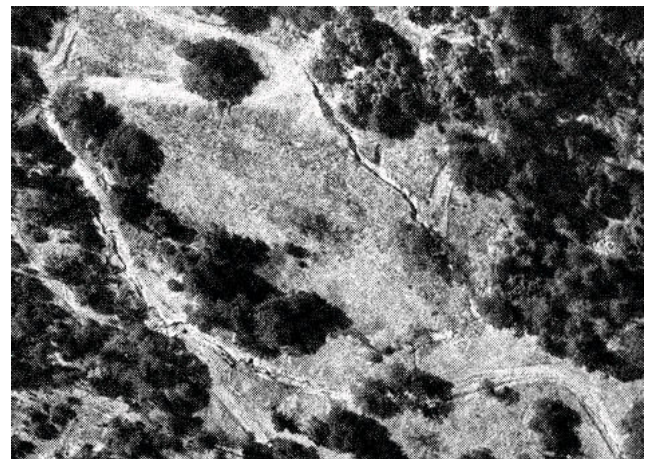
Figure 35:Left: In higher tributary watercourses that exhibited low flows in the summer, tractors pushed dirt straight into the stream to make the road crossing. The red arrow shows where a switchback turn in the road was made in the center of the creek. The yellow arrow shows where the fill slope failed as a debris slide at a second dirt fill road crossing of a stream. If such an area were subject to a THP, culverts sized to a 100 year storm event would be required today. Or the stream crossings must be pulled back and stabilized with grass seed and mulch prior to the winter rains. Right: Repair of gully erosion down abandoned roads dating to the mid century is typically repaired in areas subject to THPs. This includes installation of cross ditches, upgrading culverts and regrading inside ditches.

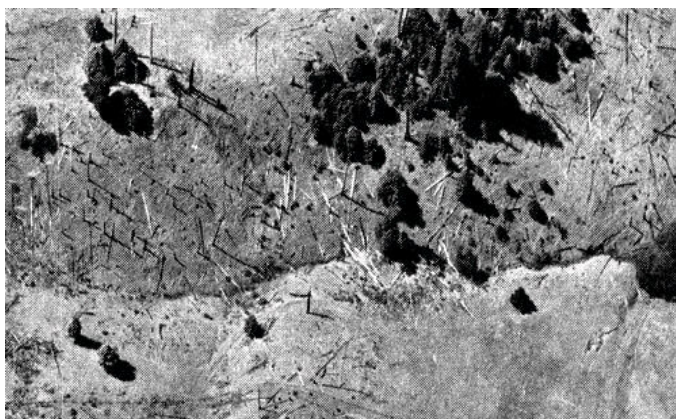
Figure 36: The Gualala NCWAP Team frequently recommended tree planting of former riparian areas that had been converted to pastureland during the mid century. The 1965 photo (left) of a tributary to the lower reaches of House Creek shows conifer extraction from the stream leaving oak and madrone upslope, surrounded by existing grasslands. Such procedures were common in the east and upslope basin reaches. Artificial regeneration can be difficult. These areas are often highly compacted from decades of prolonged cattle grazing. Several planting seasons are usually required to overcome high seedling mortality rates.
