LAND USE HISTORY OF THE GUALALA WATERSHED

**BY
DONALD MORSE RPF 2158
CALIFORNIA DEPARTMENT OF FORESTRY AND FIRE PROTECTION**

**PREPARED IN COOPERATION WITH THE CALIFORNIA RESOURCES AGENCY'S
NORTH COAST WATERSHED ASSESSMENT PROGRAM**

APPENDIX 3: LAND USE HISTORY OF THE GUALALA WATERSHED

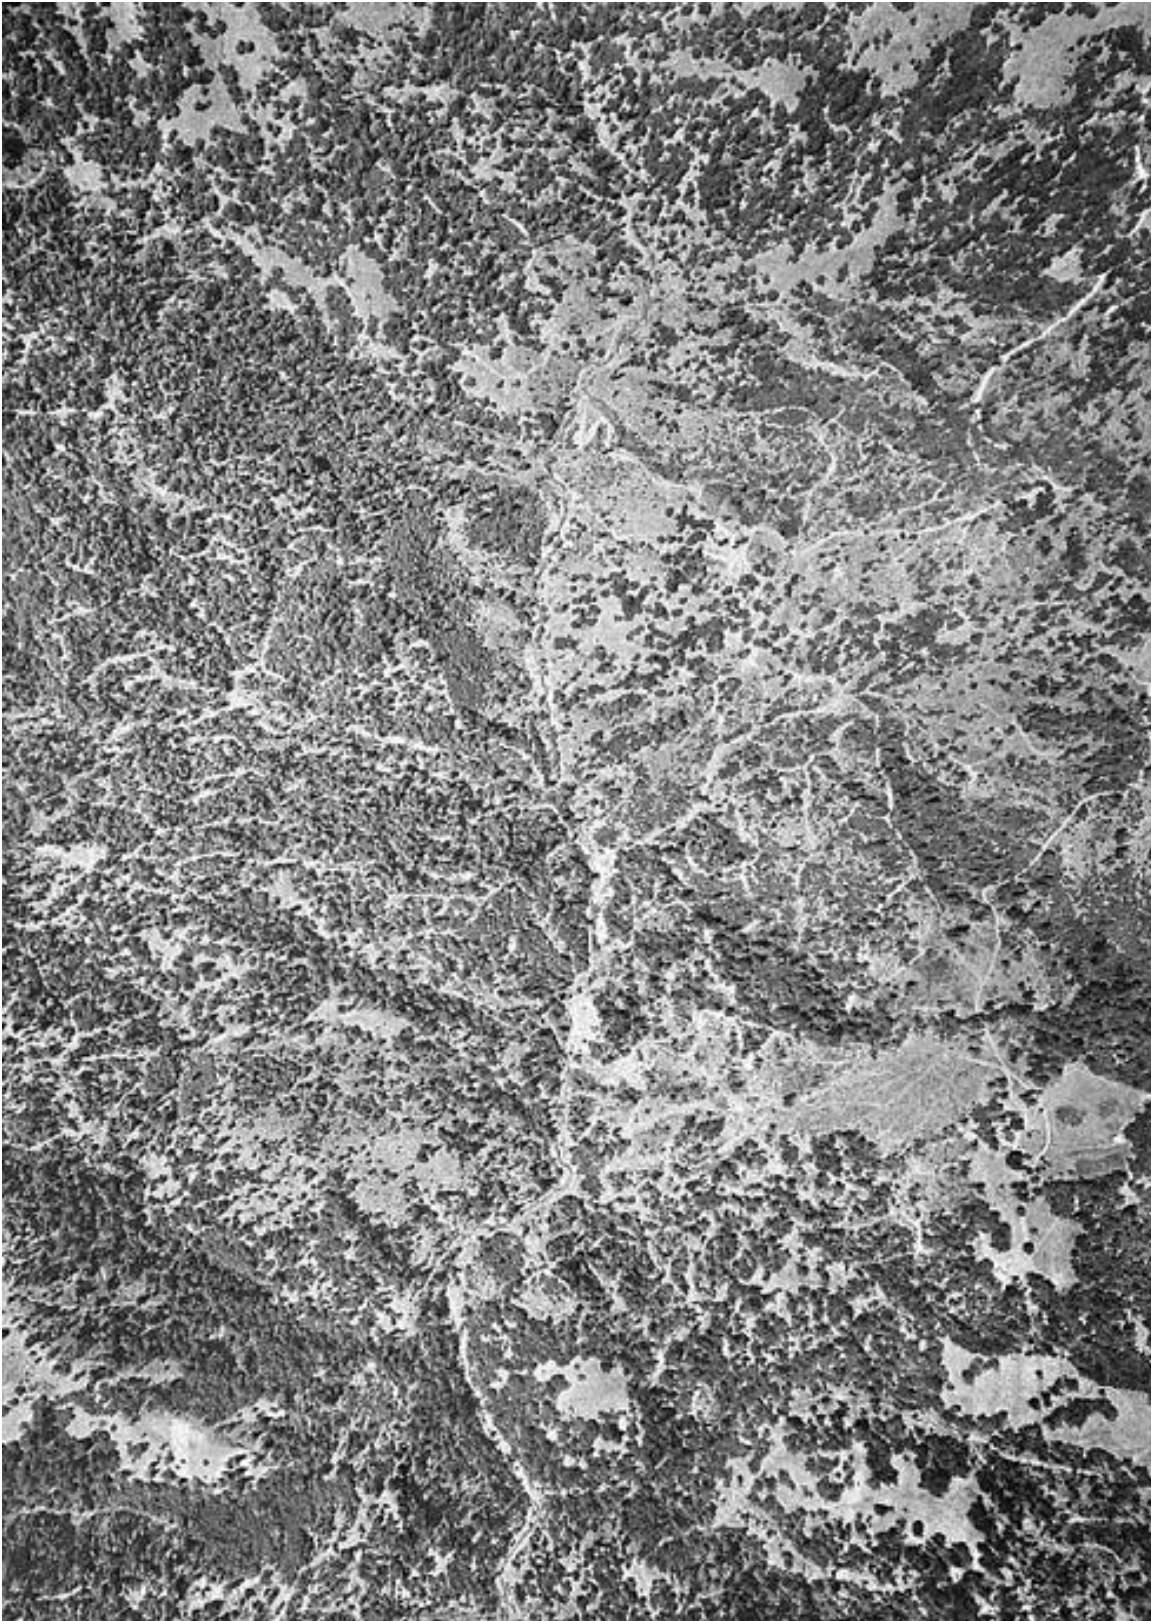
Figure 37: Long term residual effects of streamside/ in stream road construction, June, 1965. A tributary to the Upper South Fork was logged in the mid 1950s. This 1965 photo shows vegetation returning on the clear cuts indicating approximately 7 to 10 winter storm runoff periods on these roads. The in-stream road network (center) incised deeper over time, trenching down the road. There had been large storm events in 1962 and 1964 affecting this area. Numerous debris slides and debris torrent slides have been found in this photo.

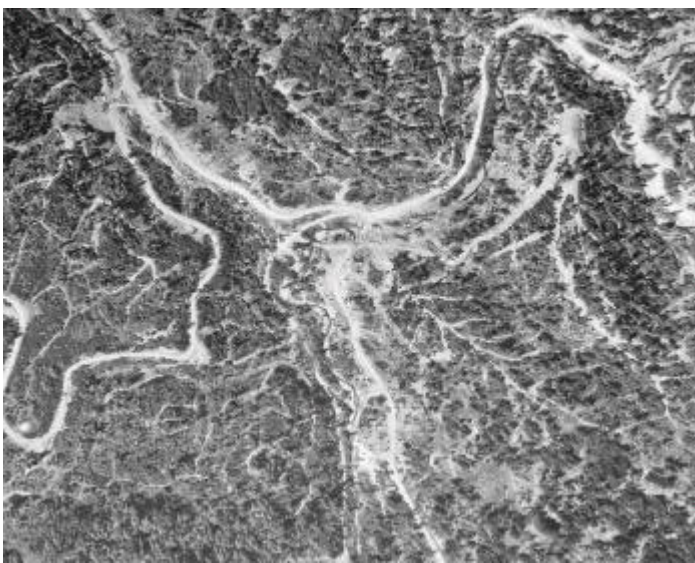
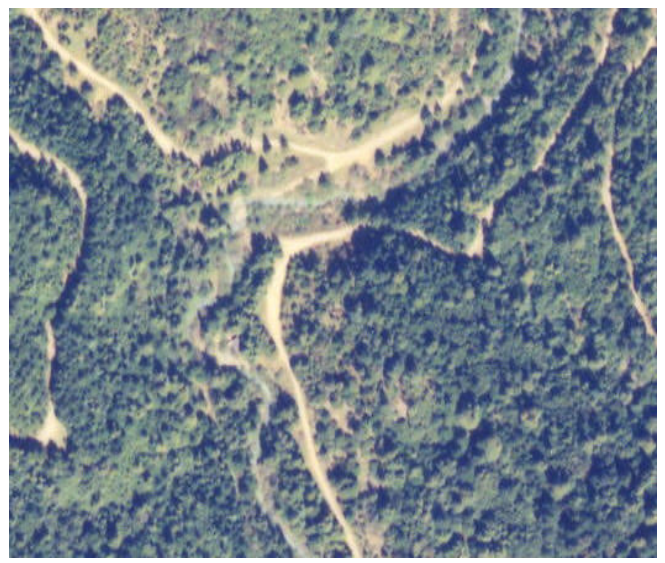
Figure 38: Fuller Creek landing complex, June, 1965 (left), and 1999 (right). Fuller Creek meanders around debris depositions in 1965 in contrast to a more lineal pattern today.

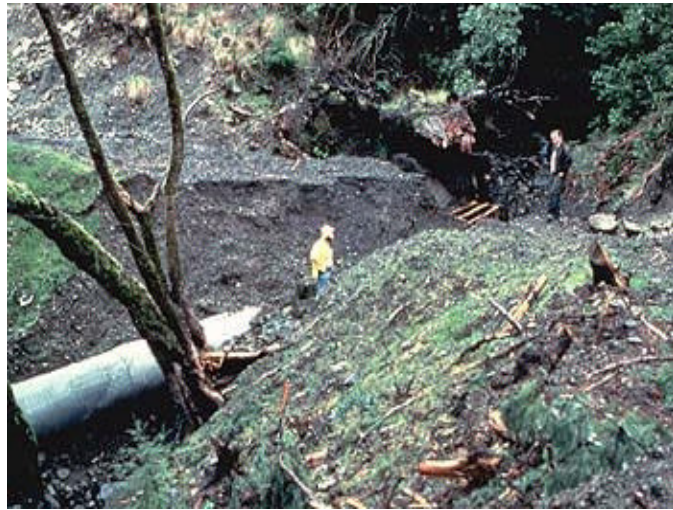
Figure 40: Culvert failure of contemporary road networks

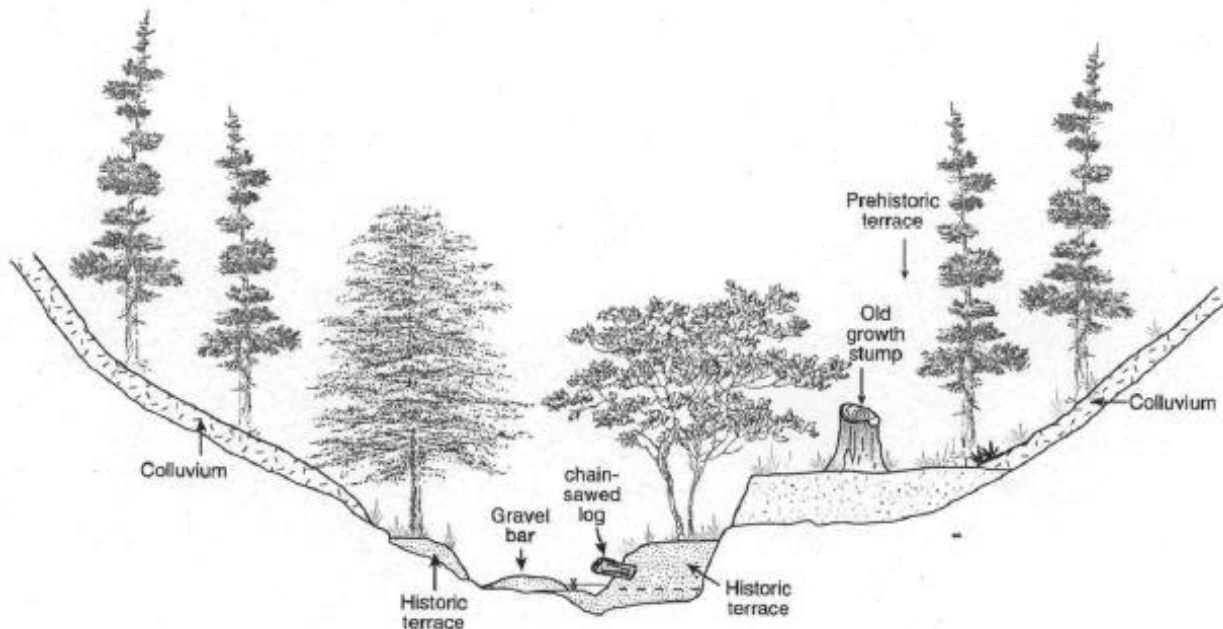
Figure 45: Schematic sketch of a typical South Fork Noyo River channel showing valley margin, prehistoric terrace, historic terraces, gravel bar, and channel. Historic terrace deposits are observed on bedrock in some locations (left) and on channel deposits in other locations (right). Old growth redwood stumps are diagnostic of prehistoric deposits and embedded chain-sawed logs are diagnostic of historic deposits. Prehistoric terraces support second growth redwood trees and ferns, historic terraces typically support alder trees and grasses.

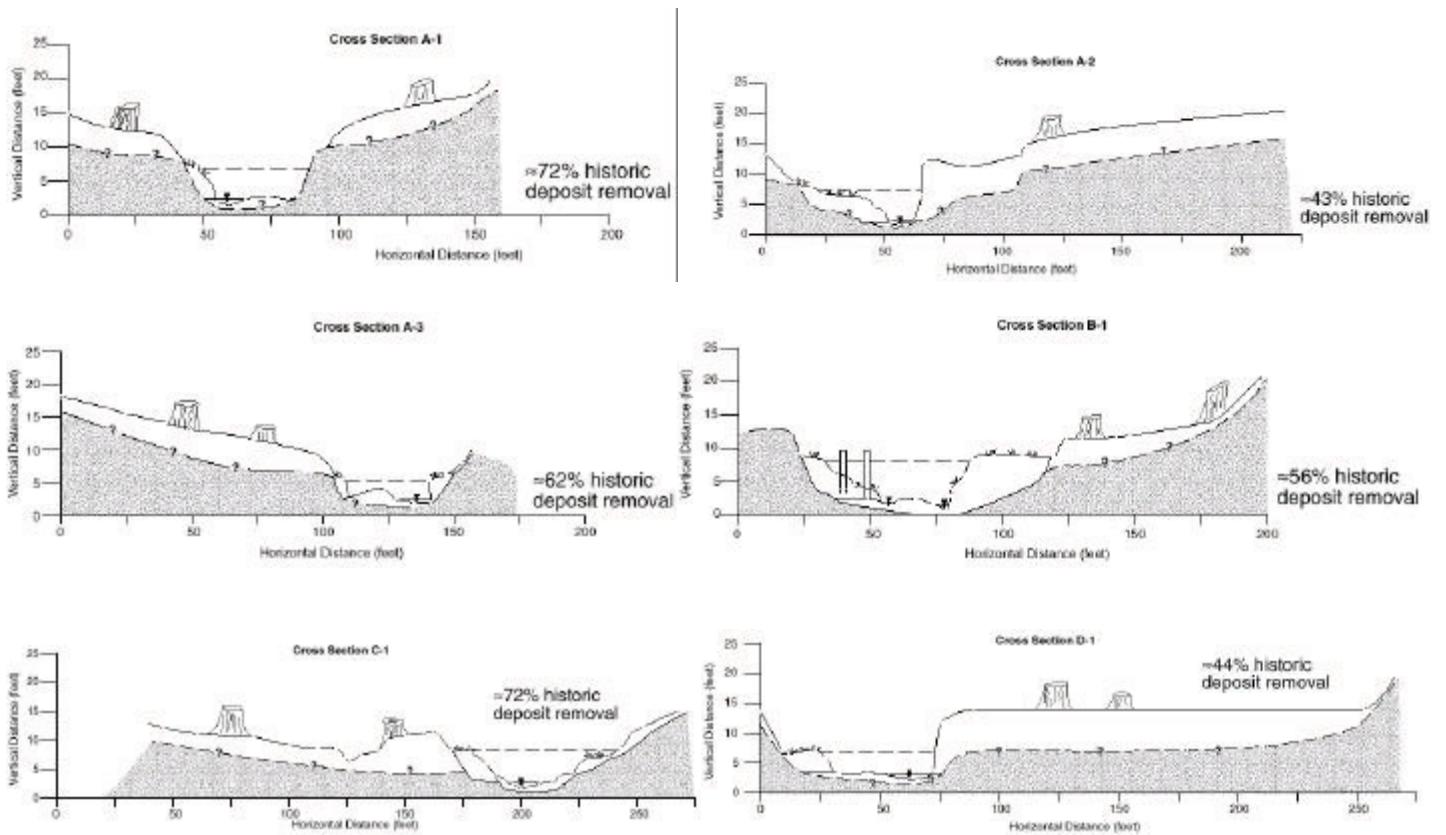
Figure 46: Six survey cross sections. Dashed lines represent probable maximum thickness of historic aggradation used to estimate amount of material removed since time of terrace deposition.

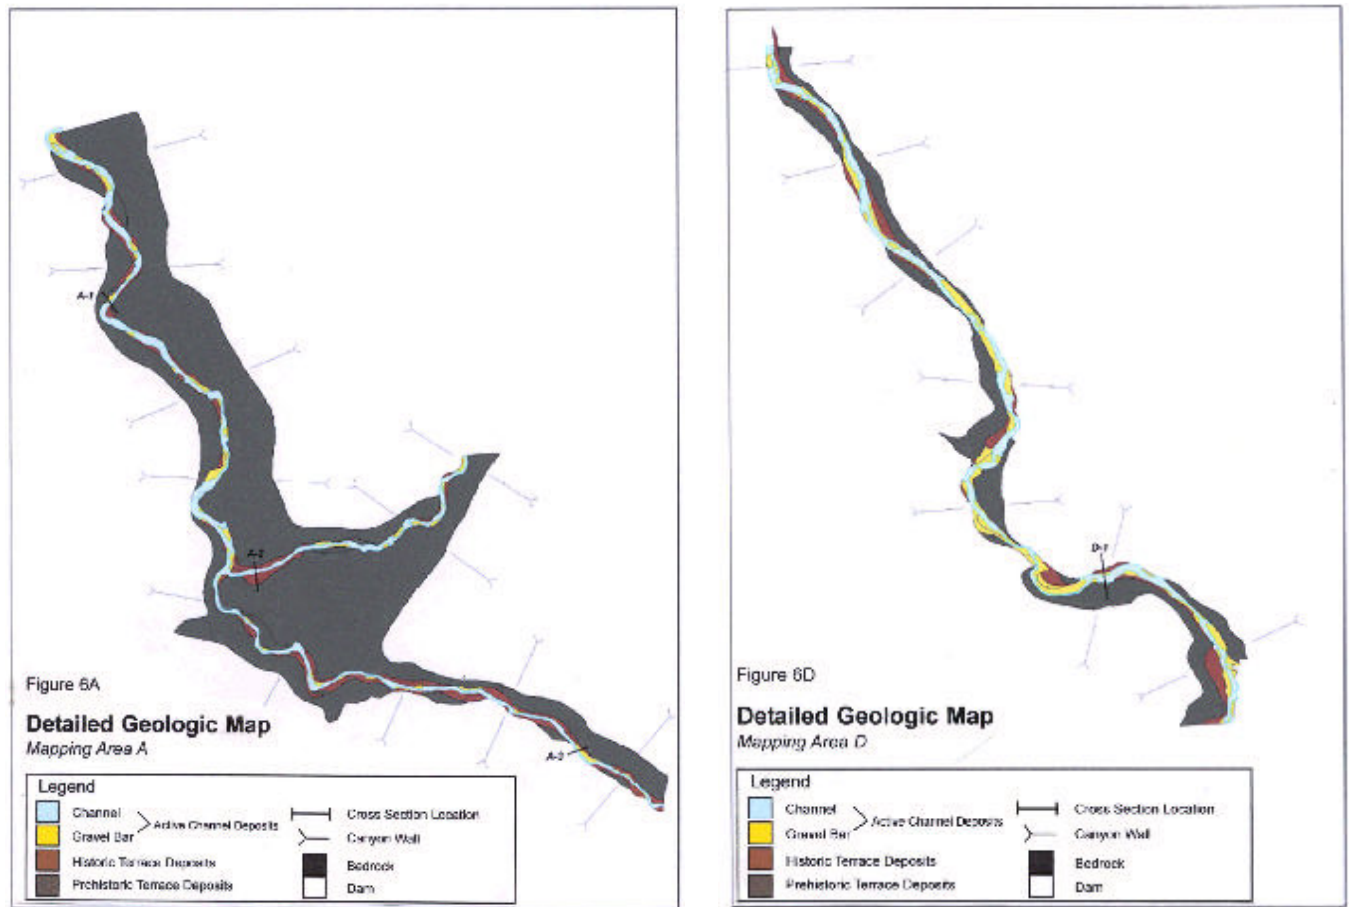
Figure 48: Additional stream channel maps showing active channel deposits, historic and pre-historic deposits, and bedrock in the South Fork Noyo Watershed. Brown = historic terrace, Grey = geologic, or pre-historic terrace, Yellow = gravel bar.

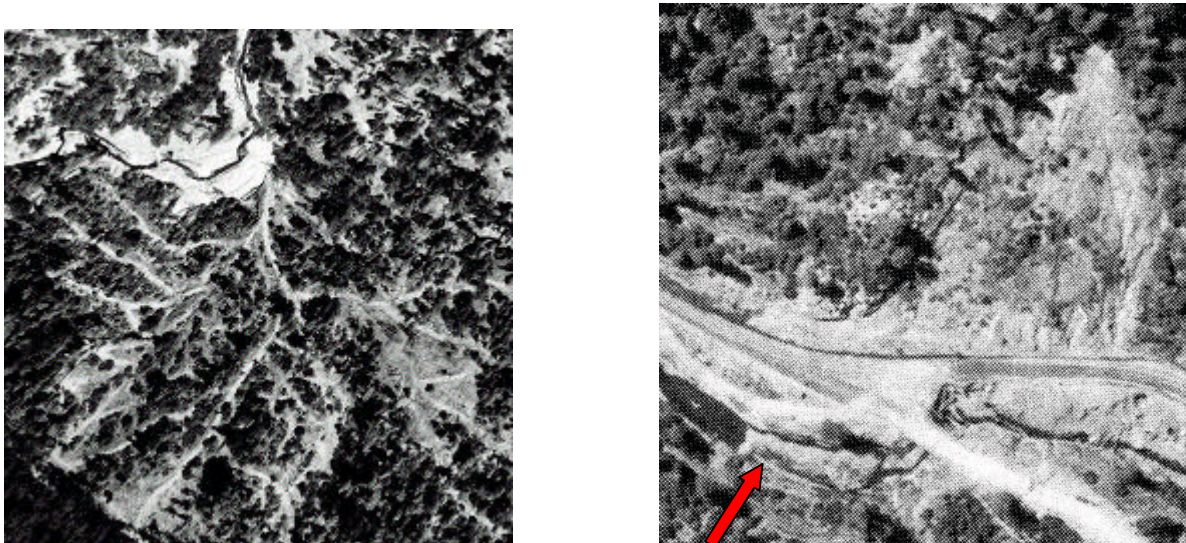
Figure 54: Left: Streamside road network leads to a landing complex adjacent to the North Fork Wheatfield. This streamside landing was built onto a natural geologic sediment terrace, as verified in 1942 photos. Right: Kelly road built through an active slide area, 1965. The left bridge approach was built onto the slide mass that had slumped into Buckeye Creek. The 1964 flows undermined the left bridge approach, causing the edge of the road to collapse (red arrow). Note braided channel pattern patterns indicating an aggraded stream channel. 1999 photos show this same area with fewer braided channel patterns indicating decreasing bed loads. Also note log debris that had floated down onto the bridge approach.

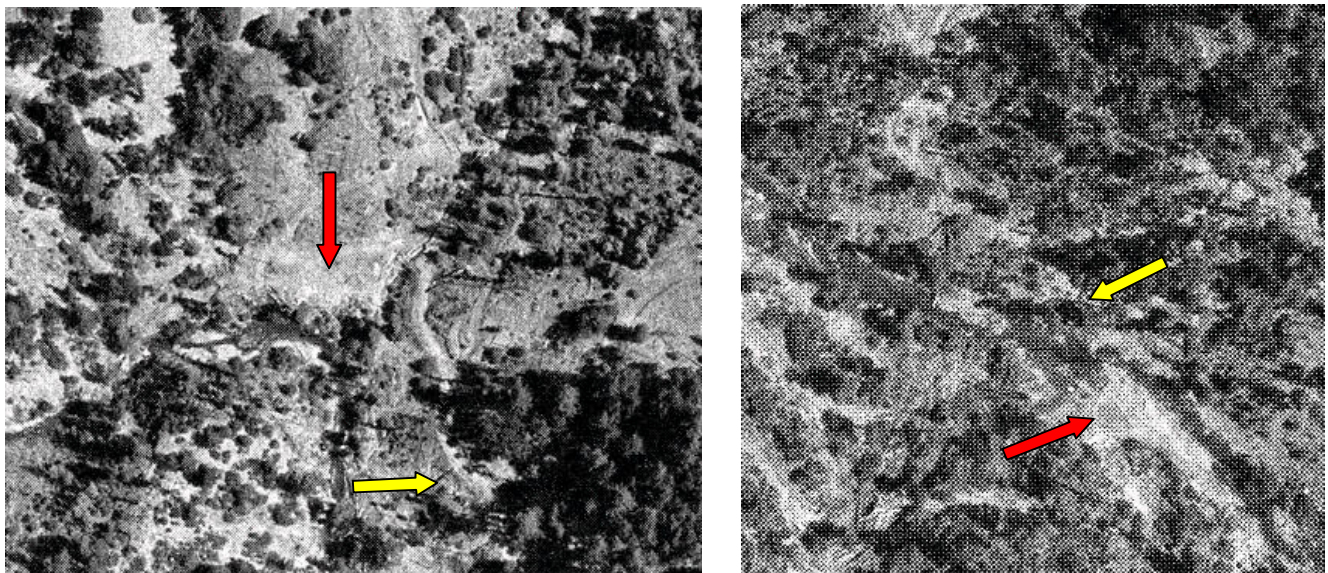
Figure 56: Left: In stream landing operations (red arrow) adjacent to an old growth residual stand (yellow arrow) showing original conifer tree cover over an upper tributary stream to Marshall Creek. Right: In stream landing operations (red arrow) disrupted stream flow patterns (yellow arrow) of a larger order fish bearing watercourse in the Marshall Creek tributary subbasin by flattening stream channel structure (1965).

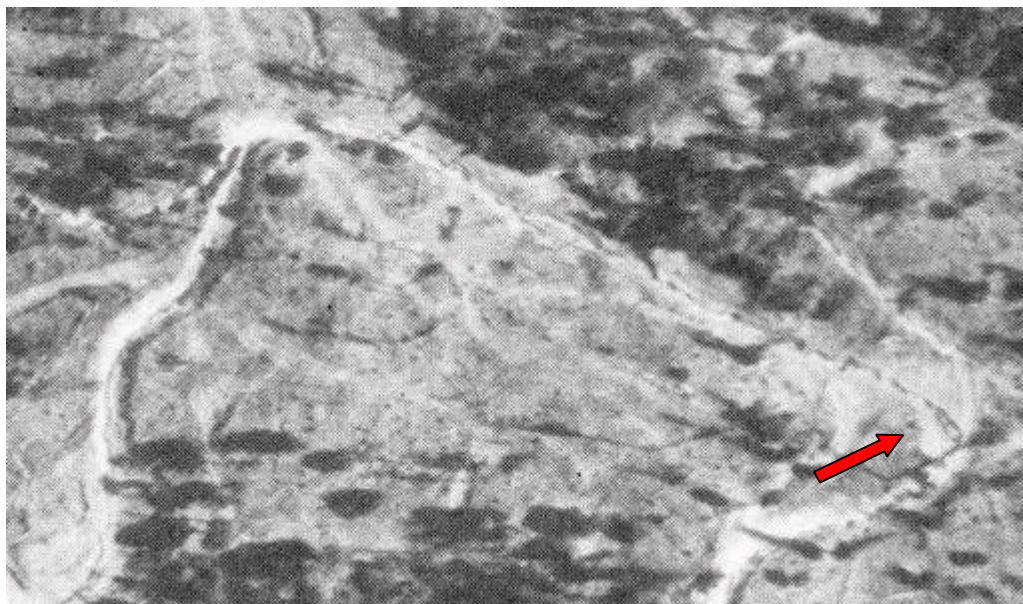
Figure 57: Stream diversion (red arrow) of a tributary stream to the North Fork Wheatfield onto a logging road

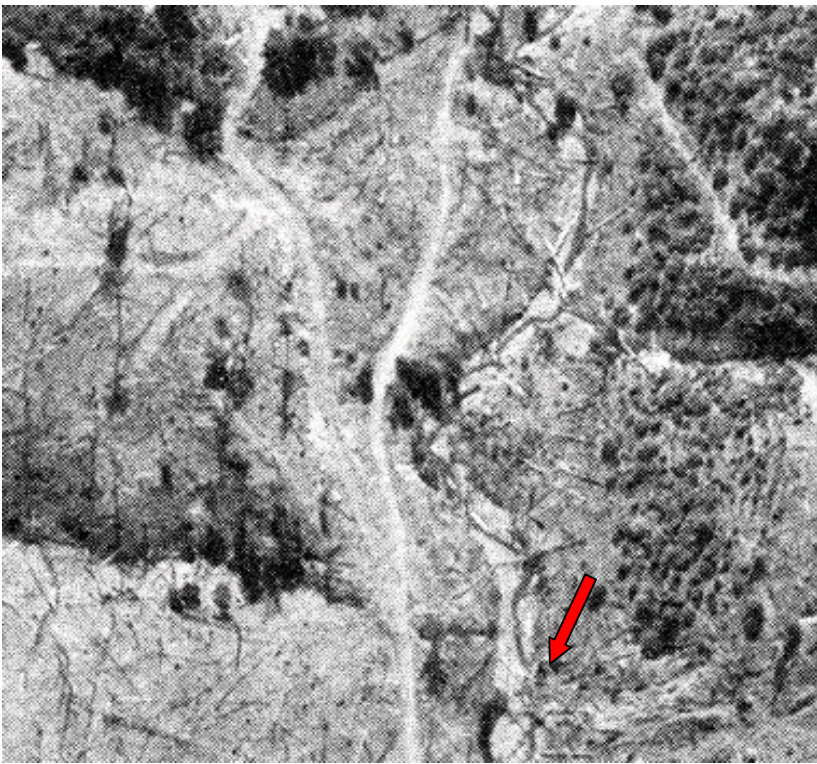
Figure 62 : Top: Road building along the streambed graded the channel smooth and straight creating a ditch. Left: Riparian clearance and logging debris over a tributary to Danfield Creek. Note debris accumulations over channel at a skid crossing (red arrow).

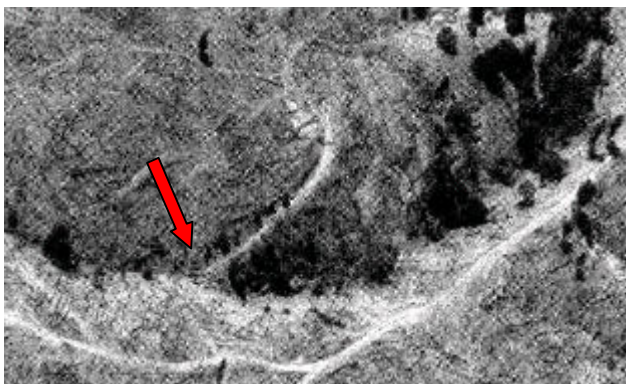
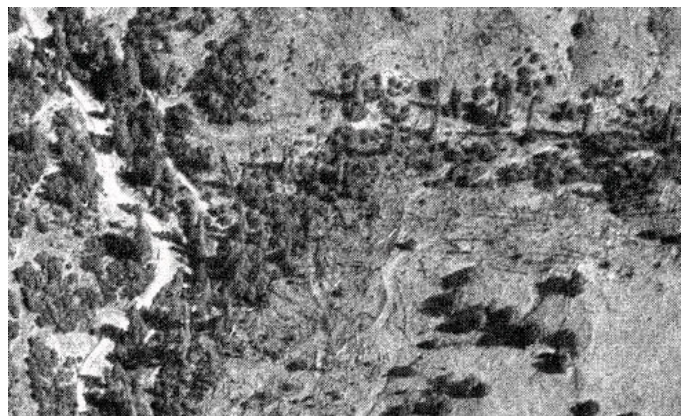
Figure 64: Potential THP repair site of a legacy stream crossing. Right: Concurrent logging operations in Pepperwood Ck.

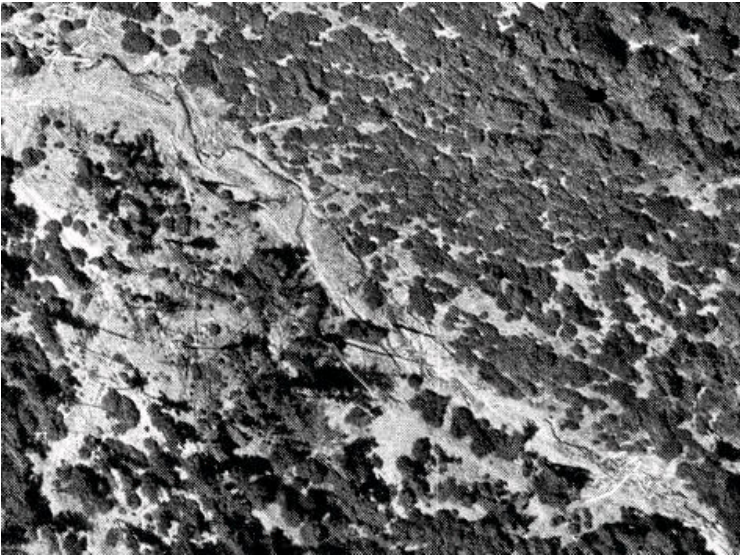
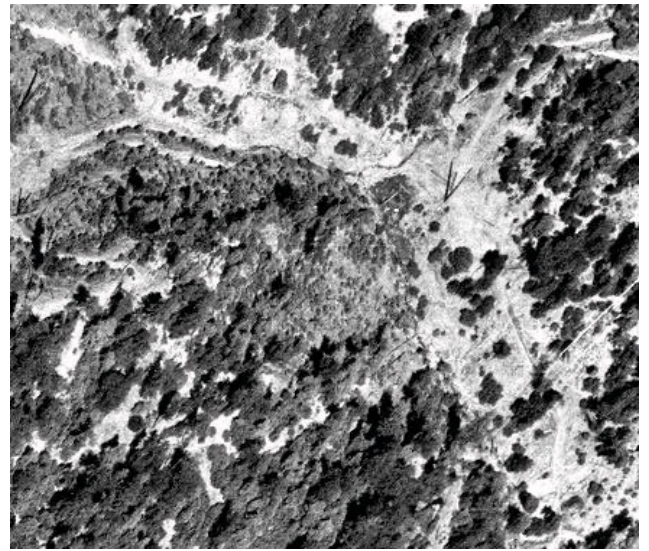
Figure 65: Streamside roads often made several crossings over channel to avoid ungradable obstacles along the streambed in a lower tributary stream to House Creek.

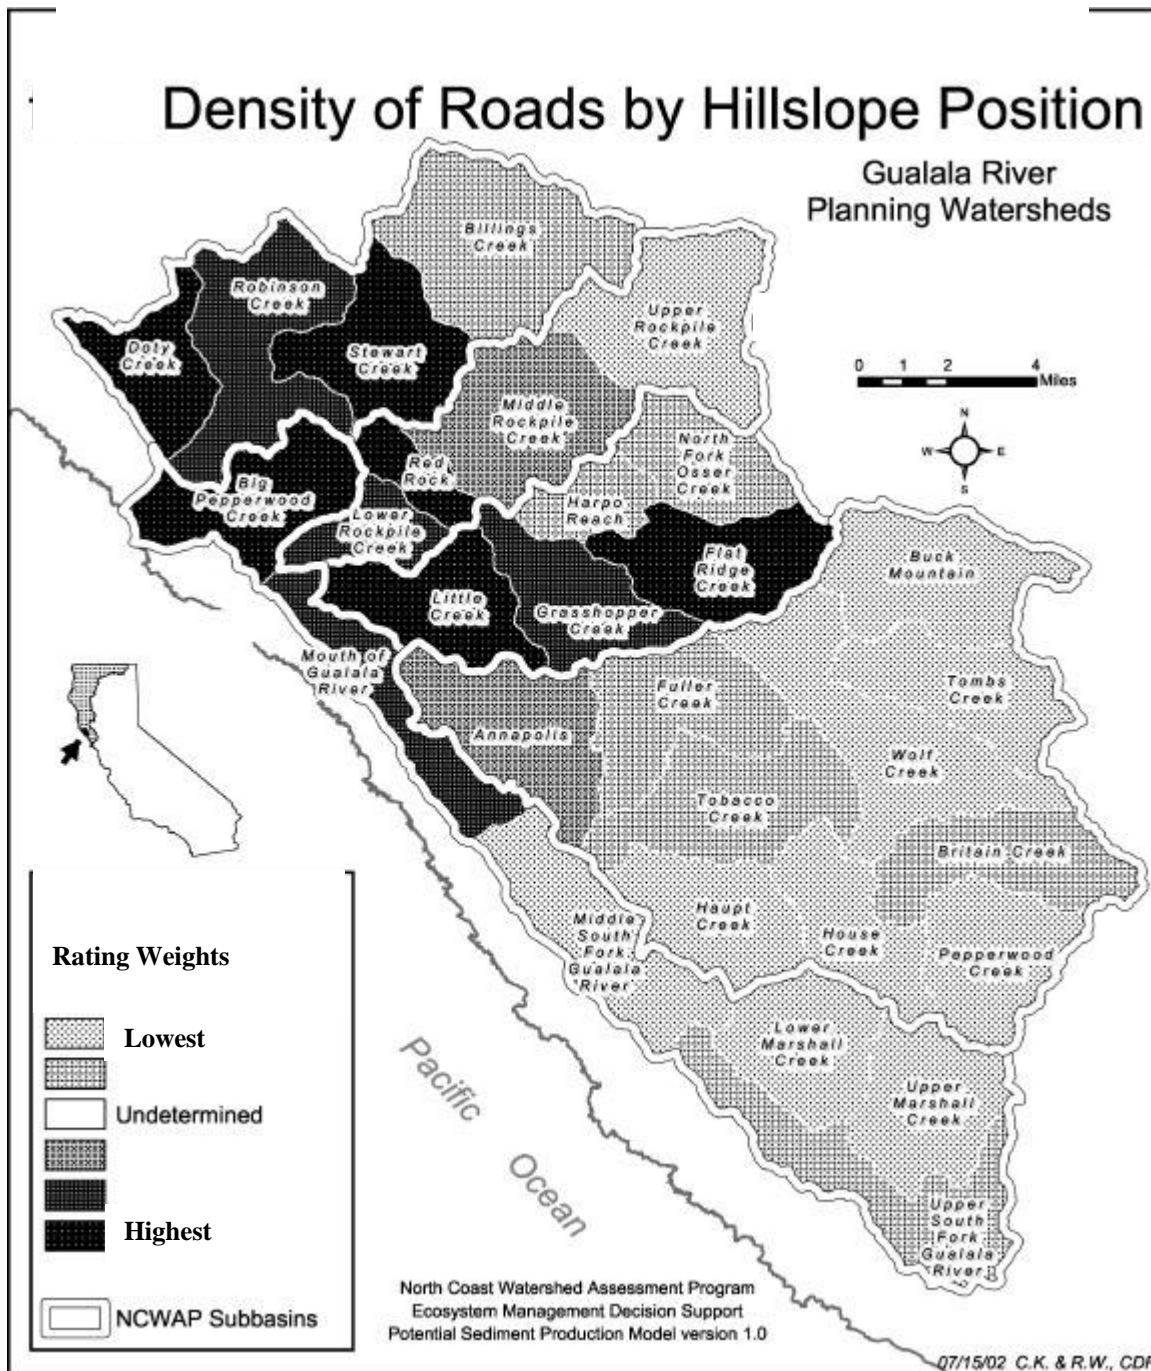
Appendix B: Density of Roads by Hillslope Position shows length of road, weighted by position on the sideslope.. The tones in this map are the length of road in each watershed weighted by their position relative to ridges. Roads in the lowest 40% of slope positions are weighted the highest (0.6), while those close to ridgetops are weighted the lowest (0.1). Roads between are weighted 0.3. Planning watersheds in darker tones show comparatively longer lengths of roads on lower portions of the sideslope.
