5.5 Wheatfield Fork Subbasin

5.5.1 INTRODUCTION

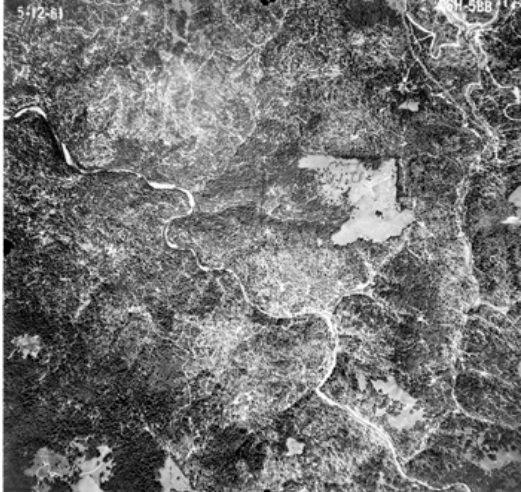
1961 Starting during the mid 1950s, early versions of the D-8 and D-10 tractors block-cleared the entire lower Wheatfield Subbasin. Tractors roamed up and down smaller creeks, and built roads and landings in or along larger streams. The lack of any erosion control measures in these areas made large parts of watershed vulnerable to large storm events. Tractors eliminated riparian canopy cover and in stream Large Woody Debris. There were still consistent coho salmon and larger steelhead counts during this time period.

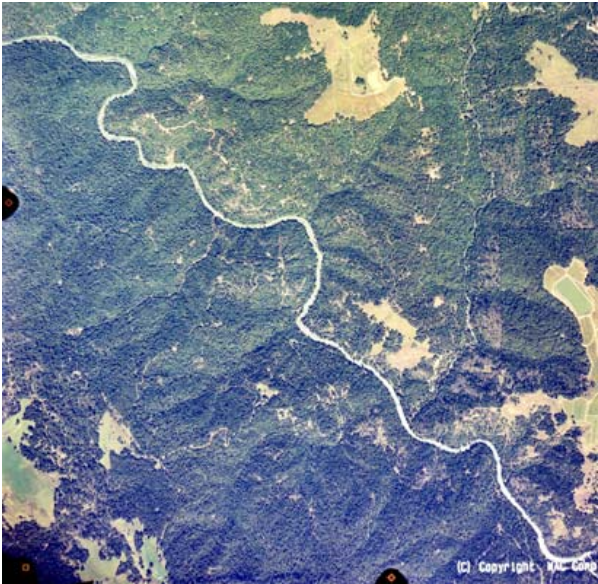
1999 The area is now more fully vegetated. Streamside legacy roads and landings have increasingly stabilized. Deep road and skid trail gullies may have incised down to rock or hard clay. CGS generally found fewer stream channel disturbances compared to 1984. Road related debris slides generally diminished. The Gualala River Watershed Council has removed many of the old log chunk/dirt fill road stream crossings in Fuller Creek (right).

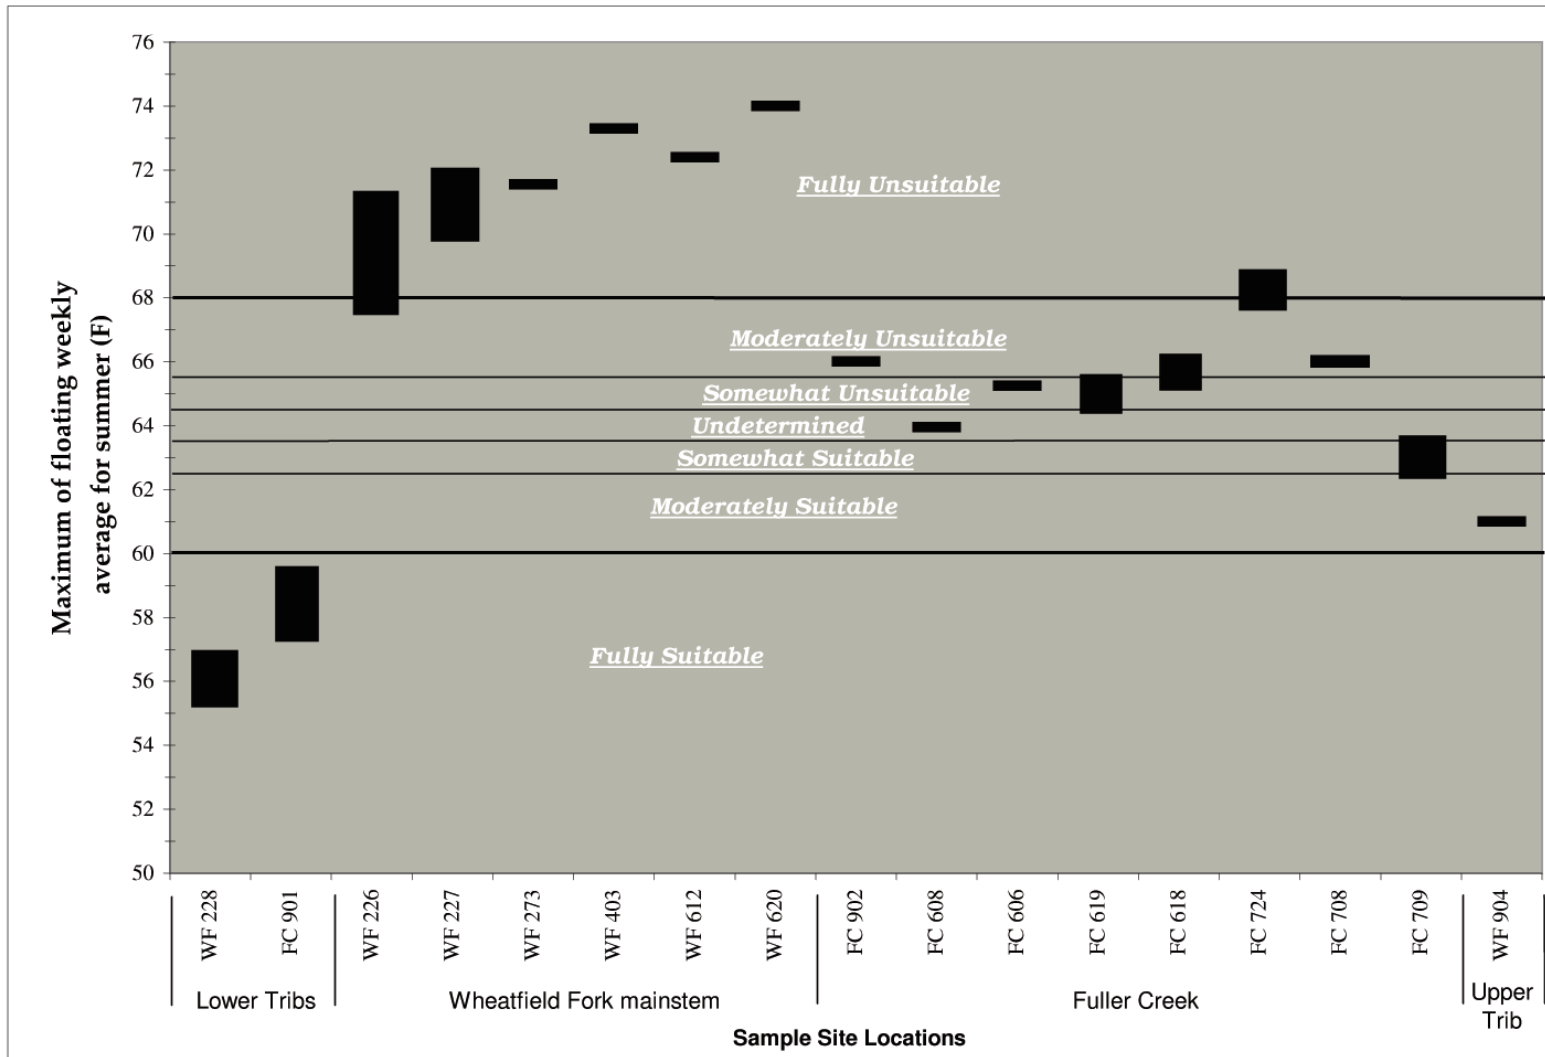
Figure 5.5-13
 MWAT Sample Site Locations in the Wheatfield Fork Subbasin

- Timber harvest operations, including road building in riparian zones, shortly after WW II eliminated overstory shade canopy cover throughout long sections of the Wheatfield Fork and tributaries. There was near entire canopy elimination along the lower main stem and main tributaries, especially pronounced during the mid to late 1950s (Figures 5.5-5 and 5.5-10).
- Water temperatures expressed as MWAT ranged from undetermined to fully unsuitable at 13 of 17 sites in the SPWS (Table 5.5-4). Some evidence of mainstem cooling by Fuller Creek was observed (from site WF620 to WF612) (Figures 5.5-13 and 5.5-14).

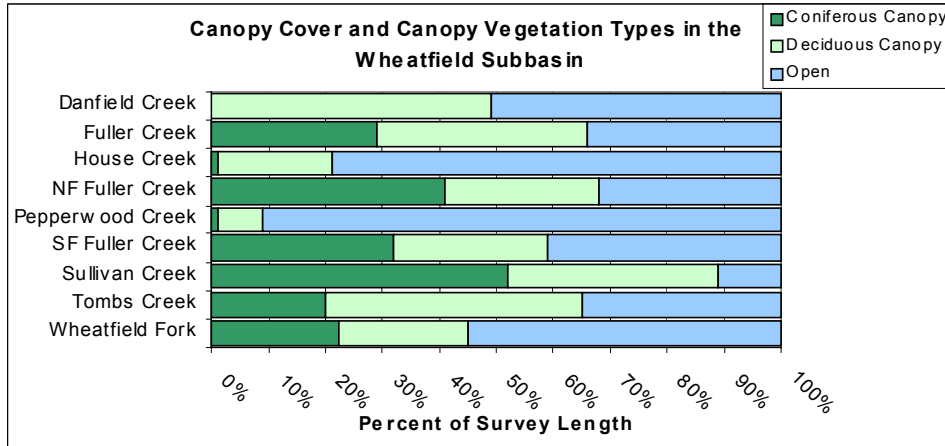
Figure 5.5-15

Canopy Cover and Canopy Vegetation Types by Percent Survey Length in Nine Tributaries, Wheatfield Fork Subbasin 1995 and 2001, Gualala River Watershed, California

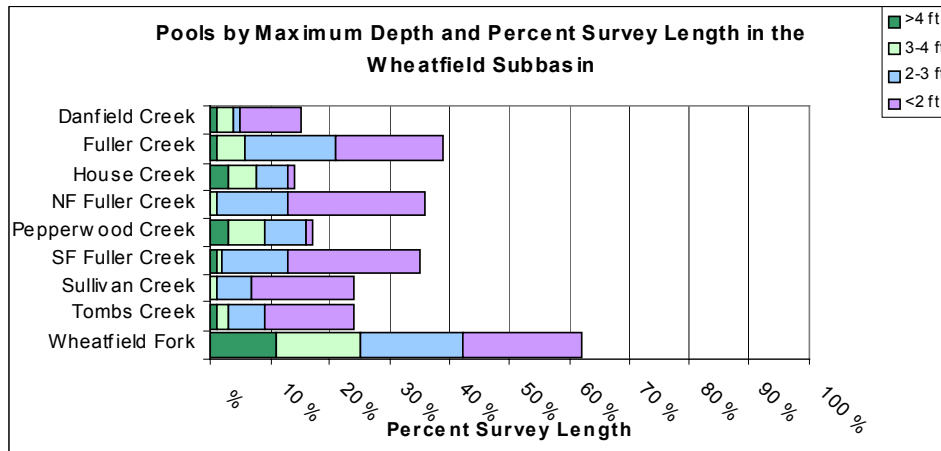
Figure 5.5-17
Pools by Maximum Depth and Percent Survey Length in the Wheatfield Fork Subbasin 1995 and 2001, Gualala River Watershed, California

All streams surveyed in the Wheatfield Fork Subbasin had habitat deficiencies in pool depth (Figure 5.5-17). None of the streams surveyed met pool frequency target values, except the Wheatfield Fork. Wheatfield Fork had a pool frequency of over 40 percent pools, meeting the frequency target value but not the depth target value based on stream order. Wheatfield Fork is a third order stream with a target of 40 percent of pools 3 feet or over. The rest of the streams in the subbasin did not meet the criteria for depth or frequency (Figure 5.5-17).

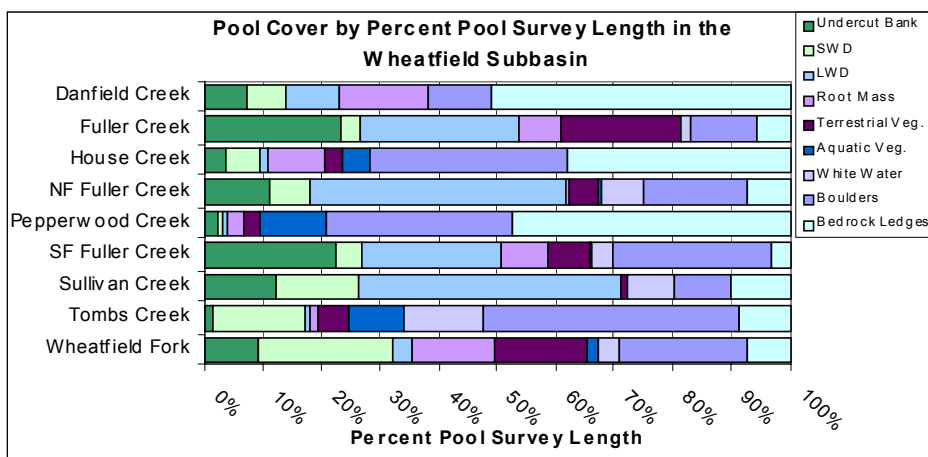
Figure 5.5-19

Type of Pool Cover by Percent of Pool Survey Length in the Wheatfield Fork Subbasin 1995 and 2001, Gualala River Watershed, California
