**Pepper THP  
Section V**

**Table of Contents**

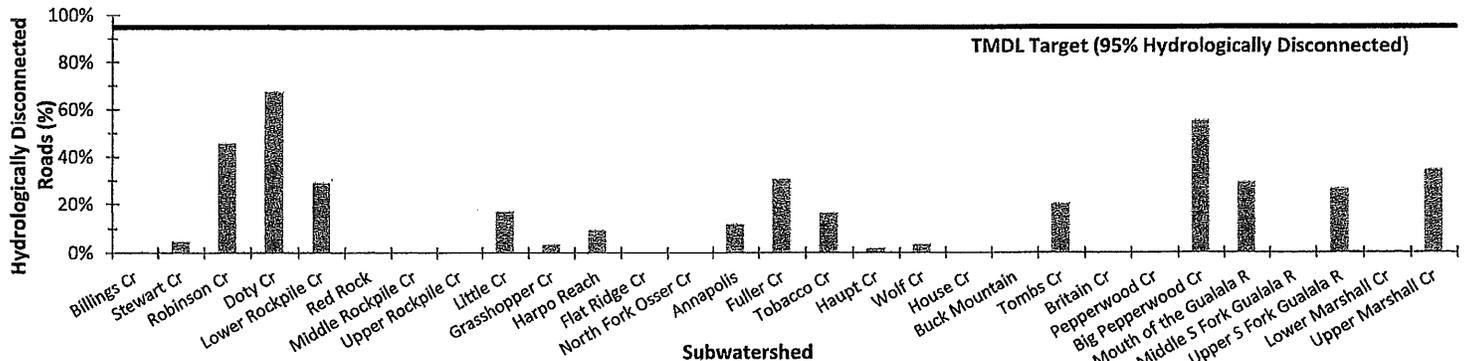
**Percentage of Roads in the Gualala River Subwatersheds that are Hydrologically Disconnected**

Hydrologically disconnected roads do not drain directly into stream channels. When the TMDL was adopted in 2001, almost all the roads were hydrologically connected to streams.

- The percent of hydrologically disconnected roads has increased; however it is still well below the TMDL target.
- Implementation actions have reduced sediment delivery and improved instream conditions and salmonid habitat.
- Streambed conditions are improving; 82% of monitoring sites show reduced sediment deposition and 85% of resurveyed monitoring reaches show streambed deepening.
- GRWC's "Large Wood in the Stream" program has improved fish habitat by controlling sediment movement and increasing size, depth, and frequency of pools.
- Road projects on over 263 miles have reduced sediment input by an estimated 500,000 tons.

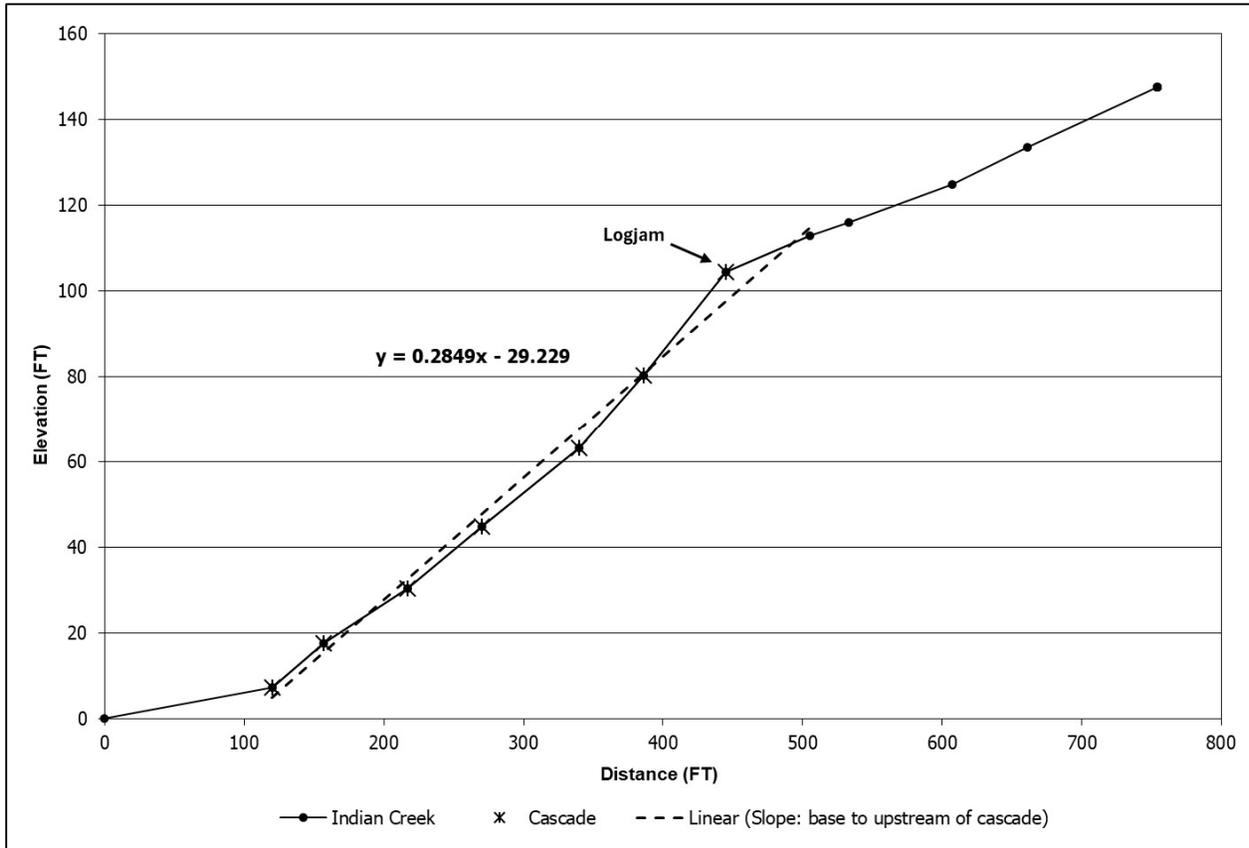
Figure 2: Channel Elevation Profile of the Cascade Barrier in Indian Creek.

During the assessment of the barrier, I noted a small landslide on the upstream-most-end, at the site of an accumulation of boulder and large wood (“Logjam” in Figure 2). To determine to what extent this accumulation might be influencing the steep gradient, I performed a longitudinal elevation profile starting at the base of the cascade and extending upstream of it for 300 additional feet. The slope of the channel from the base of the cascade to a point just upstream averages 28% for 385 feet. The cascade/jam is not retaining sediment, and Indian Creek continues steeply at an average of 14% gradient for 300 feet, indicating that this reach would continue to be naturally steep absent the jam (Figure 2).

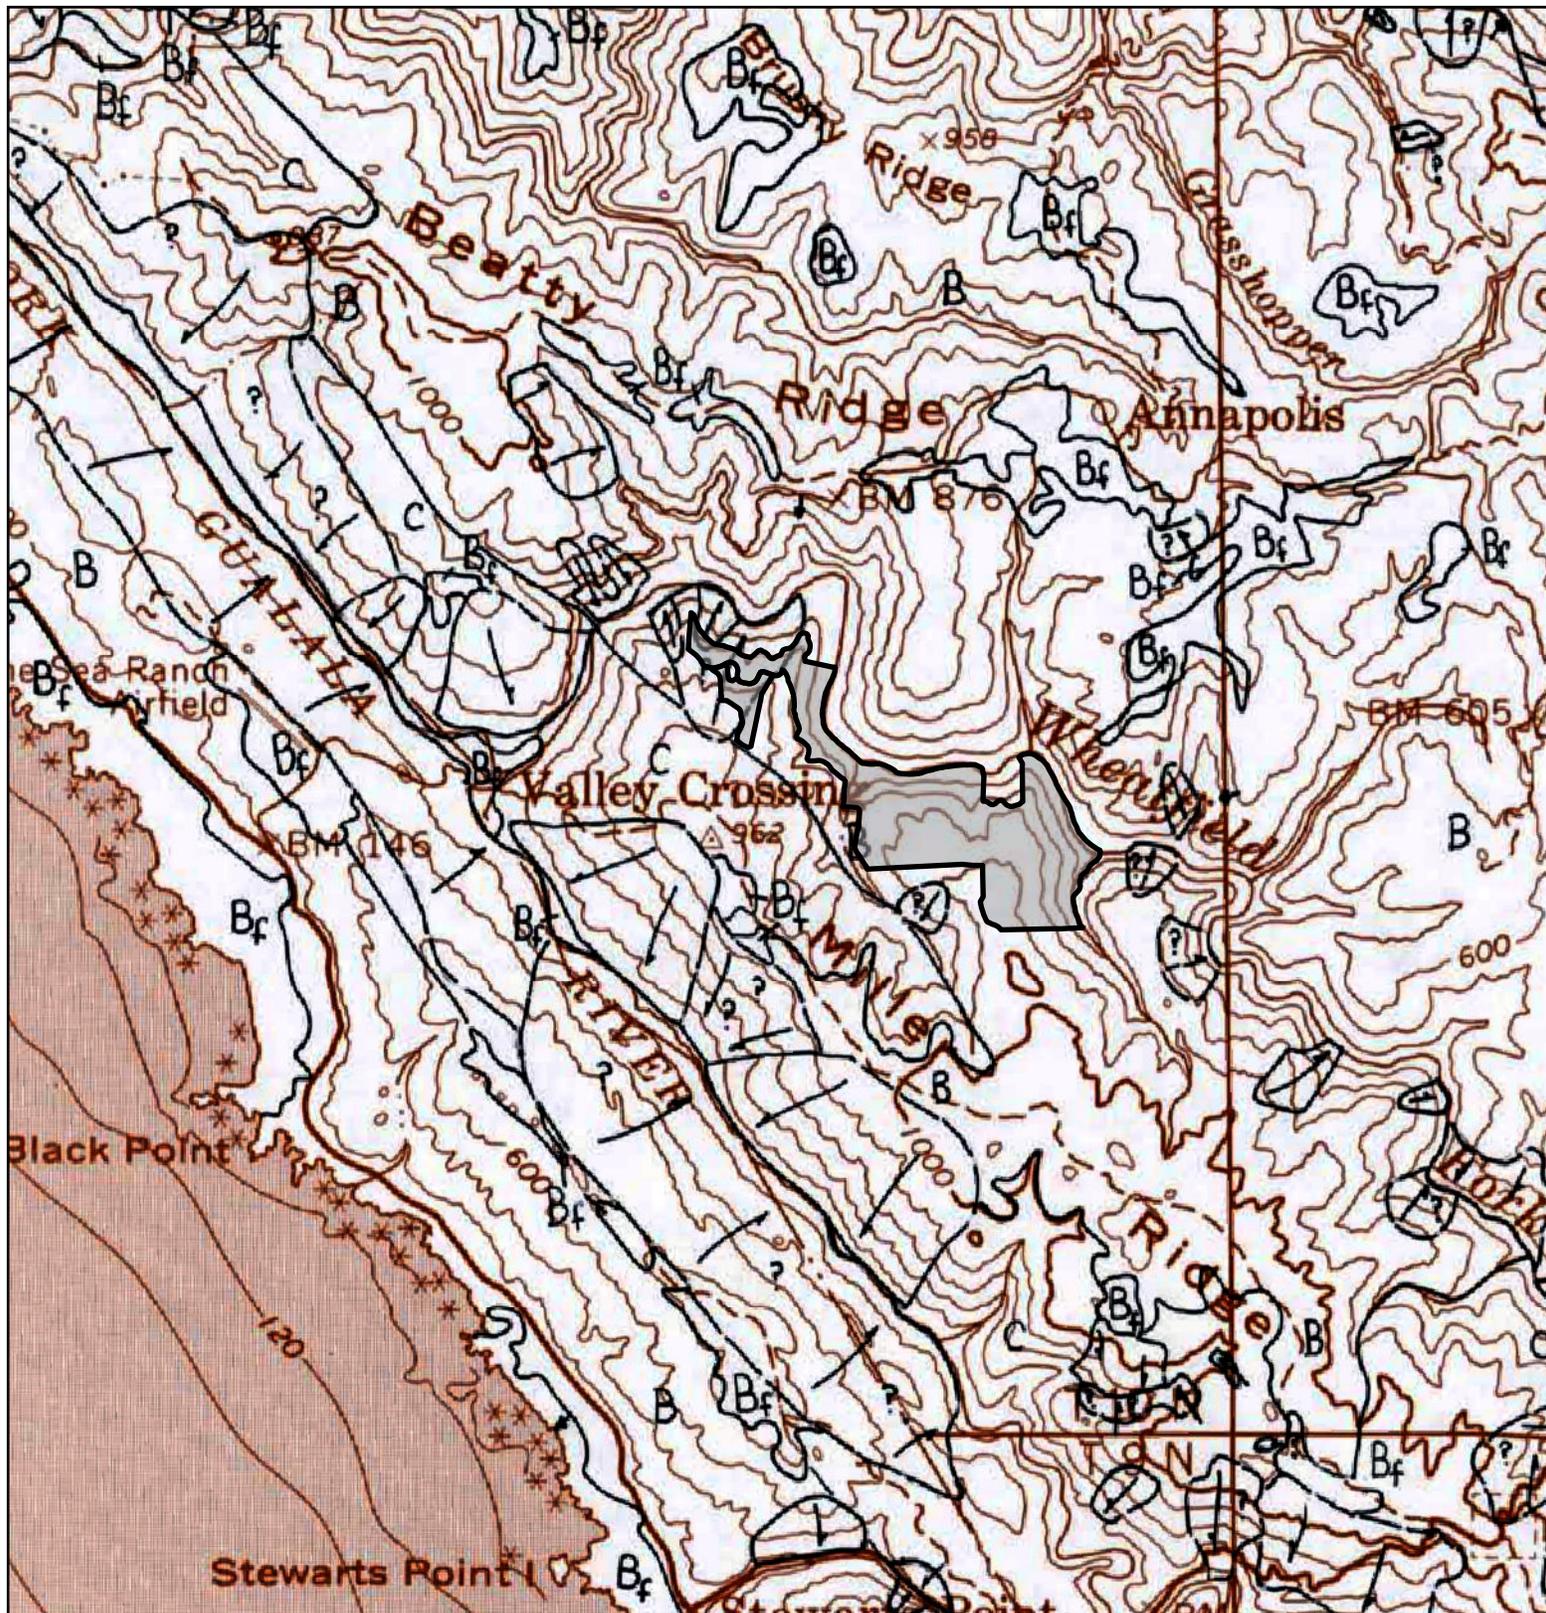
Pepper THP  
Landslide and Relative  
Stability

Figure: 3	T10N R14W Sec 14,15,22 23, and 24	Portions of Stewarts Point and Annapolis 7.5' USGS Topo Quad	Prepared For: Gualala Redwood Timber	Prepared By: J. Kilgore, CE	Date: 6/24/2024
--------------	--------------------------------------	---	---	--------------------------------	--------------------

- Figure 1: Approximate Location of Landslide Features Identified by Huffman/SR-120
- Figure 2: Approximate Location of Landslide Features Identified by Fuller/CGS
- Figure 3-6: Site Observation Maps

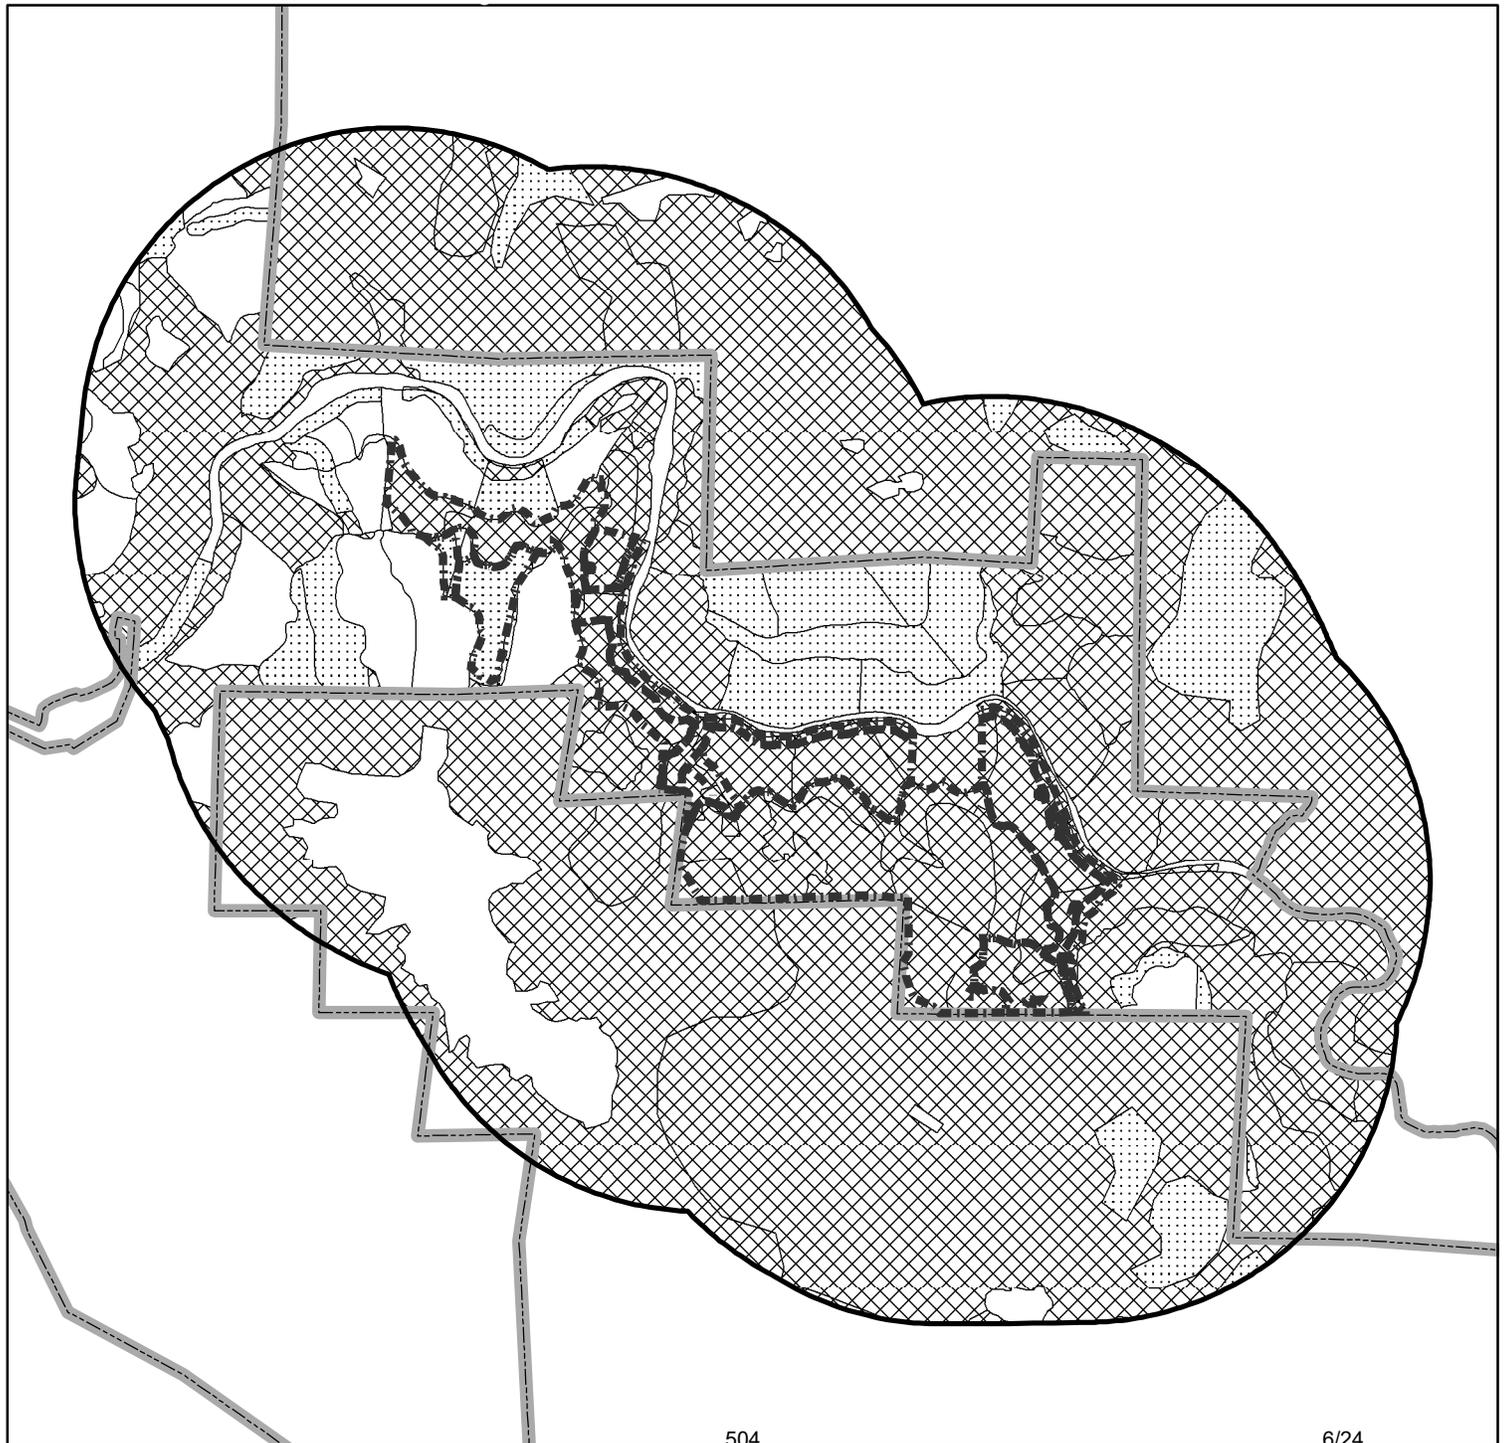
# PEPPER THP PRE HARVEST NSO HABITAT WITHIN 0.7 MILES

## PRE HARVEST HABITAT

NEST/ROOST	2,693 ACRES
FORAGE	414 ACRES
UNSUITABLE	504 ACRES

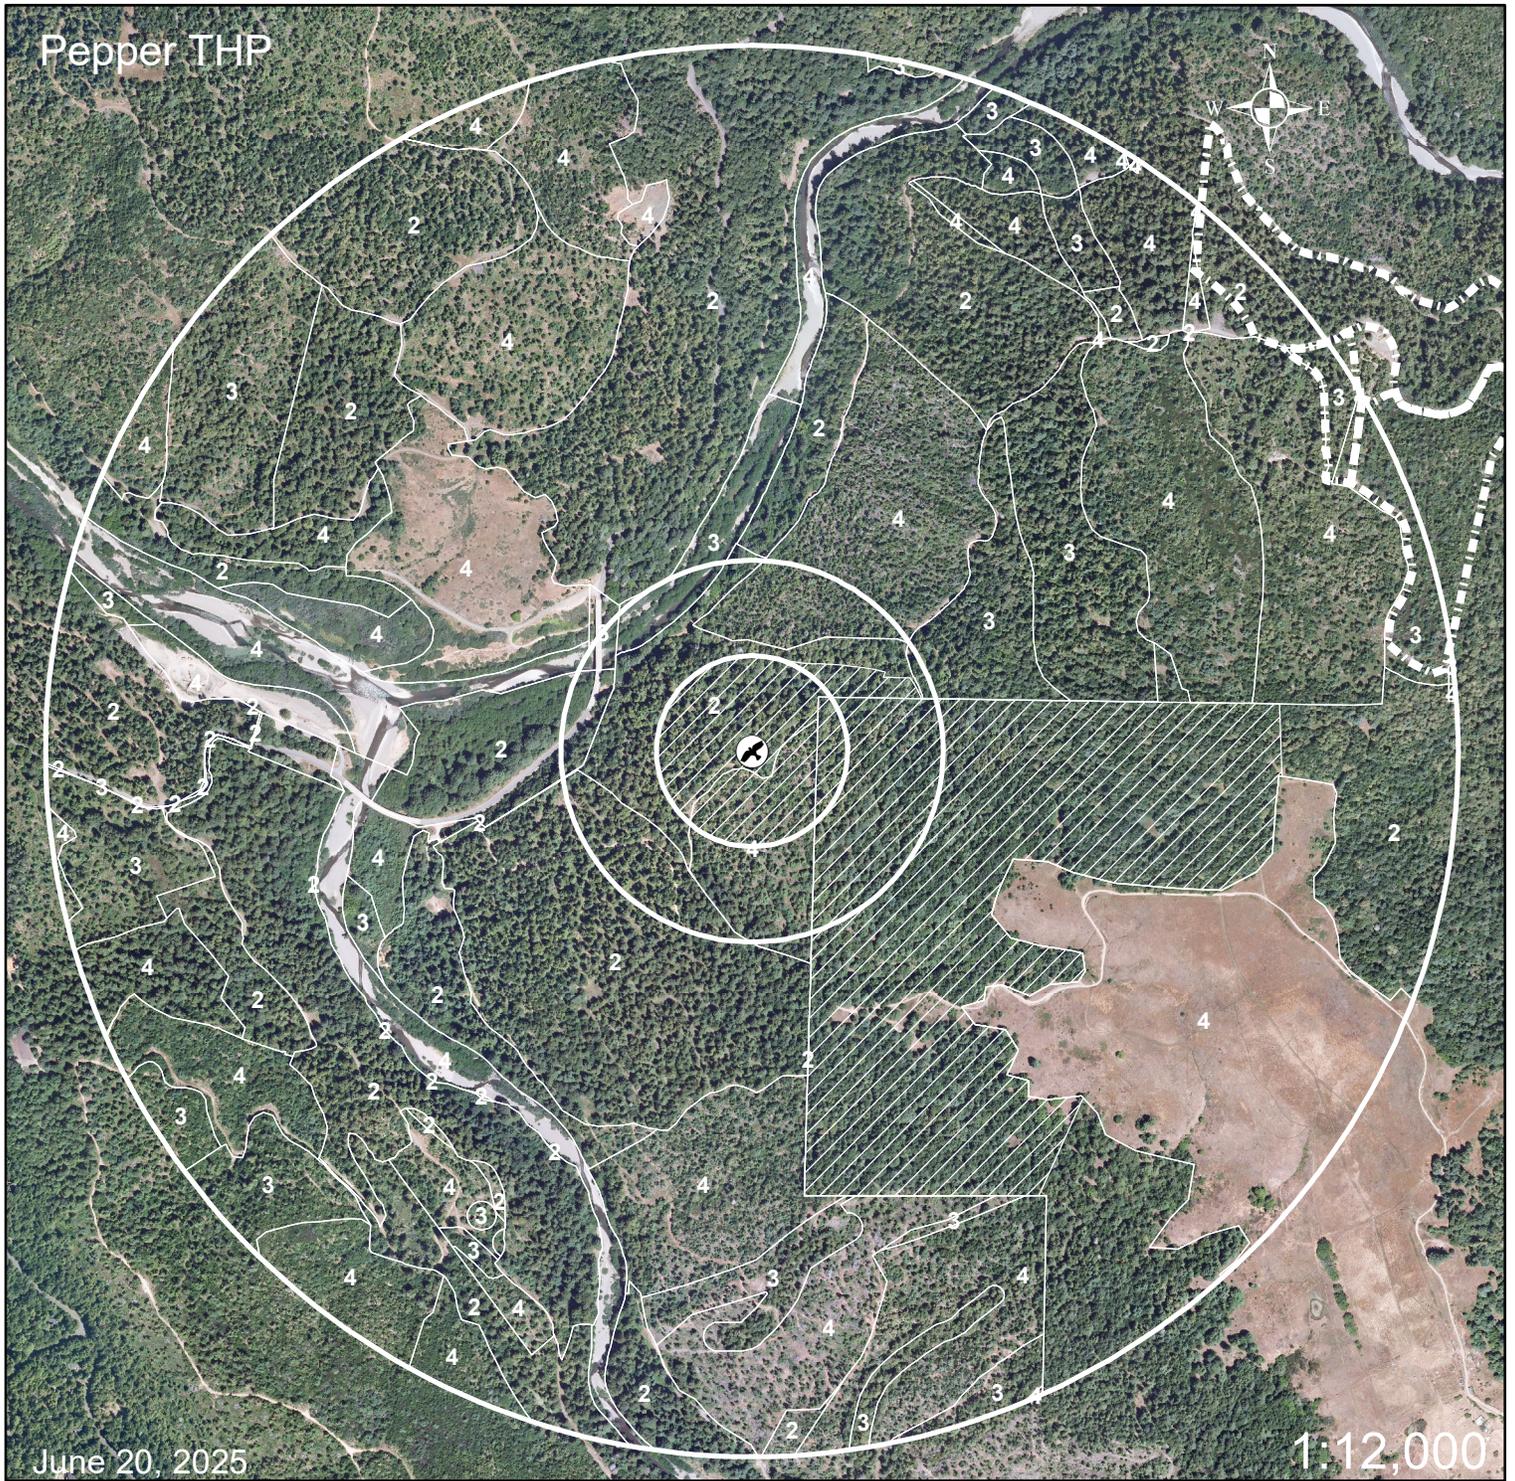
### SON0110 PRE HARVEST HABITAT MAP (0.7 MILE)

UNSUITABLE

#### HABITAT TOTALS
