# Copper Top THP

## Section V

# Engineering Geologic Evaluation of the Copper Top Timber Harvest Plan

Mendocino County, California

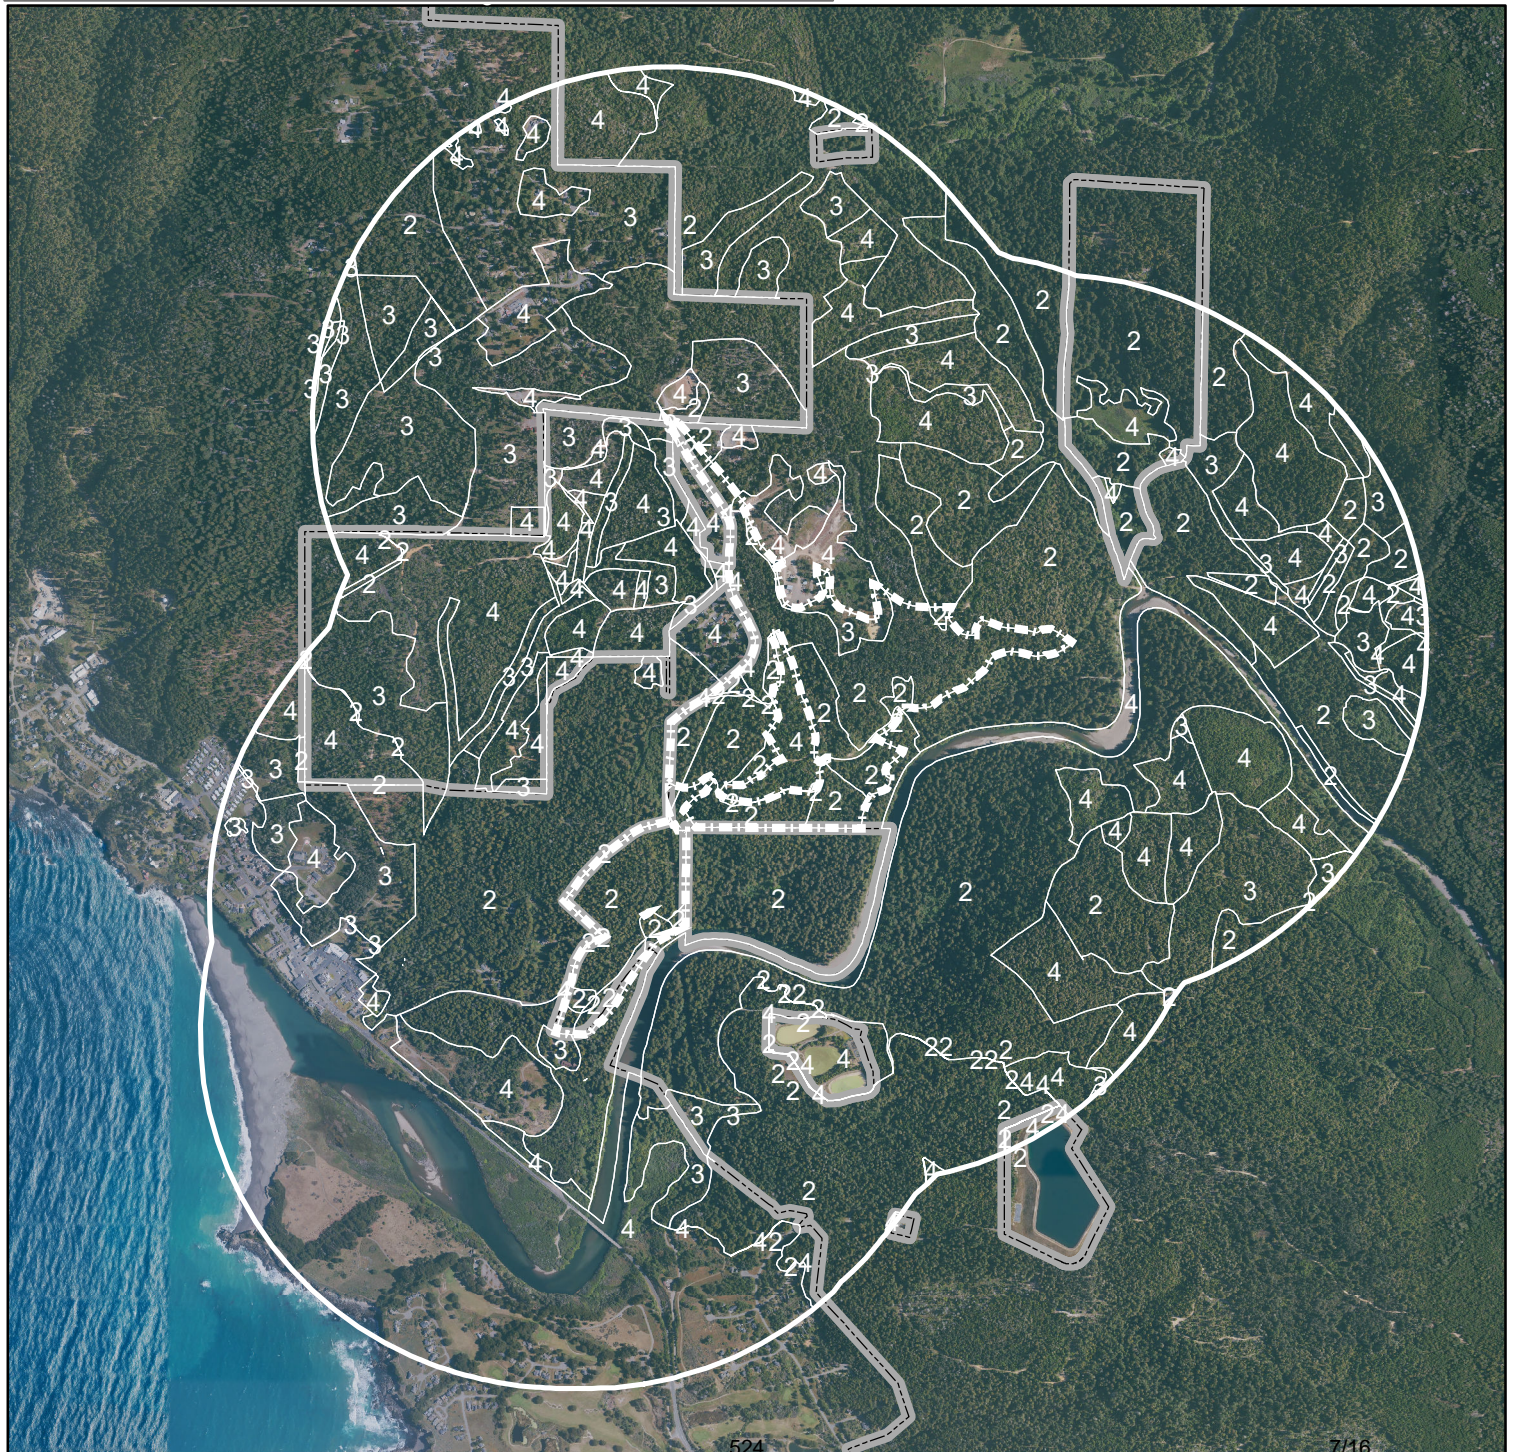
# COPPER TOP THP PRE AND POST HARVEST NSO HABITAT WITHIN 0.7 MILES

## PRE AND POST HARVEST HABITAT

NEST/ROOST	1356 ACRES
FORAGE	463 ACRES
UNSUITABLE	1008 ACRES

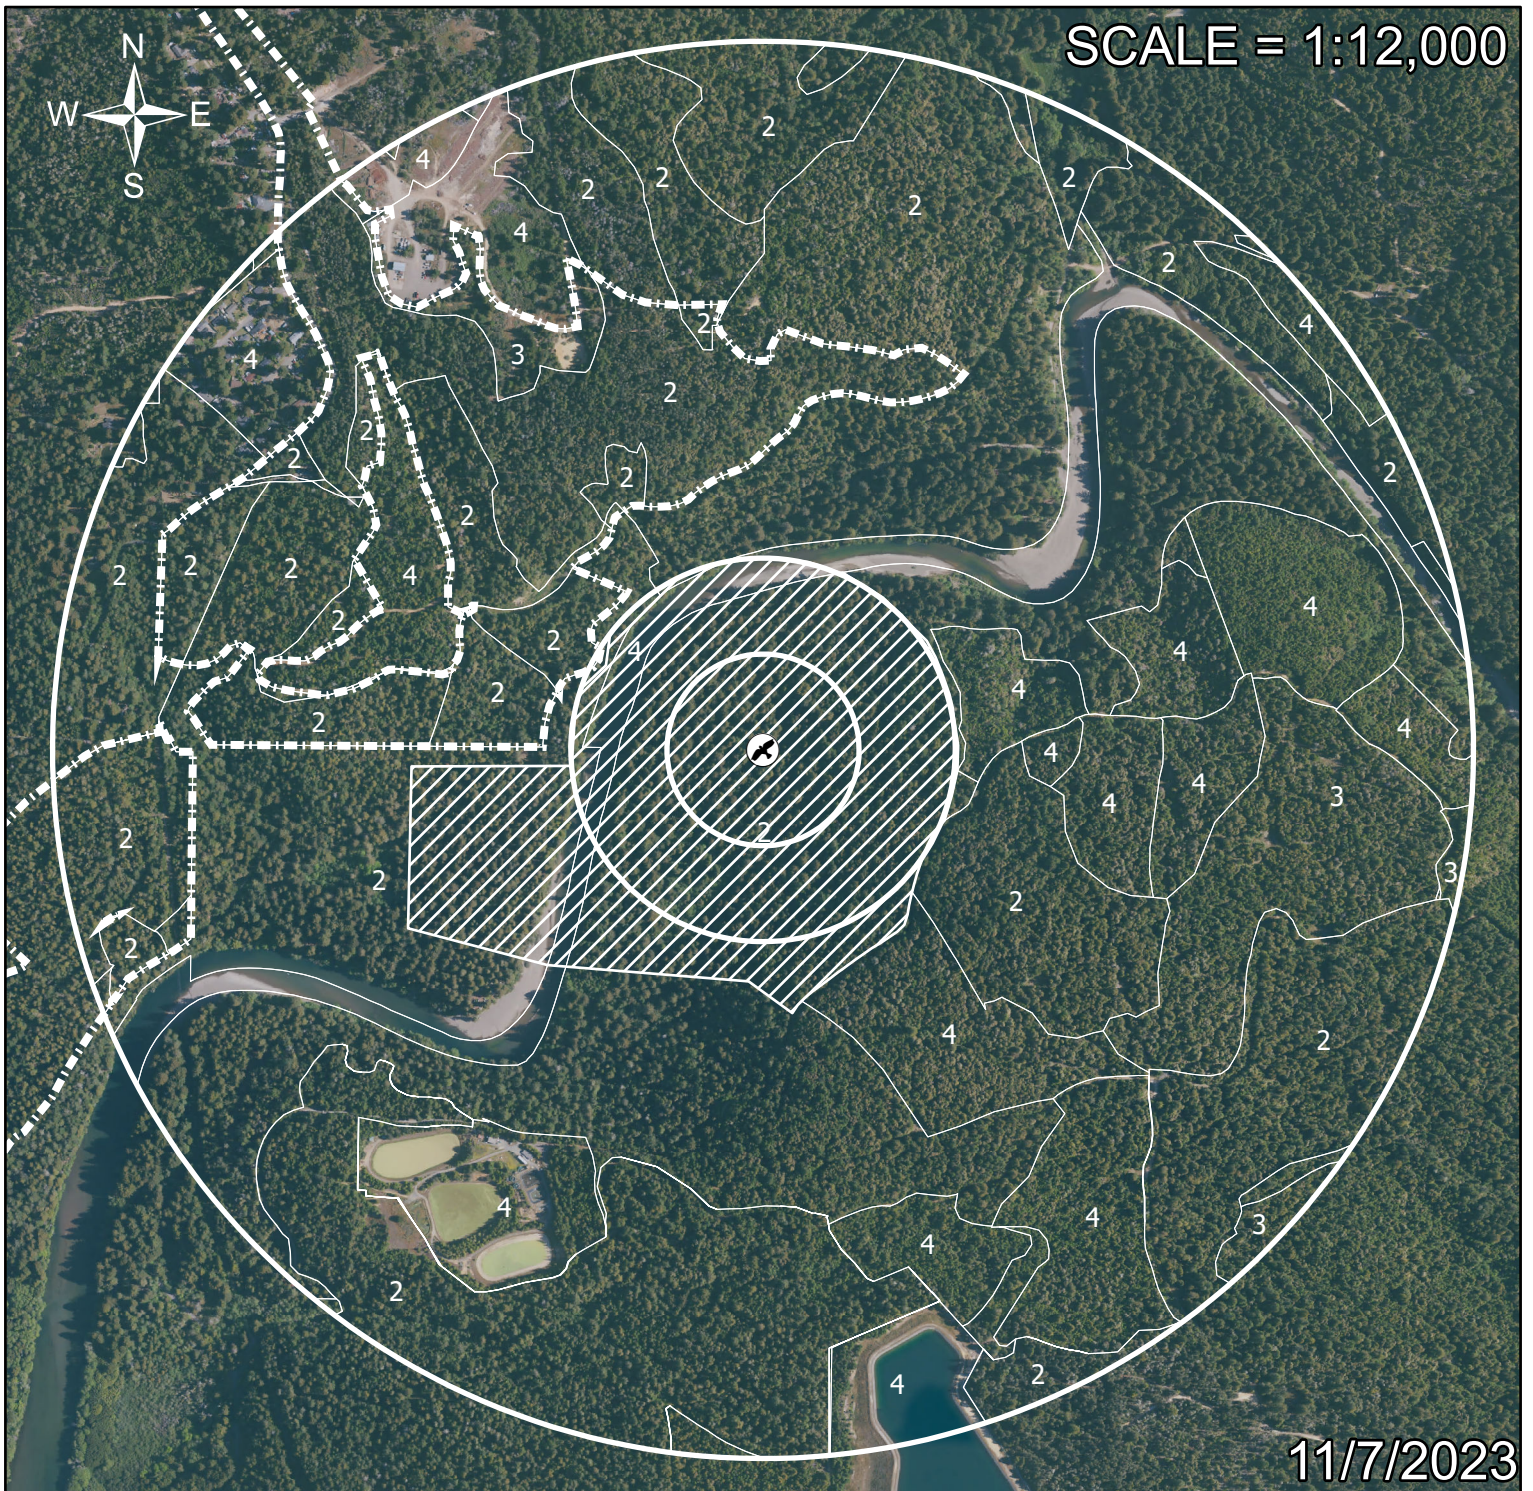
# COPPER TOP THP SON0082 PRE-HARVEST HABITAT MAP

## HABITAT TOTALS
