## 5.3 Rockpile Subbasin

The Rockpile Subbasin (Calwater 2.2a 113.82 Rockpile Creek SPWS) is bounded to the north by the North Fork Subbasin and to the south by the Buckeye Subbasin. It encompasses 35 square miles of private land primarily used for timber production and grazing. This subbasin is steeper than the North Fork Subbasin and with the same zig-zag pattern to the main channel. There are 88 miles of “blue line” streams, and two major tributaries: Red Rock Creek and Horsethief Canyon (Figure 5.3-1).

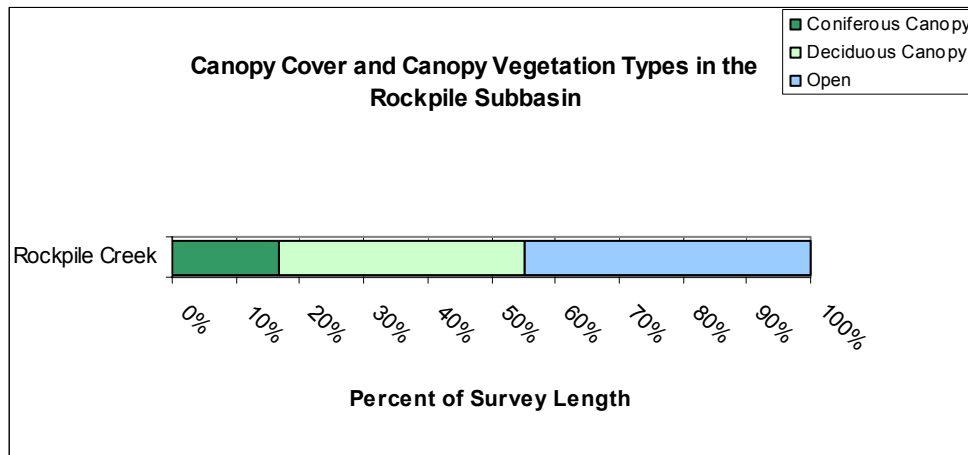
**Figure 5.3-13**  
 Canopy Cover and Canopy Vegetation Types by Percent Survey Length in Rockpile Creek, Rockpile Subbasin 2001, Gualala River Watershed, California

Rockpile Creek is a second order stream. The habitat inventory survey data showed habitat deficiencies related to canopy cover, pool frequency/depth, and shelter cover. Canopy cover was 55 percent in the lower five miles of Rockpile Creek with conifers contributing 15 percent and deciduous 40 percent (Figure 5.3-13). Fifty-two percent of pool tails surveyed in Rockpile Creek were category 1 or 2 embeddedness (Figure 5.3-14). Twenty-two percent of the survey length consisted of primary pools (Figure 5.3-15). Shelter/cover received a rating of 41 (Figure 5.3-16), and most of the cover was provided by undercut banks, large woody debris, and root masses (Figure 5.3-17).

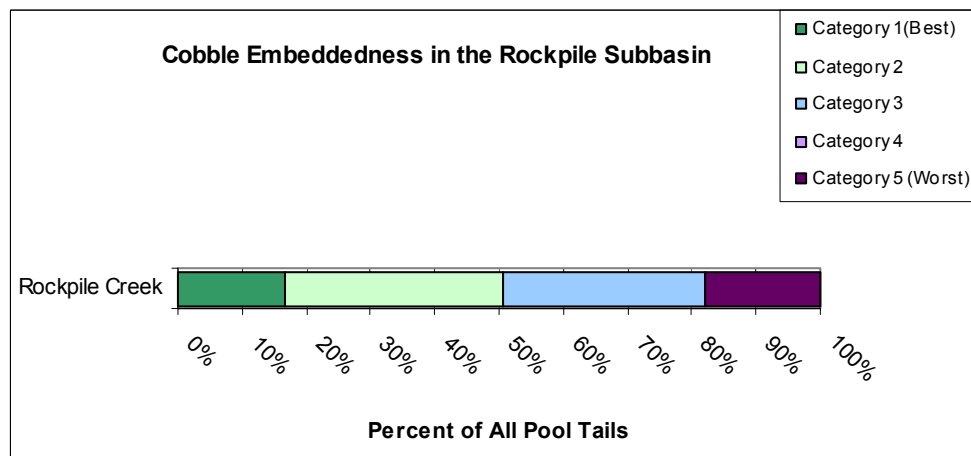
**Figure 5.3-14**  
 Cobble Embeddedness in the Rockpile Subbasin 2001, Gualala River Watershed, California

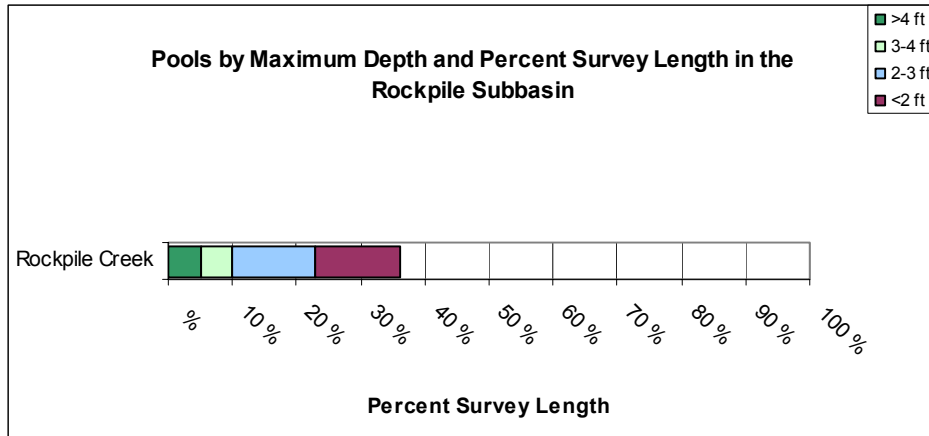
**Figure 5.3-15**

Pools by Maximum Depth and Percent Survey Length in the Rockpile Subbasin 2001, Gualala River Watershed, California

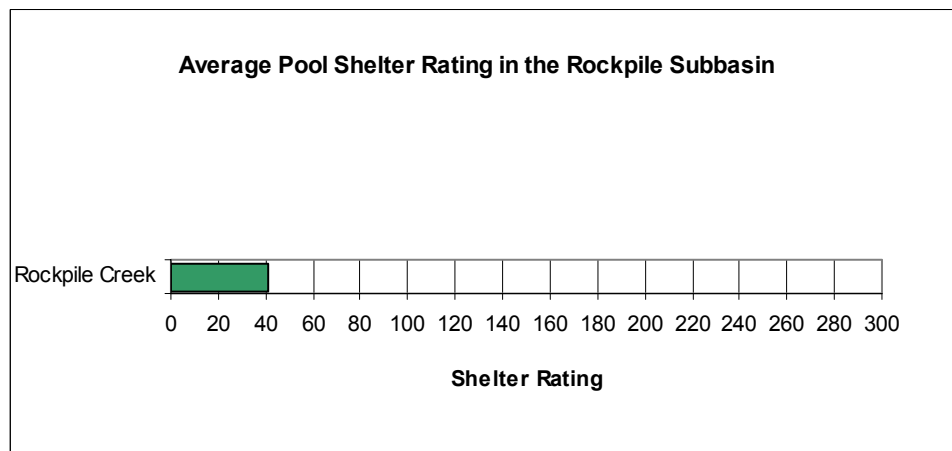
**Figure 5.3-16**

Average Pool Shelter Ratings in the Rockpile Subbasin 2001, Gualala River Watershed, California

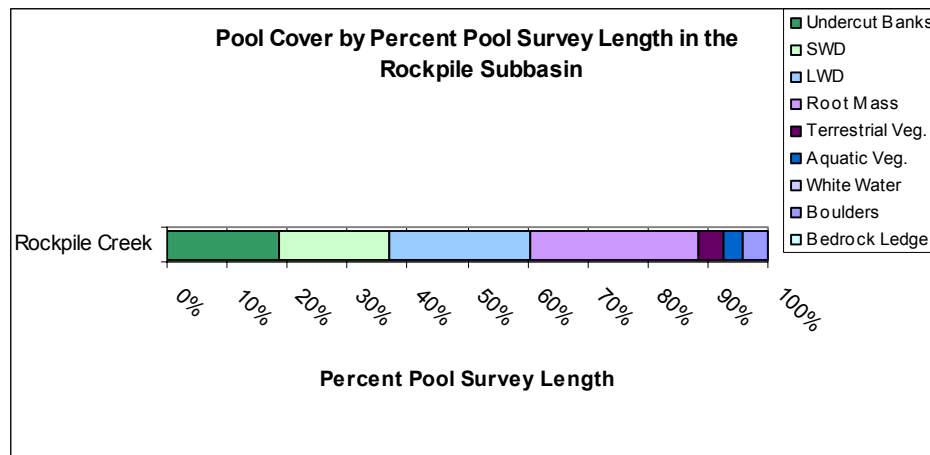
**Figure 5.3-17**

Pool Cover by Percent of Pool Survey Length in the Rockpile Subbasin 2001, Gualala River Watershed, California
