## 5.4 Buckeye Subbasin

### 5.4.1 INTRODUCTION

The Buckeye Subbasin (Buckeye Creek Super Planning Watershed, Calwater 2.2a 113.83) is bounded to the north by the Rockpile Subbasin and to the south by the Wheatfield Subbasin. It encompasses 40.3 square miles of private land used primarily for timber production, grazing, and small vineyards. It contains more moderate terrain compared to the North Fork and Rockpile. There are 90 miles of “blue line” streams, and three major tributaries: Flat Ridge, Grasshopper, and Osser creeks (Figure 5.4-1).

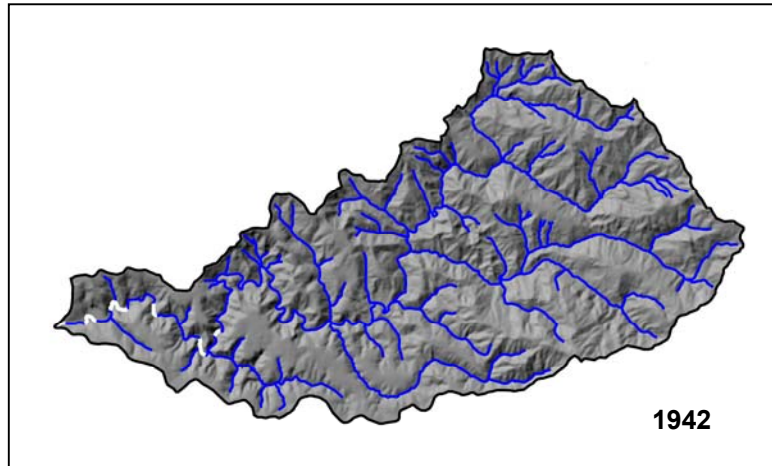
**Figure 5.4-5**  
Bank-to-Bank Stream Exposure (White) and Partial to Entire Cover (Dark Blue) in 1942

The wider Buckeye Subbasin contains high site redwood ground in the lowest reaches. Further inland, Douglas fir and then mixed conifer-hardwood predominates. Oak and prairie grassland is the dominant vegetation type east of Osser and Flat Ridge creeks. As in Rockpile Creek, the 1942 photos show mature coniferous shade canopy cover over all primary streams. Only in the lowest reaches near the confluence with the South Fork is the main channel of Buckeye Creek wide enough to result in bank-to-bank exposure (Figure 5.4-5).

Bank-to-bank overstory shade canopy cover for 1999 (Figure 5.4-9) shows improvement compared to 1968, reflecting riparian in-growth since the late 1960s. In 1942, approximately 2 percent of the blue line streams were exposed bank to bank (Figure 5.4-5), limited to alluvial openings in the lower subbasin reaches throughout generally wooded conditions. In 1968, approximately 60 percent of the blue line streams were exposed bank-to-bank by the end of the tractor harvesting era. By 1999, this improved to approximately 25 percent of blue line streams exposed bank-to-bank (Figure 5.4-9). Coastal Forestlands reported reinstatement of overstory shade canopy in numerous upper reach tributary watercourses (Coastal Forest Lands’ 1997 Sustained Yield Plan). Coastal Forest Lands, Ltd. (CFL) no harvest Watercourse and Lake Protection Zones (WLPZs) are routinely stipulated for all THPs along Buckeye Creek and Class II tributaries to mitigate temperature impairment throughout the subbasin. Canopy cover is lacking in most areas along the mainstem Buckeye Creek, in the middle to upper reaches.

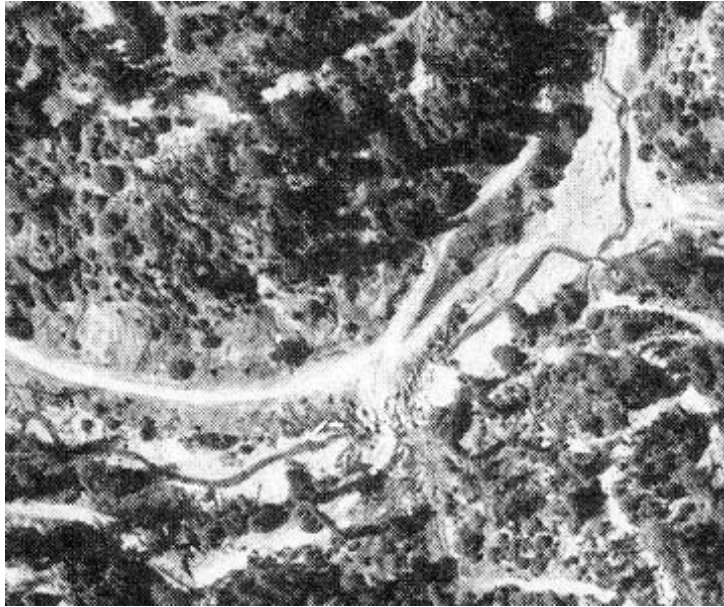
**Figure 5.4-7**  
Tractor yarding was active in the Grasshopper Creek Subbasin in the mid 60s, leaving logs and wood debris piled over the stream channel. During the 1964 flood, this debris floated down to a low road crossing of Grasshopper Creek (left), creating a jam. The resulting dam breached at the south road approach, diverting onto the west road approach, which collapsed into the creek

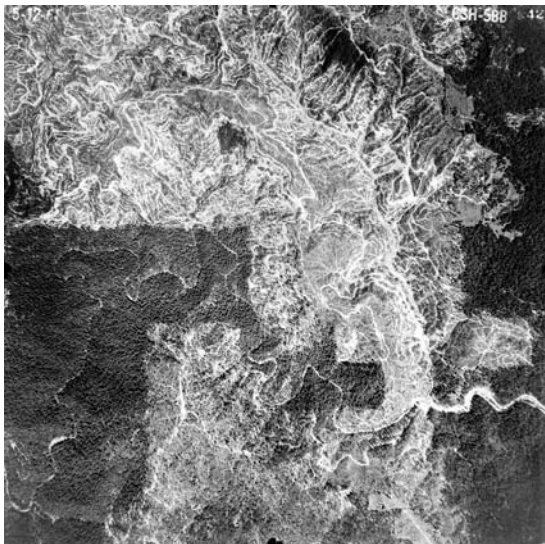
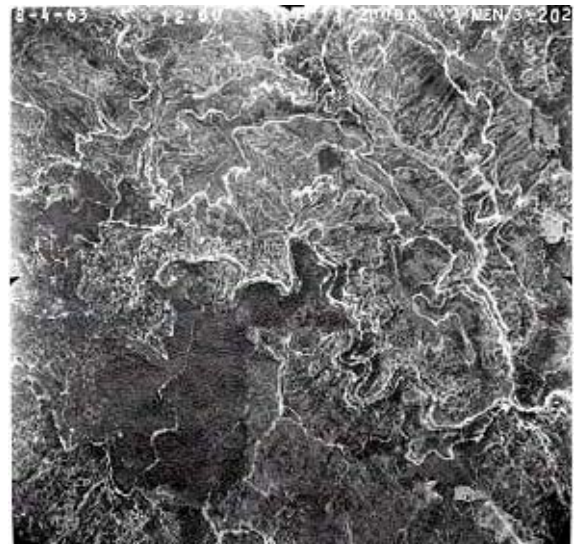
**Figure 5.4-8**  
Middle reaches of Buckeye Creek 1960, and same area (right) by 1963 showing a high rate of old growth harvesting in a three-year time period. Franchini Creek is in the center right of each photo. Note entire bank-to-bank stream exposure as a result of these operations.

In the late 1950s, the Franchini Creek watershed and surrounding area formed the south portion of the large multi-basin harvest complex area bounded by the upper North Fork and the mainstem Buckeye Creek. This unit followed a large mid-1950s operation that extended south from the mainstem Buckeye Creek through the lower Wheatfield Subbasin to lower Fuller Creek. In the middle 1950s, downslope Douglas fir trees lining a narrow riparian corridor were removed from both Roy and Osser creeks. The Grasshopper Creek Planning Watershed (PWS) was logged by 1964 (Figure 5.4-7). Downslope areas of Douglas fir were logged throughout Soda Springs and Flatridge creeks by 1964. Between 1952 and 1964, 61.5 percent of the subbasin had been tractor harvested prior to the 1964 storms (Table 5.4-1). Streamside roads and landings were concentrated throughout: (1) Franchini Creek, (2) Grasshopper Creek, and (3) the North Fork Buckeye including Osser Creek (Figure 5.4-6). By the end of the tractor era in 1968, 69.5 percent of the subbasin had been harvested (Figure 5.4-8 and Table 5.4-1).

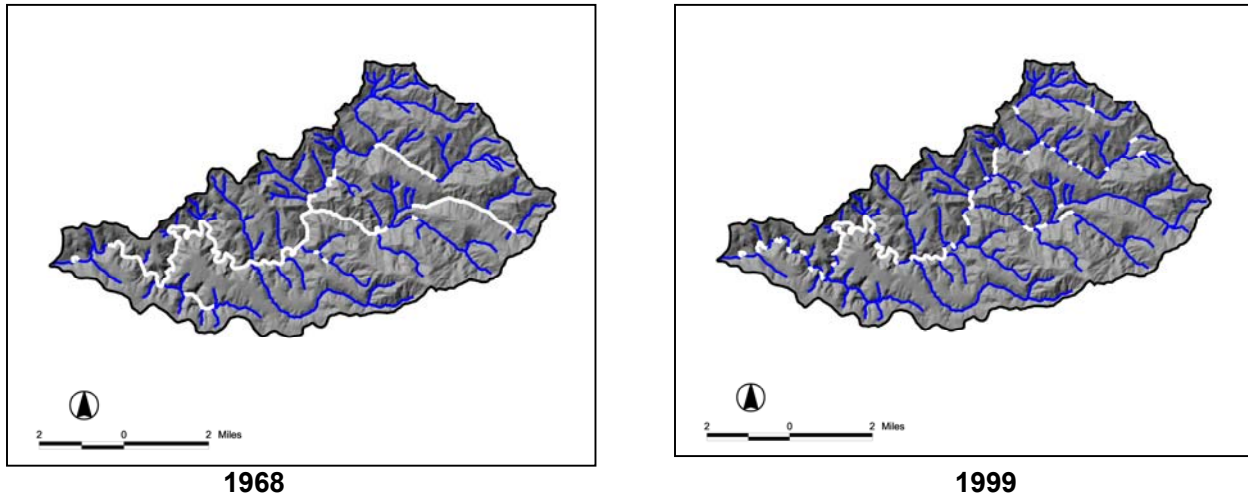
**Figure 5.4-9**  
 Bank-to-Bank Canopy Exposure (White) in the Buckeye Subbasin in 1968 (Left) and 1999 (Right)  
 (Dark blue lines show partial to entire canopy cover )

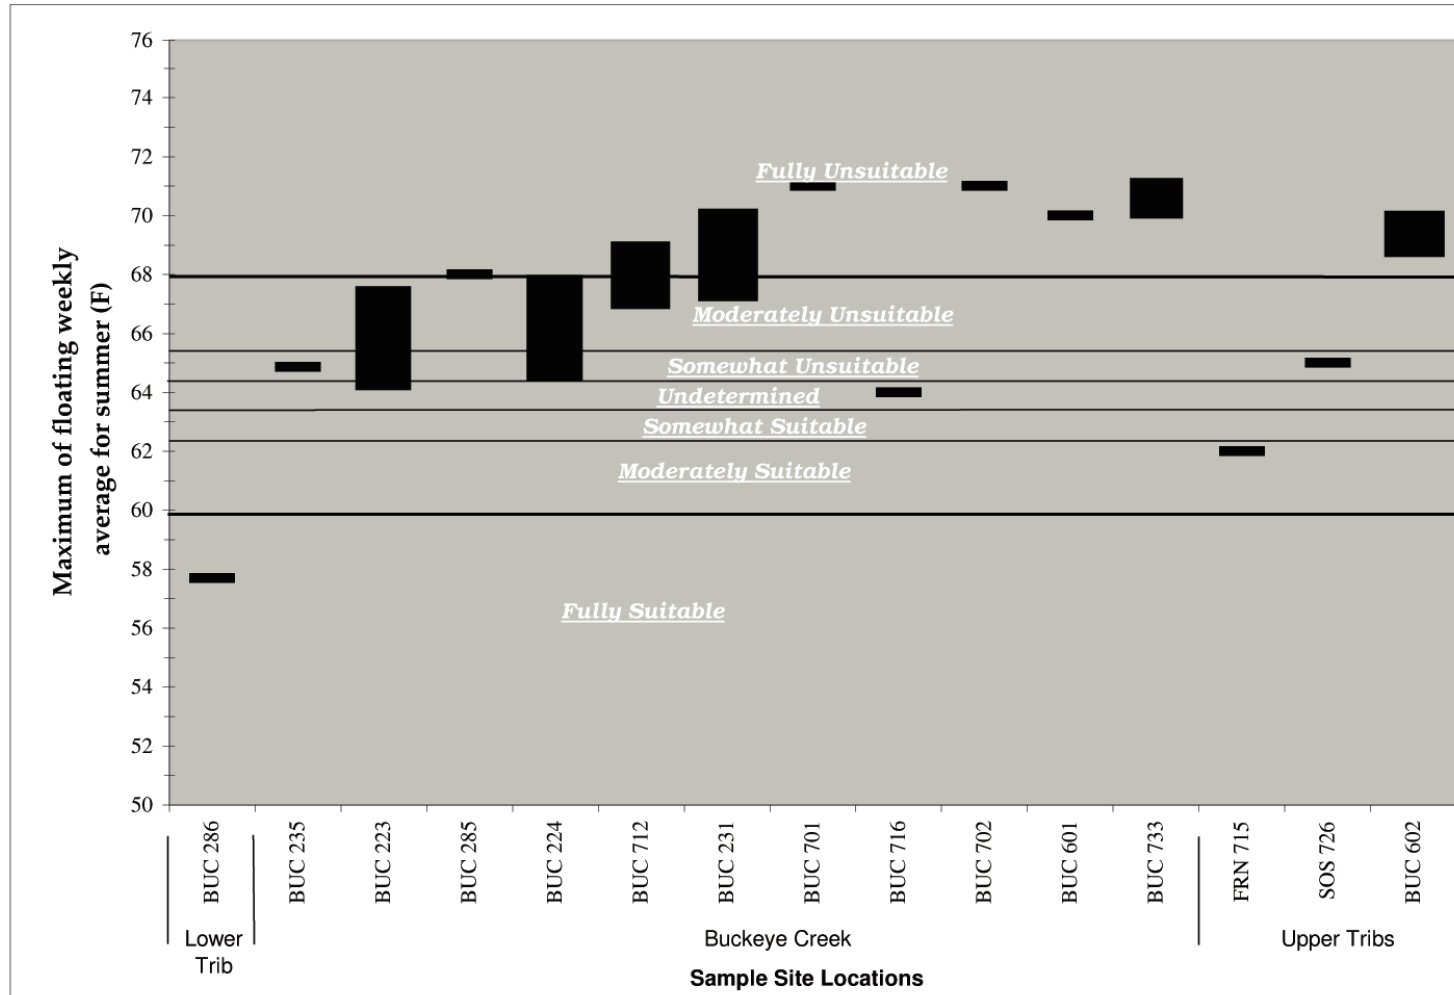
**Figure 5.4-12**  
 Maximum Weekly Average Temperature (MWAT) Ranges for the Buckeye Subbasin from 1995-2001  
 (Data From GRI And GRWC Continuous Monitoring Devices)

MWATs in the mainstem ranged from undetermined to fully unsuitable (Table 5.4-4). MWATs in Flatridge, Soda Springs, and Grasshopper creeks ranged from moderately to fully unsuitable. MWATs for the lower tributary were fully suitable for the period of record (Table 5.4-4, Figures 5.4-12 and 5.4-13).

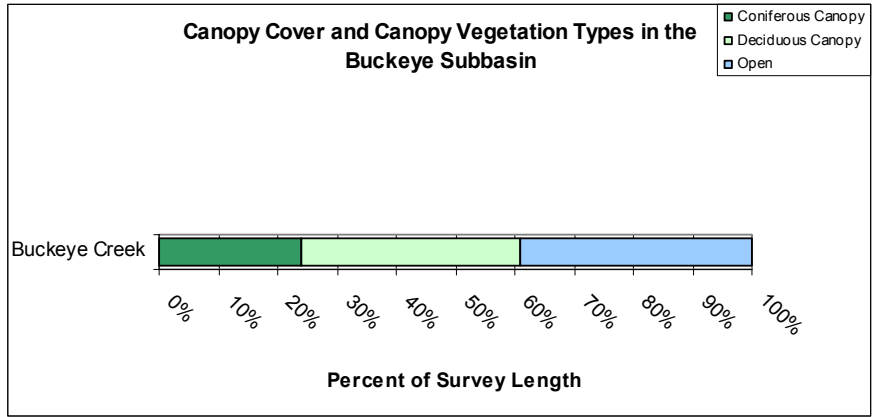
**Figure 5.4-14**

Canopy Cover and Canopy Vegetation Types by Percent Survey Length in the Buckeye Creek, Buckeye Subbasin 2001, Gualala River Watershed, California

Buckeye Creek is a third order stream. Habitat deficiencies were documented by the habitat inventory surveys related to canopy cover, pool frequency/depth and shelter cover. Canopy cover averaged 61 percent with conifers contributing 37 percent and deciduous 24 percent (Figure 5.4-14). Sixty-nine percent of pool tails surveyed in Buckeye Creek were category 1 or 2 embeddedness (Figure 5.4-15). Buckeye Creek showed 11 percent of the survey length consisted of primary pools (Figure 5.4-16). Shelter/cover received a rating of 44 (Figure 5.4-17), and the cover was provided by large and small woody debris, boulders and root masses (Figure 5.4-18).

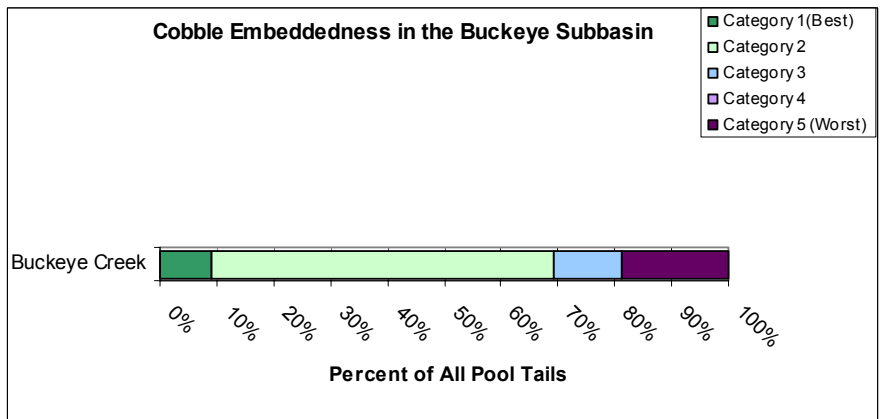
**Figure 5.4-15**

Percent of Cobble Embeddedness in all Pool Tails in the Buckeye Subbasin 2001, Gualala River Watershed, California

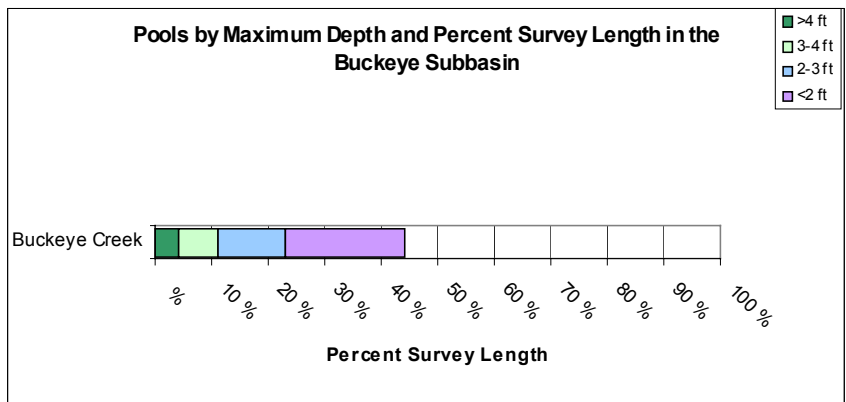
**Figure 5.4-16**

Pools by Maximum Depth and Percent Survey Length in the Buckeye Subbasin 2001, Gualala River Watershed, California

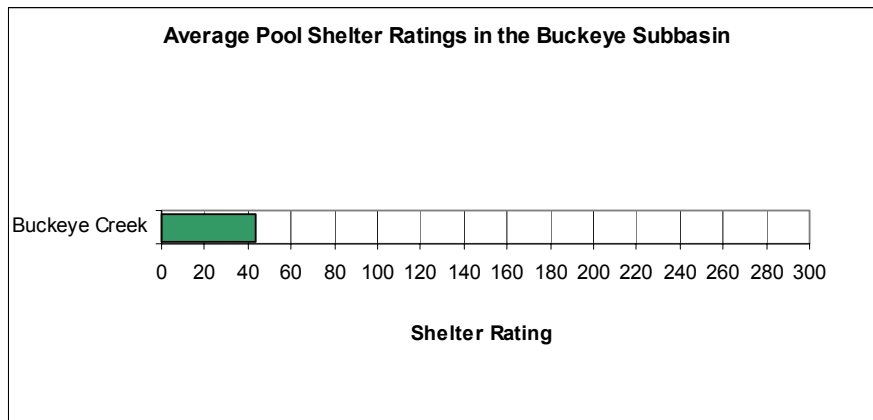
**Figure 5.4-17**  
 Average Pool Shelter Ratings in the Buckeye Subbasin 2001, Gualala River, California

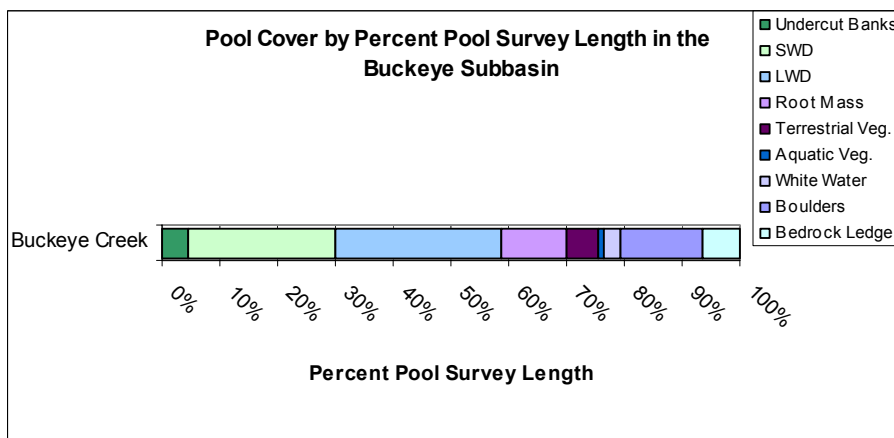
**Figure 5.4-18**  
 Pool Cover Types by Percent of Pool Survey Length in the Buckeye Subbasin 2001, Gualala River Watershed, California
