Section V

Erosion Control Plan

**Card THP
Map Points & Features Map South**

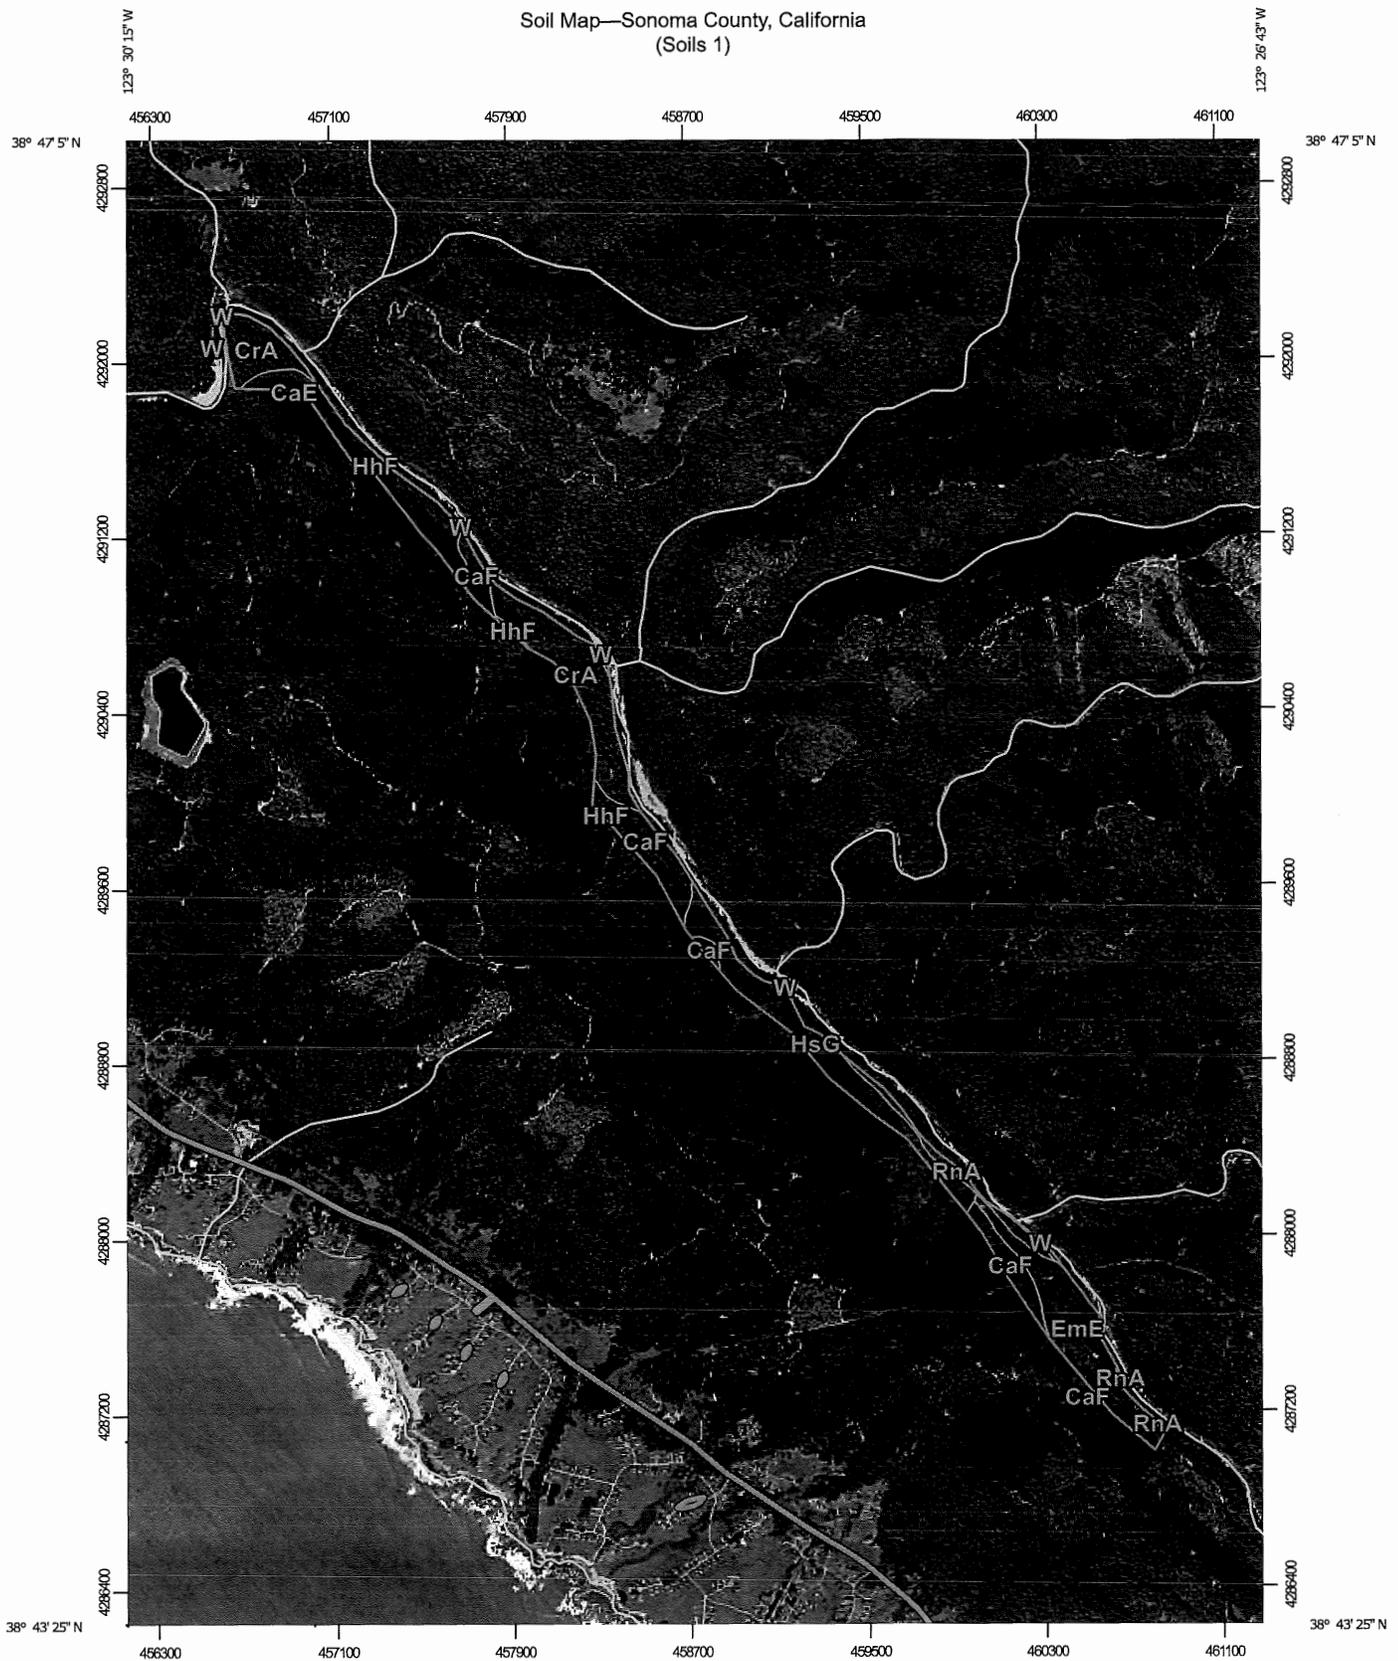
Soil Map—Sonoma County, California
(Soils 1)

Map Scale: 1:33,000 if printed on A portrait (8.5" x 11") sheet.

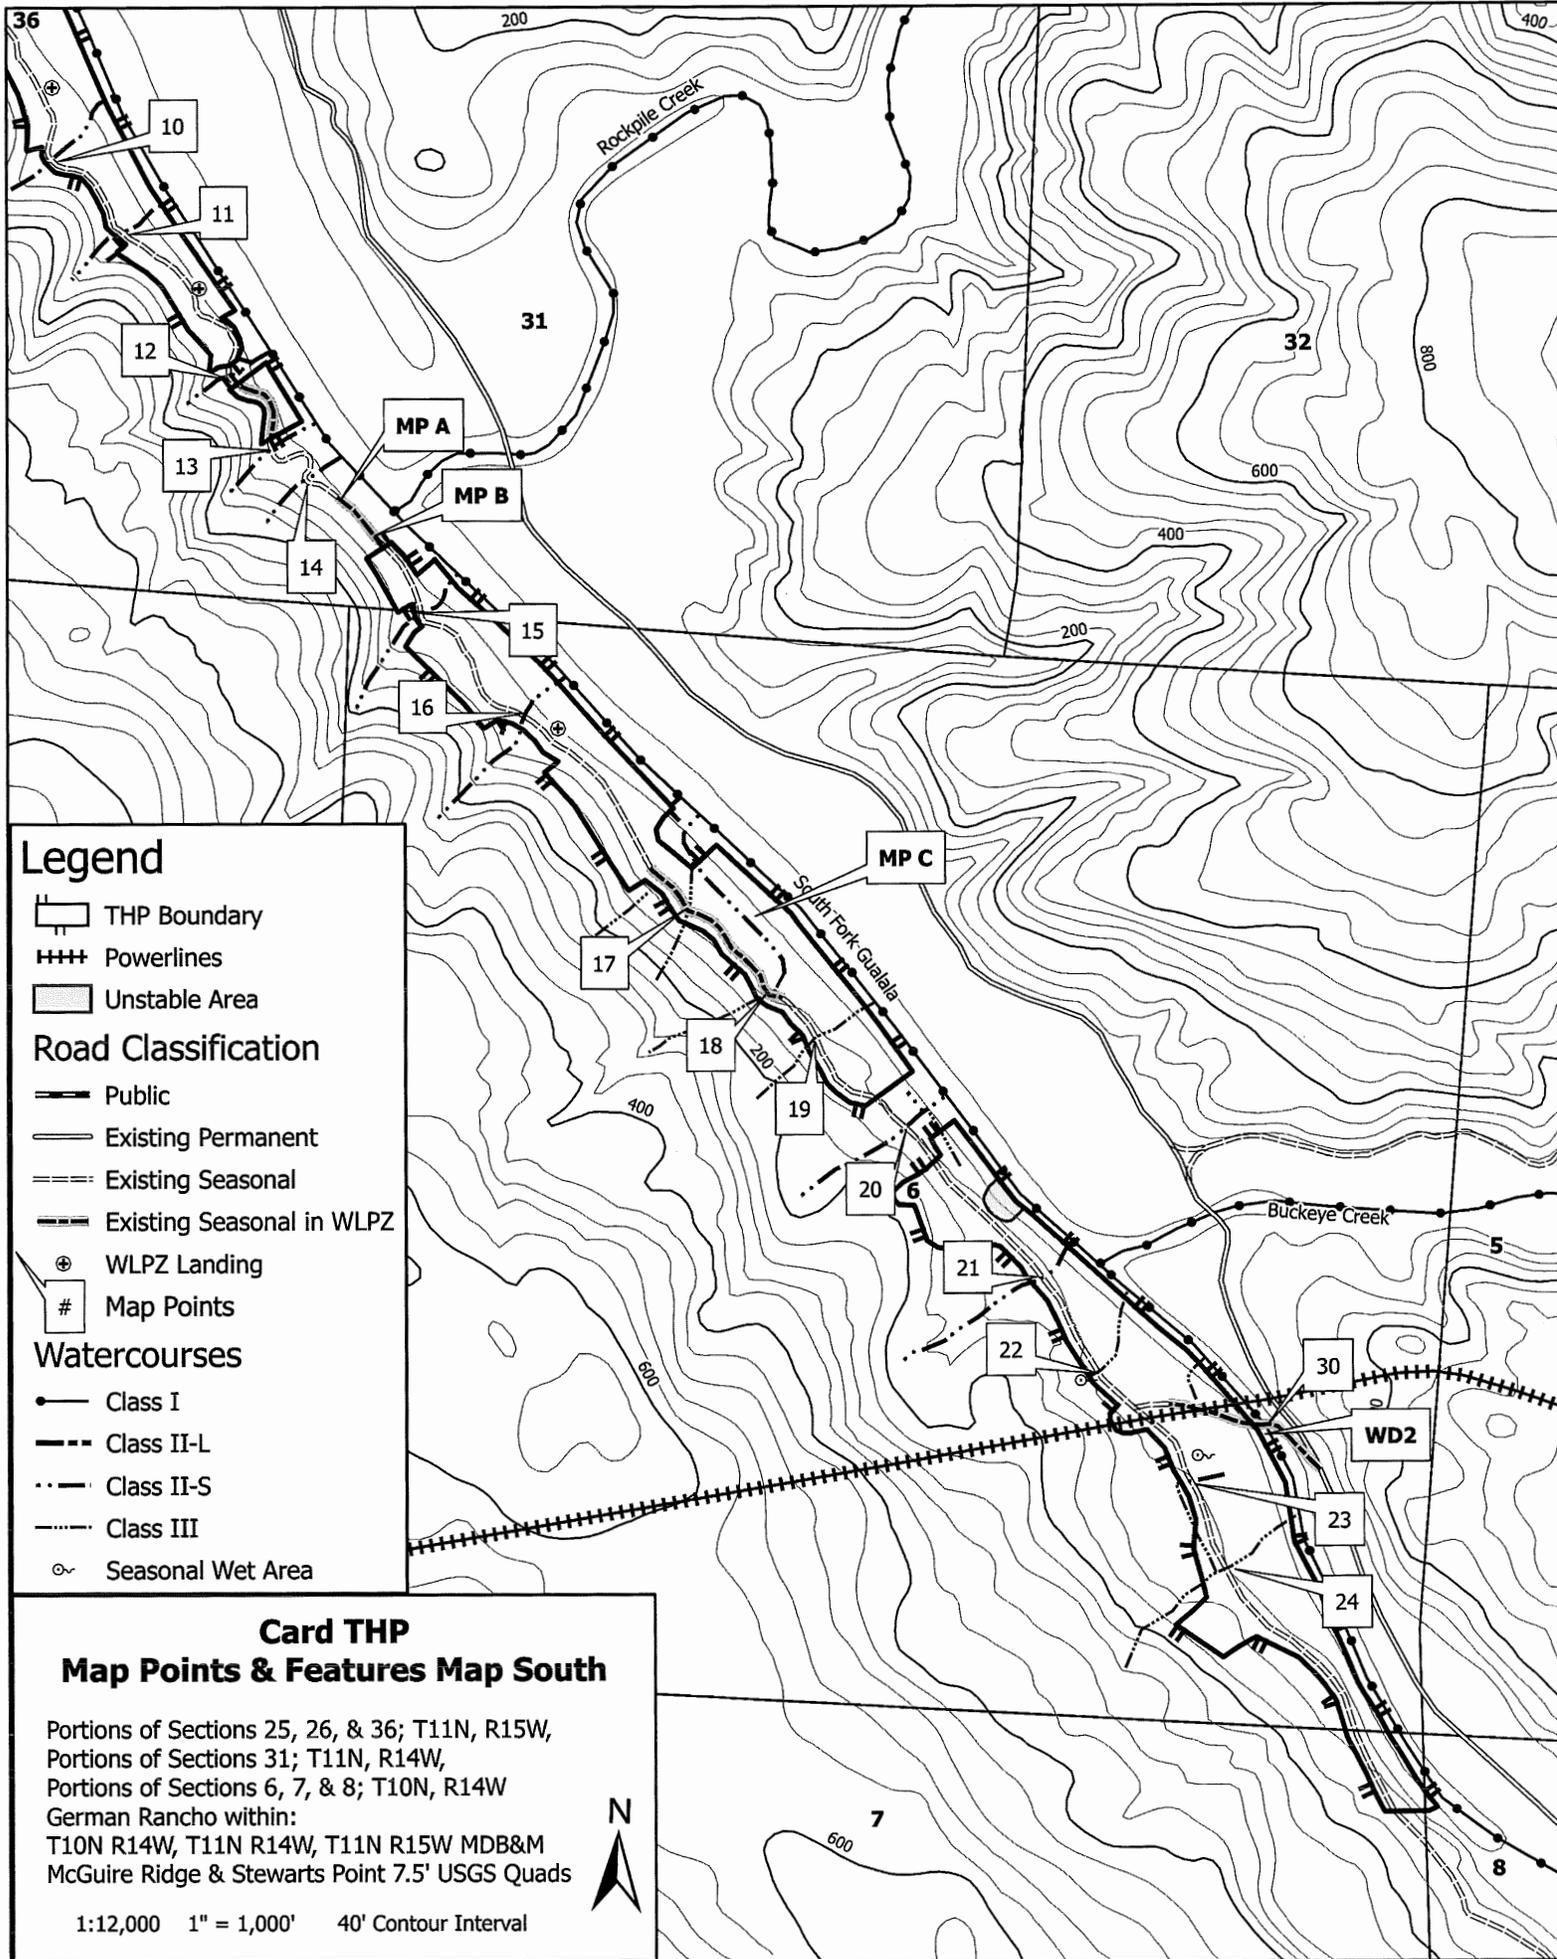
Portions of Sections 25, 26, & 36; T11N, R15W,
 Portions of Sections 31; T11N, R14W,
 Portions of Sections 6, 7, & 8; T10N, R14W
 German Rancho within:
 T10N R14W, T11N R14W, T11N R15W MDB&M
 McGuire Ridge & Stewarts Point 7.5' USGS Quads

During the spring, summer and fall of 2025, field inspections of the project area including those roads used for timber harvest activities owned by or under the control of the landowner were inspected for sites defined as controllable sediment discharge sources. All watercourses and harvest units were walked during the THP preparation. Unstable areas were found near watercourses but, are not discussed here because they do not meet #2 and #3 of the definition for controllable sediment discharge sources. A map is attached showing the project area and roads owned or controlled by the landowner.

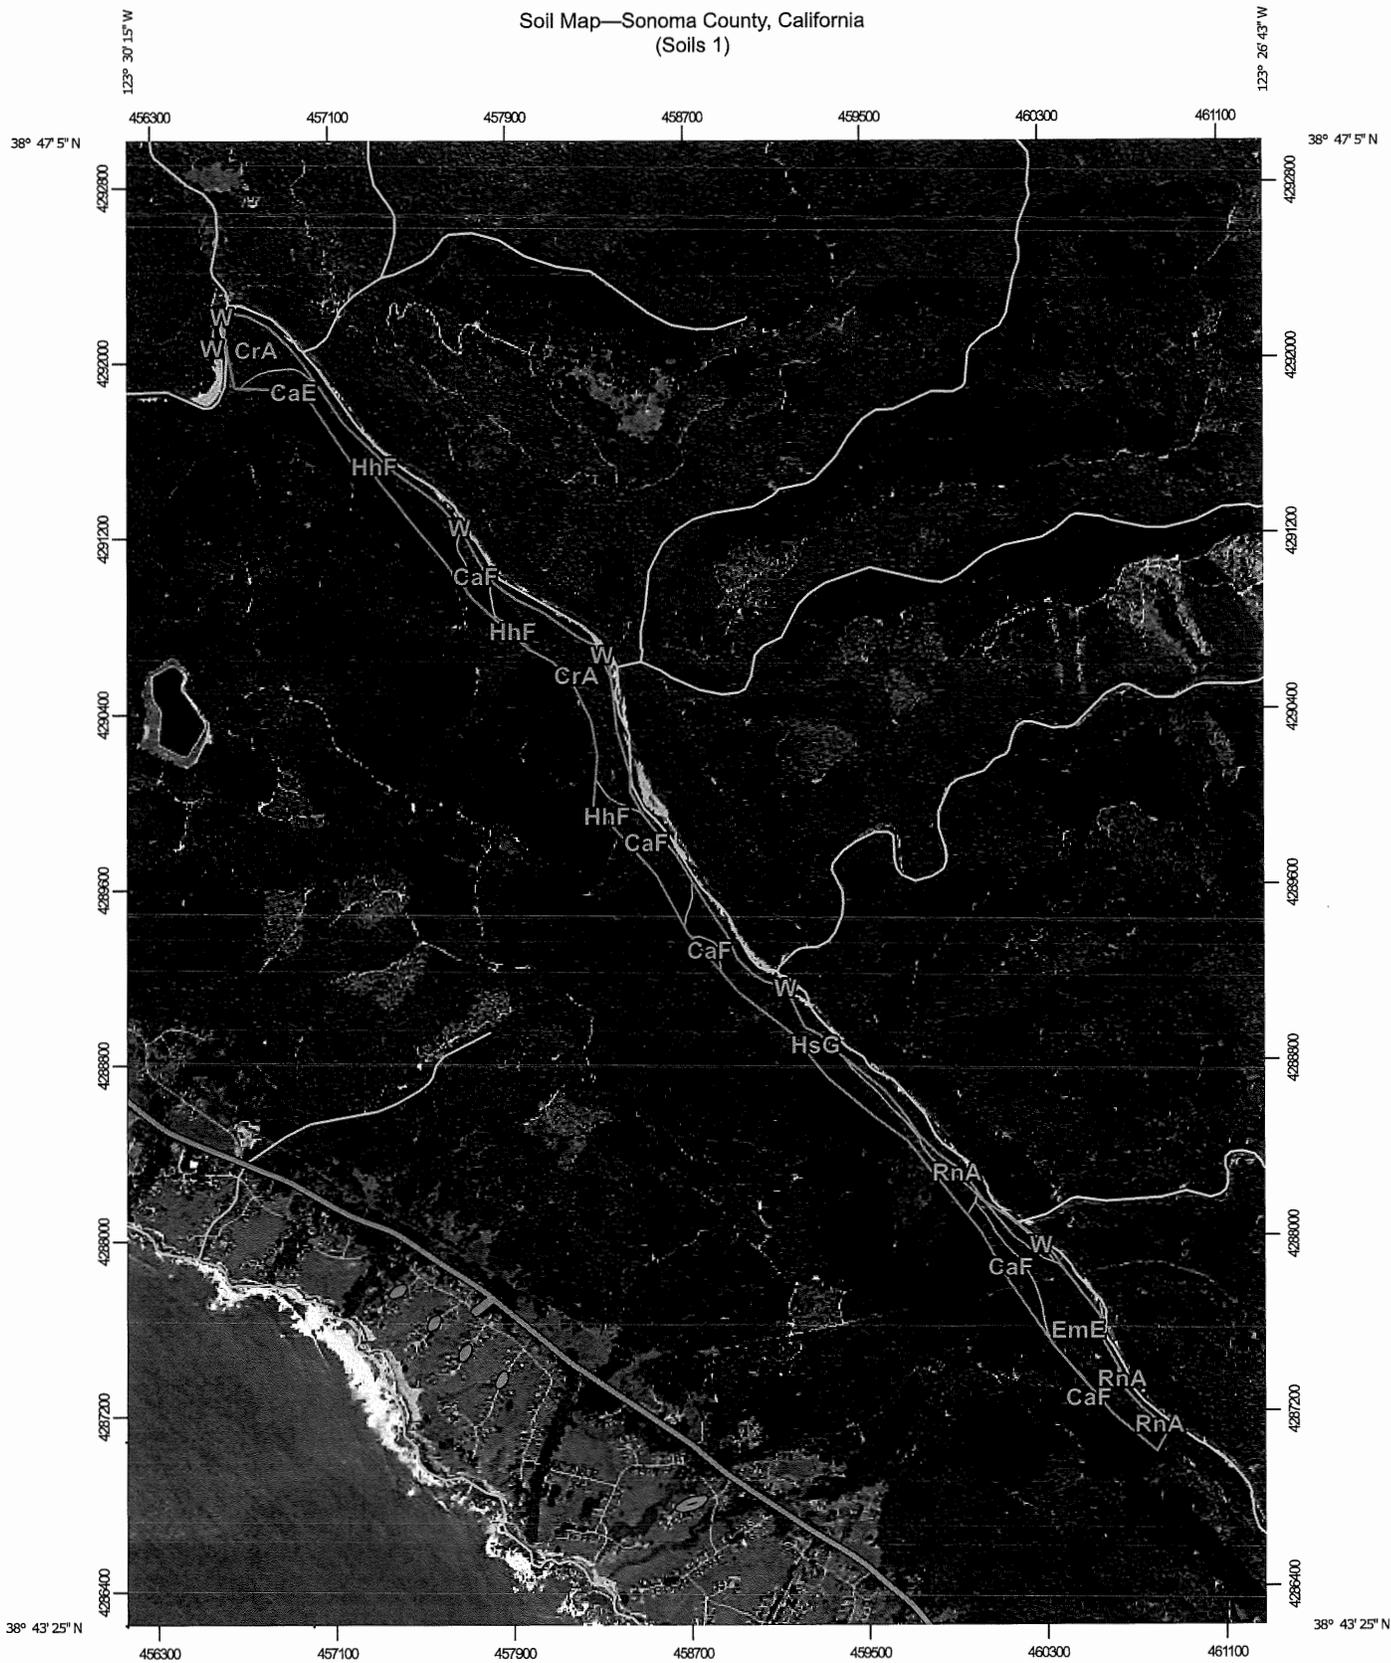
Soil Map—Sonoma County, California
(Soils 1)

Map Scale: 1:33,000 if printed on A portrait (8.5" x 11") sheet.

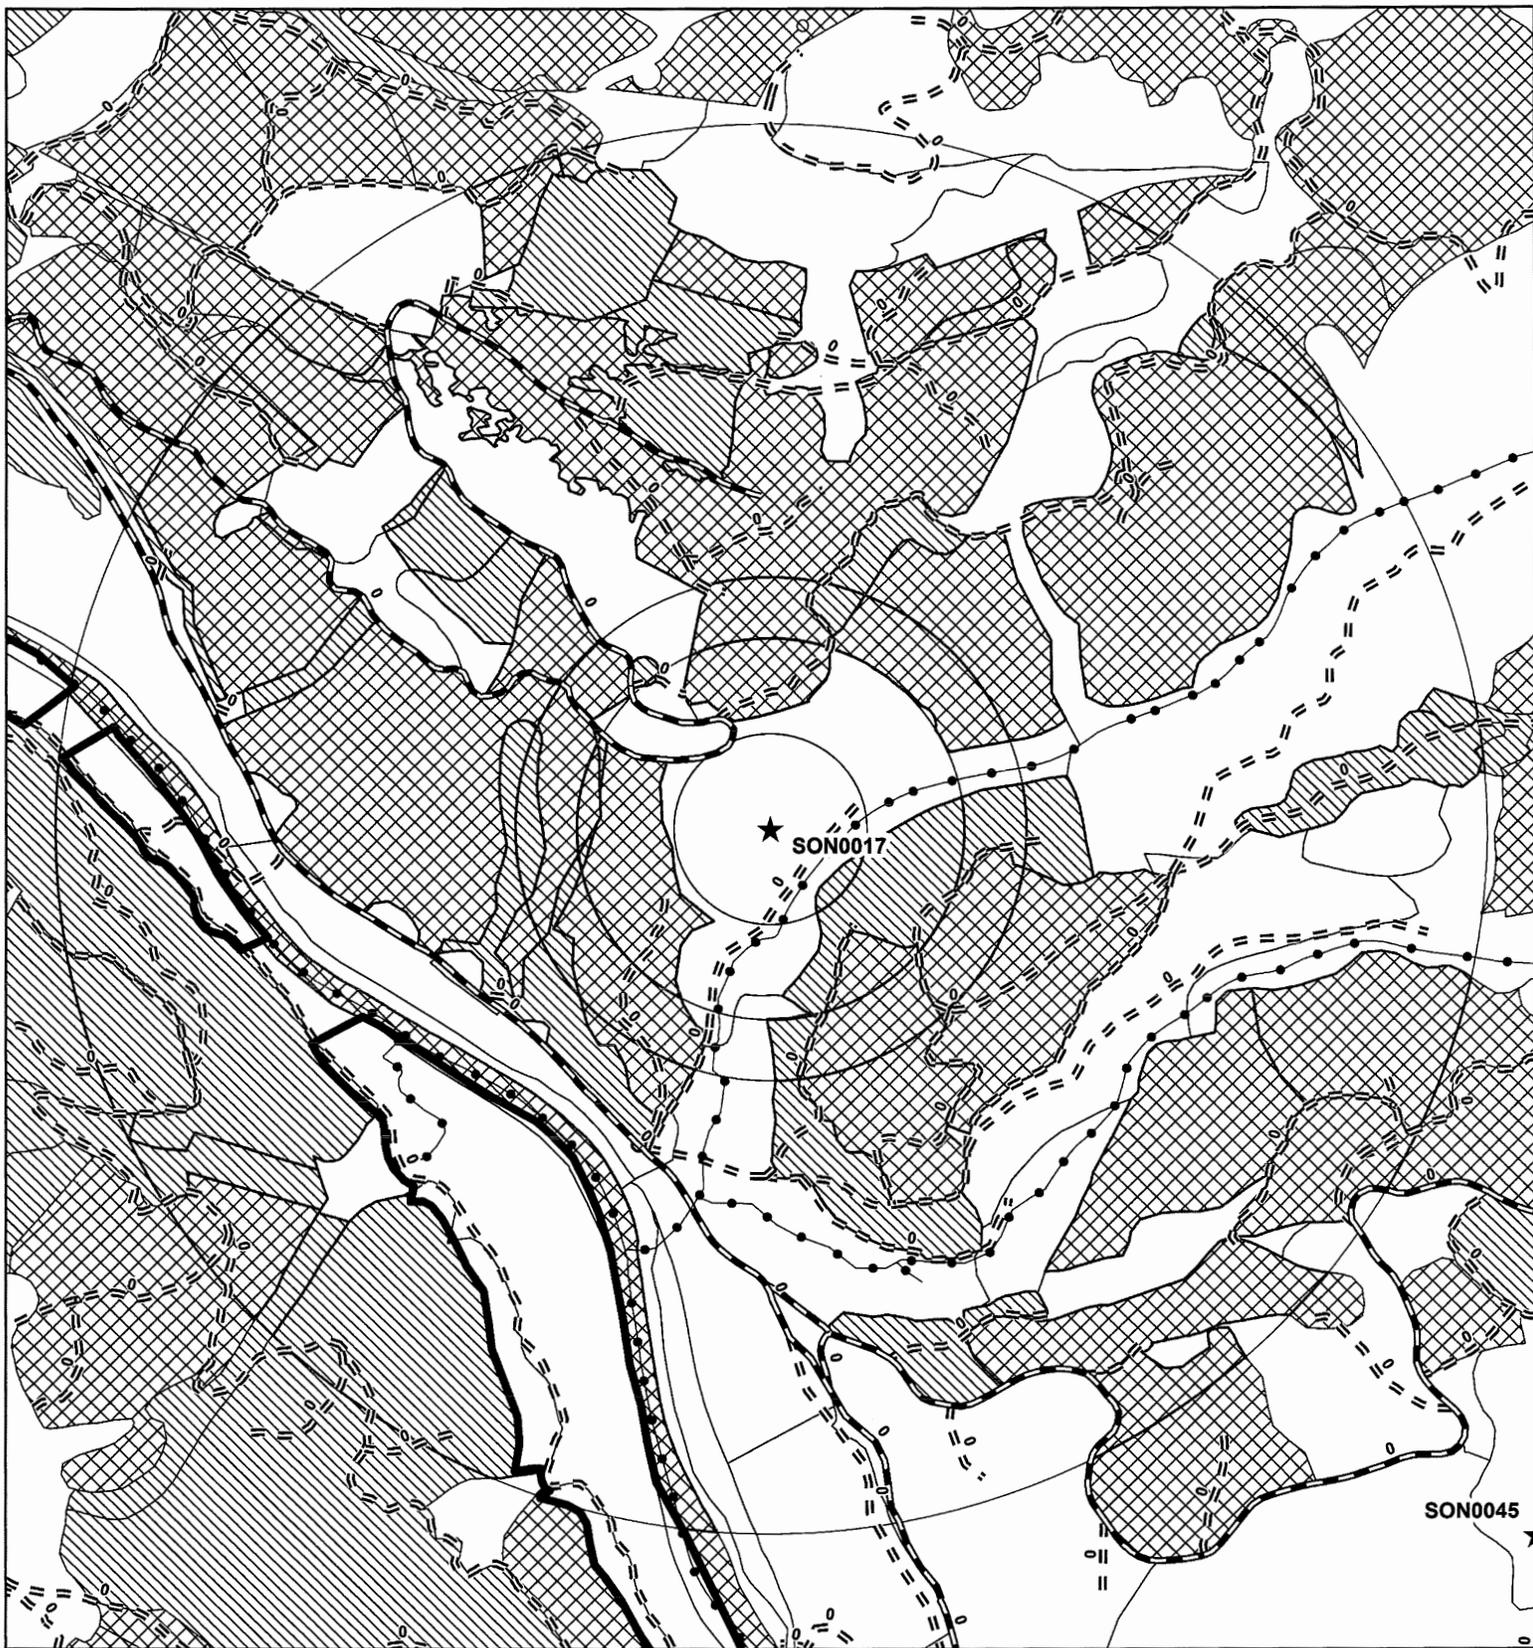
Pre Harvest Northern Spotted Owl Habitat Types within 0.7 Miles of Activity Center

SON0017

NSO Activity Center
with buffers of:
500', 1000', & 0.7 mi

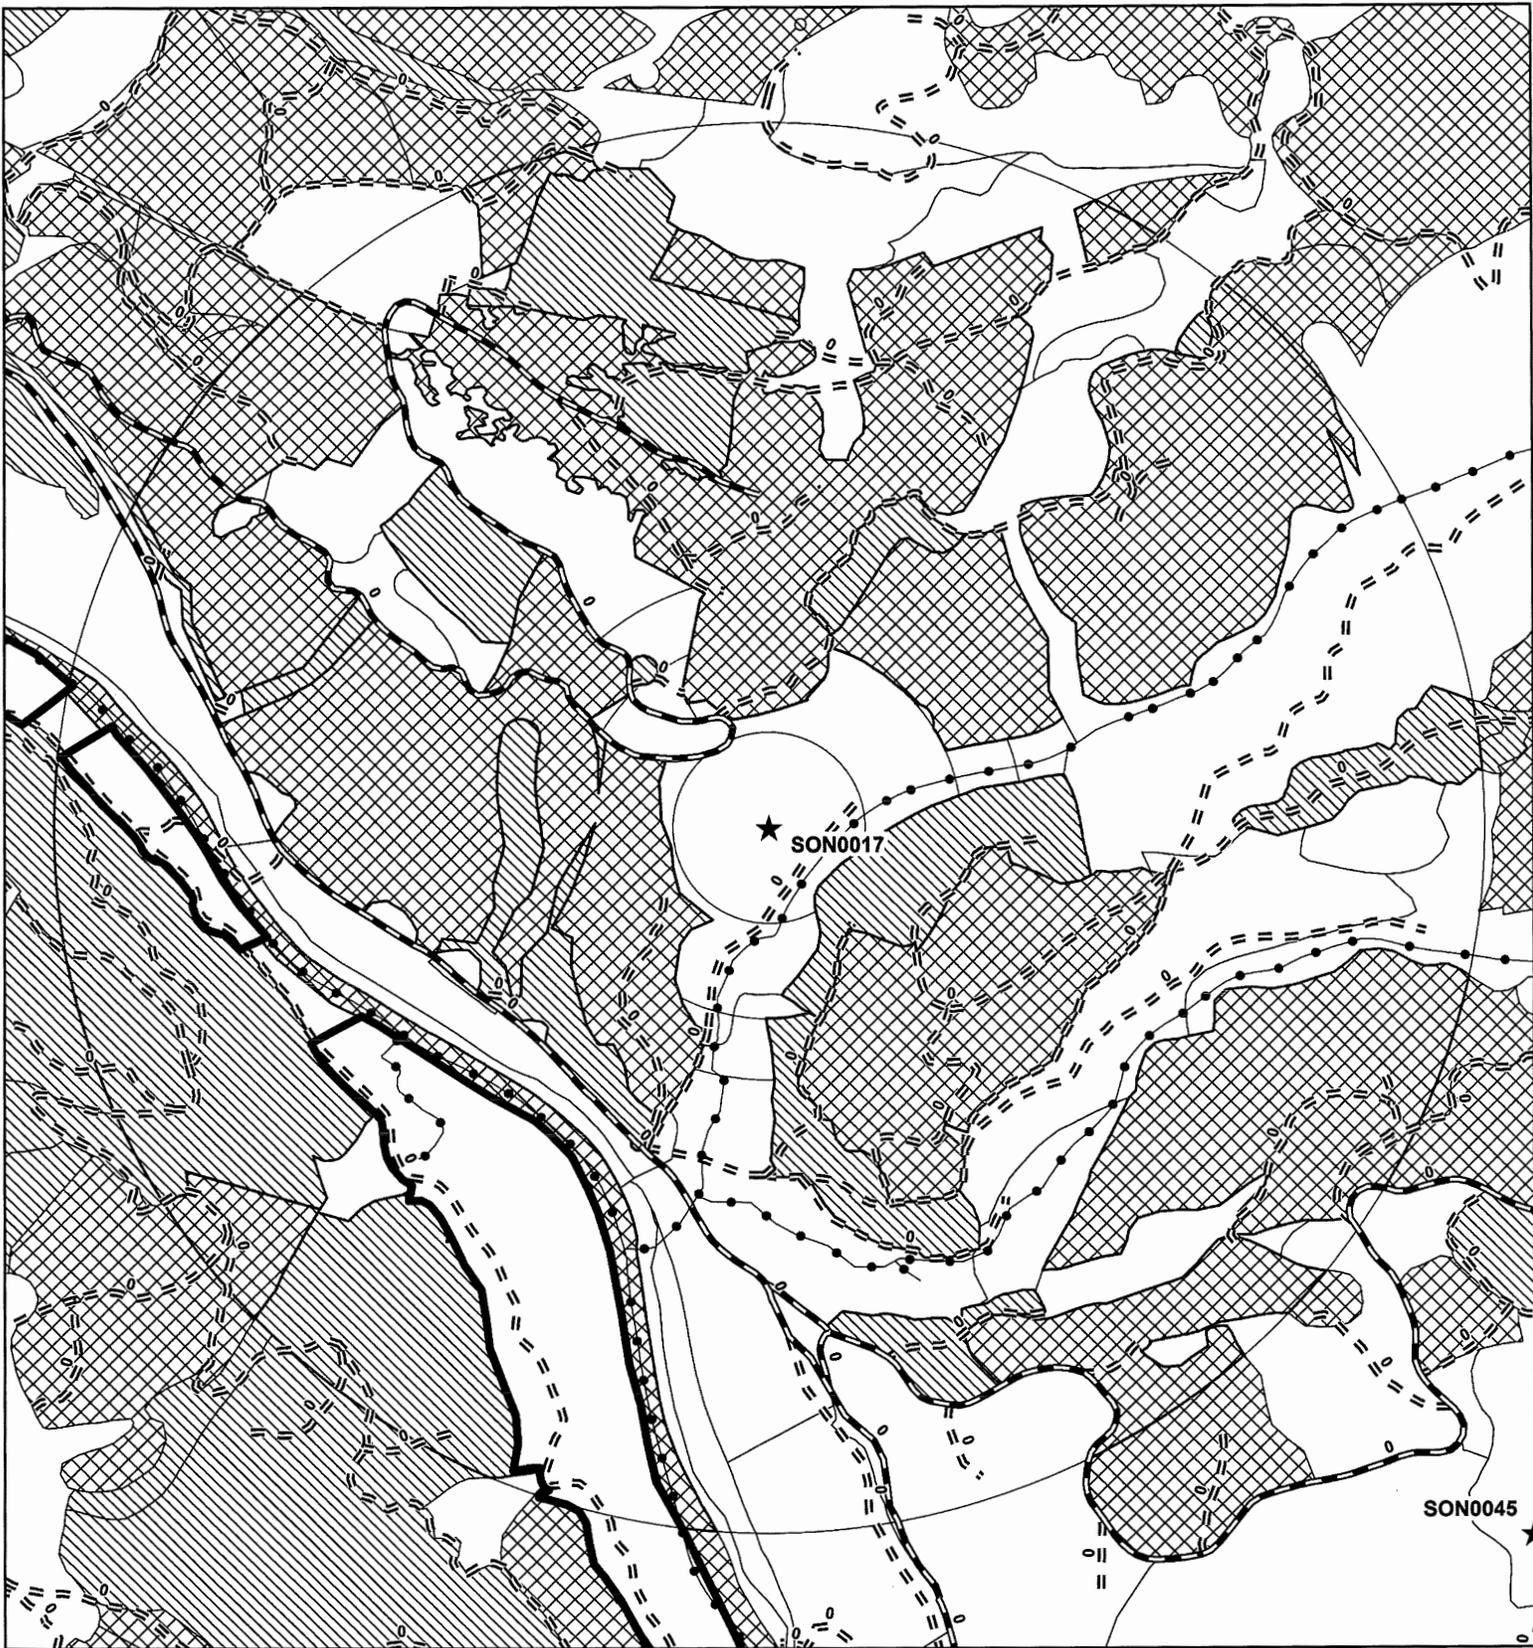
Post Harvest Northern Spotted Owl Habitat Types within 0.7 Miles of Activity Center

SON0017

NSO Activity Center
with buffers of:
500', 1000', & 0.7 mi

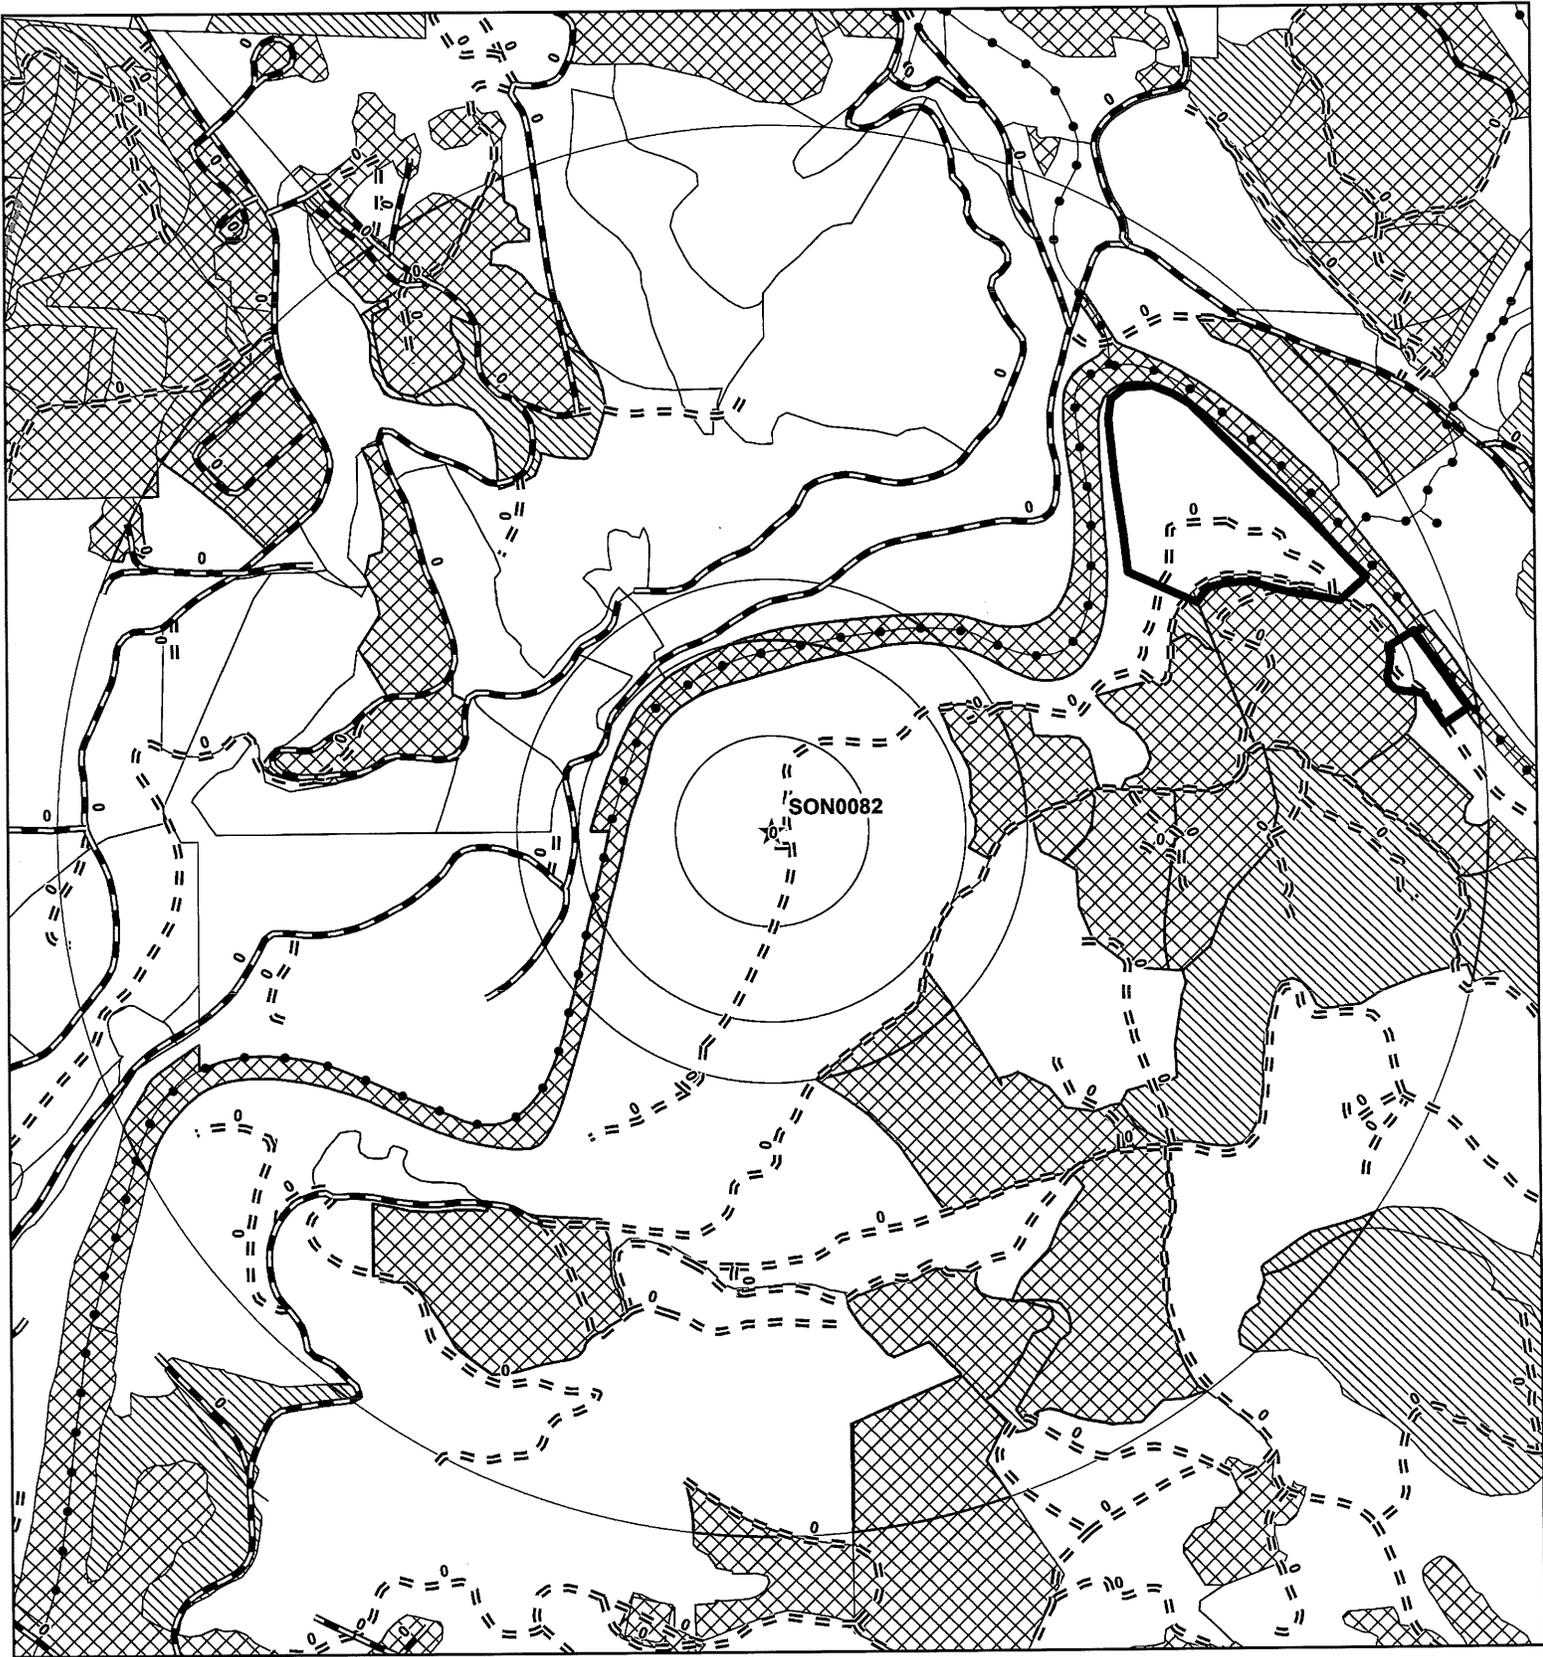
Pre Harvest Northern Spotted Owl Habitat Types within 0.7 Miles of Activity Center

SON0082

NSO Activity Center
with buffers of:
500', 1000', & 0.7 mi

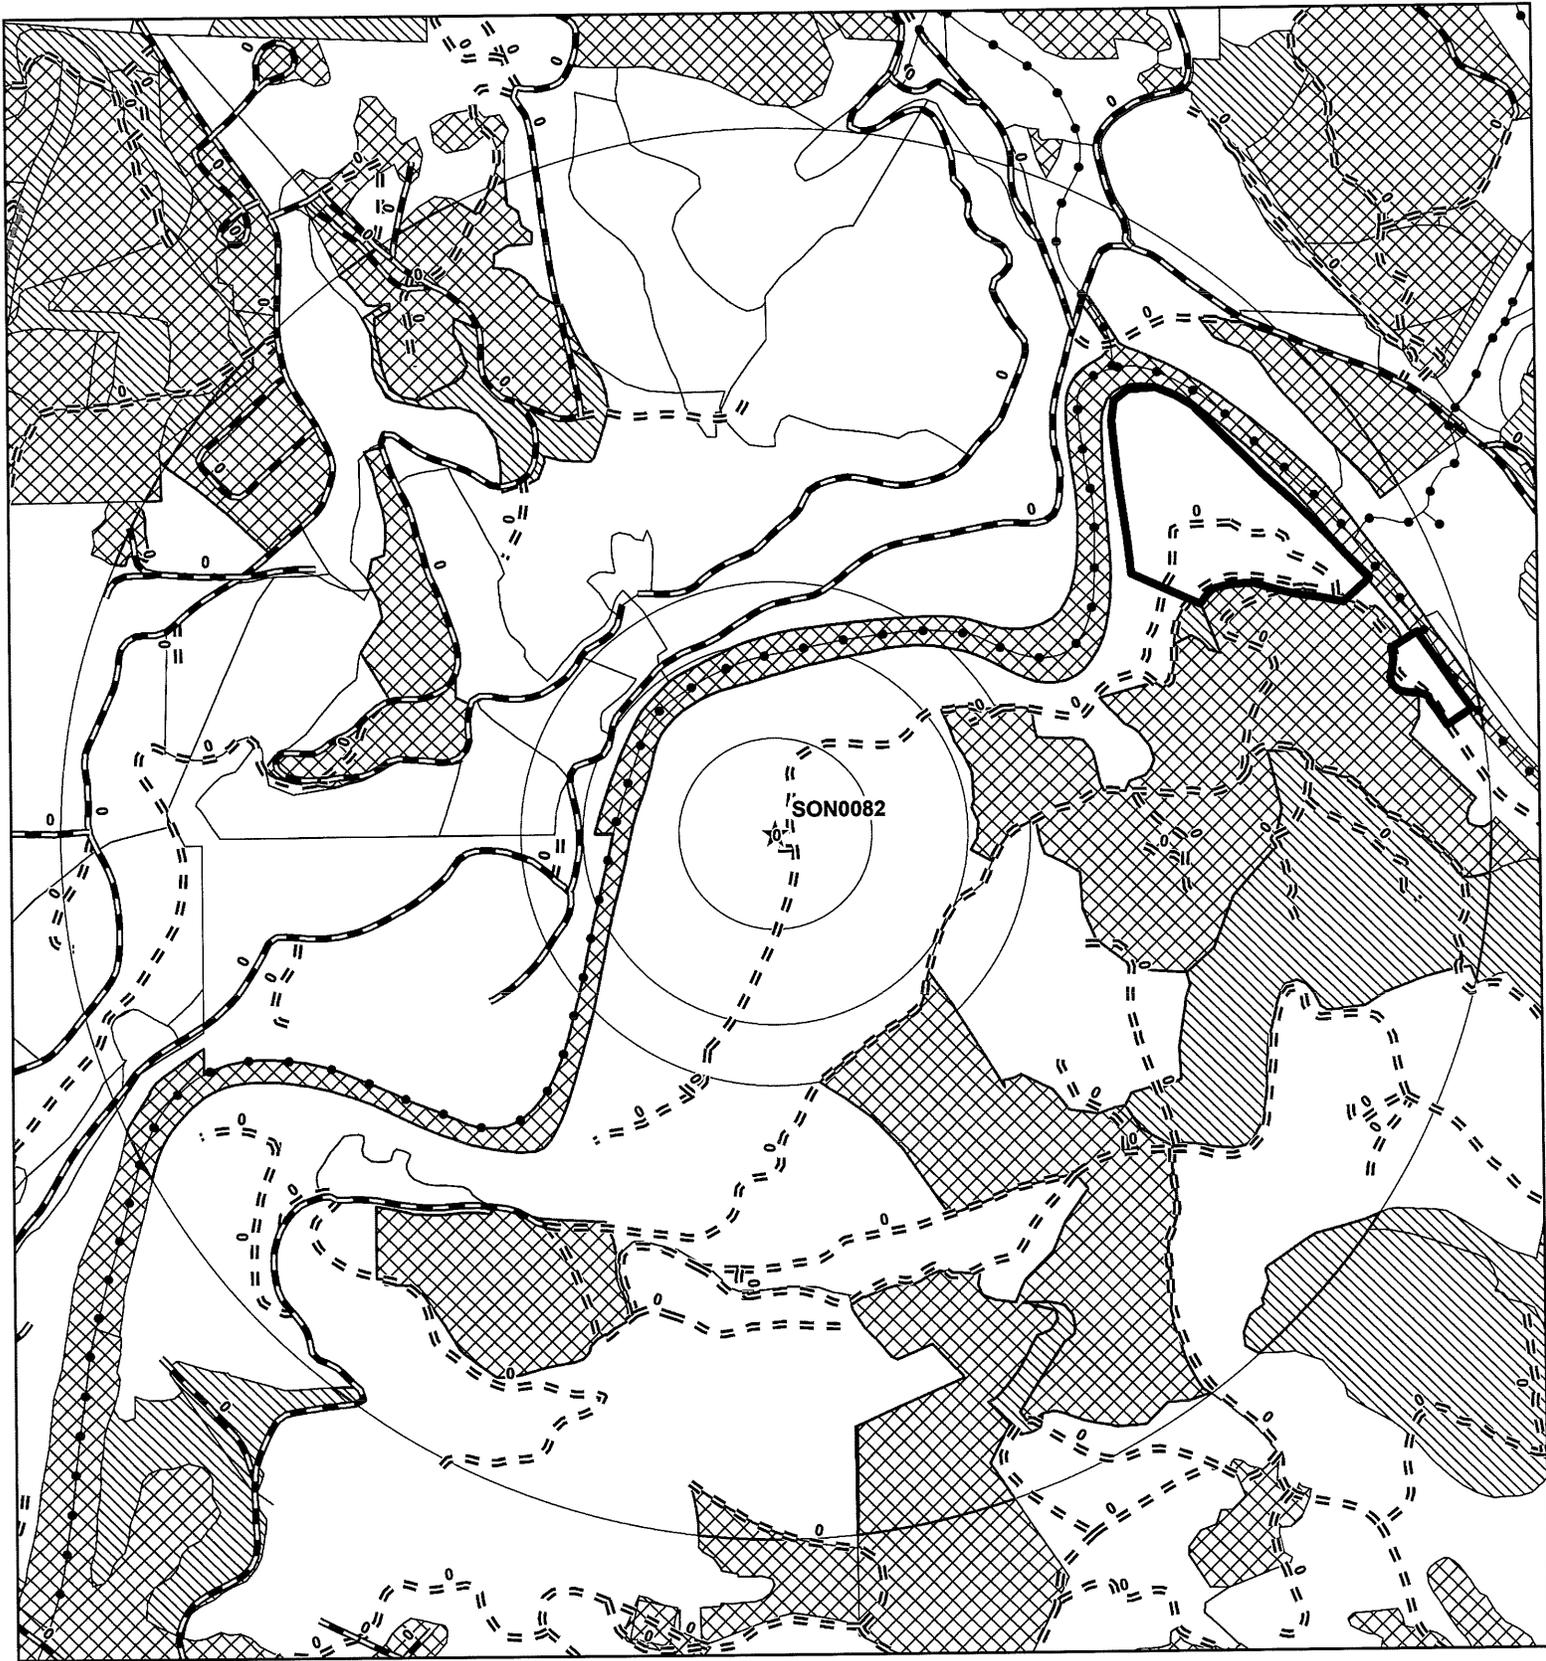
Post Harvest Northern Spotted Owl Habitat Types within 0.7 Miles of Activity Center

SON0082

NSO Activity Center
with buffers of:
500', 1000', & 0.7 mi

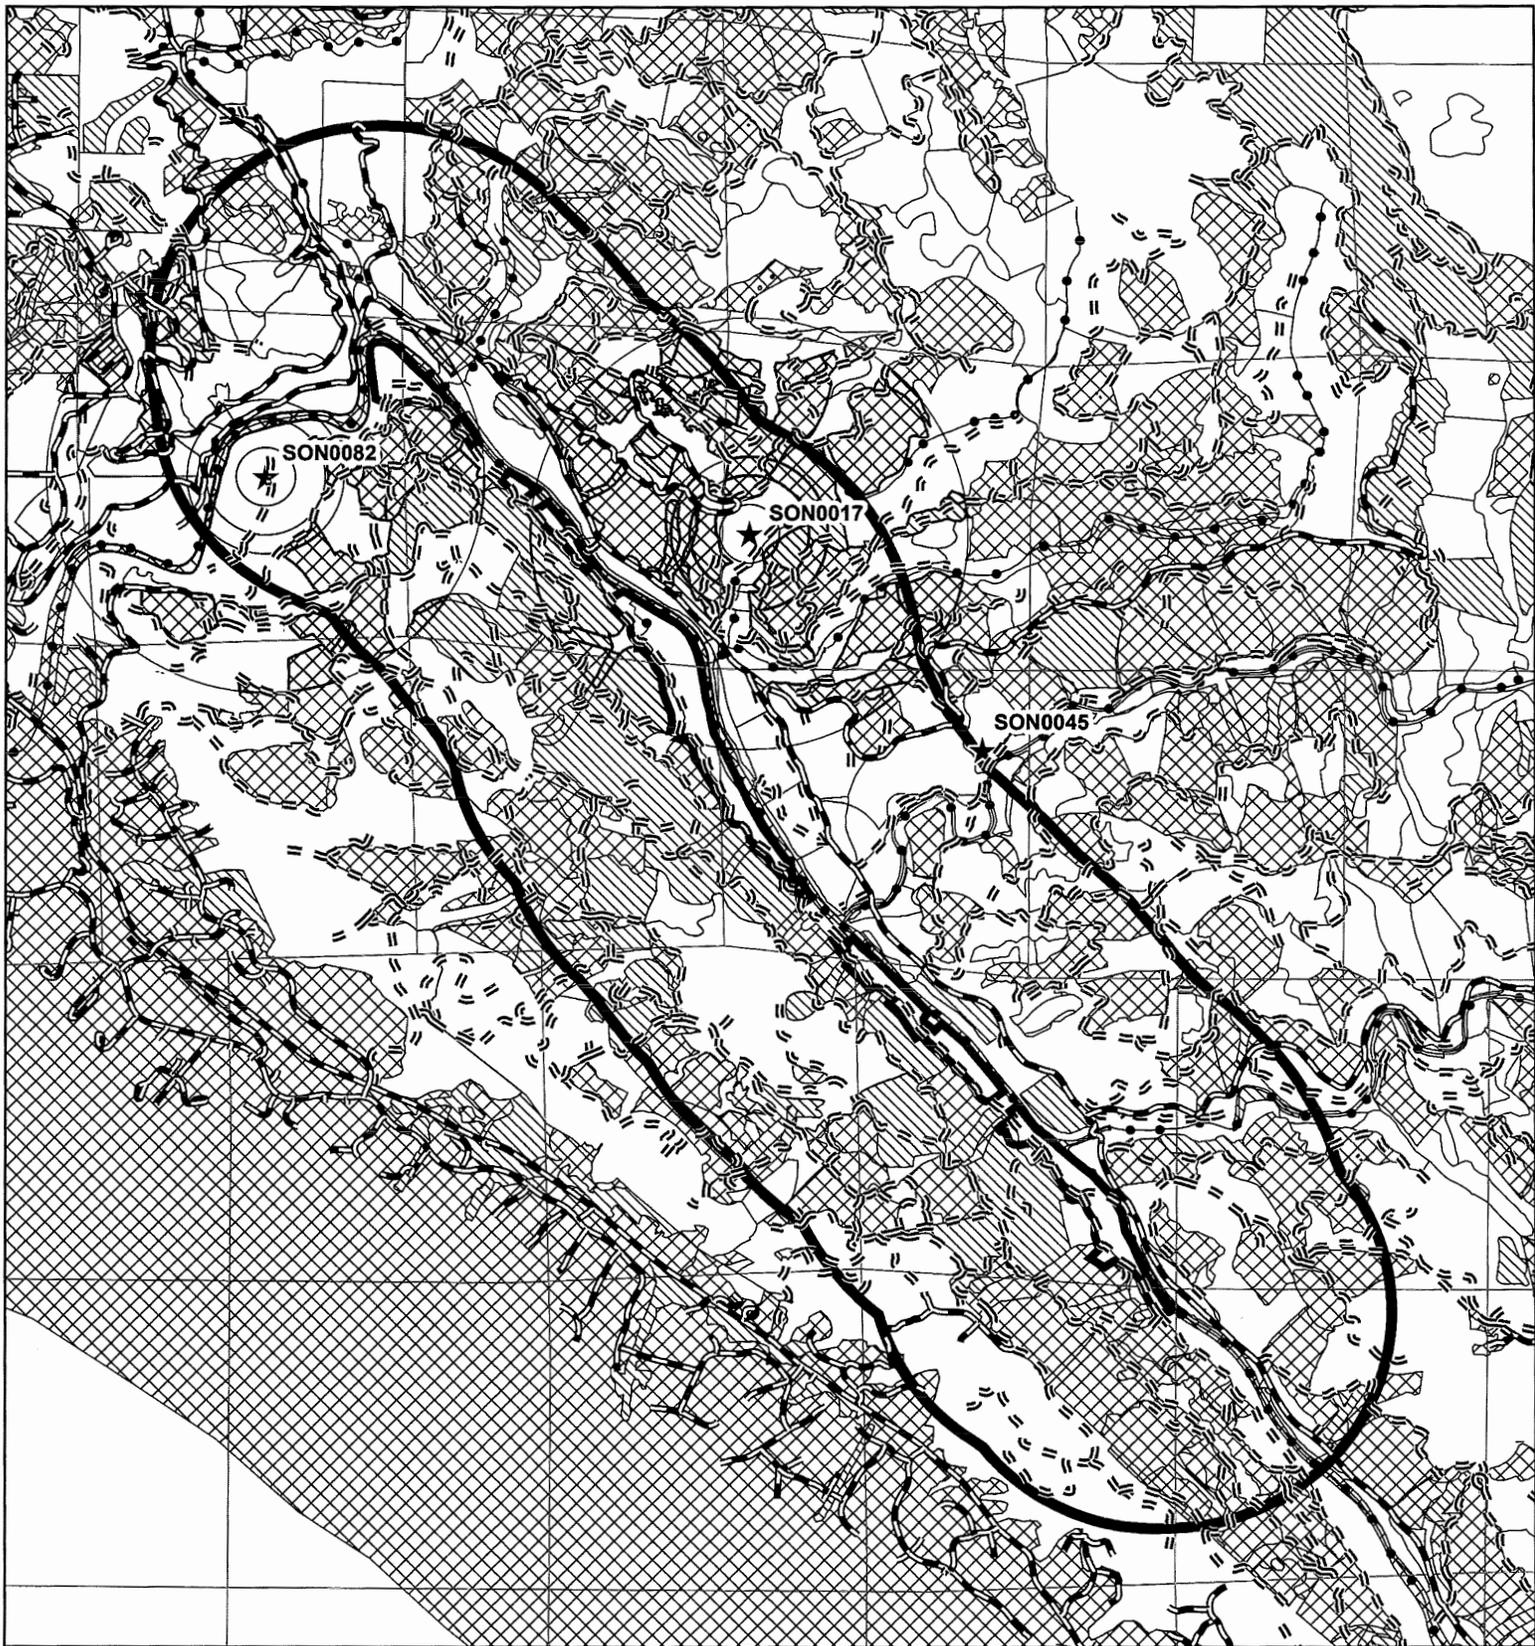
Pre Harvest Northern Spotted Owl Habitat Types within 0.7 Miles of Plan Area

Card	0.7 mile NSO Buffer	Class I Watercourse
	Dirt Road	NSO Sites
Pre Habitat	Permanent Road	Harvest Area
Foraging		NSO Activity Center with buffers of: 500', 1000', & 0.7 mi
Nesting/Roosting		1:39,168 Print Date: 1/22/2026
Non Habitat		350
