Section V

Erosion Control Plan

**Card THP
Map Points & Features Map South**

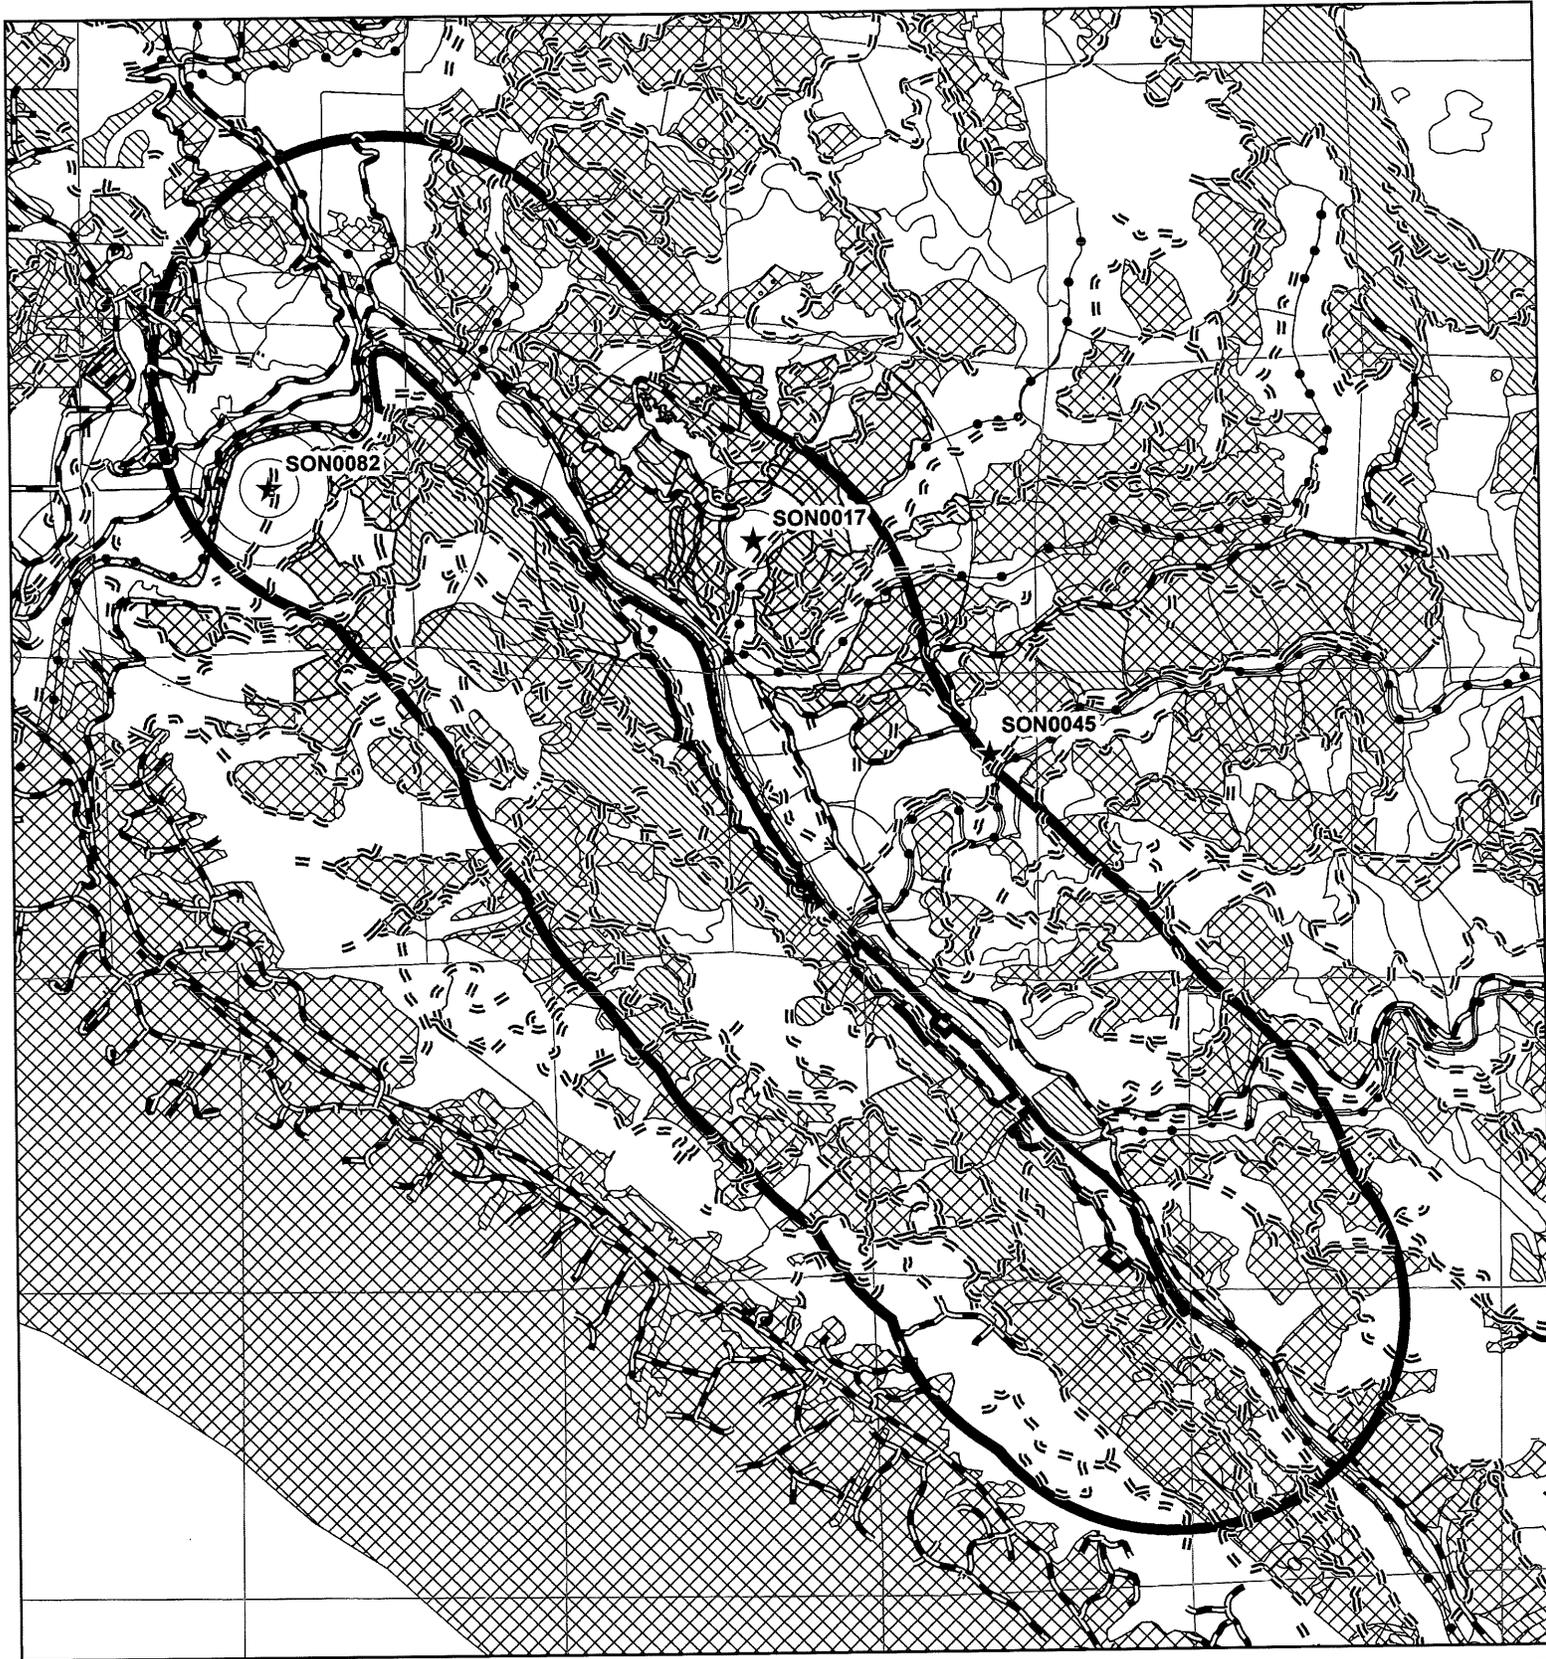
Post Harvest Northern Spotted Owl Habitat Types within 0.7 Miles of Plan Area

Card

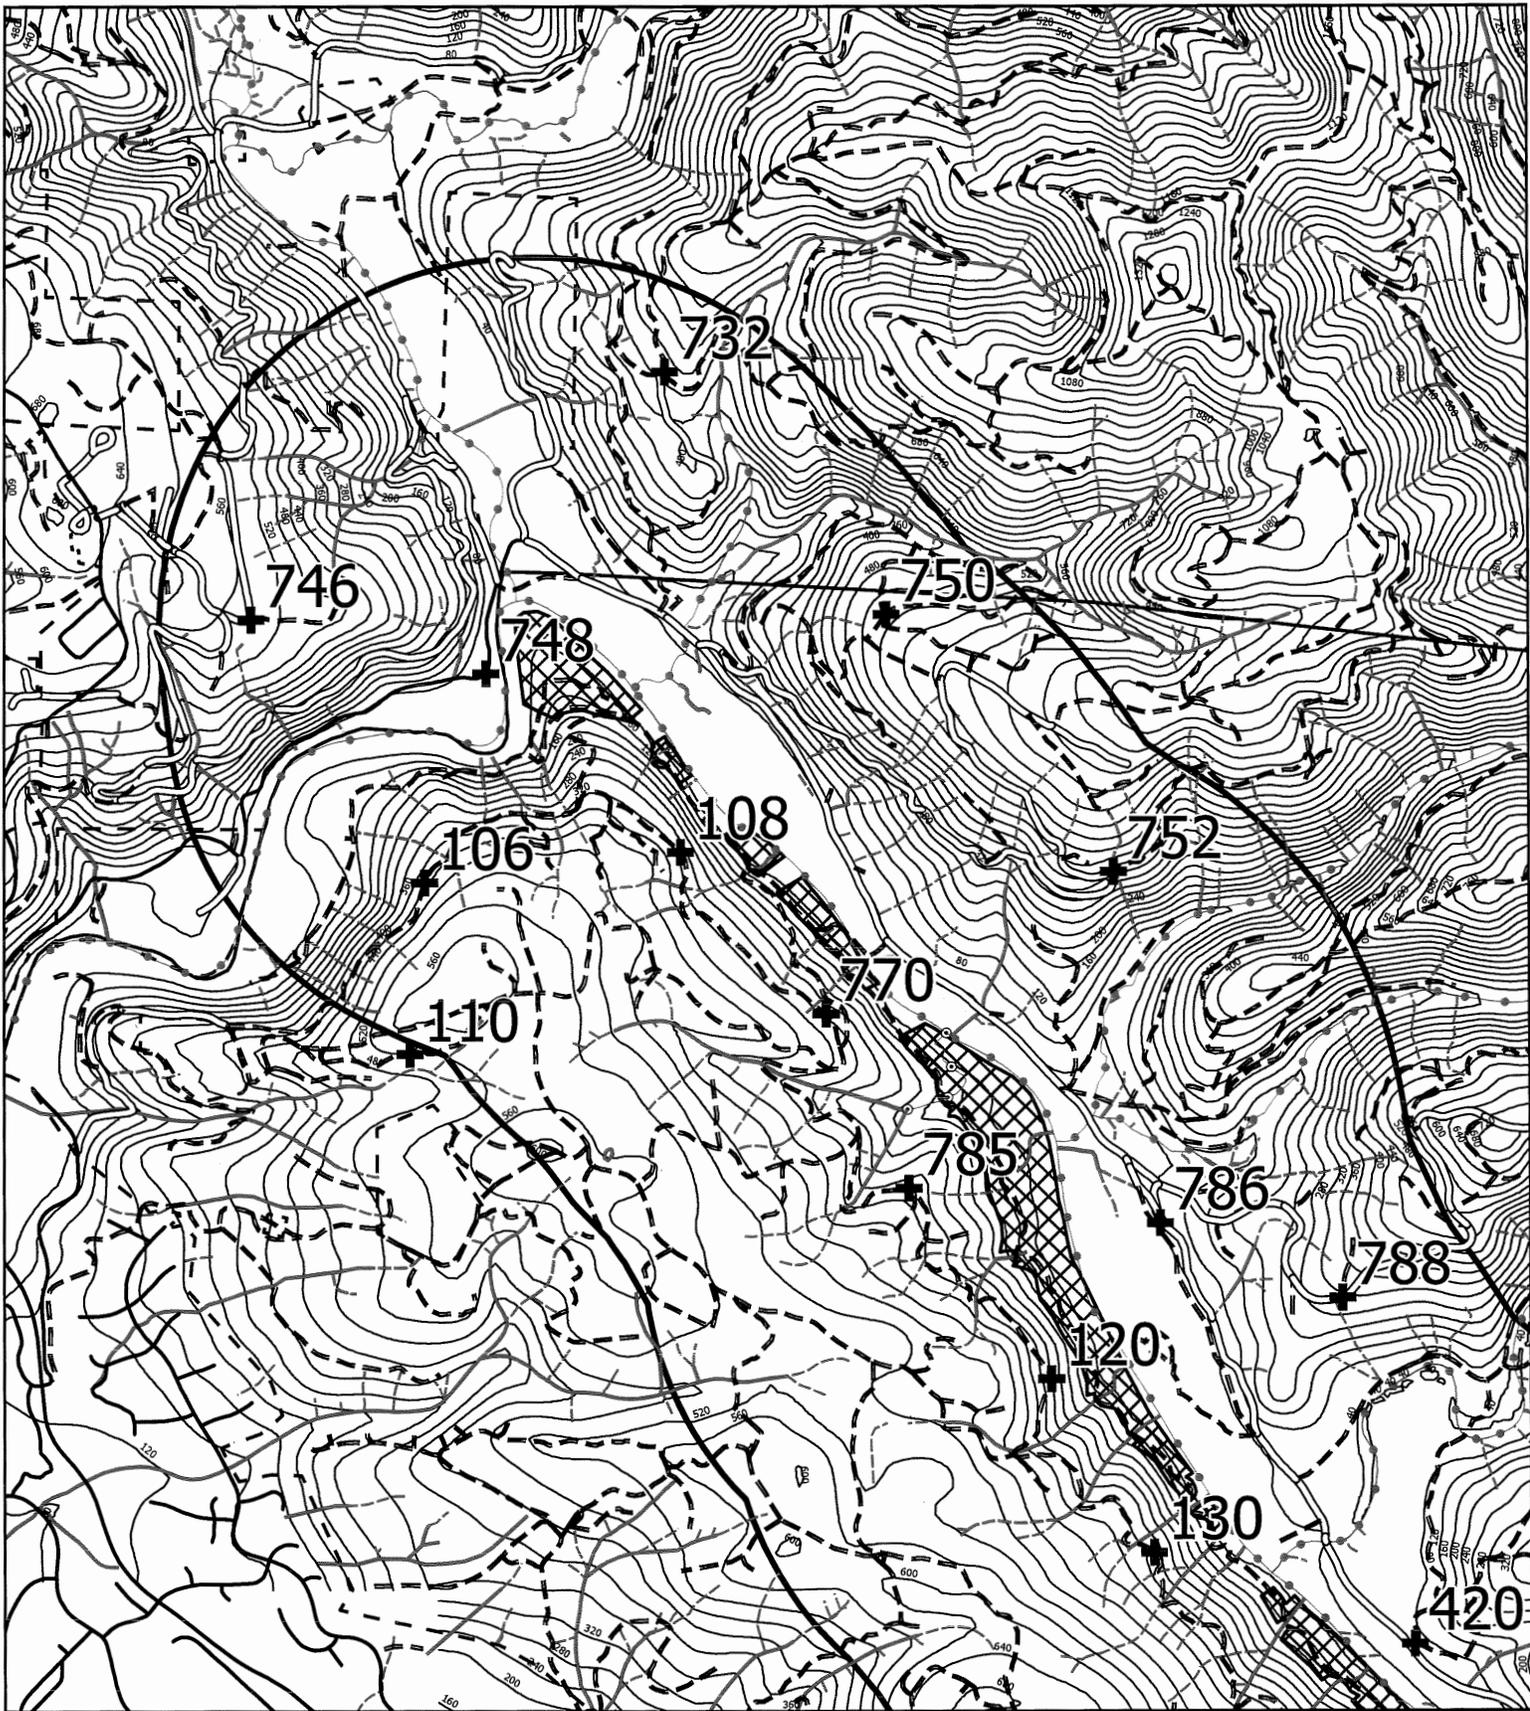
N
 Card THP
 NSO Call Stations
 Map 1 of 2
 Scale: 1:24,000

- Public Permanent Road
- Private Permanent Road
- - - Private Seasonal Road
- Class I Watercourse
- Class II-S Watercourse
- - - Class III Watercourse

- Class II-L Watercourse
- ▭ 0.7 Mile Buffer
- ▨ Card THP
- - - GRT Ownership

+ NSO Call Point
 Contour Interval 40'
 356
