## Section V

### Attachments:

Erosion Control Plan

### Card THP culvert sizing

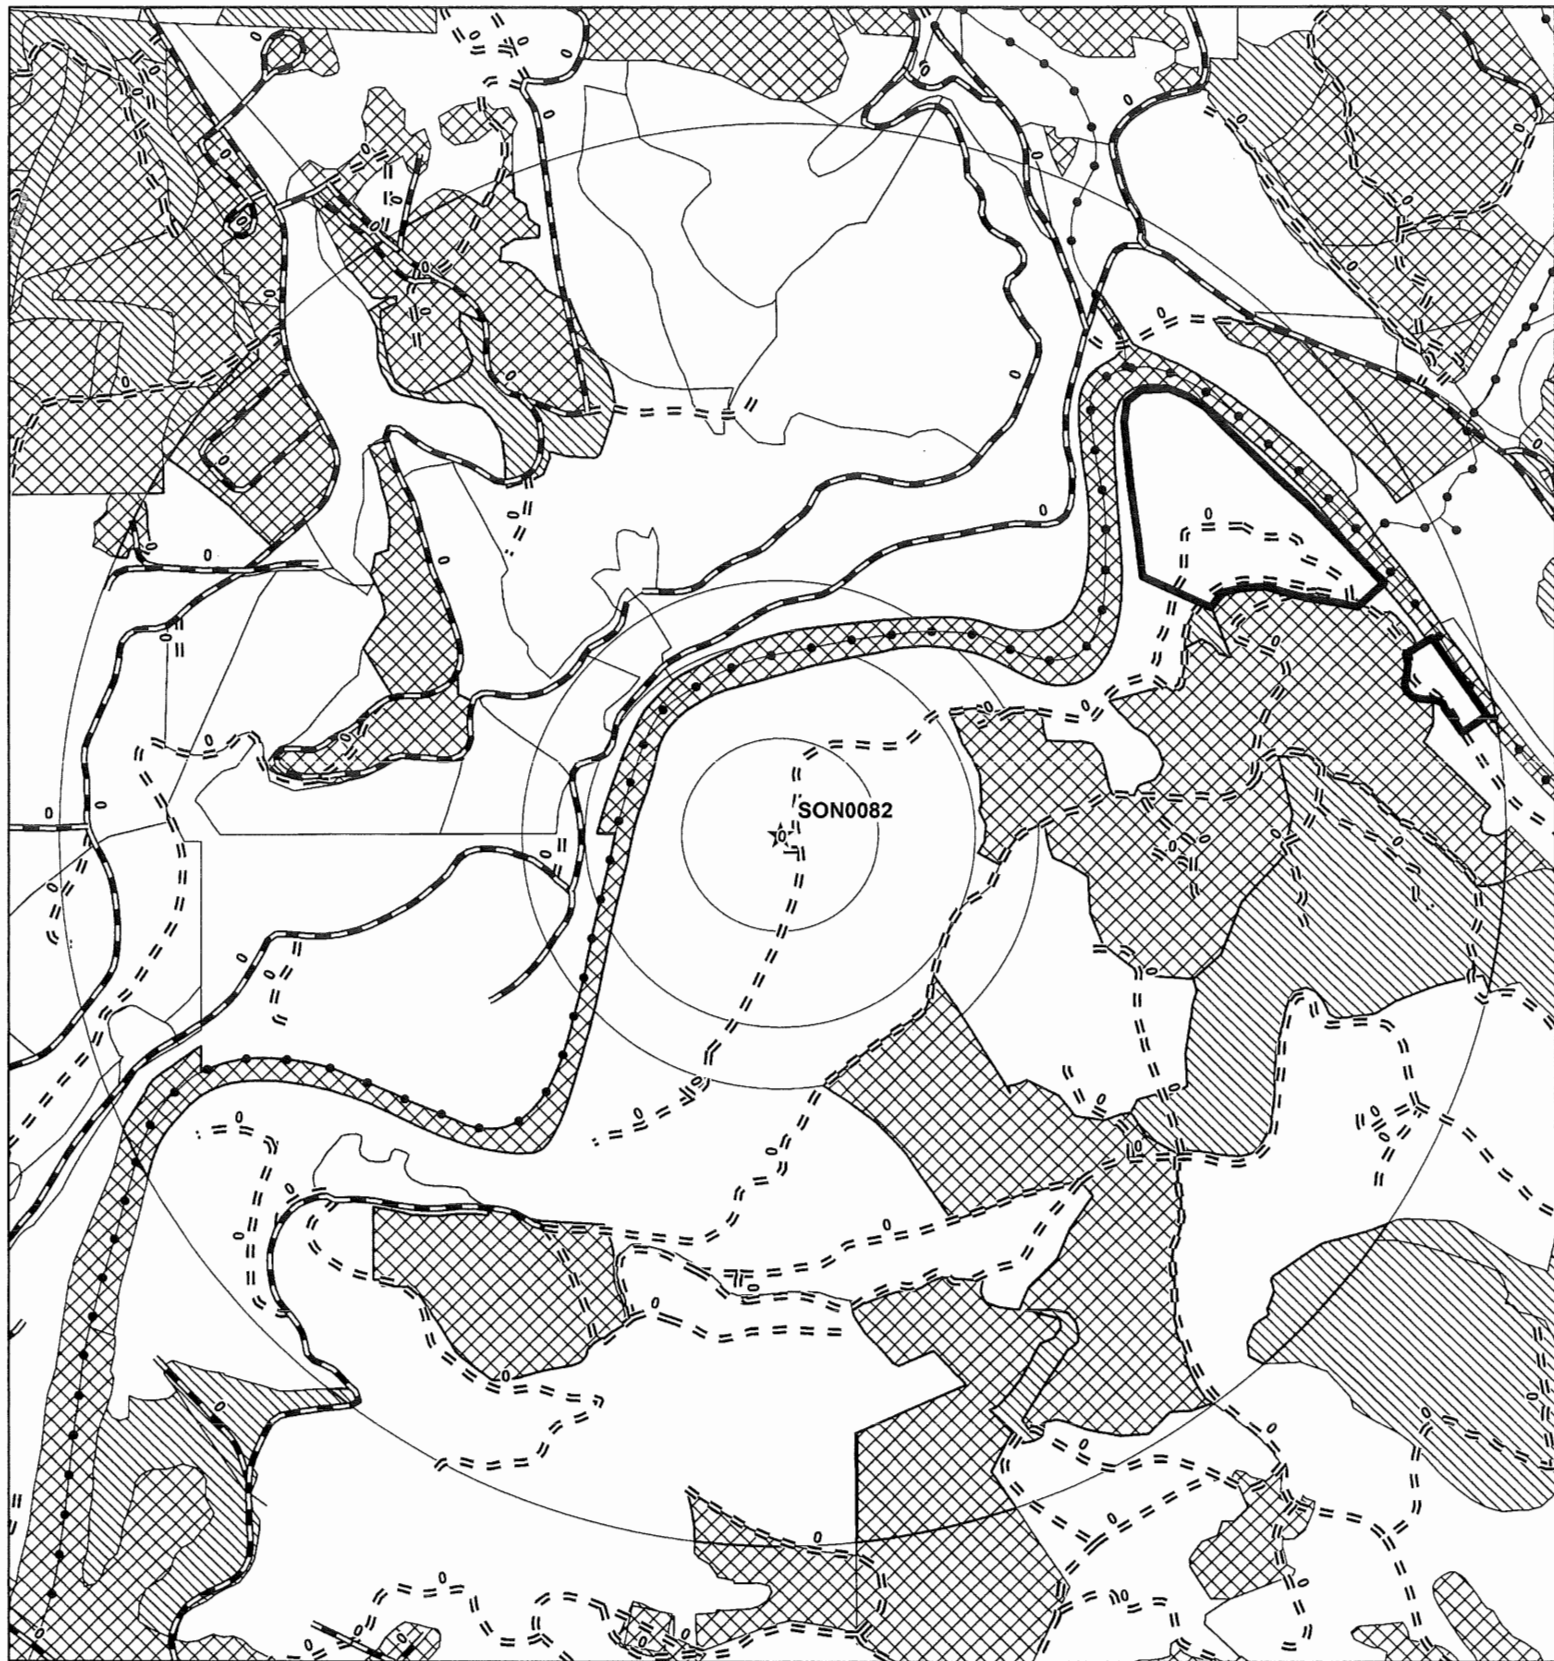
## Post Harvest Northern Spotted Owl Habitat Types within 0.7 Miles of Activity Center

**SON0082**
