RE: PHI Responses to 1-23-00099 SON "Steam Donkey" THP

Below are responses to the PHI recommendations for 1-23-00099 SON "Steam Donkey". The RPF responses are highlighted in **Bold text**.

### THP 1-23-00099SON PHI RPF Responses

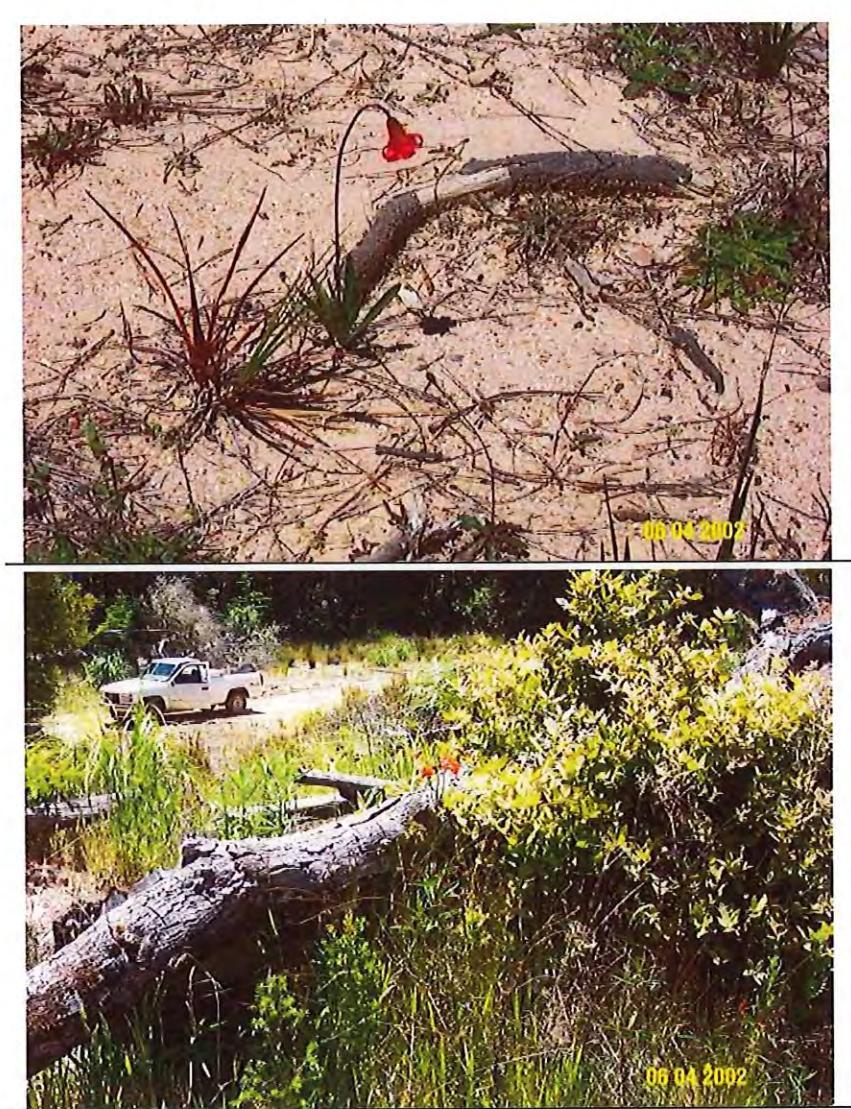
Wildlife		Ph	oto #	950	)
PW			6/	4/20	002
Project			PID		0
Map Pt 0	Road 0		Mi.	0	
		Old	Ne	w	
Creek		Cr Di	st		0
Ref 0	LWD Site		Tag#	0	
Monitoring	0

Here is a coast lily which has colonized a heavily used landing. Additional individual coast lilies are also present on the landing.

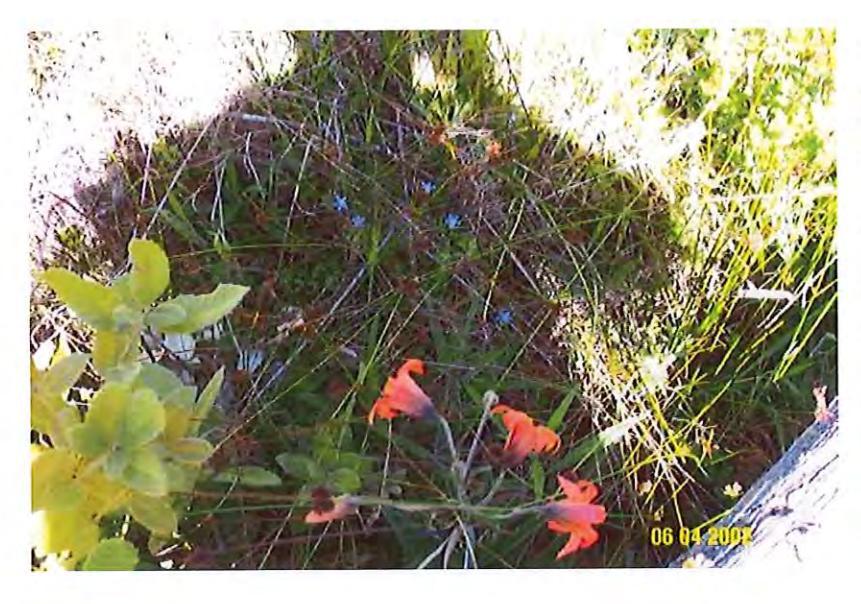
Wildlife		Ph	noto #	948
PW		6/-	4/2002	
Project Del N	Mar		PID	0
Map Pt 0	Road 0		Mi.	0
		Old	New	w
Creek		Cr D	ist	0
Ref 0	LWD Site	6	Tag#	0
Monitoring C	)

This is a coast lily with swamp harebell growing below it. These plants are growing in the center of an old burn pile. This clearcut was tractor piled and burned then sprayed with a broad spectrum herbicide. While no lilies or swamp harebell were observed within this unit prior to harvest, they are now scattered throughout the unit.

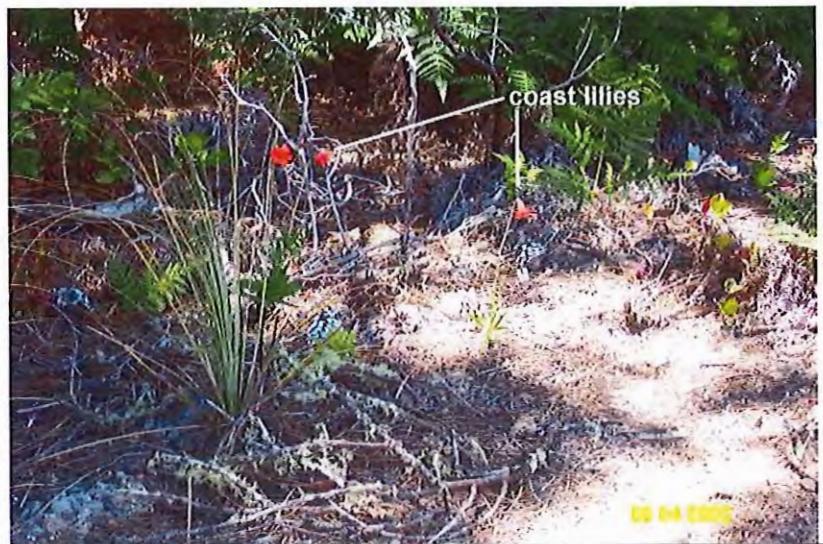
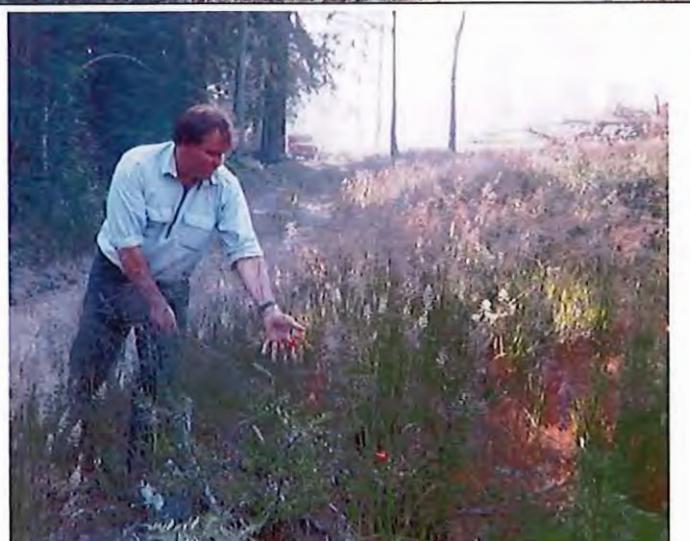
Wildlife		Pł	noto #	108	33
PW			8/	6/20	002
Project			PID		0
Map Pt 0	Road 0		Mi.	0	
		Old	Ne	w	
Creek		Cr D	list		0
Ref 0	LWD Site	•	Tag#	0	
Monitoring	0				
Here are co roadside op	ast lilies which app ening.	eared	in a

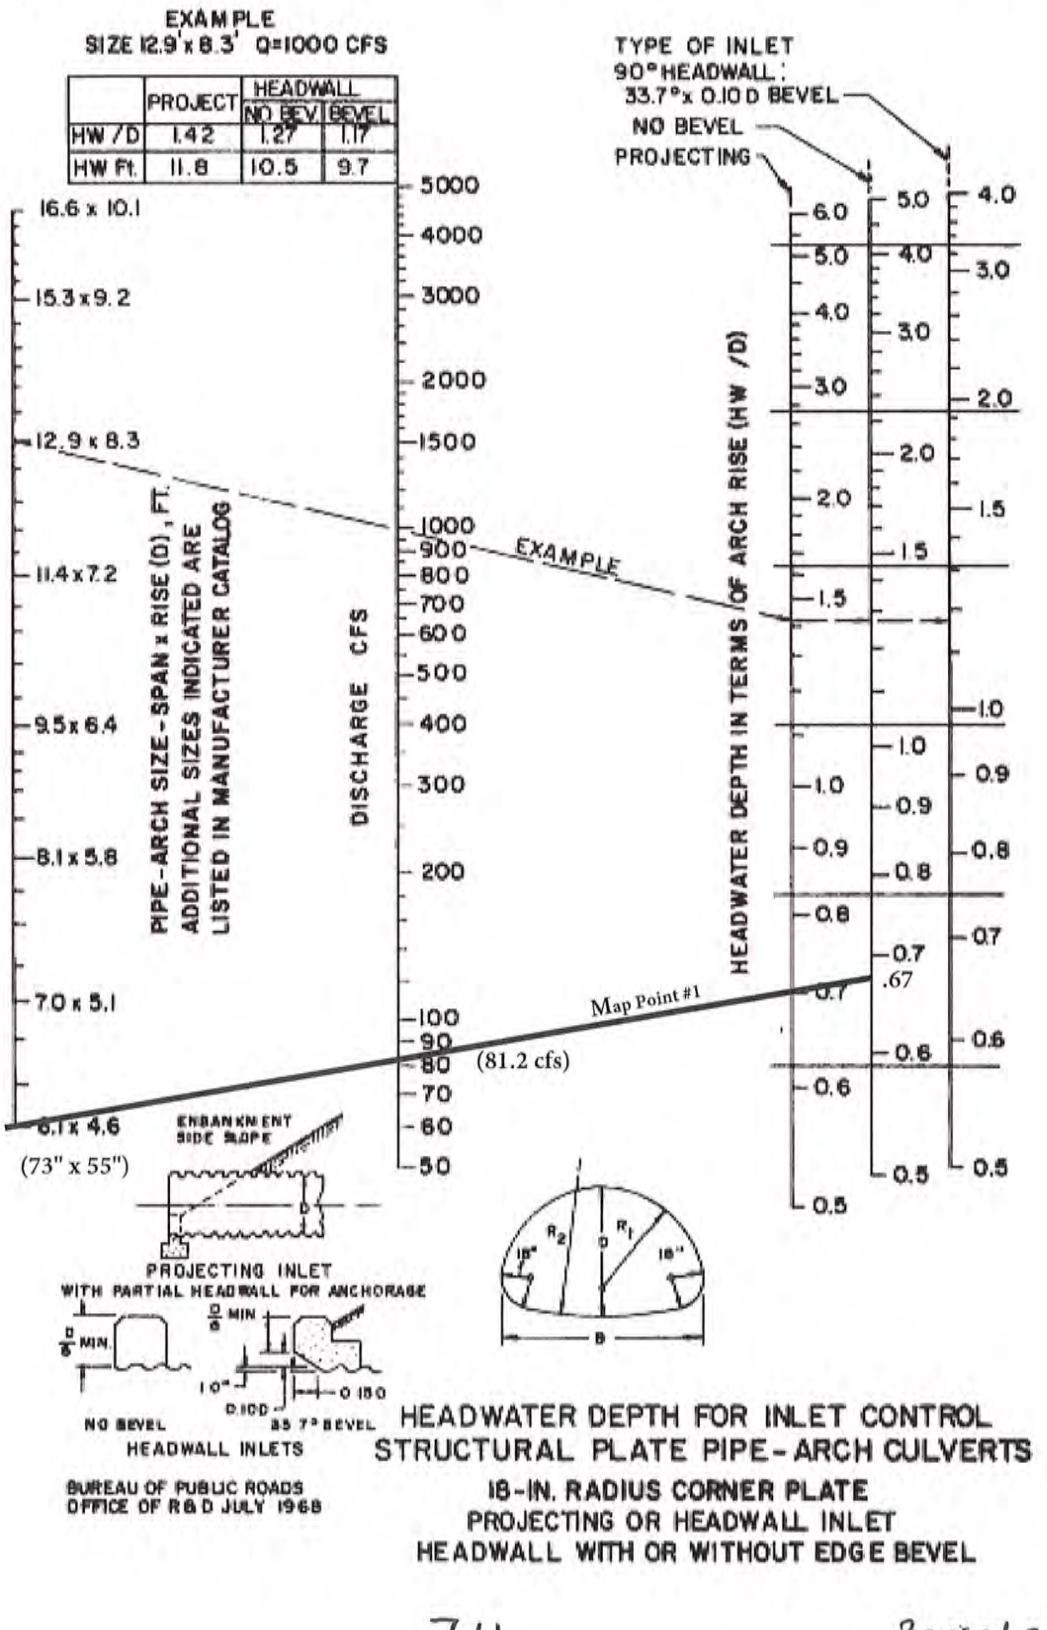
Steam Donkey THP Map Point #1: Pipe-arch Culvert Sizing Chart

Map Point #1: 81.2 cfs

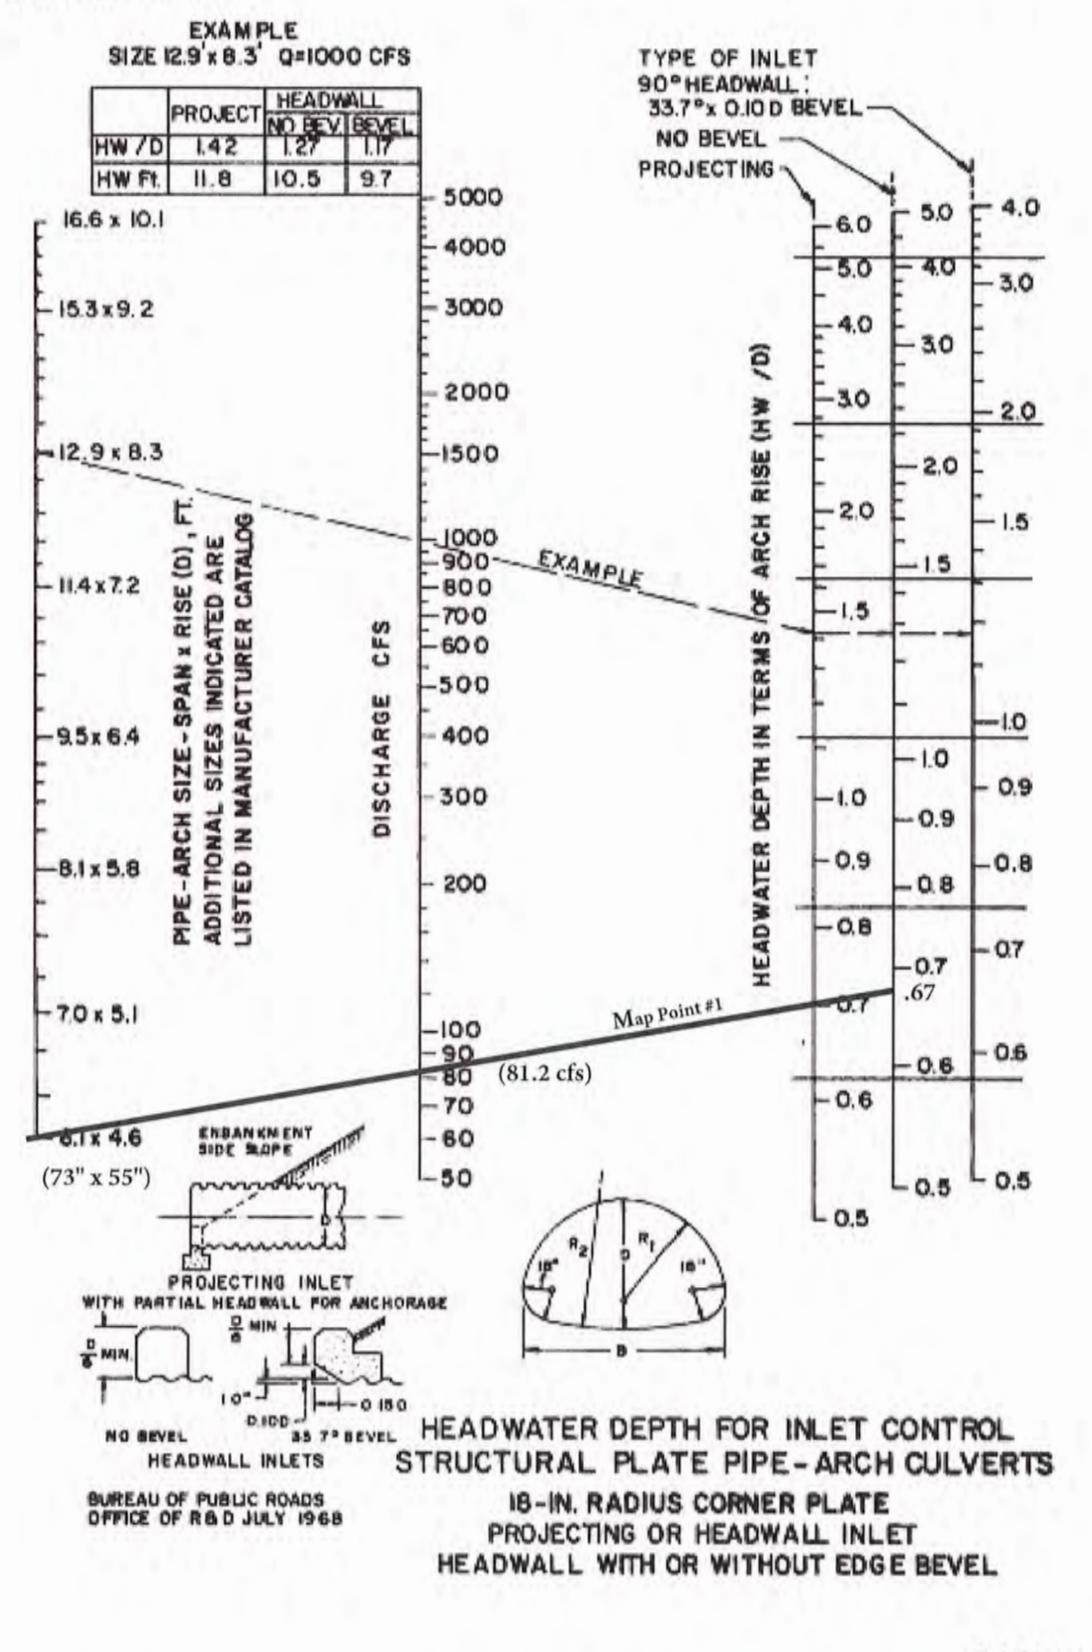
Steam Donkey THP Map Point #1: Pipe-arch Culvert Sizing Chart

Map Point #1: 81.2 cfs

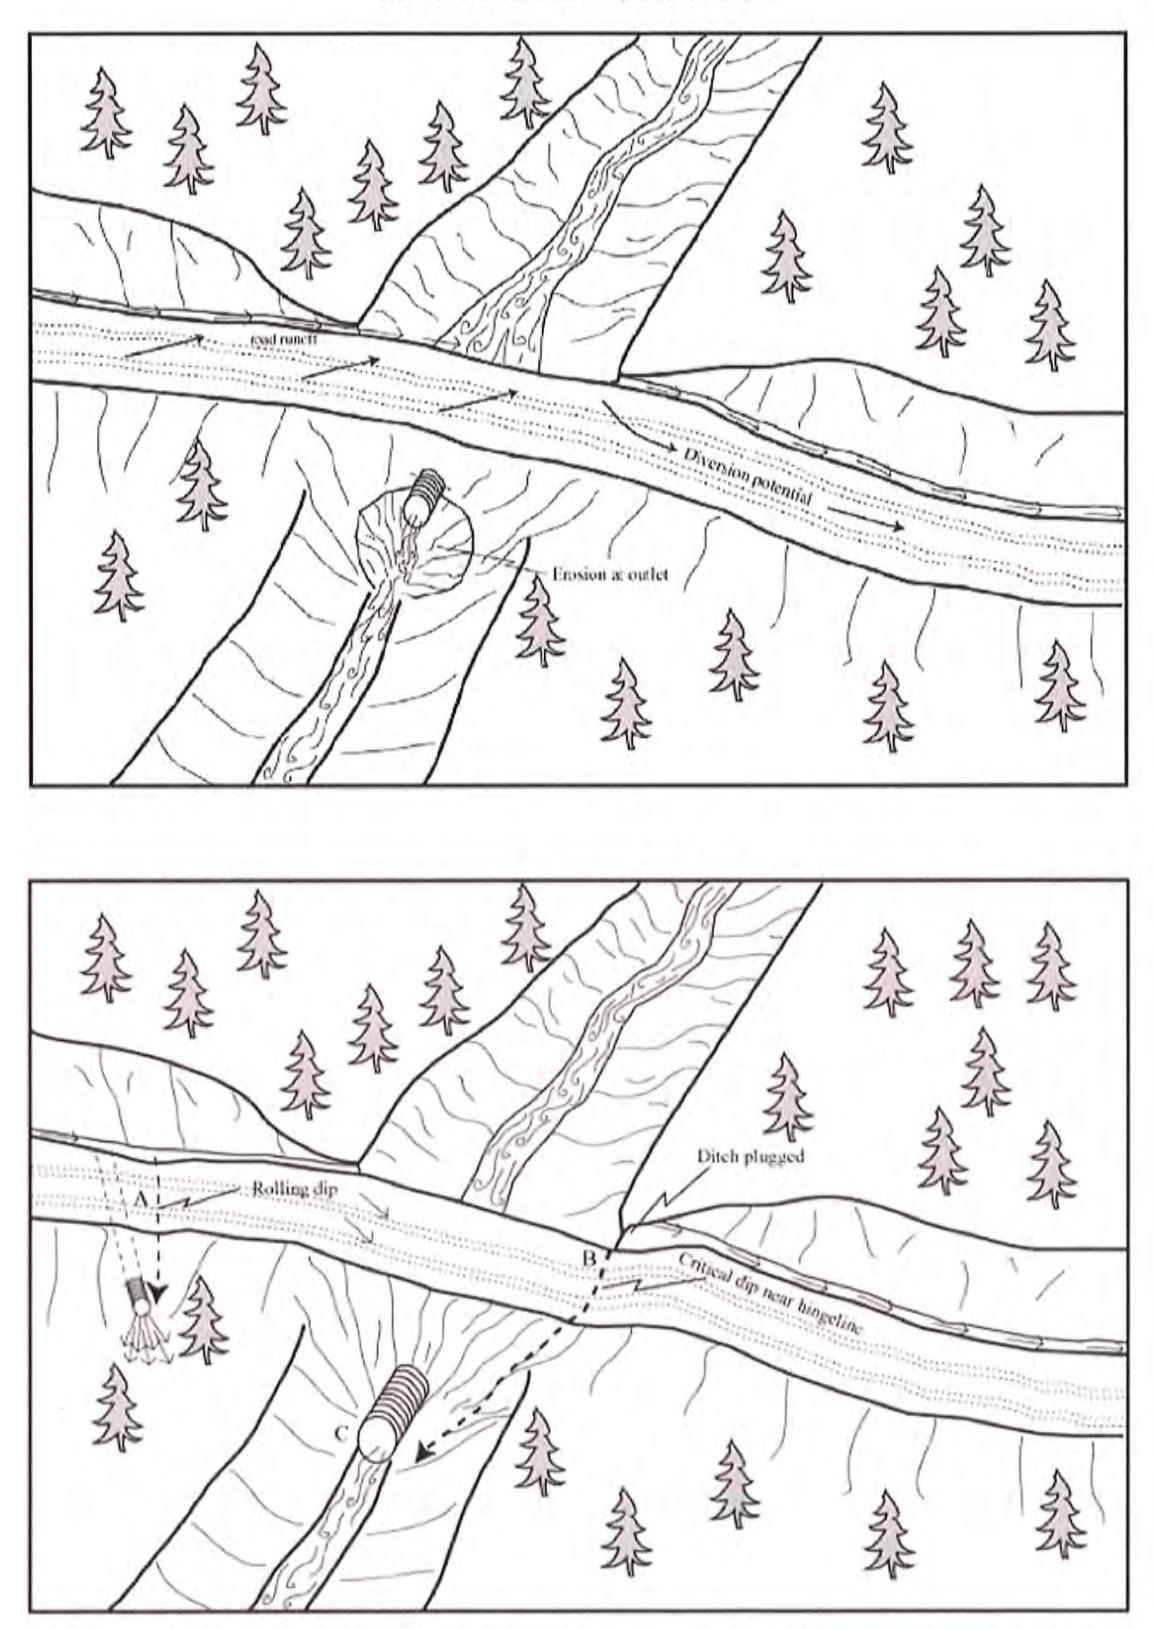
Point G.1 Critical Dip Installation

**Figure 2.** Illustration of a critical dip installed at a watercourse crossing to remove diversion potential (from DFG 2006). The critical dip should be constructed at the point where the potential for erosion and the loss of fill is minimized.
