Gualala River Lagoon Breach

Saturday, April 6, 2013

Photography and annotation: Peter Baye

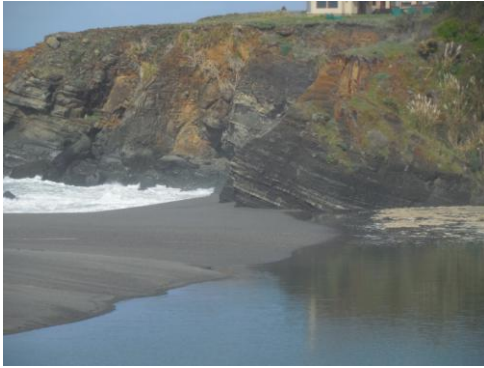
11:12 a.m.

1. **Pre-breach:** Rapidly rising lagoon levels morning to mid-afternoon at lowest beach crest elevation in lee of headland, north end of Gualala Point Beach. Lagoon high water line moves seaward in shallow trough on beach at bedrock outcrop in beach berm.

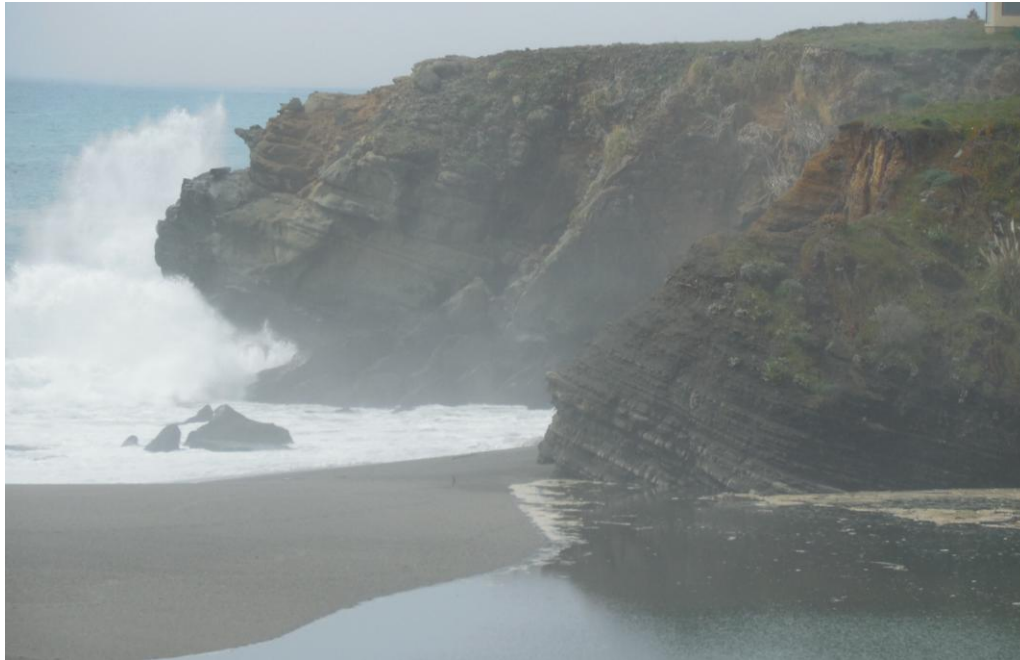
2:18 p.m. Lagoon water line reaches berm crest; threshold for spillover. Lagoon seeps into beach, saturating sand across beach profile at the narrow spill zone.

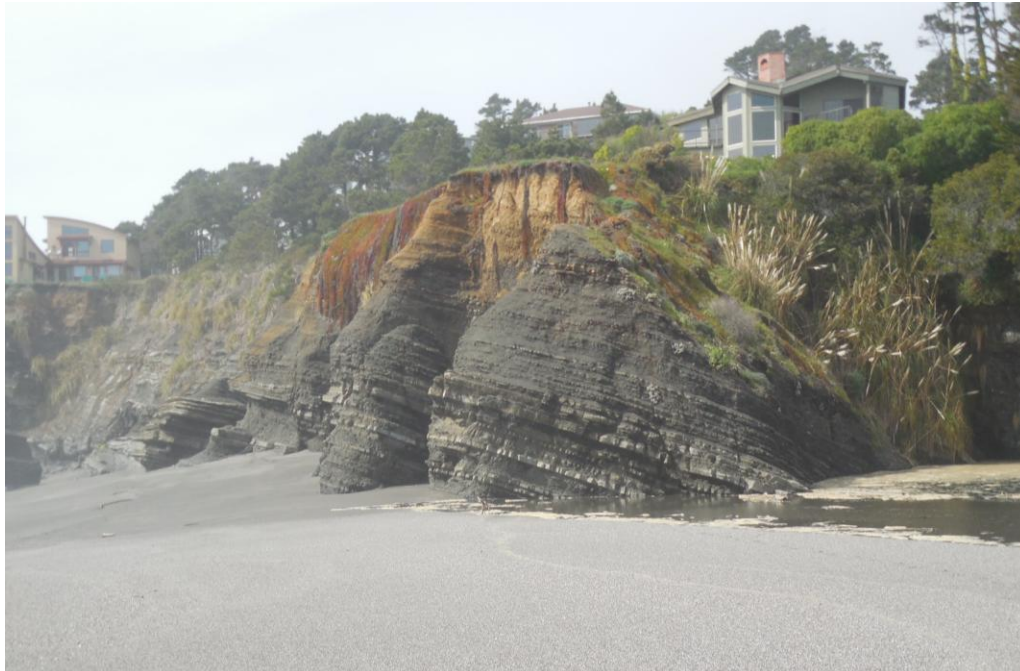
3:19 p.m. Beach sapping of lagoon outflow by seepage slows as the sand saturates at the spill zone. Lagoon water surface starts to overtop the crest, with slow sheetflow currents that terminate as seepage (infiltration) into the sand.

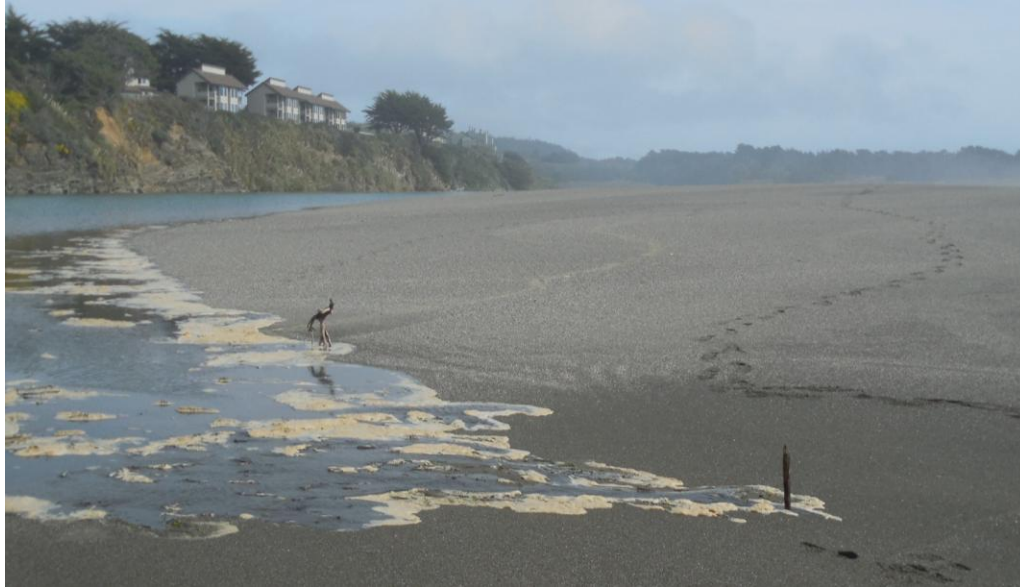
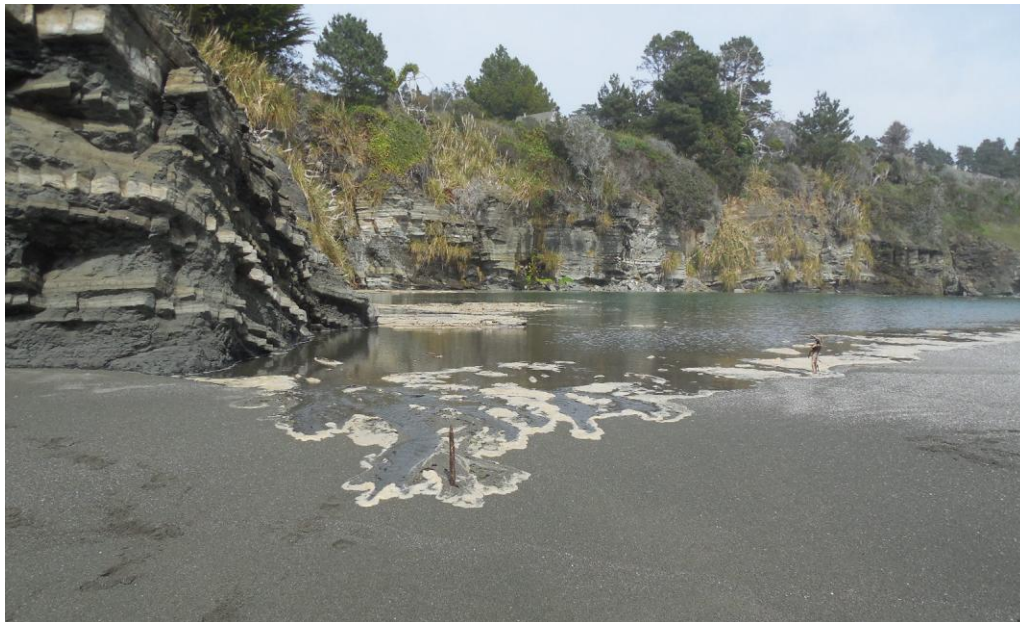
3:21-3:23 p.m. Lagoon discharges at surface as rapid sheetflow (shallow but current velocity), but the overtopping of the berm remains very slow due to sapping of lagoon outflow by infiltration into the upper beachface, seaward of the flat-topped berm crest. Sand in beachface is saturated around the foam line.

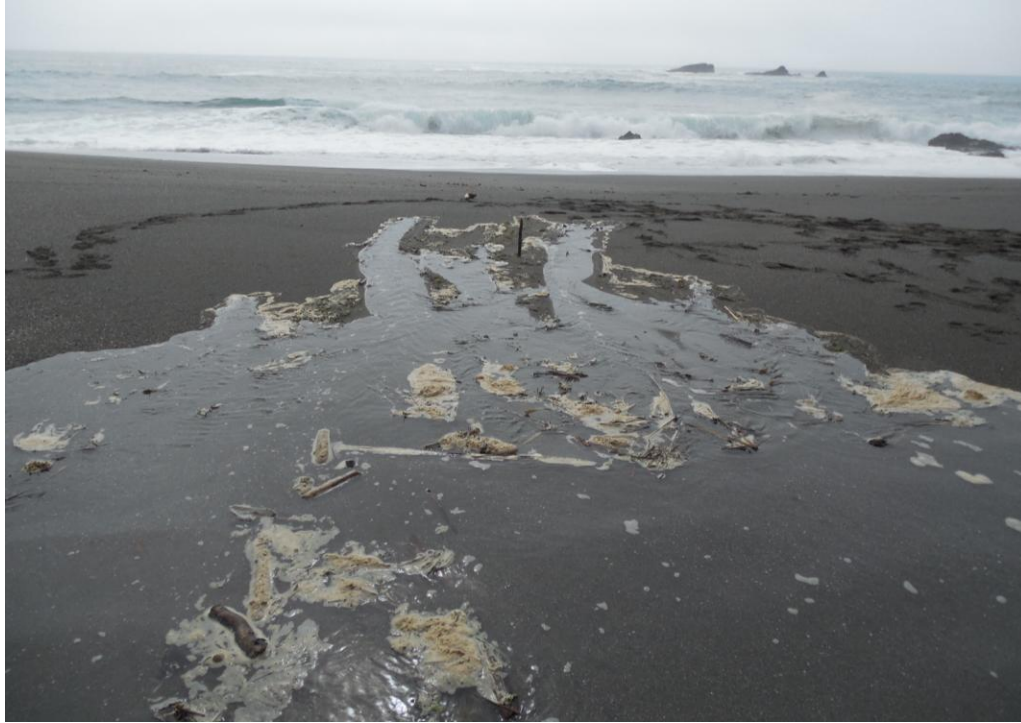
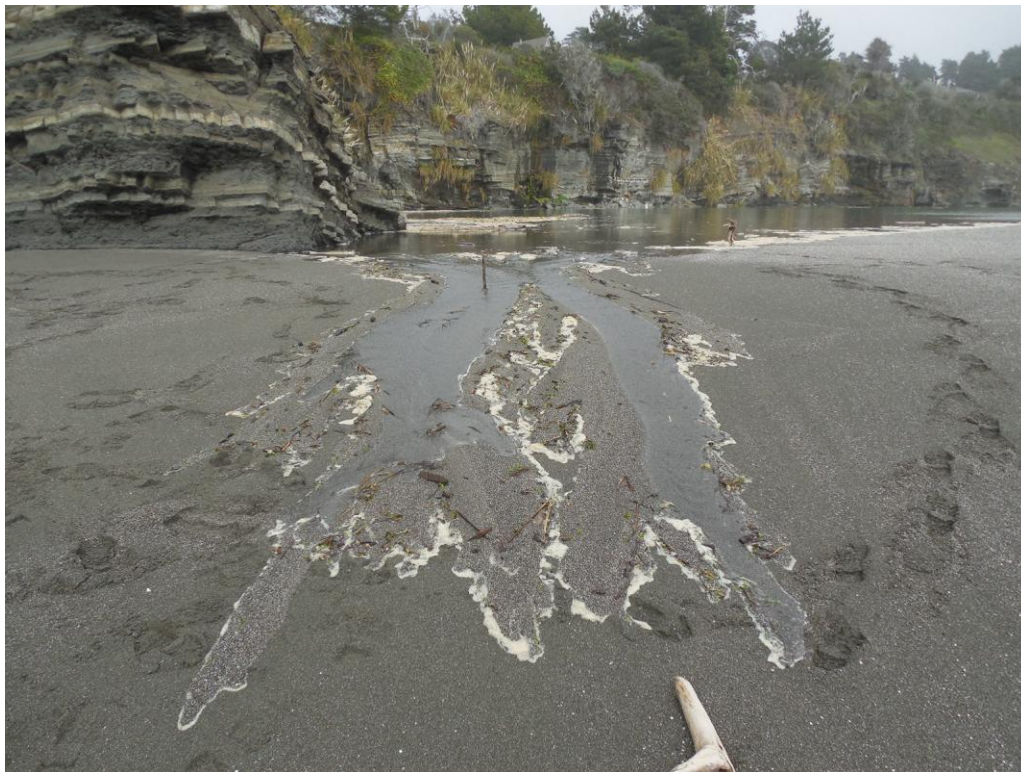
3:26-3:29 p.m. Overtopping starts to discharge as channelized flow as it passes over the steep upper beachface. Delta lobes of sand deposit along the creeping front, but at the berm crest, the channel begins to erode into defined beds and banks.

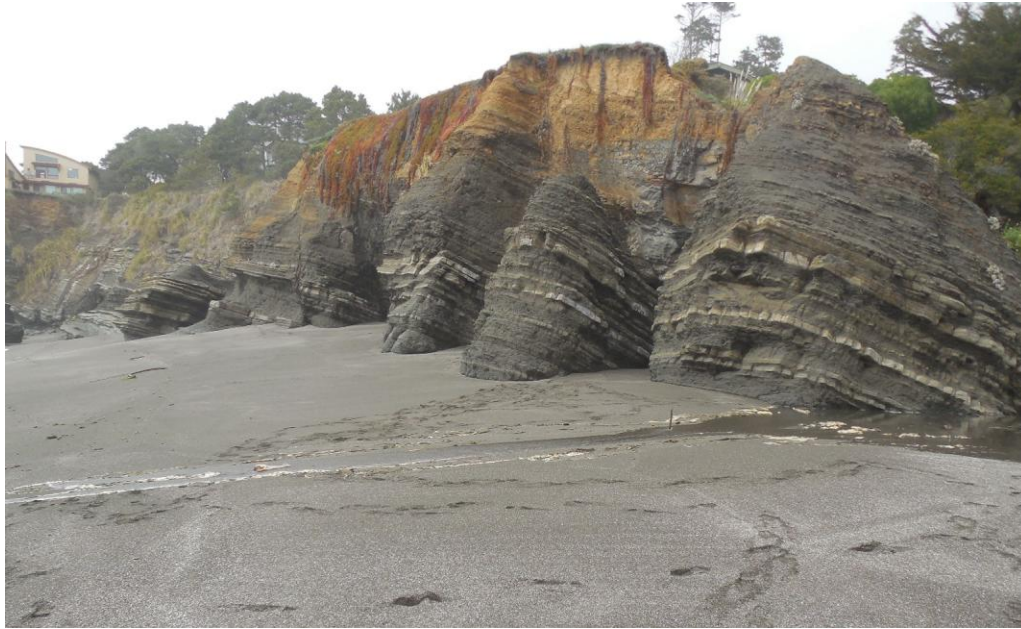
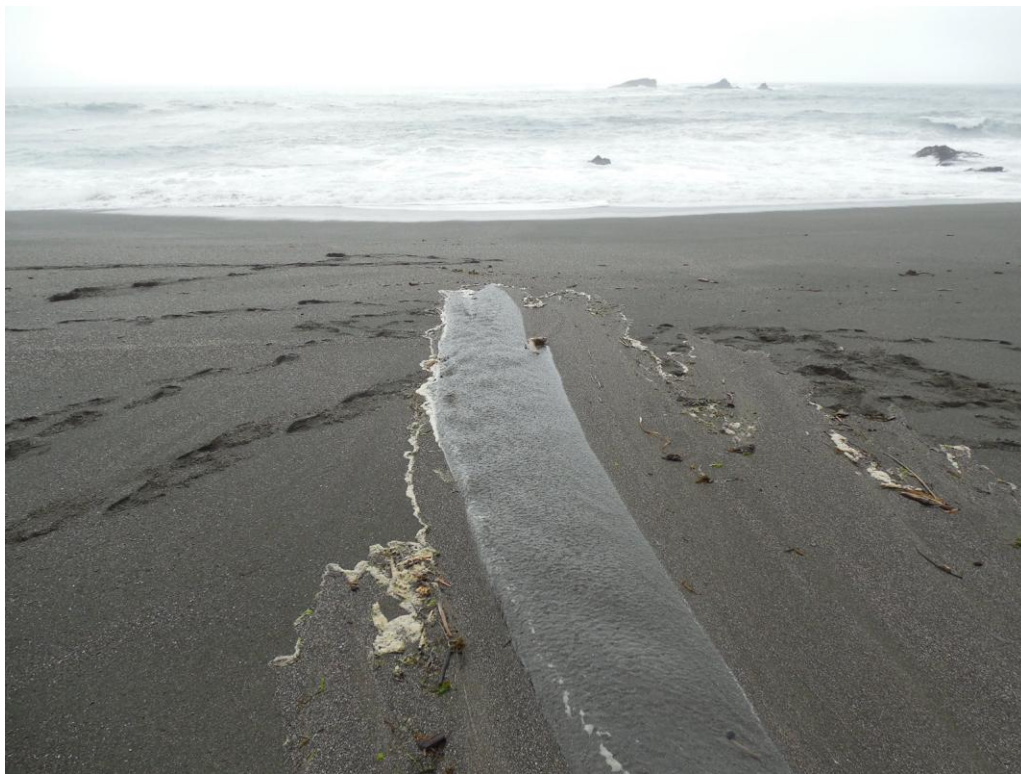
3:33- 3:34: Surface discharge of lagoon is confined to a narrow (< 0.5 m), unstable, shifting linear shallow channel with rapid currents that flow down the steep beachface. The front migrates rapidly towards the swash zone, one to several meters per minute.

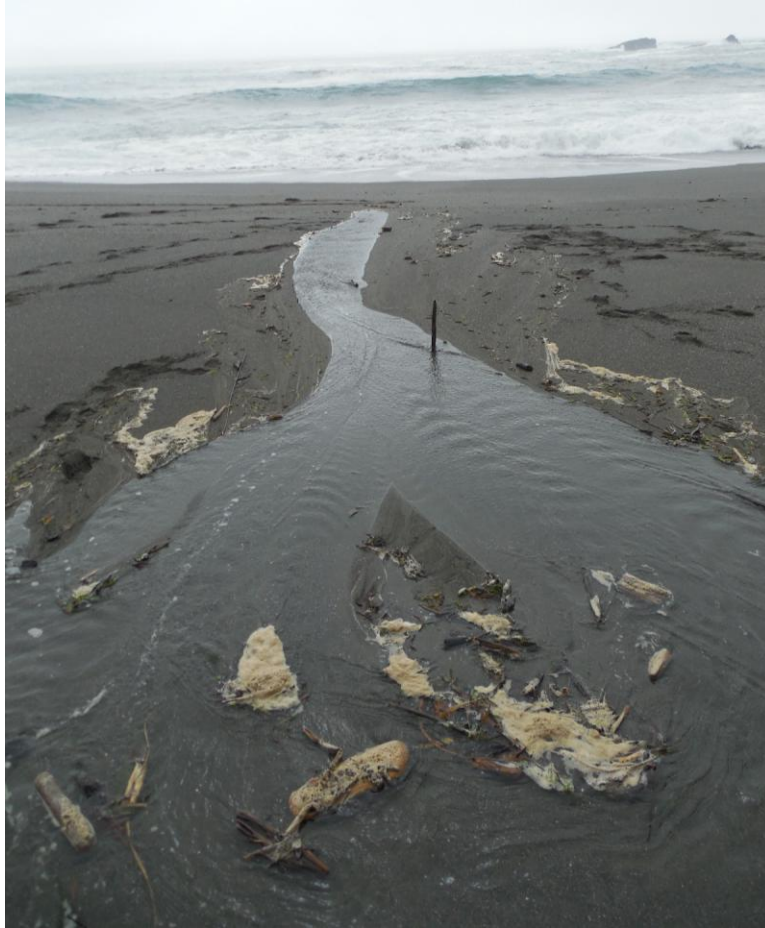
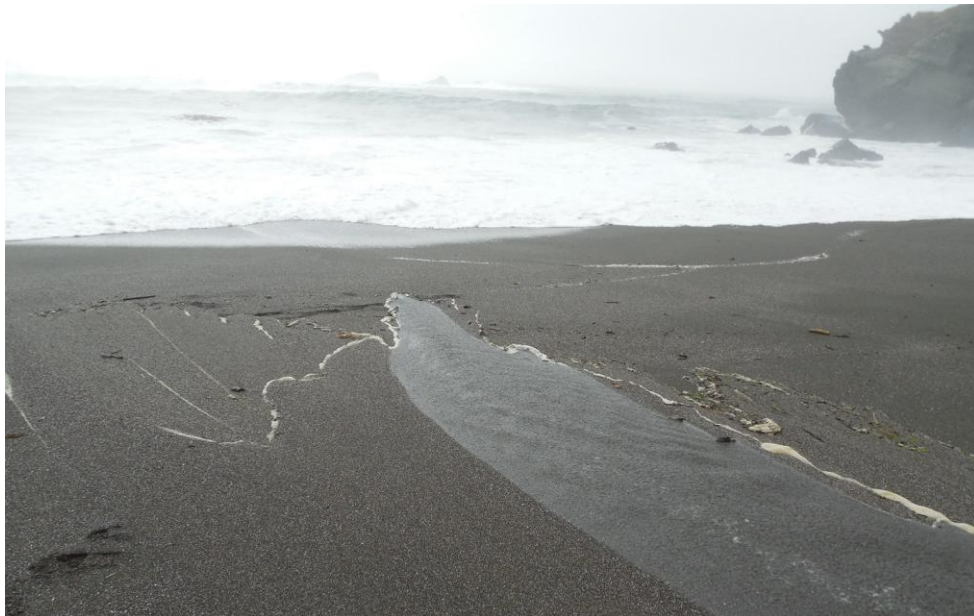
3:34-3:39: The front of the surface discharge reaches the most recent swash line (wave uprush) position, and flows accelerate all along the entire channel across the beachface, where standing waves begin to form.

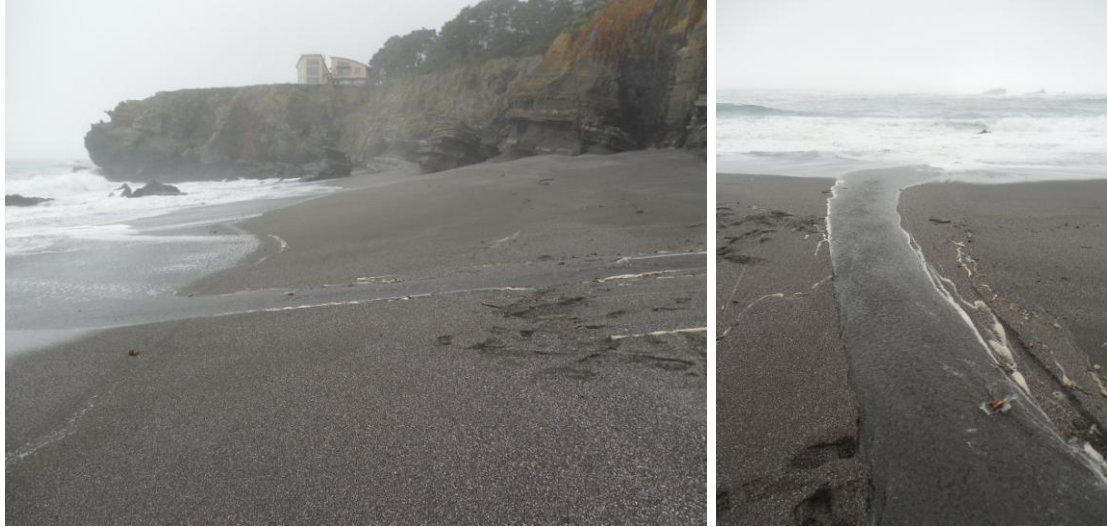
3:40 p.m. The surface discharge of the lagoon connects directly into the active swash zone of the beach.

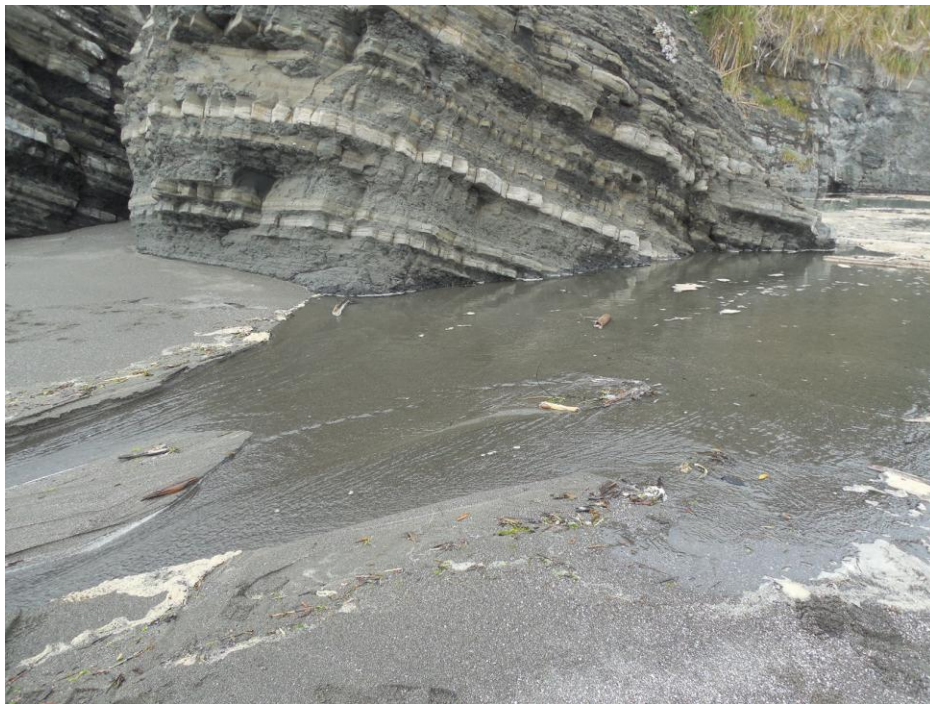
3:43 p.m. The channel rapidly downcuts through the berm crest as it captures more lagoon outflow, and the erosional “nick” in the berm crest erodes headward (upstream, landward).

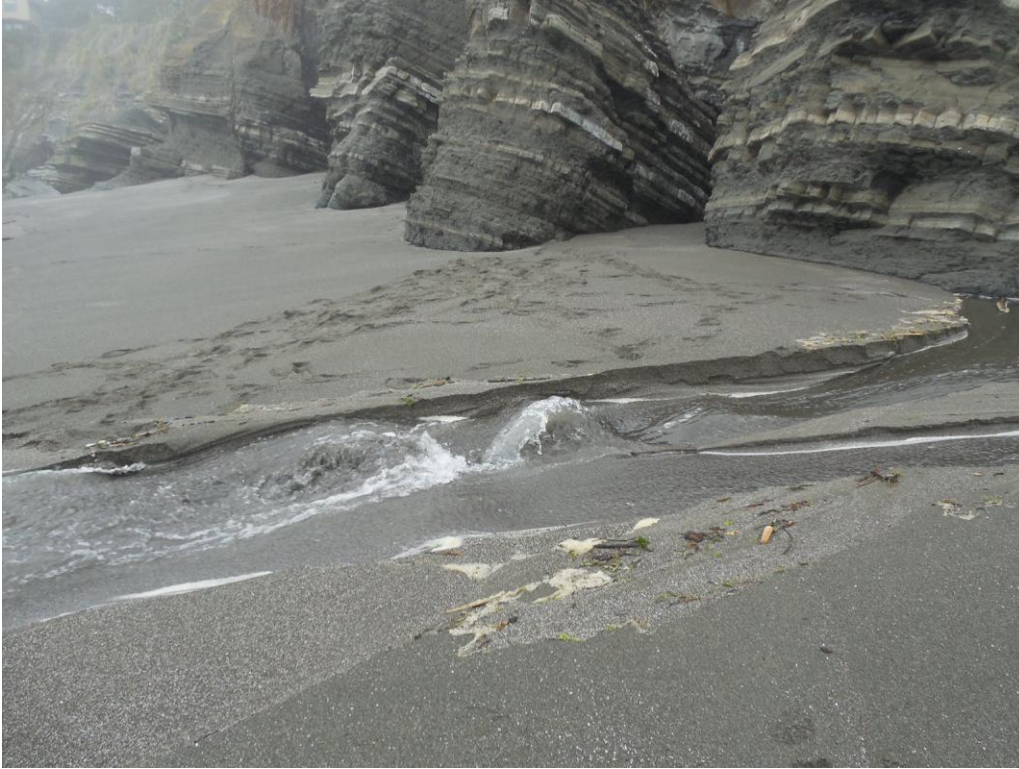
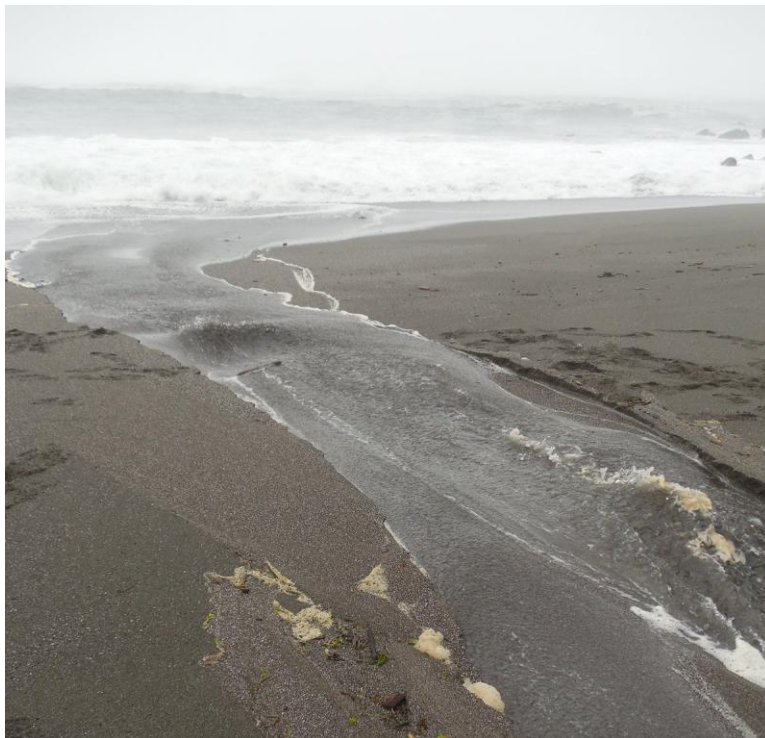
3:43 p.m- 3:47 p.m. Standing waves in the rapidly downcutting channel in the upper beachface form hydraulic jumps as they rapidly steepen. The channel is about a meter wide, and the bank scarp is up to about 20 cm high. Flows are very rapid (floating debris moves over 1 meter/second in glides between standing waves).

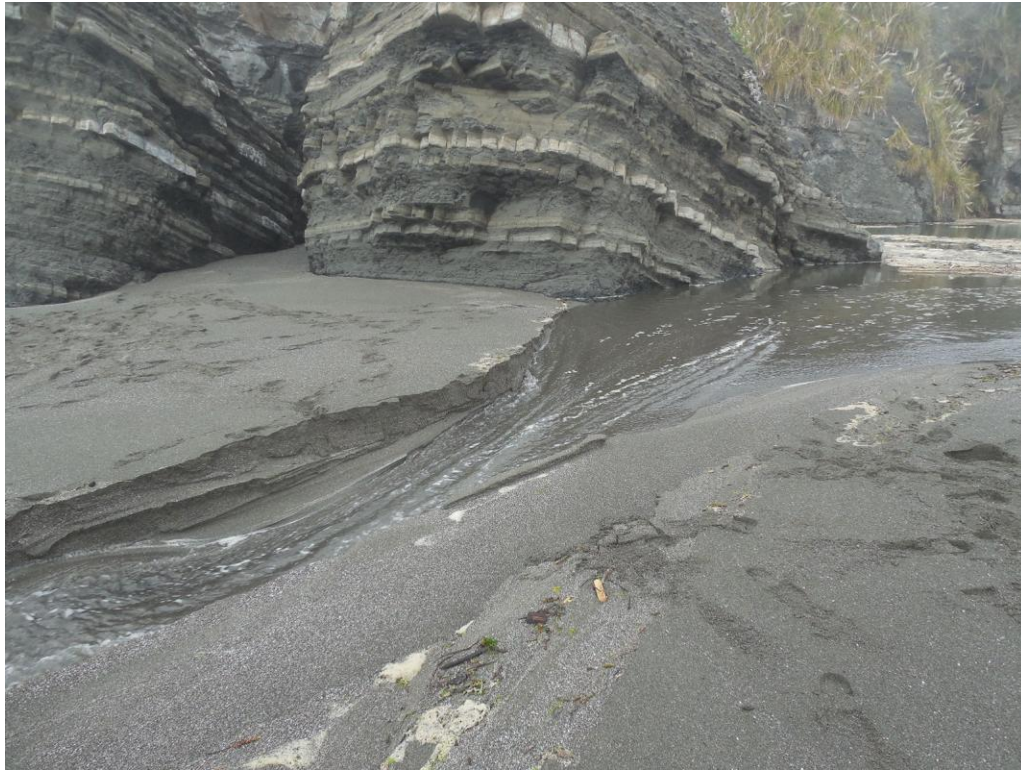
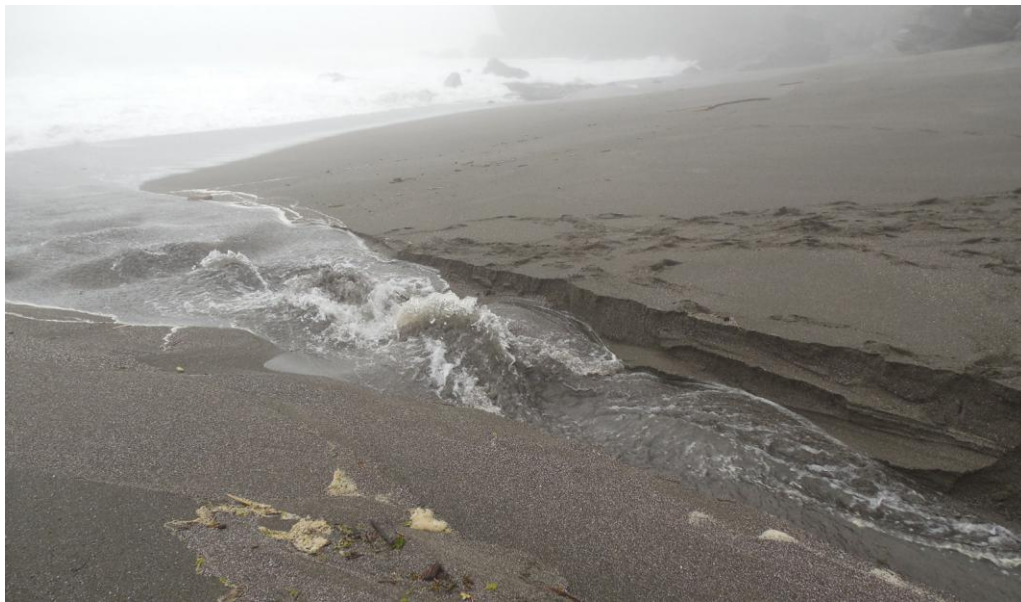
3:50-3:51 p.m. The channel head-cut narrows, deepens, and steepens as it migrates upstream across the berm crest. The jumps multiply and enlarge (about half a meter high) as the channel also narrows and deepens rapidly in the beachface. Breaching is now rapidly progressing and accelerating.

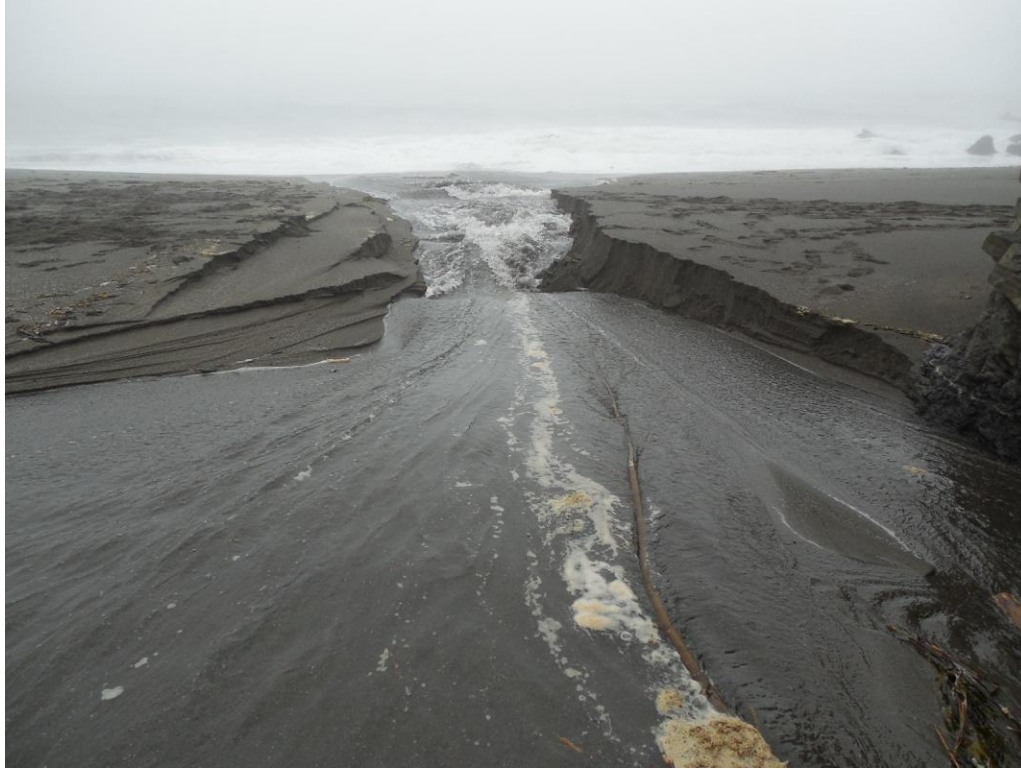
3:59: The breach in the beachface is a whitewater chasm over a meter deep and two meters wide, but the berm crest adjacent to the bedrock outcrop (overtopping zone) is still shallow, wide, and discharging with laminar to turbulent flow.

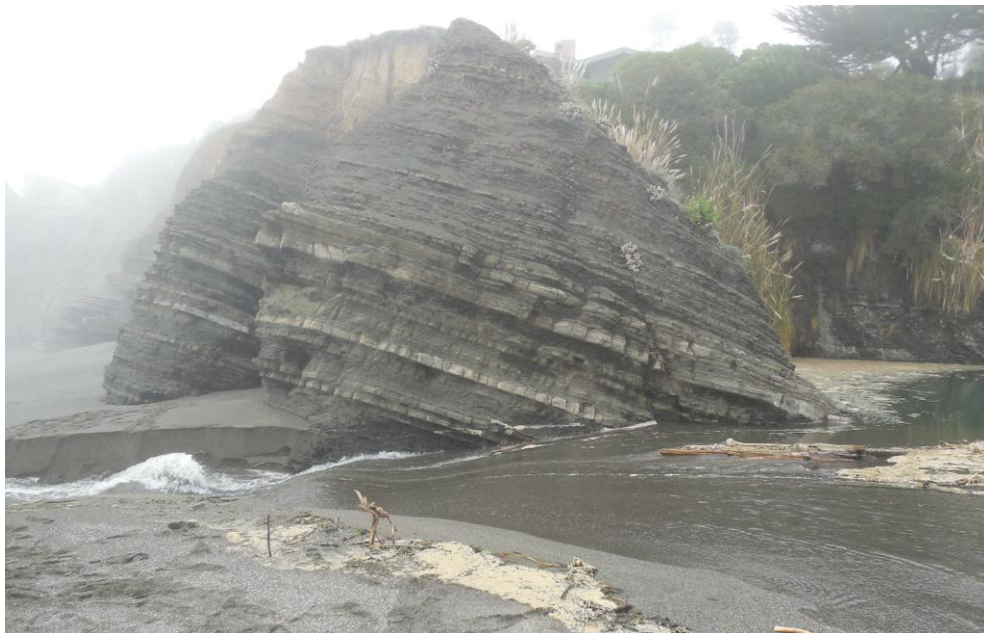
4:08 p.m. The breach is over a meter deep at the beach crest, and the head-cut (rapid change in channel slope) is migrating past the bedrock outcrop's seaward edge.

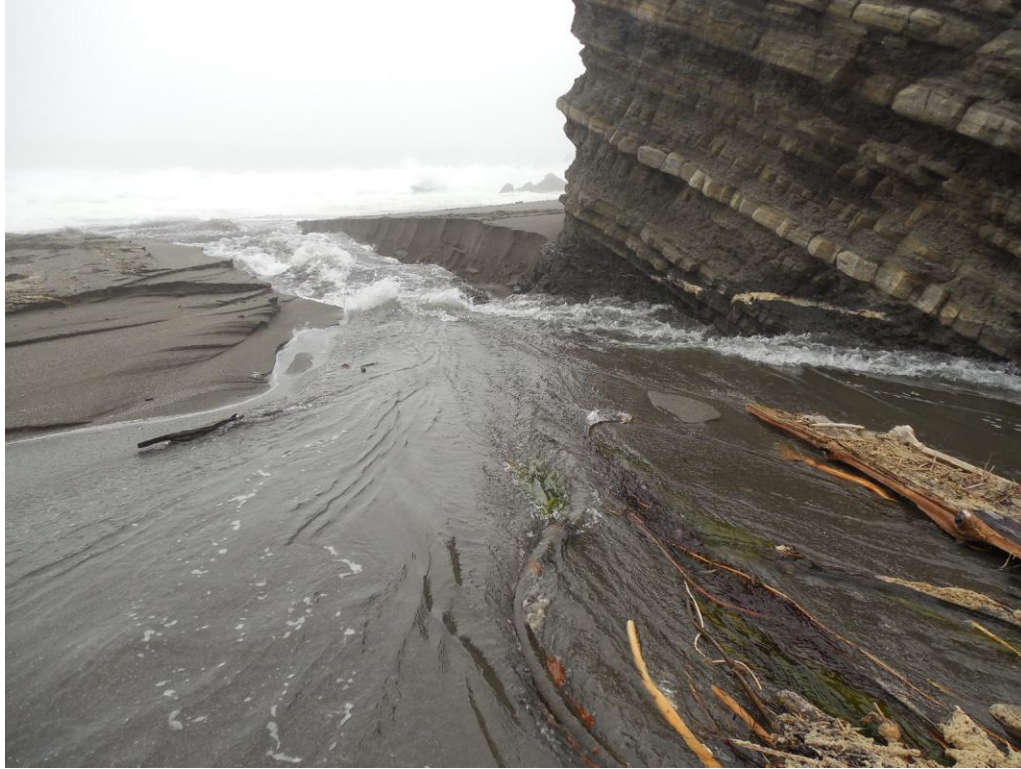
4:12 p.m. The head-cut (rapid change in channel slope) is migrating past the bedrock outcrop's seaward edge, but the gentle landward slope (overwash fan) of the barrier beach is still acting as a flat-topped sill or spillway, prior to full breach threshold.

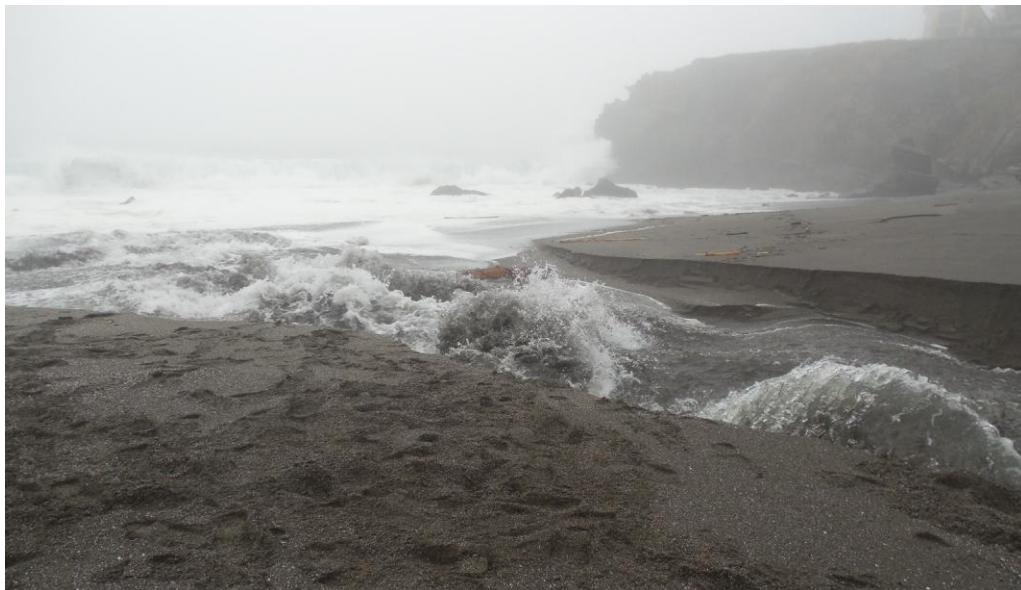
4:17 p.m. The outlet channel in the beachface is a cascading series of high jumps – giant ripples, breaking, roaring standing waves - each over a meter high, cresting above the level of the beach. The channel is over 4 meters wide, and the vertical banks are over a meter high.

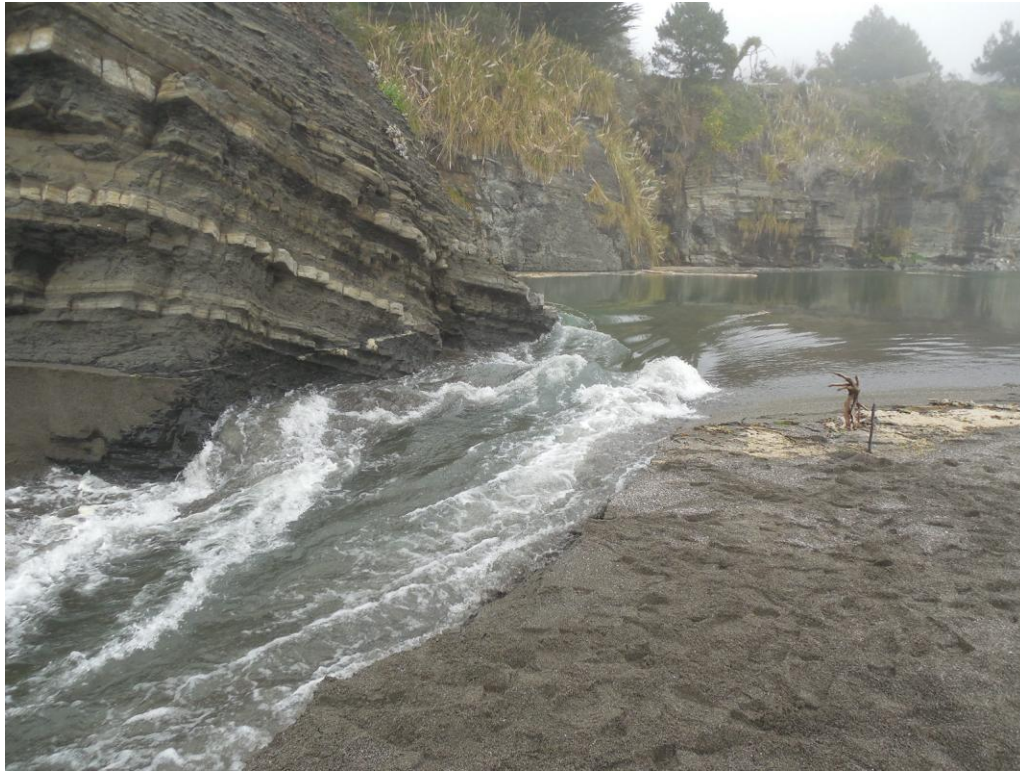
4:20 p.m. View of the narrow (less than about 2 m wide) outlet neck of the breach after the channel cuts across the entire beach profile. Deep lagoon water directly flows across the breach, without passing over a shallow sill. Lagoon begins full breach stage.

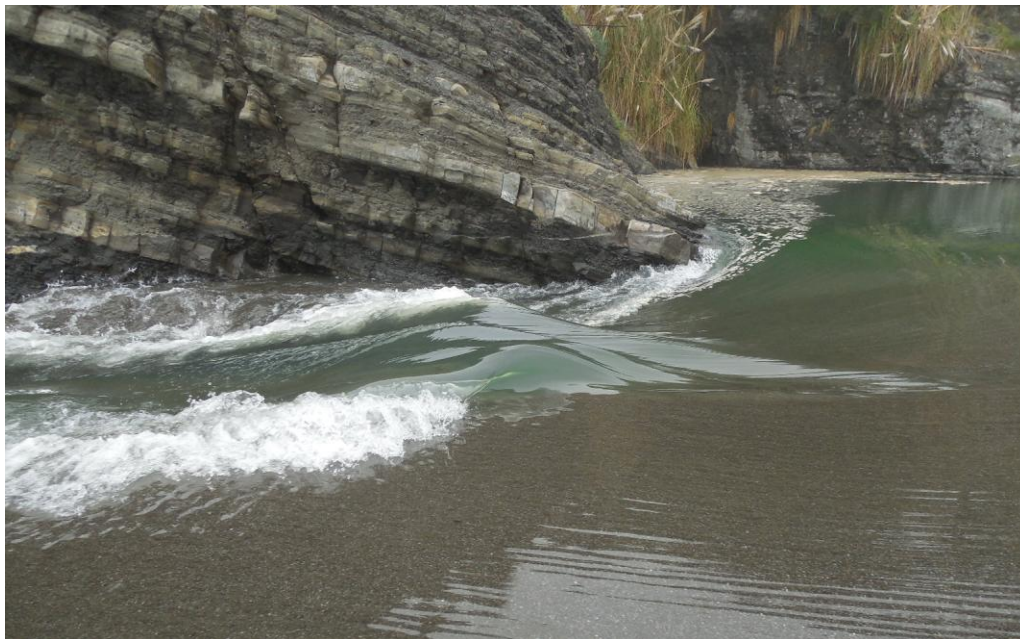
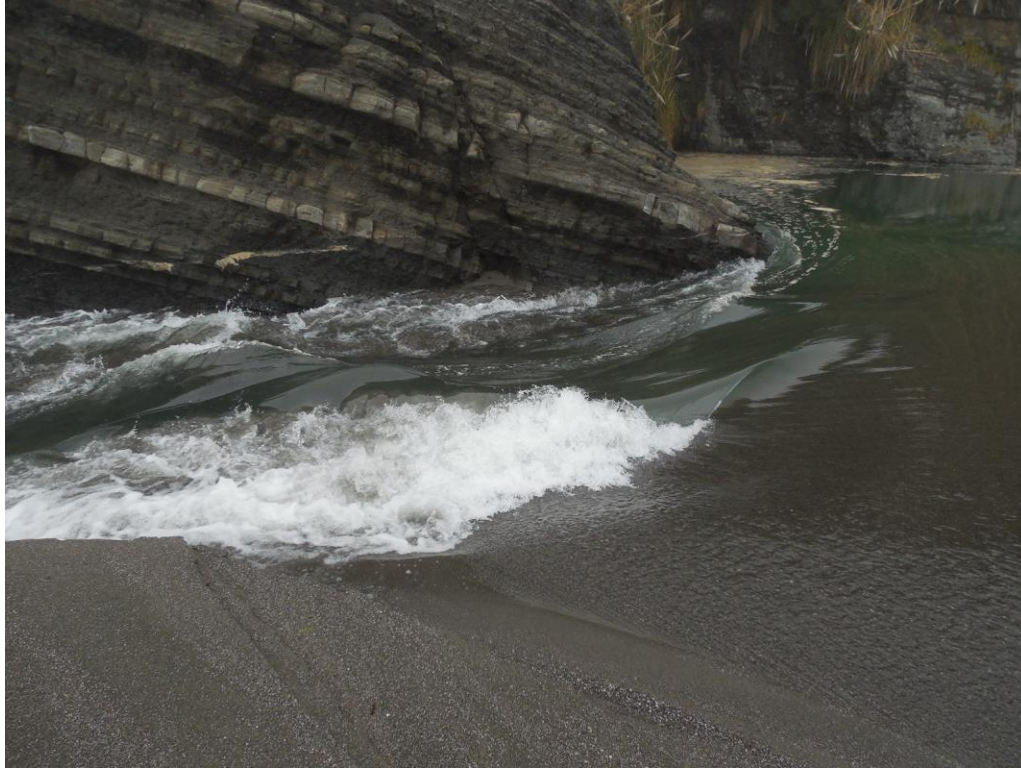
4:18-4:20 p.m. A breaking standing wave with a green (algal-hued) “curl” forms at the nick point when the head-cut crosses the barrier top profile, and flows cross the gradient between shallow and deep lagoon. Lagoon enters full breach stage.

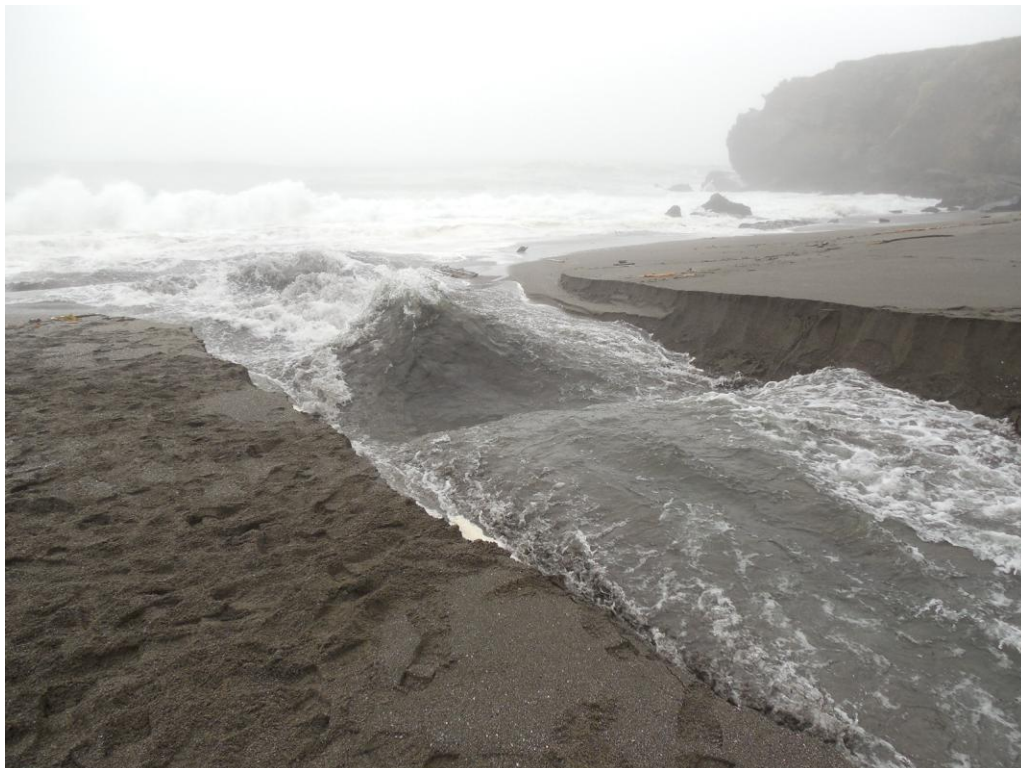
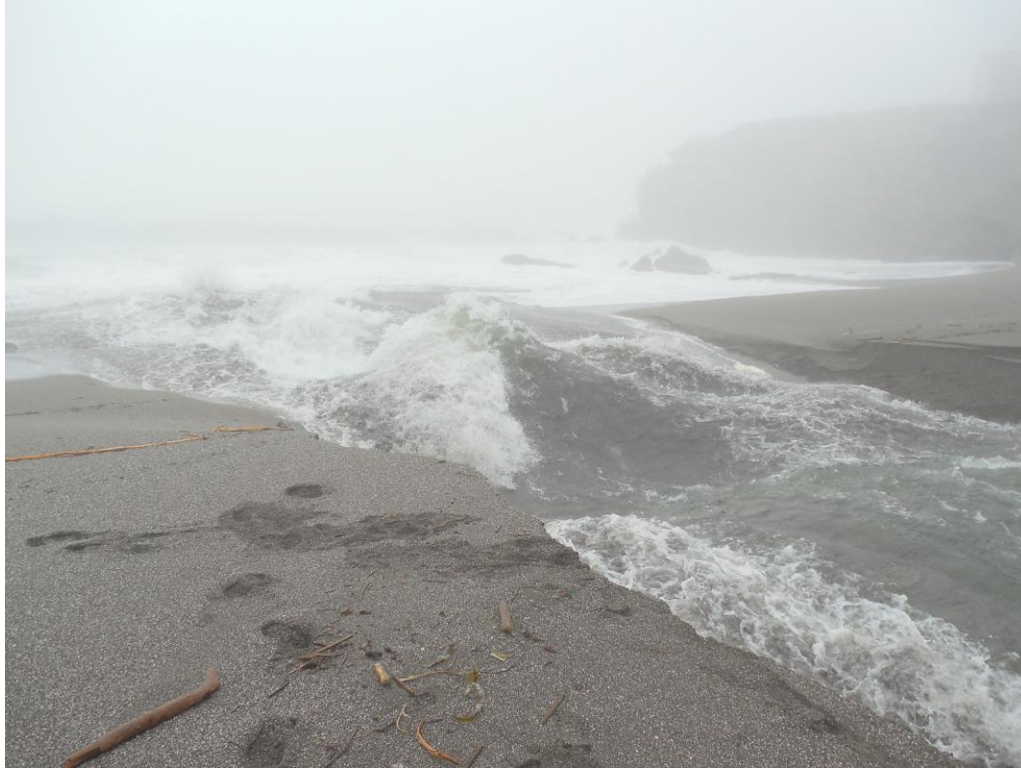
4:19-4:26 p.m. Once the barrier crest spillway or sill is cut through, the discharge increases and the roaring jumps increase to more than about 1.5 m high. The channel widens seaward.

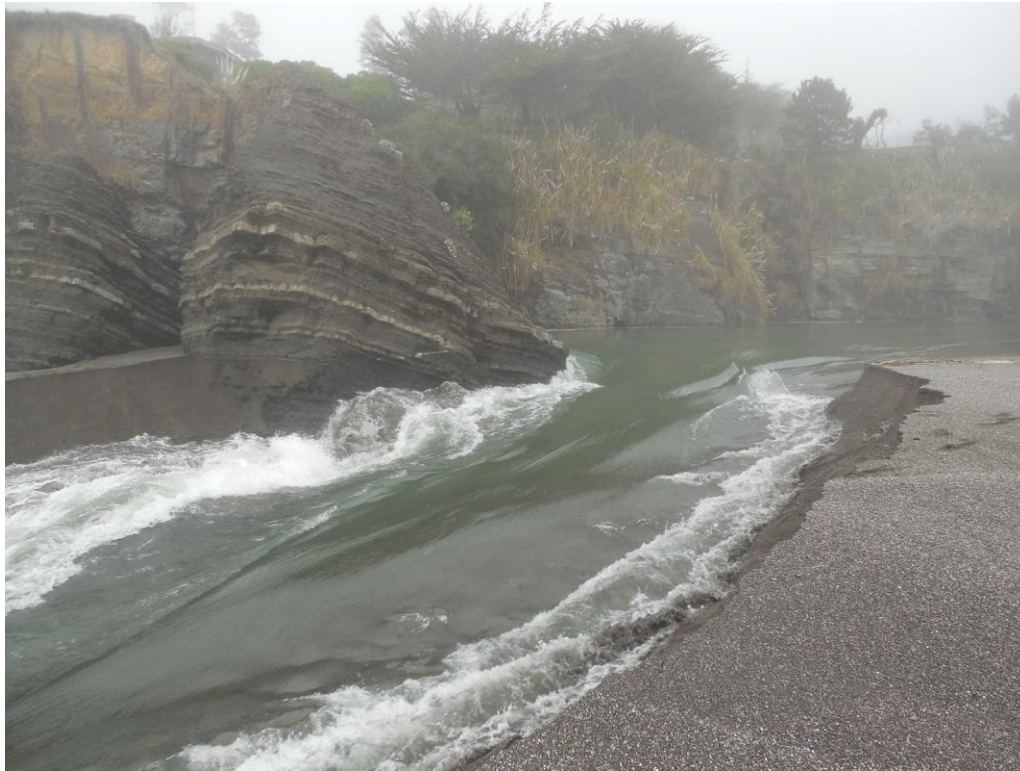
4:30-4:31 p.m. The outlet channel widens and flattens as massive lagoon outflows lower the channel gradient across the breach from the lagoon to the surf zone. Jumps flatten out, and standing waves interact with wave bores from ocean swell. The narrowest neck of the breach rapidly widens to several meters.

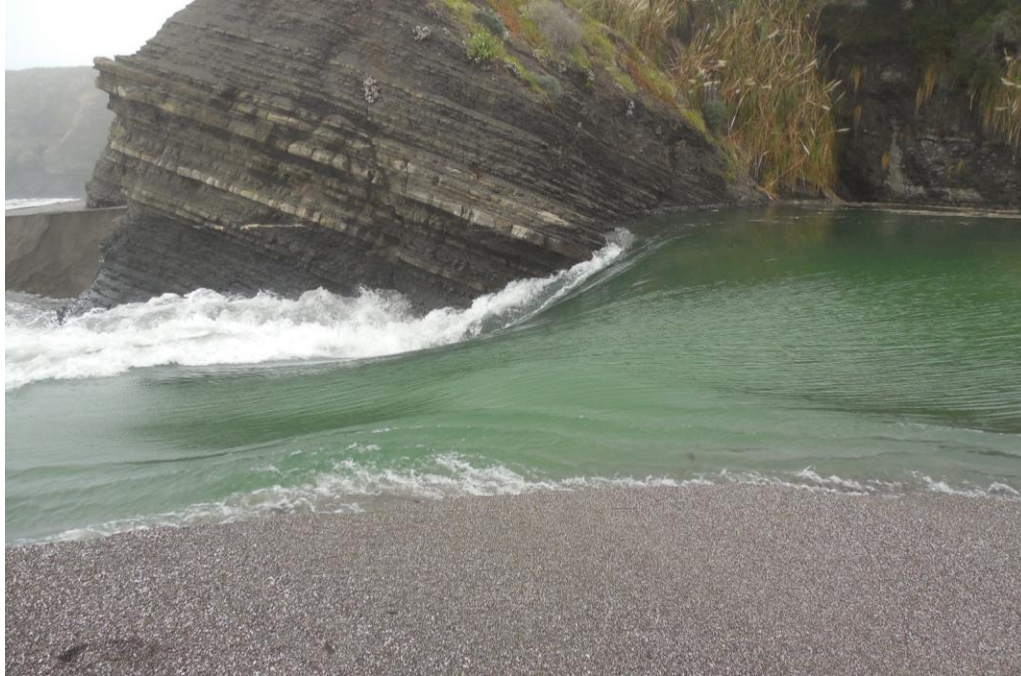
4:36 p.m. Steep and relatively smooth water surface slides from the lagoon across the widened, deepened breach at the barrier crest. Floating debris crosses the breach and reaches the ocean in 5-6 seconds.

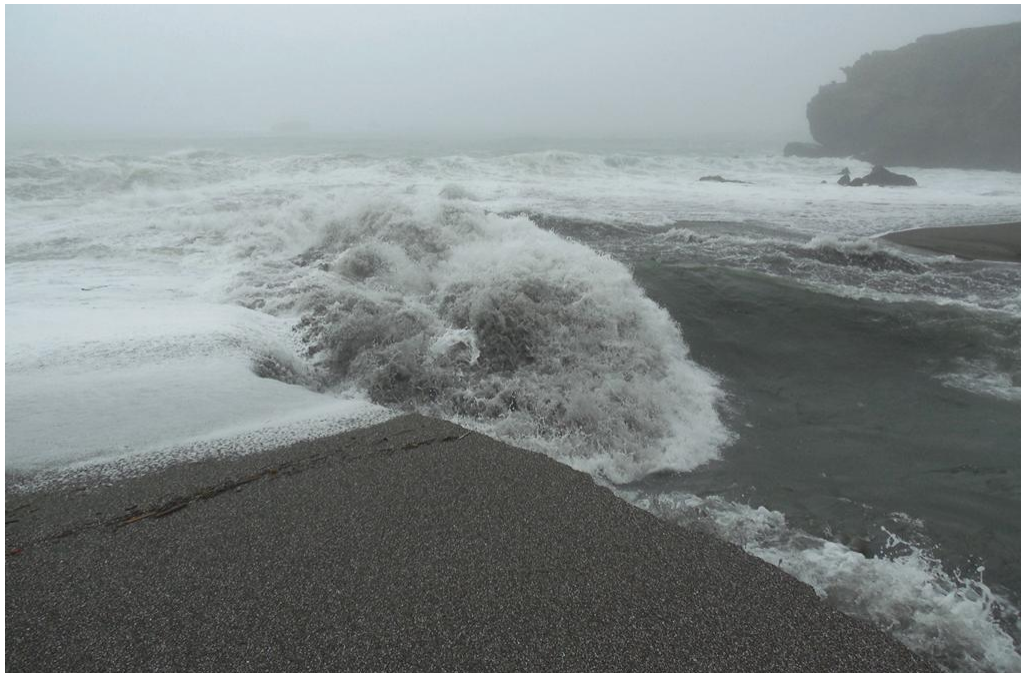
4:33 p.m. A huge jump forms at the toe of the channel where it scours deep below the adjacent beachface level. Note the swash pouring over the channel edge.

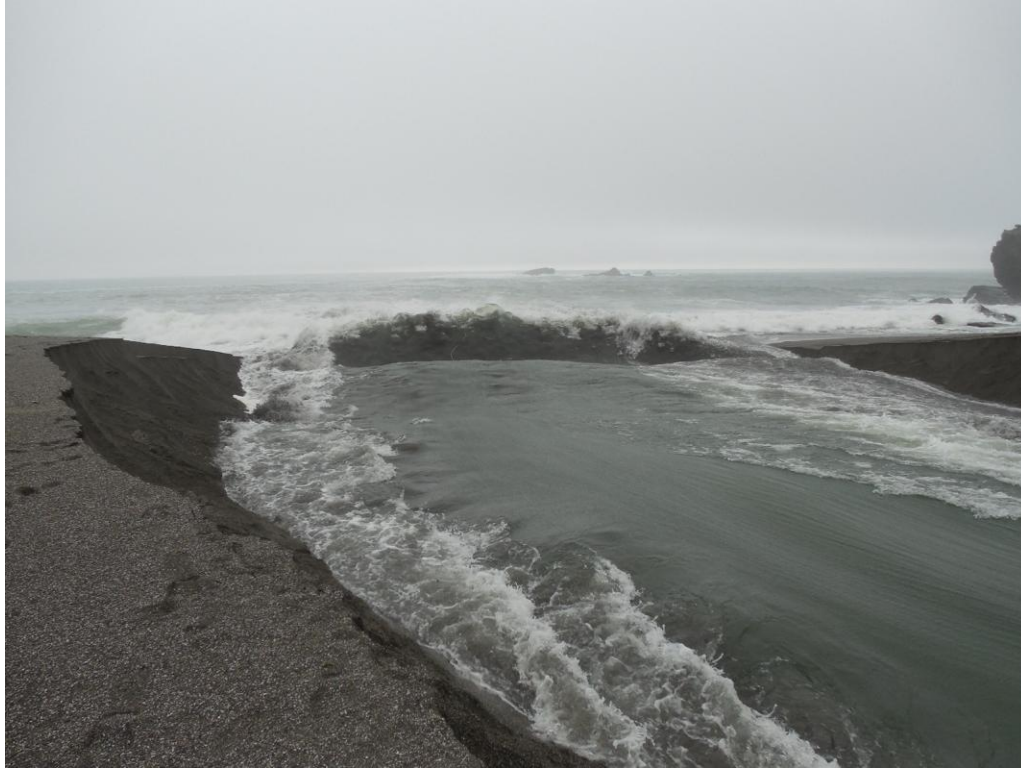
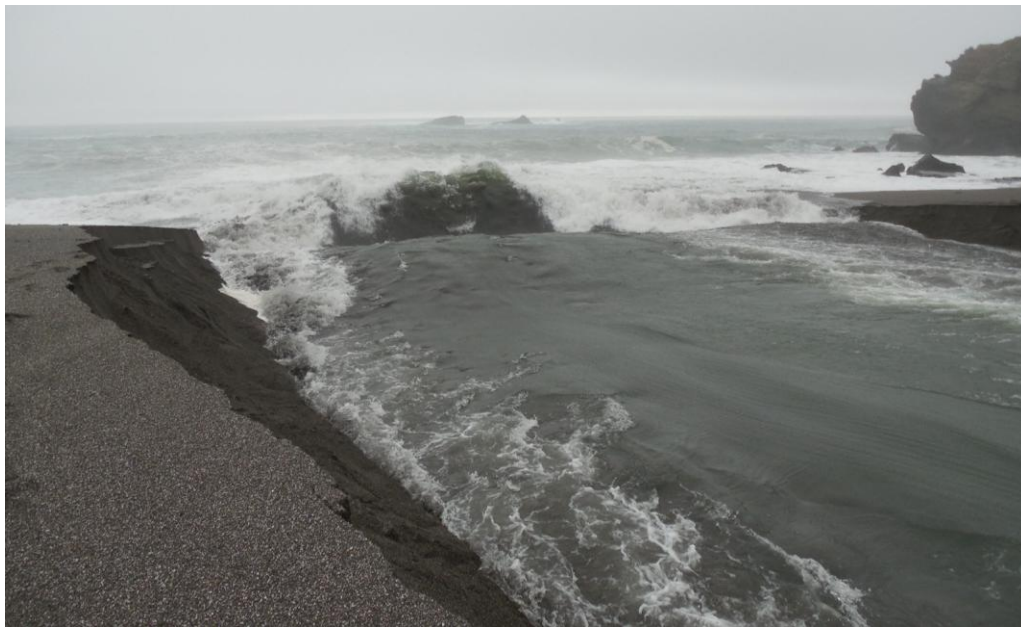
4:37 p.m. The lagoon outflow captures and slows breakers. The channel bank cuts (scarps) are over about 2 m above the water surface, and the channel is over about 10 m wide, and is continuing to widen slowly.
