Gualala River Lagoon Breach

Saturday, April 6, 2013

Photography and annotation: Peter Baye

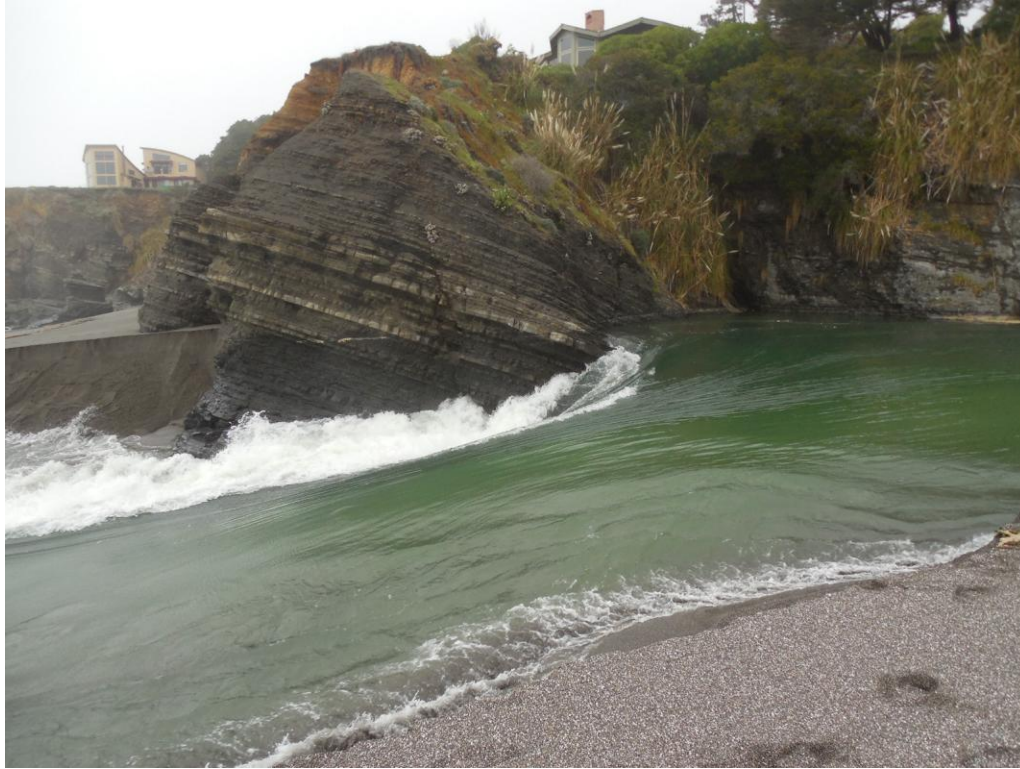
4:42 p.m. The breach continues to deepen and widen rapidly while the steep water slope surface between lagoon and channel smooths over the deep channel breach, turbulent only around the banks of the breach.

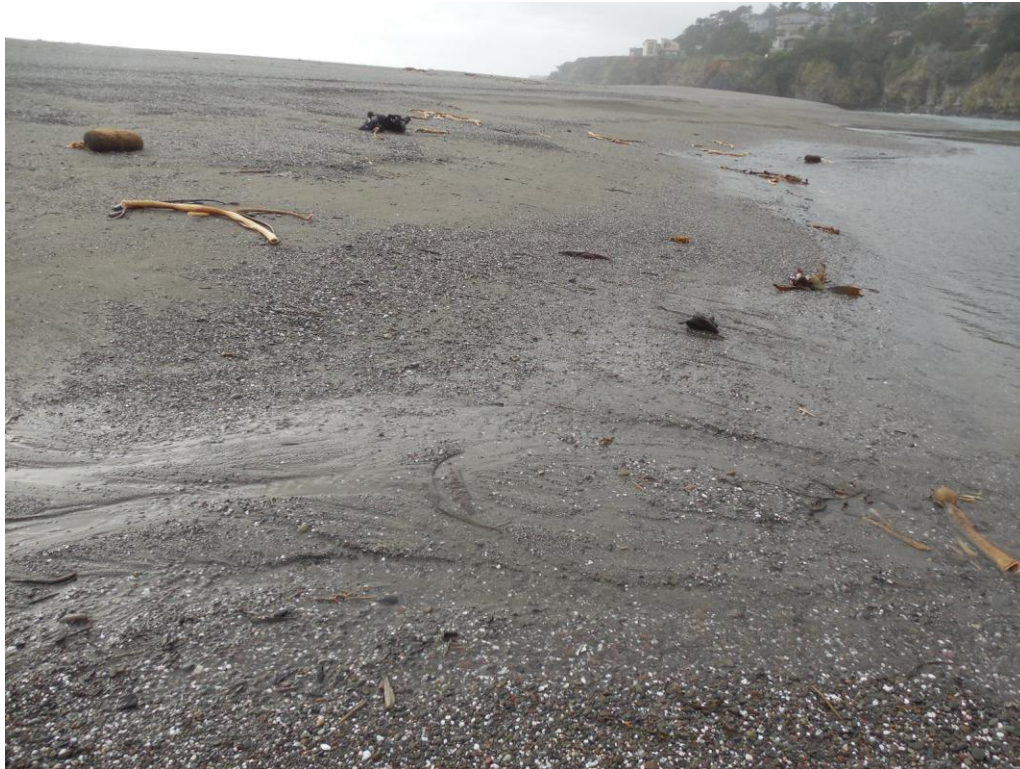
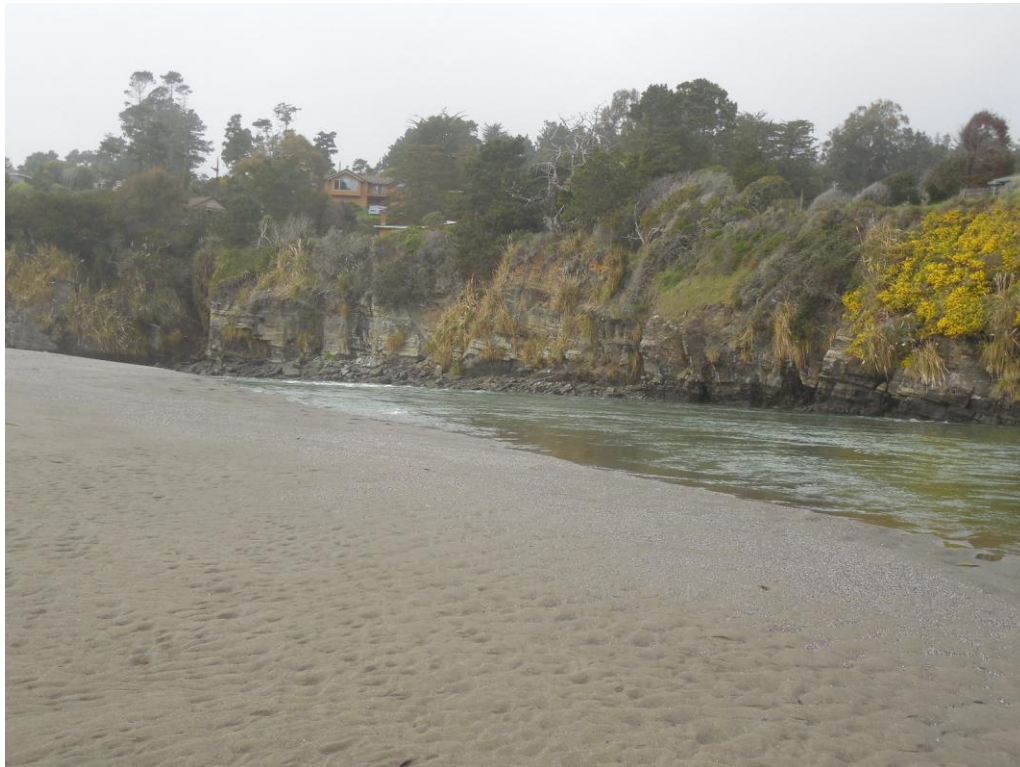
5:30 p.m. The lagoon water level falls over 2 m, exposing extensive sand and gravel flats in the lower lagoon. Beach groundwater rapidly discharges as flowing seeps and springs above the lagoon surface.

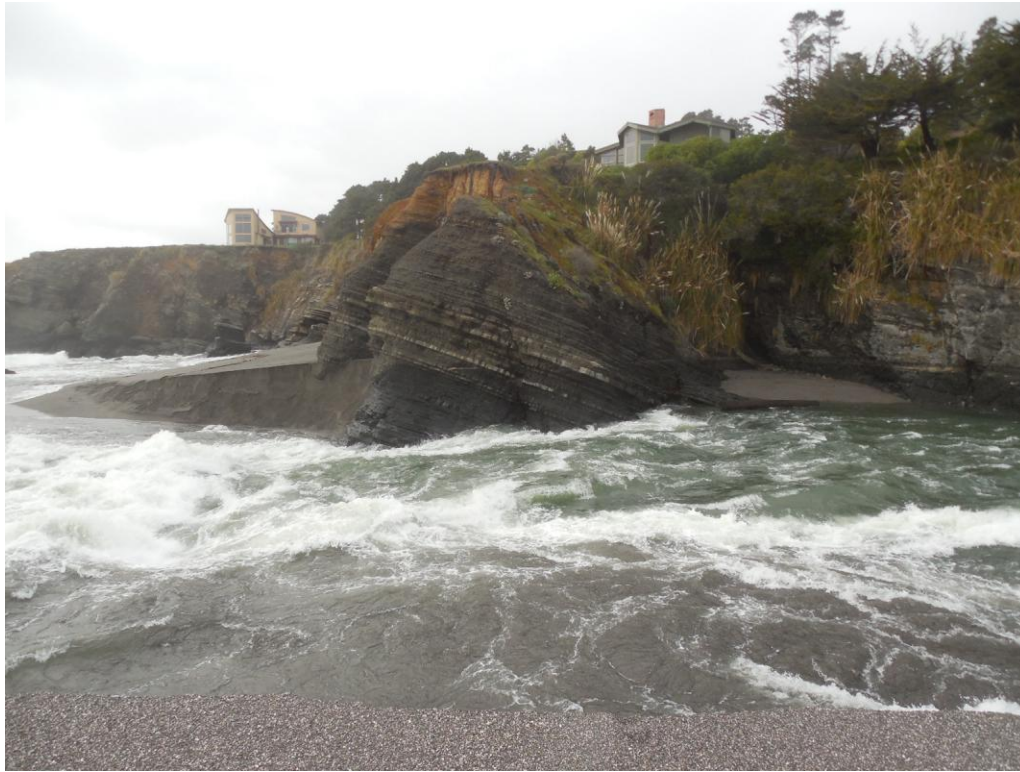
5:37 p.m. As the lagoon grows shallower after an hour of high discharge during low tide, outflows across the lagoon grow turbulent again, but more chaotic and complex than the cascade of jumps and standing waves in early breach stages. The full size outlet channel has widened to about 30 m.

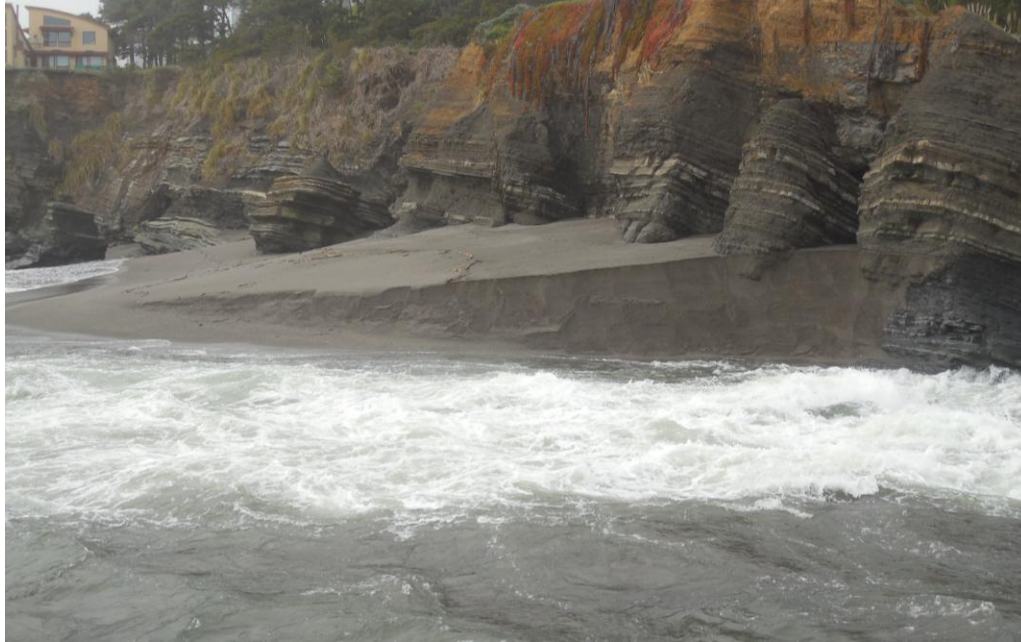
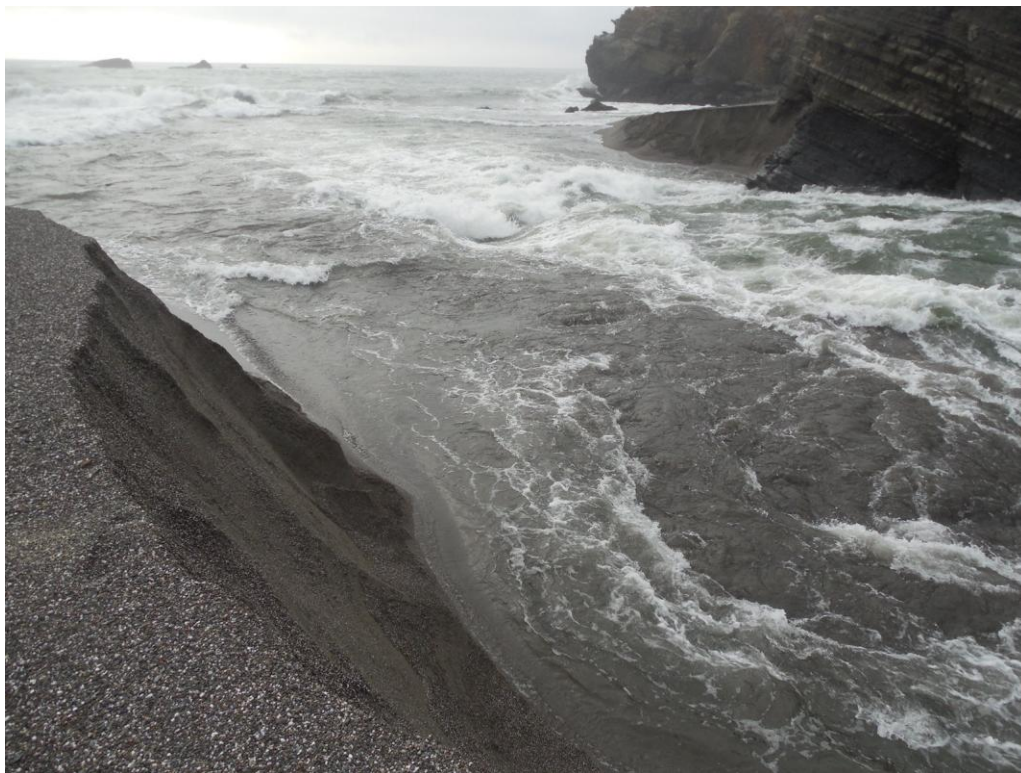
5:38-5:42 p.m. The beach scarp along the beach crest channel bank ranges about 3-4 m high. Slumping and widening has slowed as the tide rises and swell starts to enter the eroded channel, which begins to act as a tidal inlet.

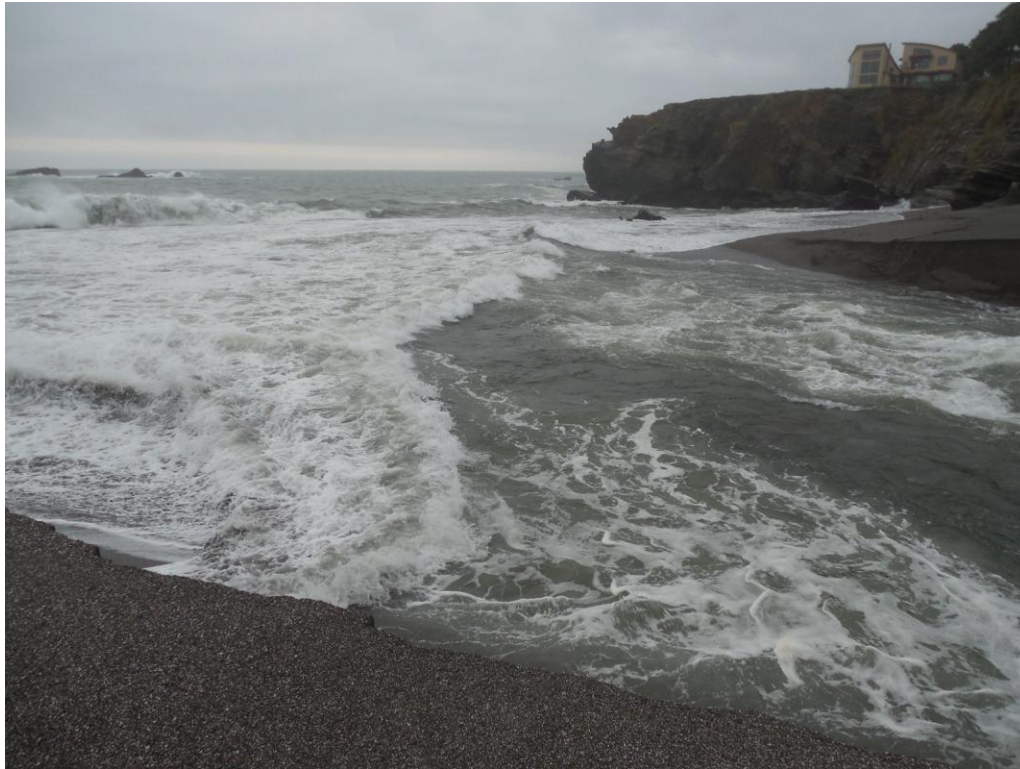
5:56 p.m. Breaking swell starts to enter the new deep tidal inlet throat.

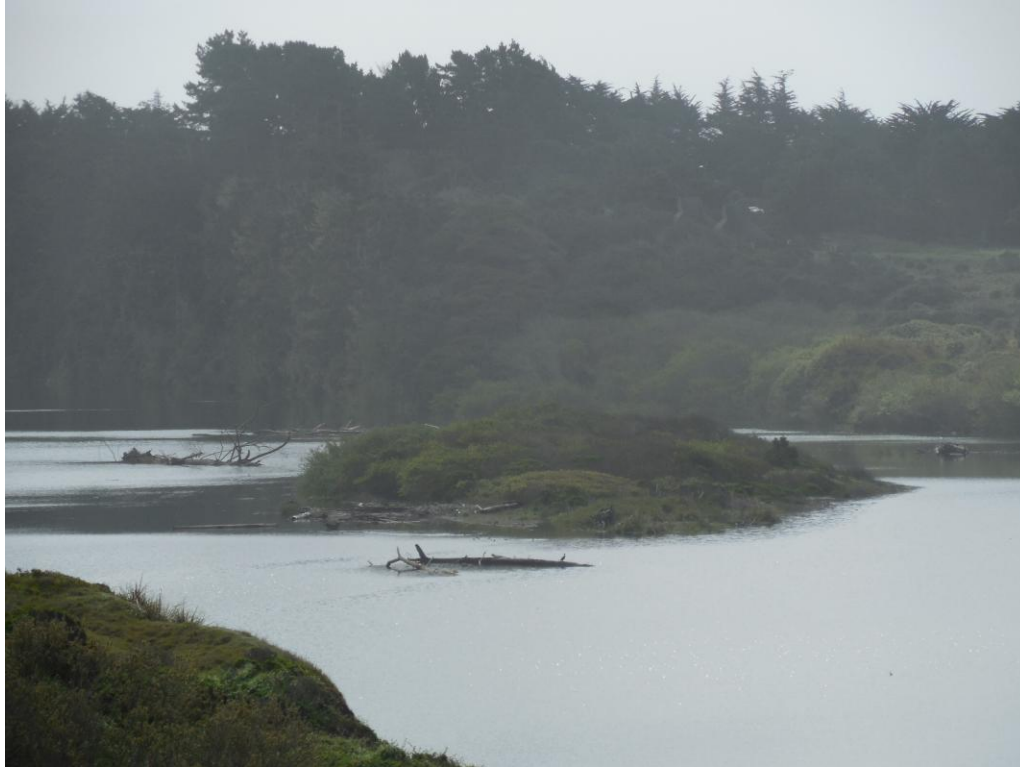
11:06 a.m. Near-full lagoon submerges the mid-channel bar island to the edge of vegetation.

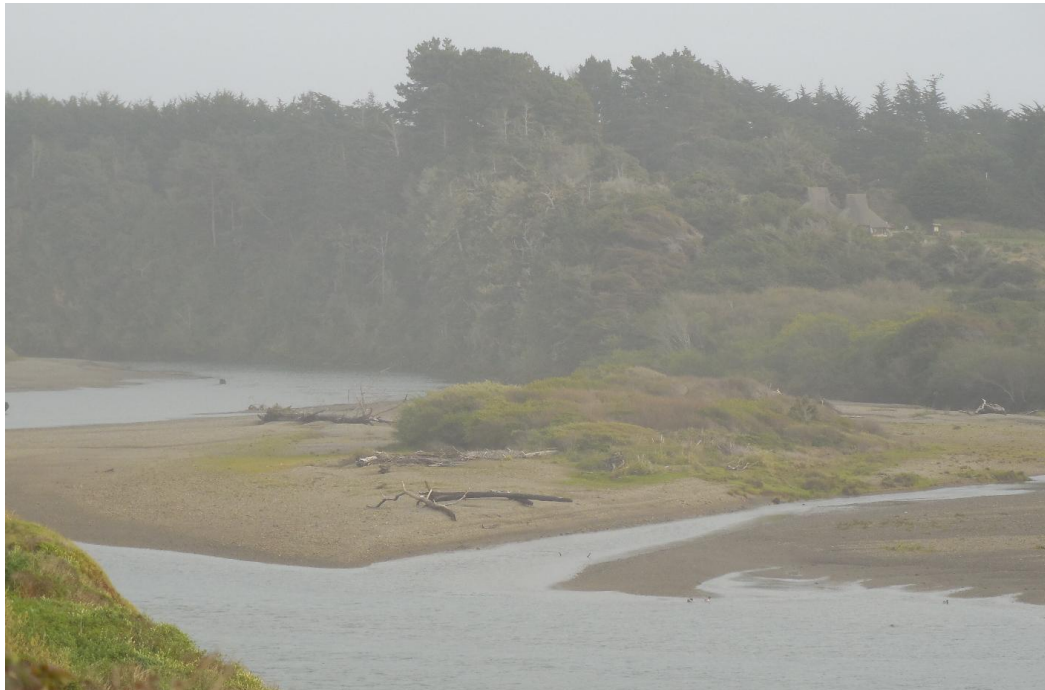
6:43 p.m. Mid-channel bar island gravel flats are emergent less than 2 hours after full breach.
